**VTT, Characterisation of probe test samples exposed to BLRB lower  
furnace environments – draft report 26.11.2012**

# Characterisation of probe test samples exposed to BLRB lower furnace environments

Author: Pekka Pohjanne

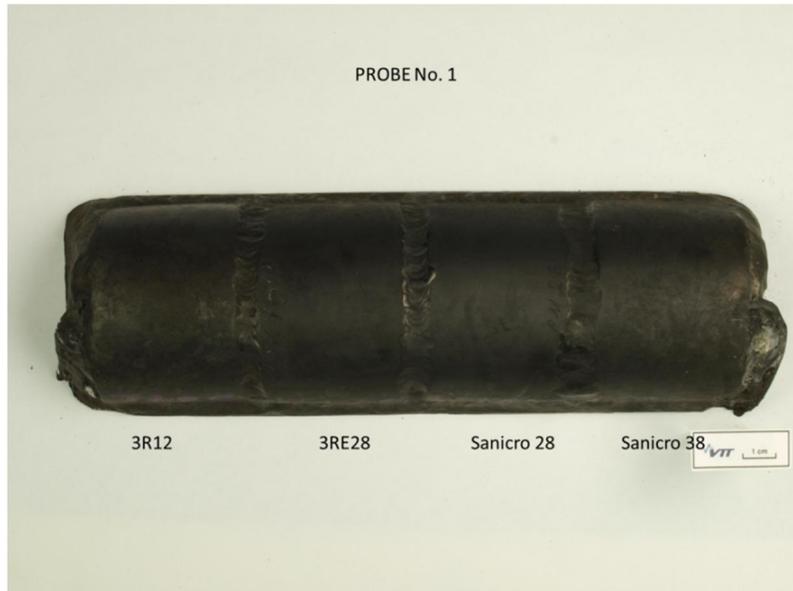
Total test duration of the test No. 1 was 1006 hours from which 906 hours at the target temperature of 440 °C. The test materials in this exposure were 3R12, 3RE28, Sanicro 28 and Sanicro 38, Figure 3. According to visual inspection all samples were in good condition after testing i.e. neither marked general or localised corrosion nor deposits or oxide scales were observed either on outer or inner surfaces.

Figure 3. Macrographs taken from the probe No. 1 head after exposure: a) outer surface exposed to the furnace side and b) inner surface exposed to the cooling liquid.

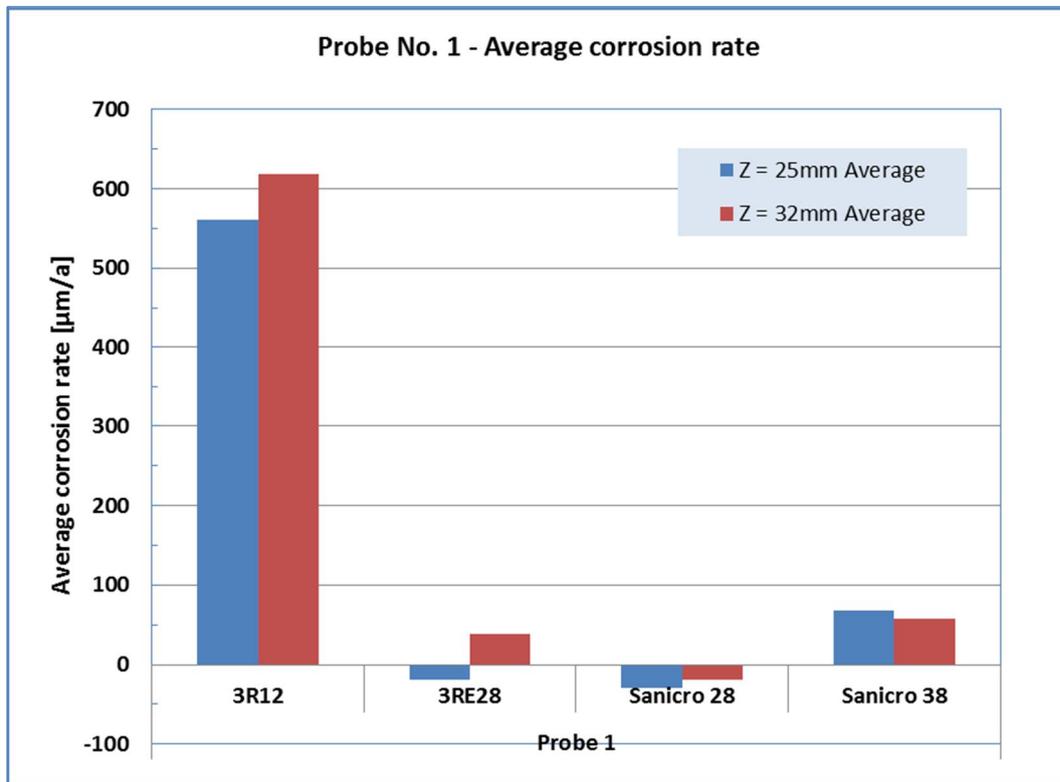
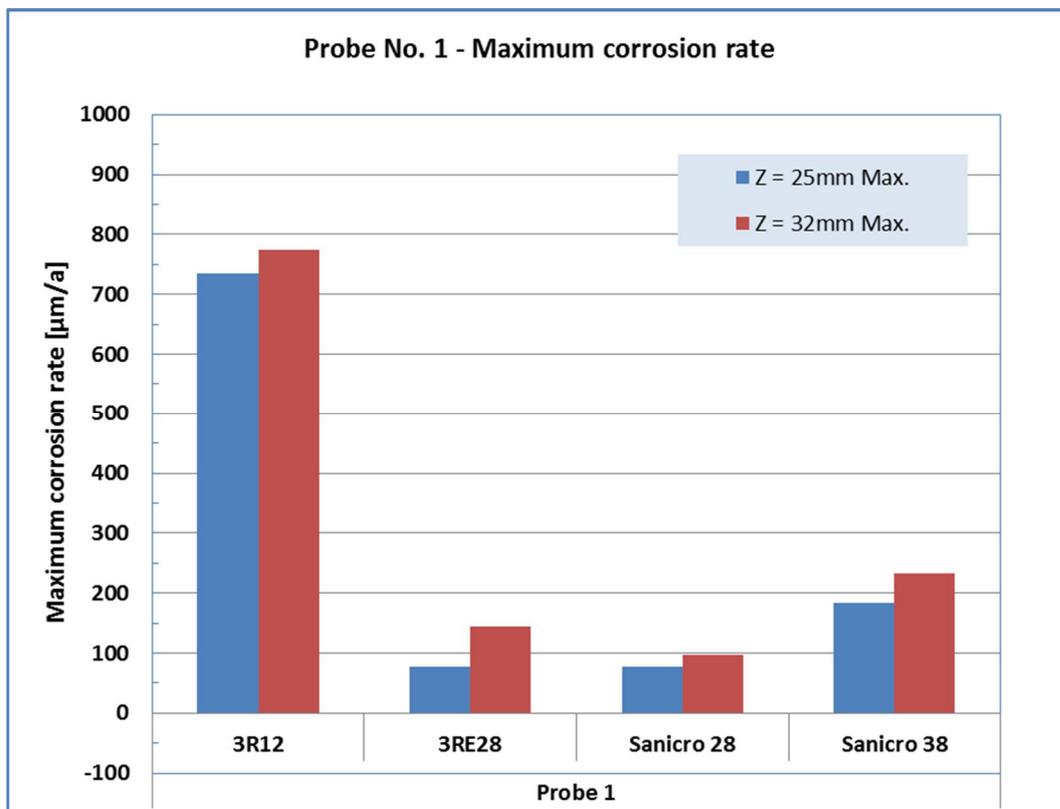
The average and maximum corrosion rates calculated on the basis of the wall thickness measurements are presented in Figure 12. In this test highest corrosion rate, order of 0.7 mm/a, was measured for the 3R12 material. Corrosion rate was next highest in the Sanicro 38, for which a maximum corrosion rate of ca. 0.2 mm/a was determined. The maximum corrosion rates of Sanicro 28 and 3RE28 materials were in the order of 0.1 mm/a and they were best performing materials in this test.

The reason to the negative values in average corrosion rates is that the washing and brushing with nylon brush was not effective enough to remove all deposits from the surfaces prior wall thickness measurements, indicating that average corrosion rates may give too optimistic result. Respectively the maximum corrosion rates may give too conservative results, if there are some problems in specimen alignment during WT measurements; this is a specific concern of samples with scratches or dents.

Figure 12. a) Average and b) maximum corrosion rates of the test materials calculated on the basis of the wall thickness measurements after 906 h exposure in lower furnace at 440 °C (Probe test No. 1).

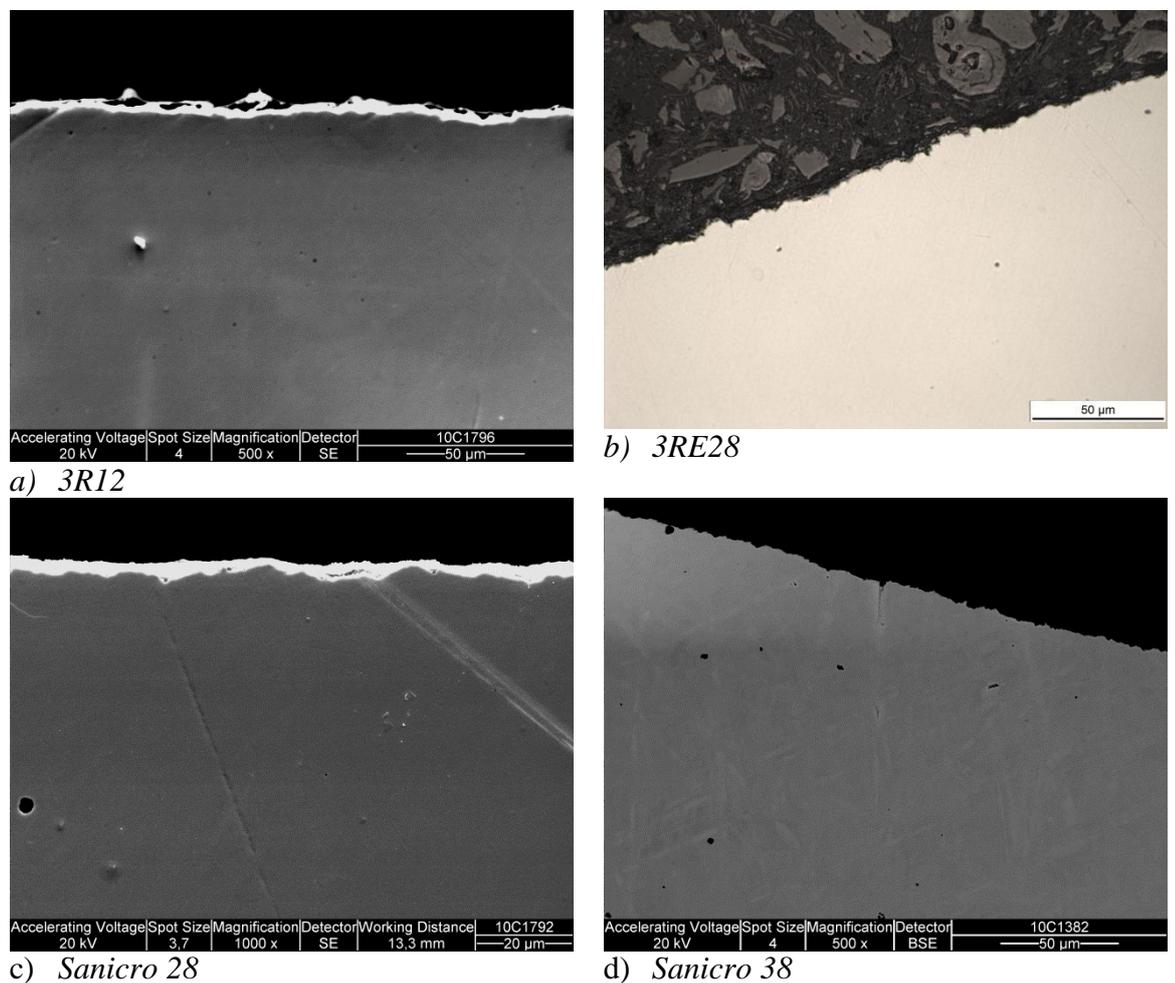
After the tests the samples were examined with optical microscope and/or SEM to determine the type of the corrosion attack. All samples had suffered from general thinning and no marked deposits or oxide/sulphide scales were observed, Figure 13. According to the EDS (Figure 14) analysis the thin layers (thickness ca. 5  $\mu\text{m}$ ) on 3RE28 and Sanicro 28 were depleted in iron and nickel and enriched in chromium and contained also high amounts of sulphur. Whereas the composition of thin layer on 3R12 was similar to the base material and no sulphur was detected.

Figure 13. Cross sections from a) 3R12, b) 3RE28, c) Sanicro 28 and d) Sanicro 38 after 906 h exposure in lower furnace at 440 °C (Probe test No. 1)

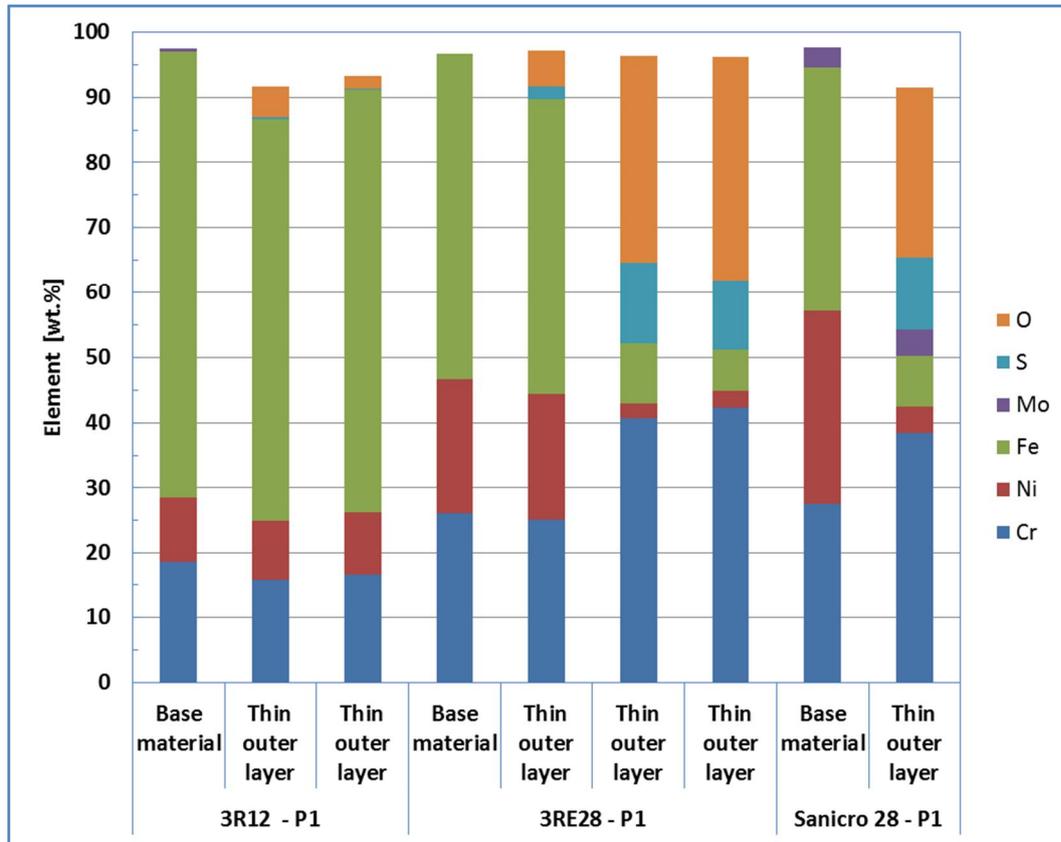
Figure 14. Results from the EDS analysis performed for the 3R12, 3RE28 and Sanicro 28 specimens after 906 h exposure in lower furnace at 440 °C (Probe test No. 1). Note: Quantitative results from cross sections, carbon excluded. Data from layers are from point analysis, whereas area analysis was used for base materials.

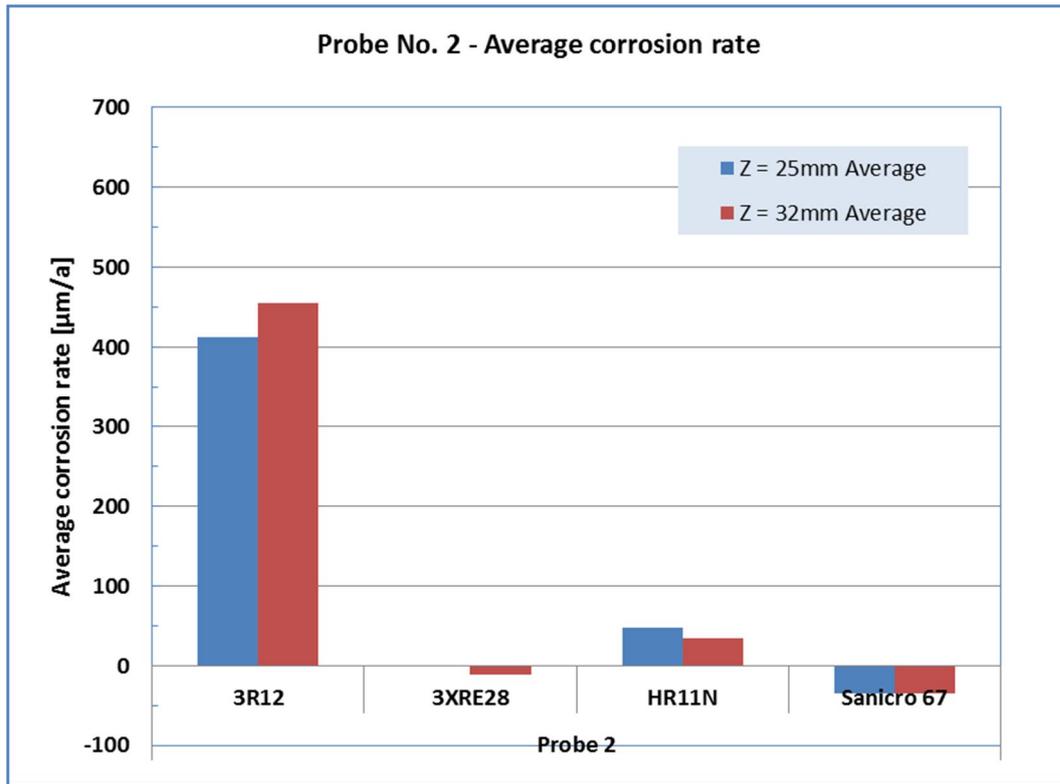
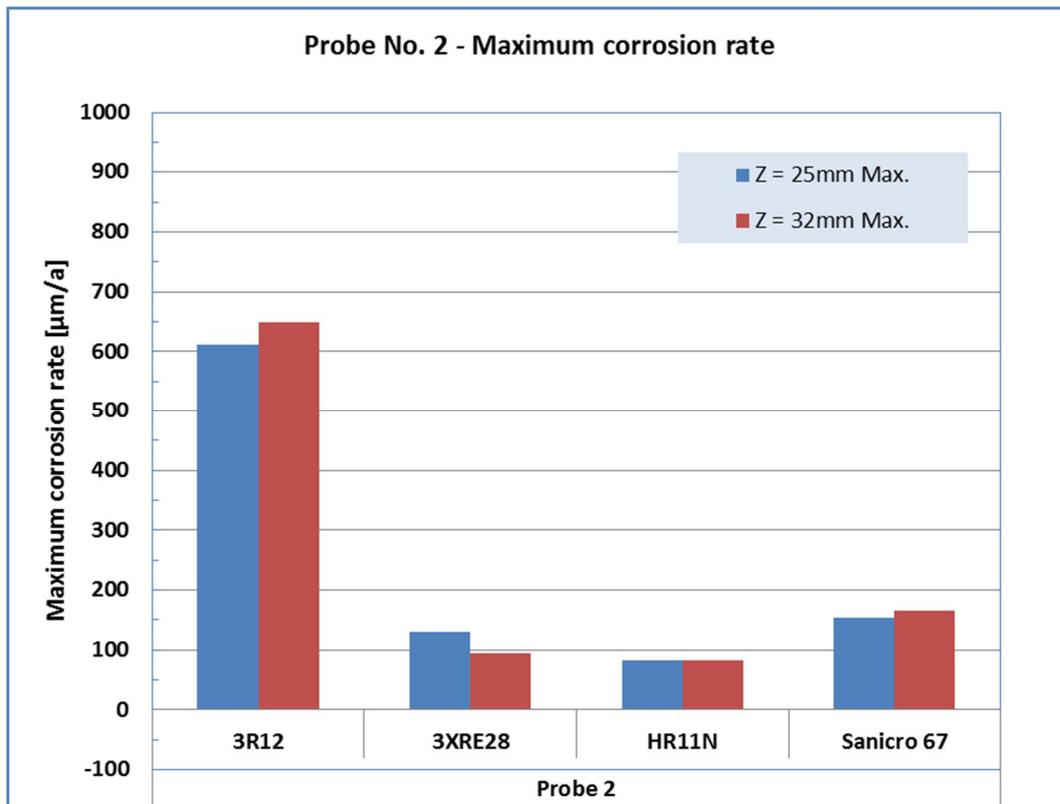
The results of the wall thickness profile measurements and the wall thinning curves derived from them are presented in Figures 16...23. The results showed that marked wall thinning had taken place on the 3R12 specimen and lesser degree also on the HR11N specimen. The data of the 3XRE28 and Sanicro 67 materials was more scattered showing that wall thinning and deposit formation (increase in wall thickness) had taken place locally. Measurements showed also that the wall thickness variations were smaller in the machined HR11N specimen than in the other specimens tested in as received condition. The average and maximum corrosion rates calculated on the basis of the wall thickness measurements are presented in Figure 12. In this test highest corrosion rate in the order of 0.6 mm/a was measured for the 3R12 material. The corrosion resistance of the 3XRE28, HR11N and Sanicro 67 was practically at the same level.

Figure 24. a) Average and b) maximum corrosion rates of the test materials calculated on the basis of the wall thickness measurements after 744 h exposure in lower furnace at 440 °C (Probe test No. 2).

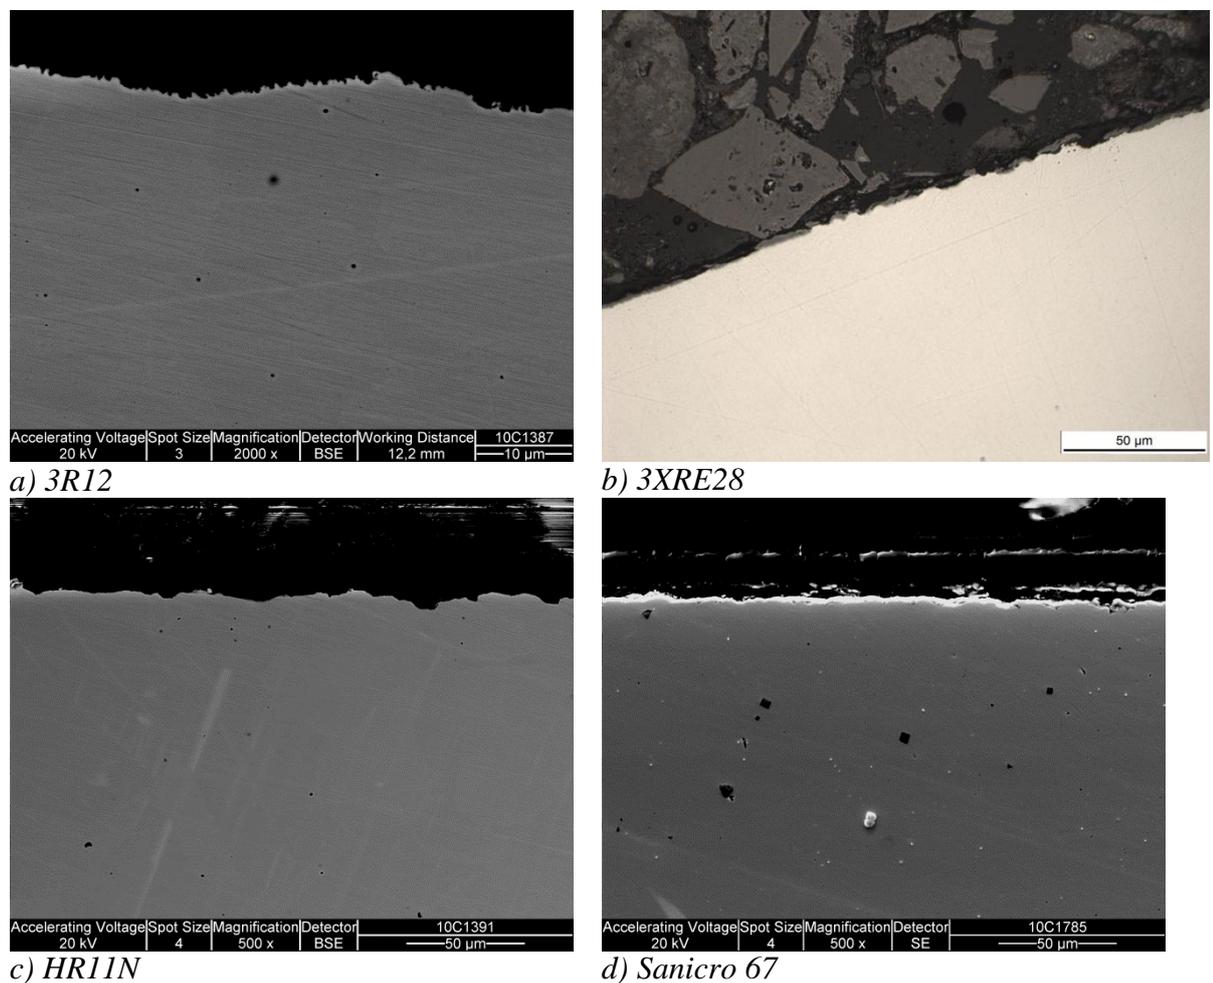
After the tests the samples were examined with optical microscope and/or SEM to determine the type of the corrosion attack. All samples had suffered from general thinning and no marked deposits or oxide/sulphide scales were observed on the surfaces, Figure 25. According to the EDS analysis (Figure 26) the thin, a few  $\mu\text{m}$  thick layer, observed on 3XRE28 was depleted in iron and nickel and enriched in chromium and contained also high amounts of sulphur. The similar thin layer on Sanicro 67 contained high amounts of sulphur and was depleted in nickel and iron whereas chromium content was at the same level than in the base material.

Figure 25. Cross sections from a) 3R12, b) 3XRE28, c) HR11N and d) Sanicro 67 after 744 h exposure in lower furnace at 440 °C (Probe test No. 2)

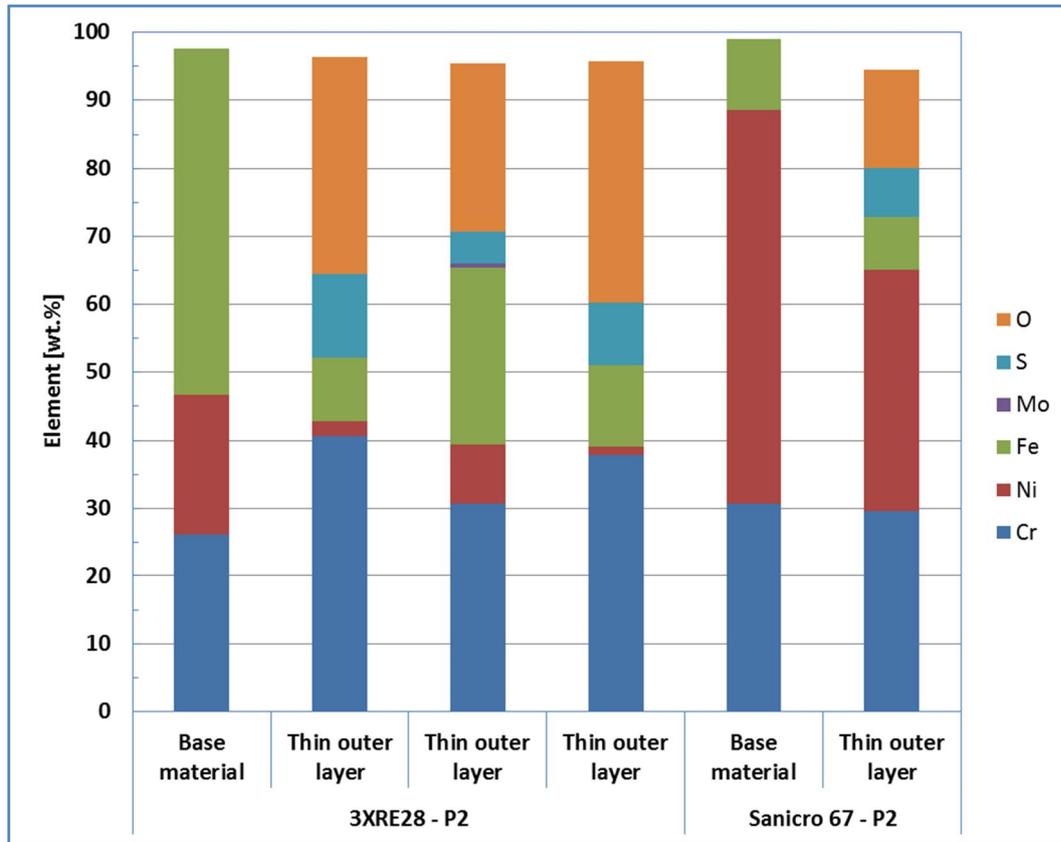
Figure 26. Results from the EDS analysis performed for the 3XRE28 and Sanicro 67 specimens after 744 h exposure in lower furnace at 440 °C (Probe test No. 2). Note: Quantitative results from cross sections, carbon excluded. Data from layers are from point analysis, whereas area analysis was used for base materials.

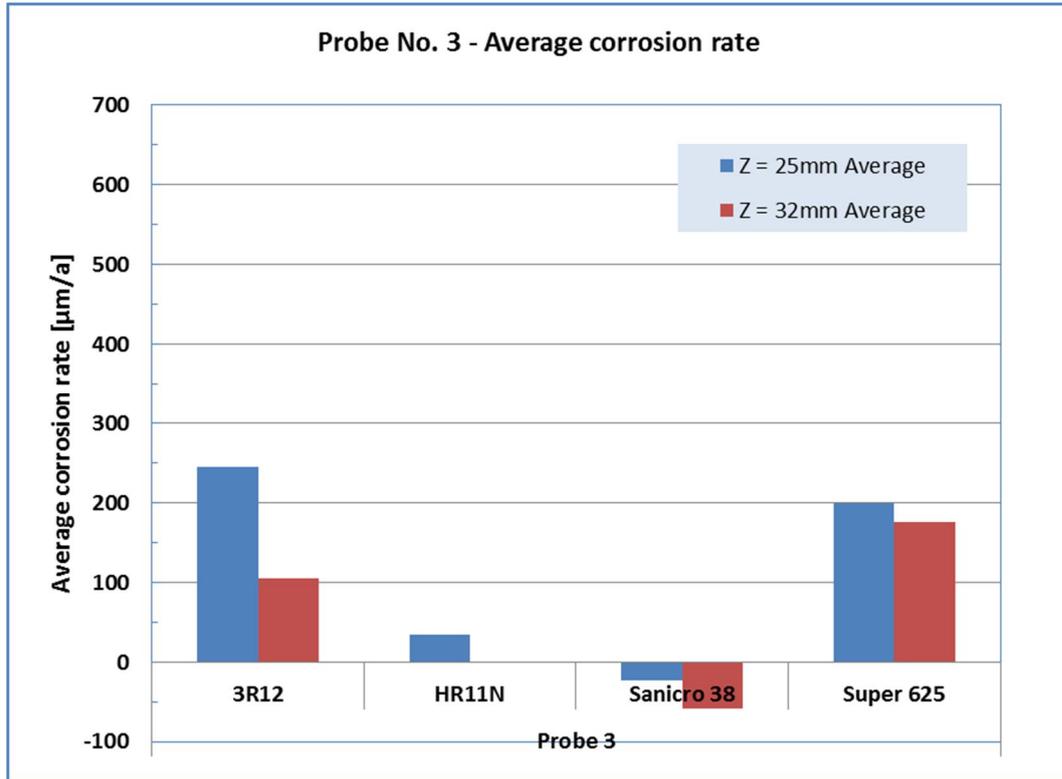
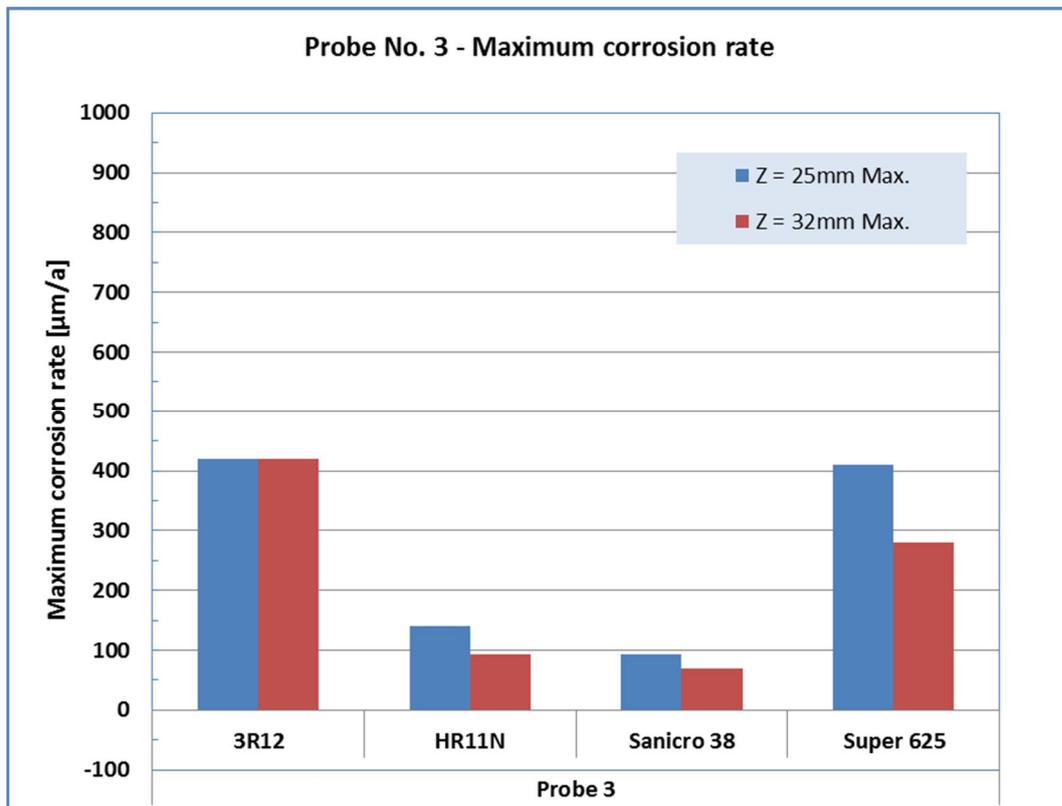
The average and maximum corrosion rates calculated on the basis of the wall thickness measurements are presented in Figure 36. In this test the corrosion rate of 3R12 was in the order 0.4 mm/a, i.e. about 0.2 mm/a lower than in the first two tests, most probably due the lower probe temperature. The corrosion rate of the Super 625 was unexpectedly high ca. 0.3...0.4mm/a. The maximum corrosion rates of HR11N and Sanicro 38 were in the order of 0.1 mm/a, and they were best performing materials in this test.

Figure 36. a) Average and b) maximum corrosion rates of the test materials calculated on the basis of the wall thickness measurements after 750 h exposure in lower furnace at 430 °C (Probe test No. 3)

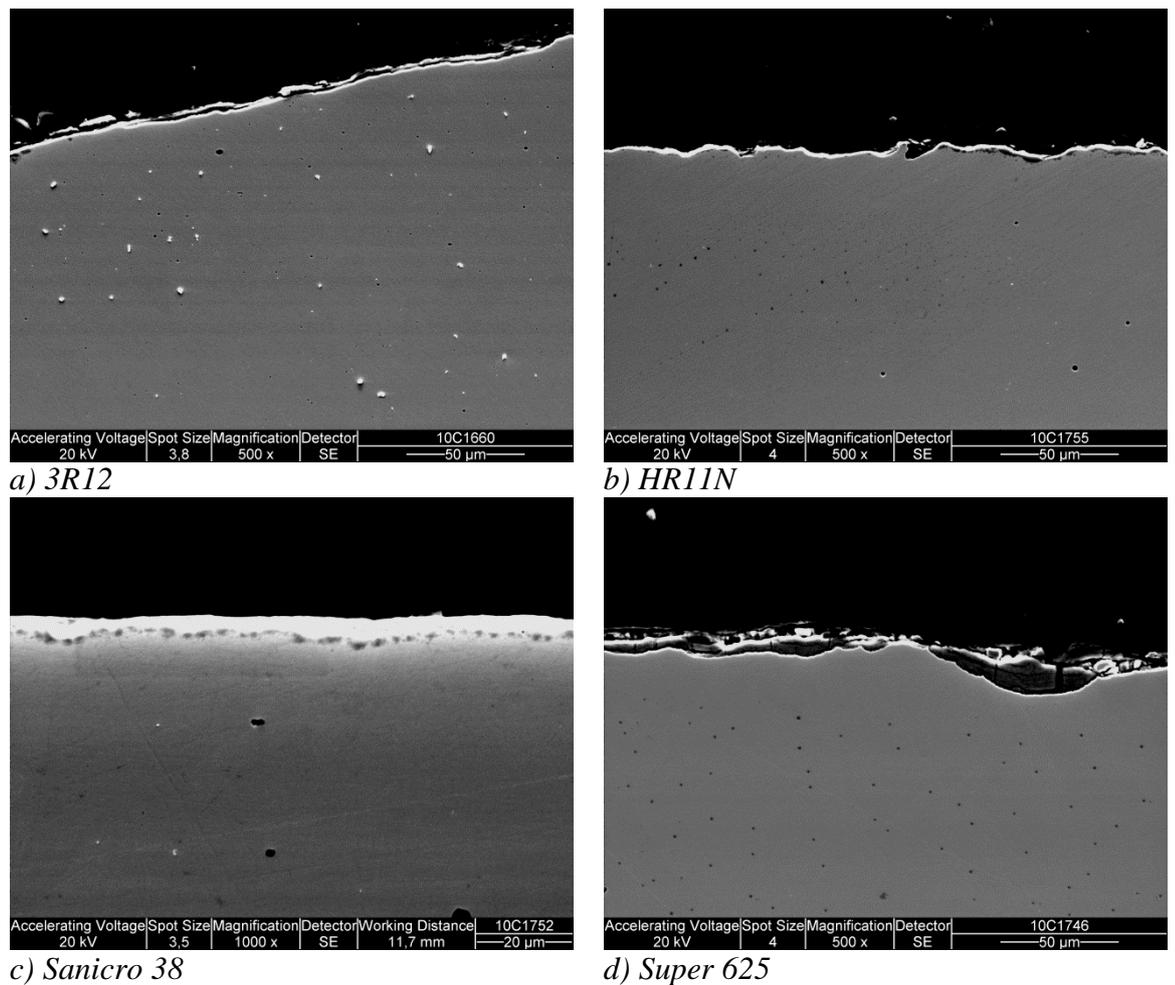
After the tests the samples were examined with optical microscope and/or SEM to determine the type of the corrosion attack. All samples had suffered from general thinning. The layers formed on 3R12, HR11N and Sanicro 38 were thin ca. 5  $\mu\text{m}$  in thickness. Whereas on the Super 625 ca. 10...20  $\mu\text{m}$  thick peeling like scale was observed.

Figure 37. Cross sections from a) 3R12, b) HR11N, c) Sanicro 38 and d) Super 625 after 750 h exposure in lower furnace at 430 °C (Probe test No. 3)

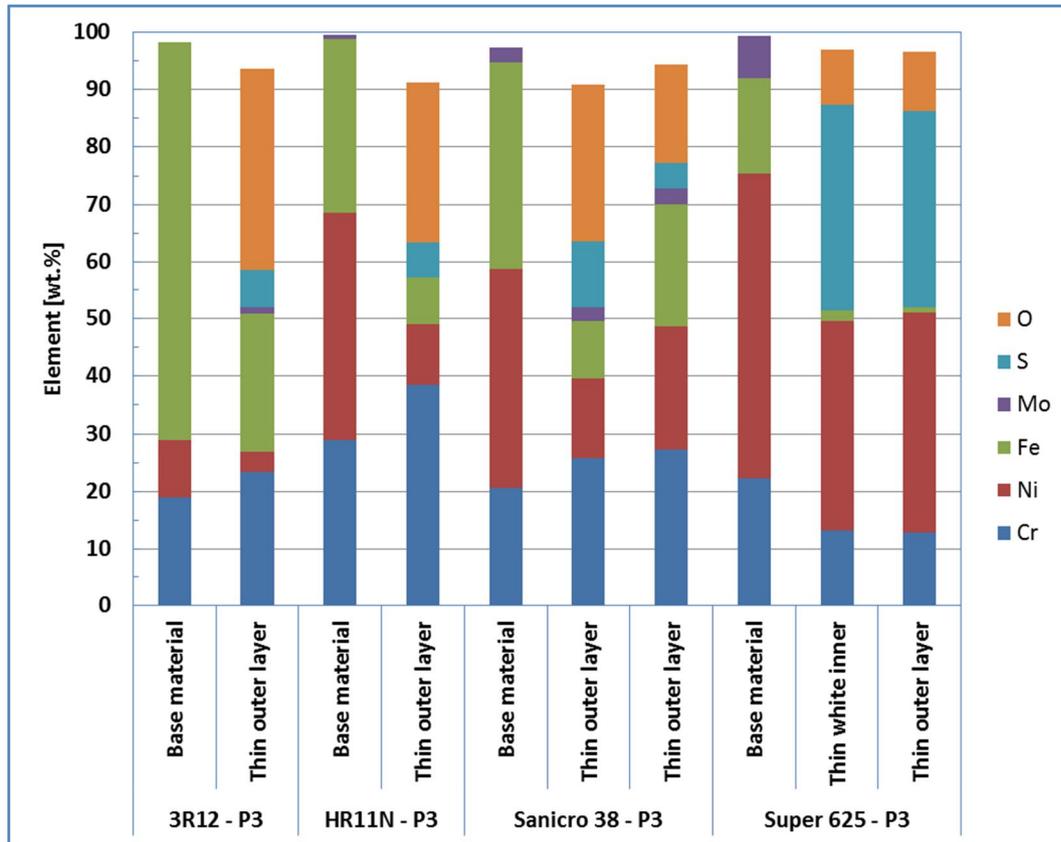
According to the EDS analysis (Figure 38) the layers on 3R12, HR11N and Sanicro 38 were depleted in iron and nickel and enriched in chromium and contained also sulphur. The layers on the Super 625 were depleted in iron, nickel, molybdenum and chromium and contained high amounts of sulphur. Reference analysis made from unexposed reference samples showed that the depleted/enriched layers are formed during exposure and do not originate from the specimen manufacturing process.

Figure 38. Results from the EDS analysis performed for the 3R12, HR11N, Sanicro 38 and Super 625 specimens after 750 h exposure in lower furnace at 430 °C (Probe test No. 3). Note: Quantitative results from cross sections, carbon excluded. Data from layers are from point analysis, whereas area analysis was used for base materials.

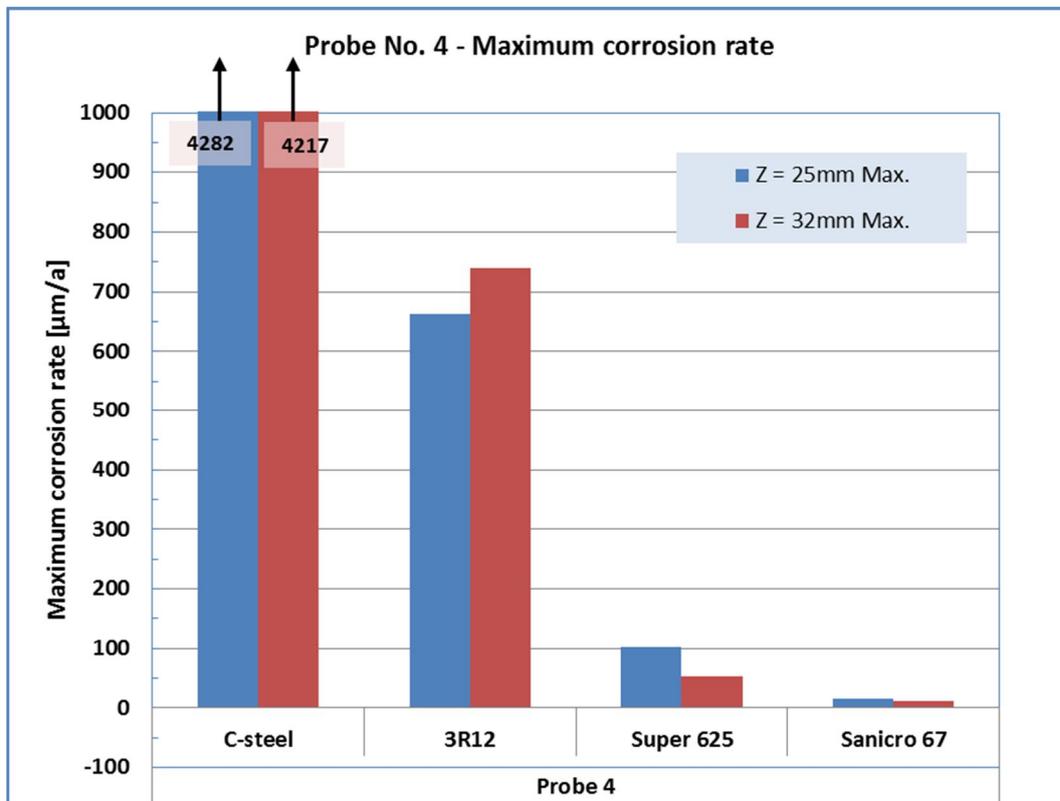
The average and maximum corrosion rates calculated on the basis of the wall thickness measurements are presented in Figure 48. Highest corrosion rates, ca. 4 mm/a, were measured for the carbon steel as expected. The 3R12 had the second highest corrosion rates, order of 0.6 mm/a. Maximum corrosion rate of the Super 625 was in the order 0.1 mm/a in this test, i.e. significantly lower than in the test No.3, where a maximum corrosion rate of 0.2...0.3 mm/a was observed. The best material in this test was Sanicro 67, its maximum corrosion rate was only about 0.02 mm/a.

Figure 48. a) Average and b) maximum corrosion rates of the test materials calculated on the basis of the wall thickness measurements after 2154 h exposure in lower furnace at 440 °C (Probe test No. 4).

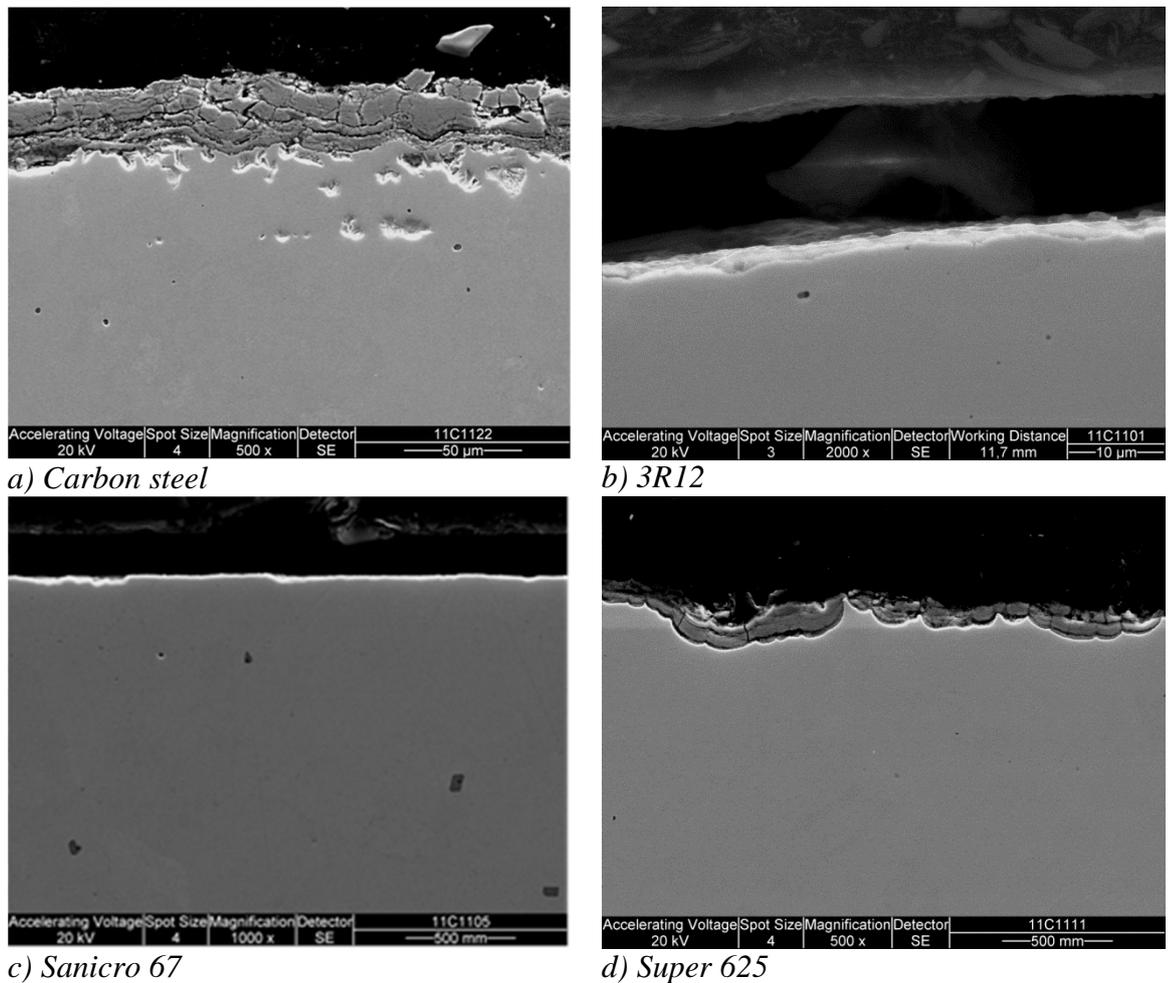
After the tests the samples were examined with optical microscope and/or SEM to determine the type of the corrosion attack. All samples had suffered from general thinning, Figure 49. The carbon steel showed scale thickness of about 25  $\mu\text{m}$  after 2700 h exposure. The layers formed on 3R12 and Sanicro 67 were thin ca.5  $\mu\text{m}$  in thickness. Whereas on the Super 625 ca. 10...20  $\mu\text{m}$  thick peeling like scale was observed.

Figure 49. Cross sections from a) carbon steel b) 3R12, c) Sanicro 67 and d) Super 625 after 2154 h exposure in lower furnace at 440 °C (Probe test No. 4).

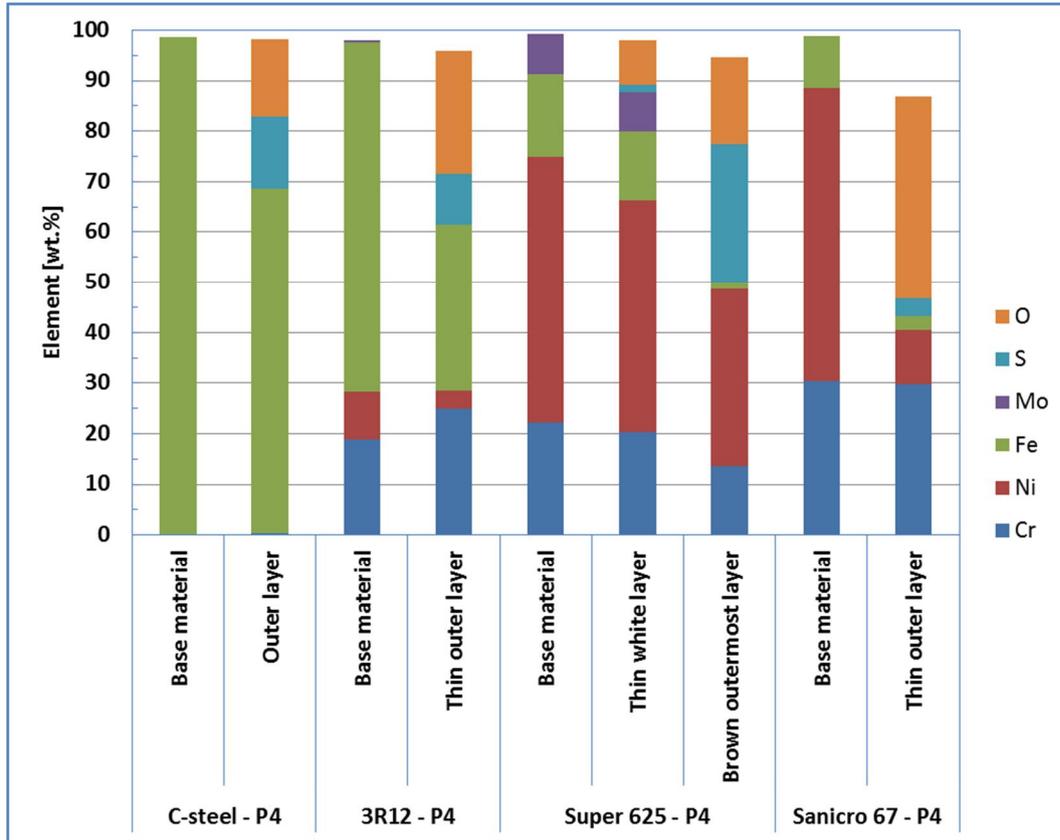
According to the EDS analysis (Figure 50) the layer on 3R12 was depleted in iron and nickel and enriched in chromium and contained also sulphur. The layer on Sanicro 67 contained sulphur and was depleted in iron and nickel, but the chromium content was at the same level than in the base material. The outermost layers on the Super 625 were depleted in iron, nickel, molybdenum and chromium and contained high amounts of sulphur.

Figure 50. Results from the EDS analysis performed for the carbon steel, 3R12, Sanicro 67 and Super 625 after 2154 h exposure in lower furnace at 440 °C (Probe test No. 4). Note: Quantitative results from cross sections, carbon excluded. Data from layers are from point analysis, whereas area analysis was used for base materials.

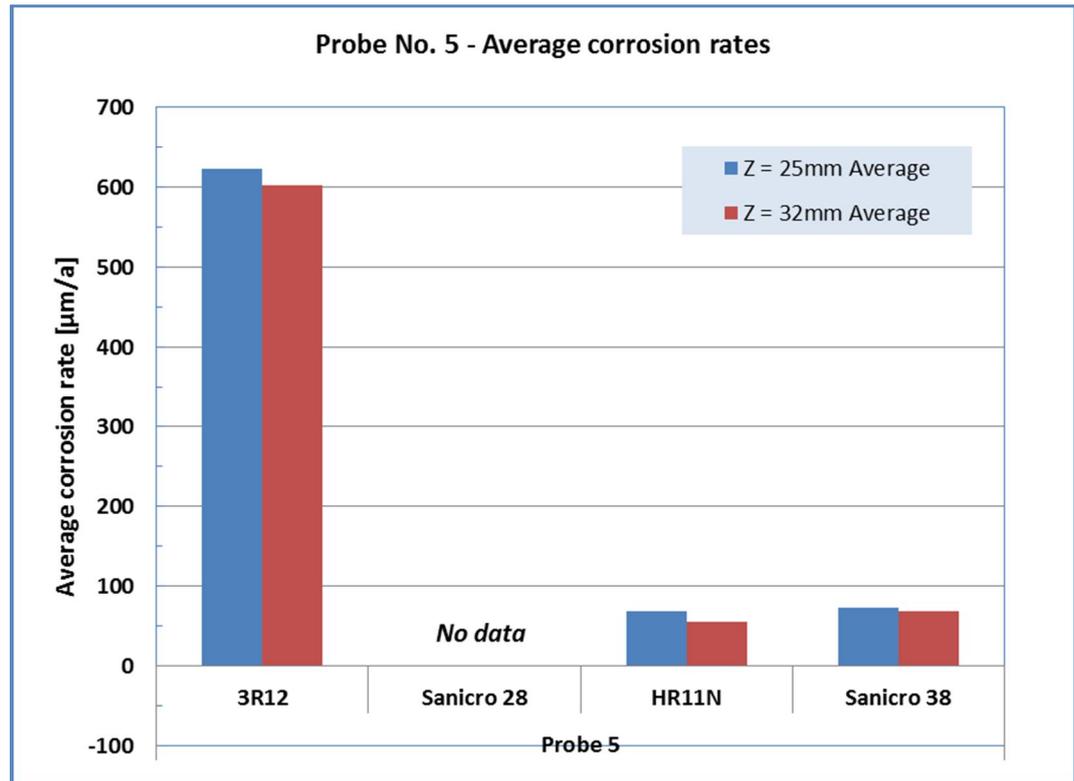
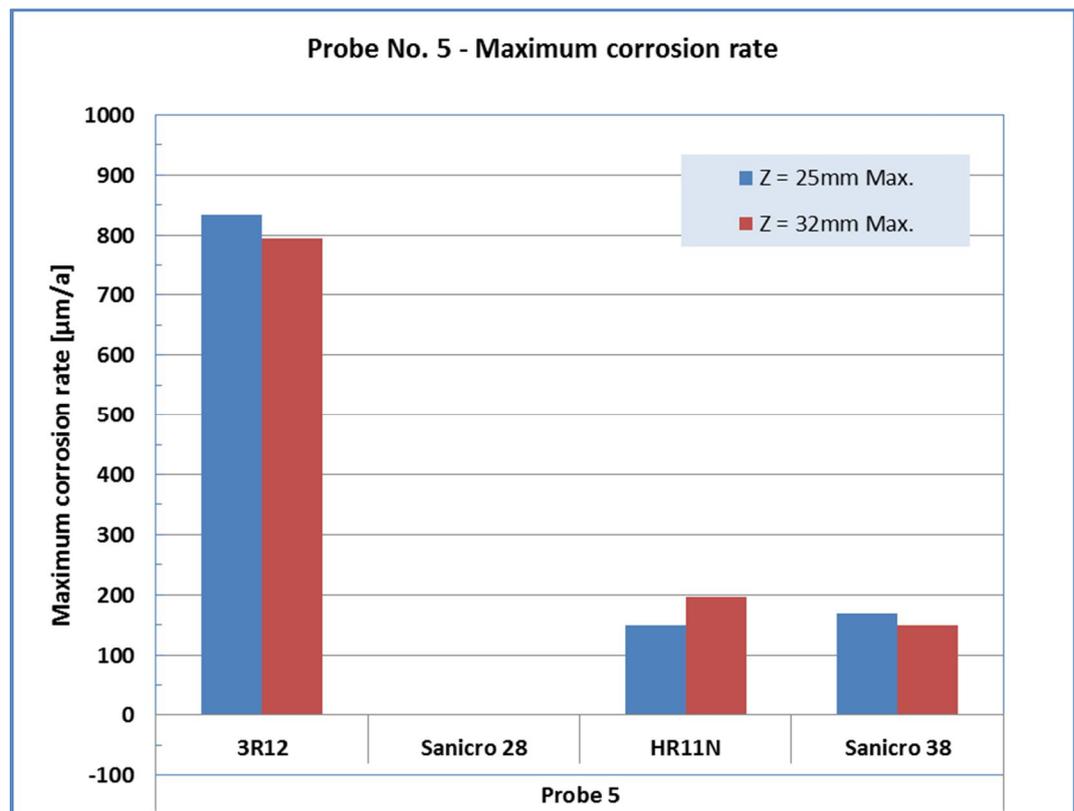
The average and maximum corrosion rates calculated on the basis of the wall thickness measurements are presented in Figure 48. In this test the corrosion rate of the 3R12 was in the order 0.8 mm/a. The maximum corrosion rates of HR11N and Sanicro 38 were in the order of 0.15 mm/a, i.e. at the same range than in the previous tests.

Figure 58. a) Average and b) maximum corrosion rates of the test materials calculated on the basis of the wall thickness measurements after 2157 h exposure in lower furnace at 440 °C (Probe test No. 5).

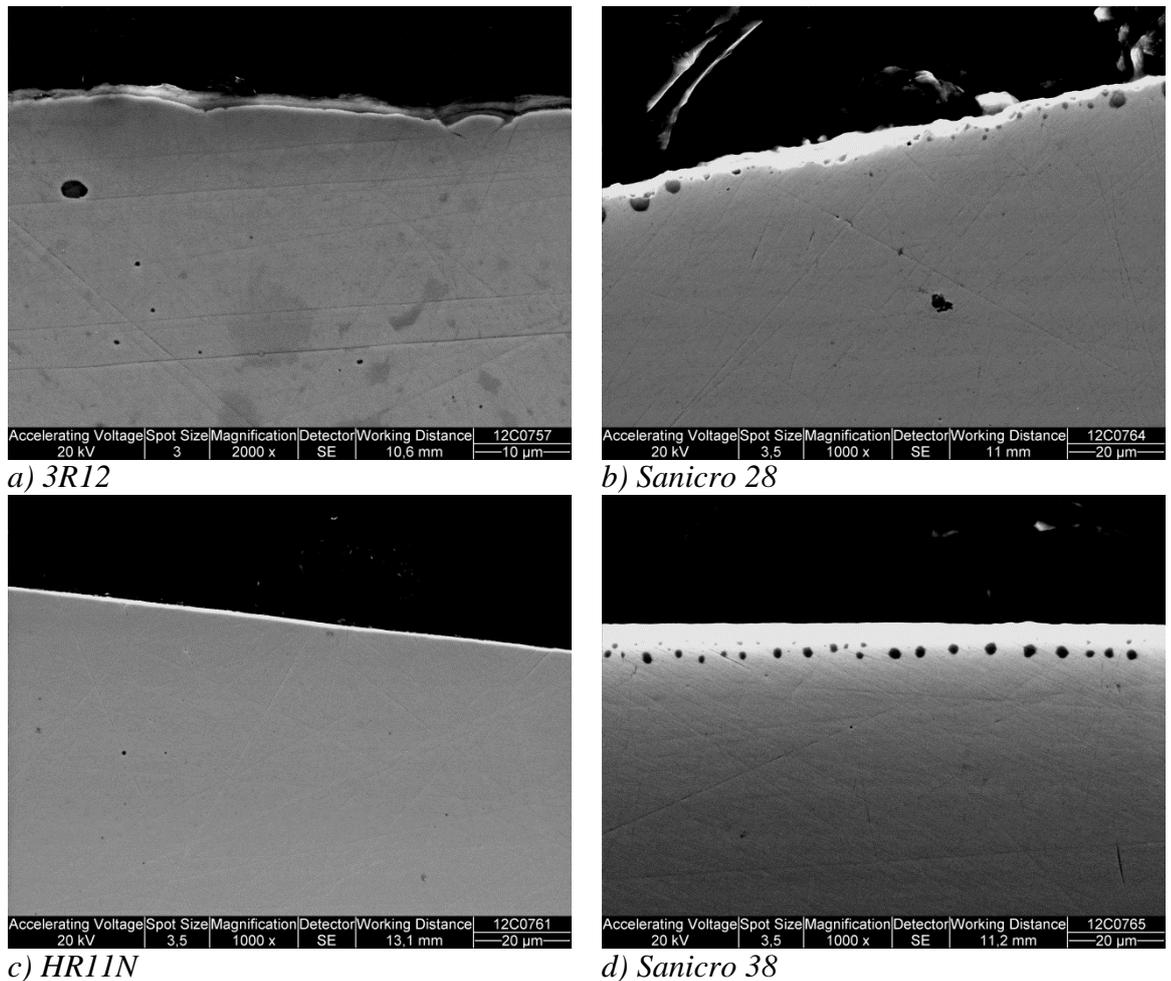
After the tests the samples were examined with optical microscope and/or SEM to determine the type of the corrosion attack. All samples had suffered from general thinning and no marked deposits or oxide/sulphide scales were observed on the surfaces, Figure 49. The layers found on 3R12, Sanicro 28, HR11N and Sanicro 38 were very thin ca. 2  $\mu\text{m}$  in thickness. EDS analysis showed that iron and nickel depletion and chromium enrichment had taken place in some locations in all materials and that in these locations sulphur was also detected (Figure 50).

Figure 59. Cross sections from a) 3R12, b) Sanicro 28, c) HR11N and d) Sanicro 38 after 2157 h exposure in lower furnace at 440 °C (Probe test No. 5).

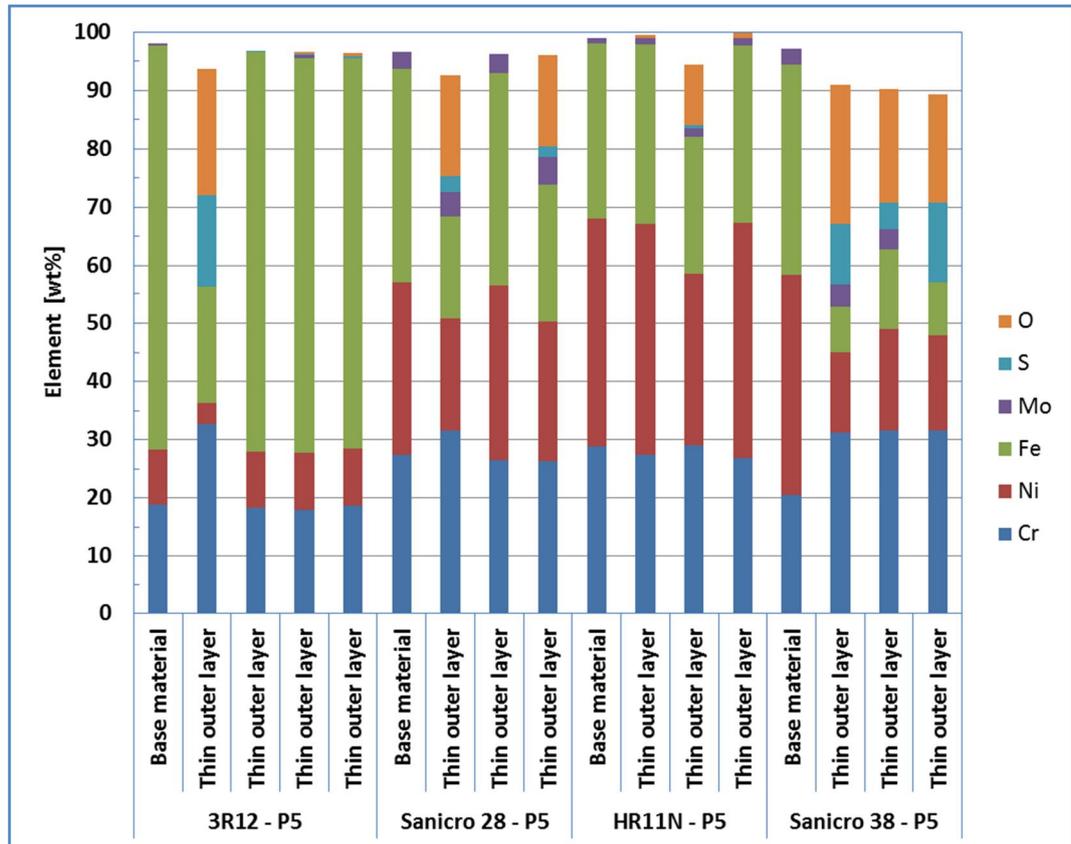
Figure 60. Results from the EDS analysis performed for the 3R12, Sanicro 28, HR11N and Sanicro 38 after 2157 h exposure in lower furnace at 440 °C (Probe test No. 5). Note: Quantitative results from cross sections, carbon excluded. Data from layers are from point analysis, whereas area analysis was used for base materials.

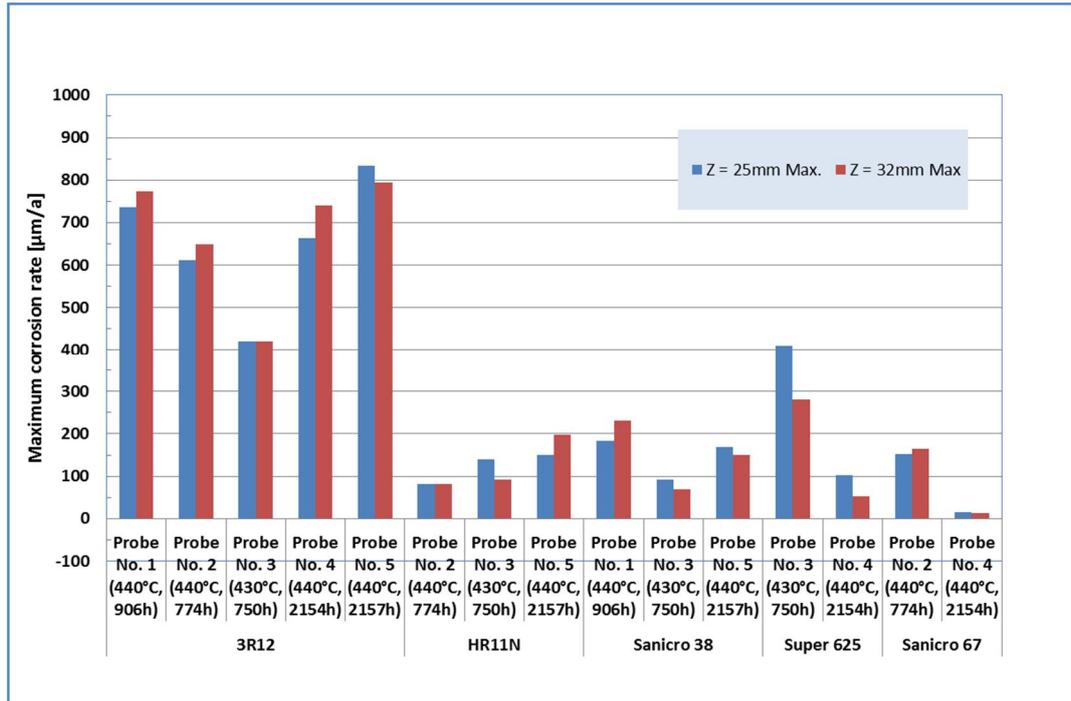
In current tests no marked differences were observed between Sanicro 38 and HR11N. Their maximum corrosion rates were in the order of 0.15...0.2 mm/a in the long term (>2000 h) test, i.e. about four times lower than that of the 3R12 (Figure 61).

The results for the Super 625 were inconsistent. In short term 750 h test at 430 °C it's corrosion resistance was only slightly better than that of the 3R12, but in the long term 2154 h test at 440 °C it's resistance was even better than that of the Sanicro 38 and HR11N (Figure 62). Similar kind of behaviour was observed in Sanicro 67. In short term 744 h test at 440 °C it's corrosion resistance was only slightly better than that of the Sanicro 38 and HR11N, but in the long term 2154 h test at 440 °C it's corrosion rate was only 1/10 of that of the Sanicro 38 and HR11N and 1/5 of the Super 625.

Figure 61. Calculated maximum corrosion rates for the 3R12, HR11N, Sanicro 38, Super 625 and Sanicro 67 materials from the probe test No. 1 - 5.

Tests showed that polishing together with longer exposure time improves the accuracy, both of which are recommended to be used in future tests and especially when evaluating highly alloyed materials.
