**VTT, Characterisation of probe test samples exposed to BLRB lower  
furnace environments – draft report 26.11.2012**

# Characterisation of probe test samples exposed to BLRB lower furnace environments

Author: Pekka Pohjanne

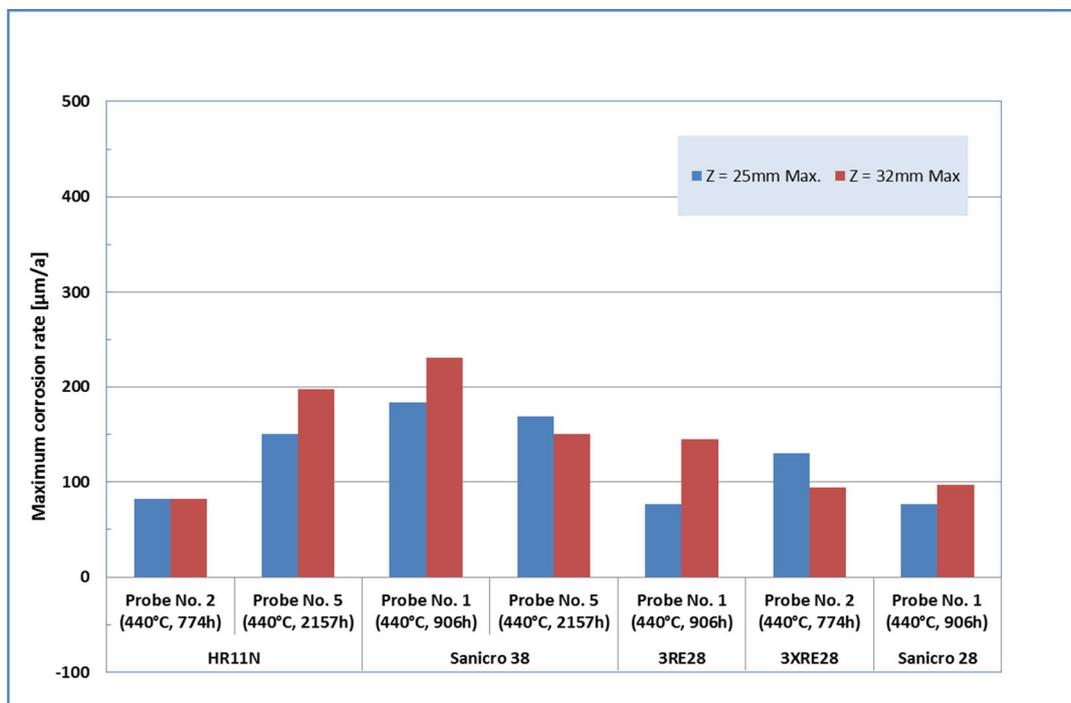
In short term (<1000 h) tests the corrosion resistance of the 3RE28, 3XRE28 and Sanicro 28 were as good as or even slightly better than that of the Sanicro 38 or HR11N (Figure 62). Because the 3RE28 and 3XRE28 were not included in the long term tests and no results were obtained for the Sanicro 28 from the long term test No. 5, due to the misplaced thermocouple, it is recommended to verify their promising performance with long term tests in the future.

Figure 62. Calculated maximum corrosion rates for the 3RE28, 3XRE28, HR11N and Sanicro 38 from the probe test No. 1-3 and 5.
