**Sulakourujen materiaalitutkimus, VTT – KMP esitys 23.1.2020**

# Sulakourujen materiaalitutkimus

Konemestaripäivät 23.01.2020  
Sanni Yli-Olli  
Satu Tuurna

# SOODAKATTILAN AJO-OLOSUHTEET JA TULIPESÄN ALAOSAN KORROOSIO

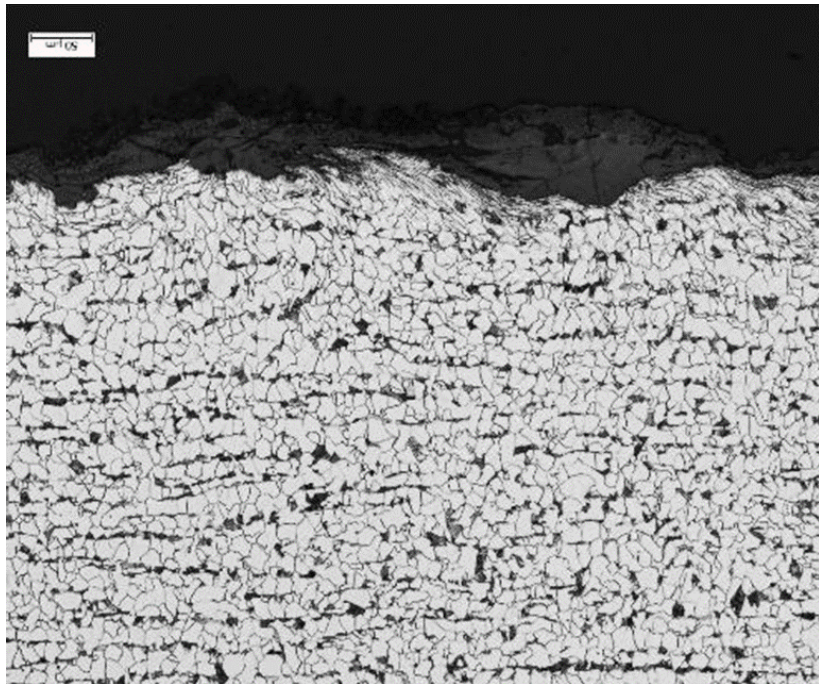
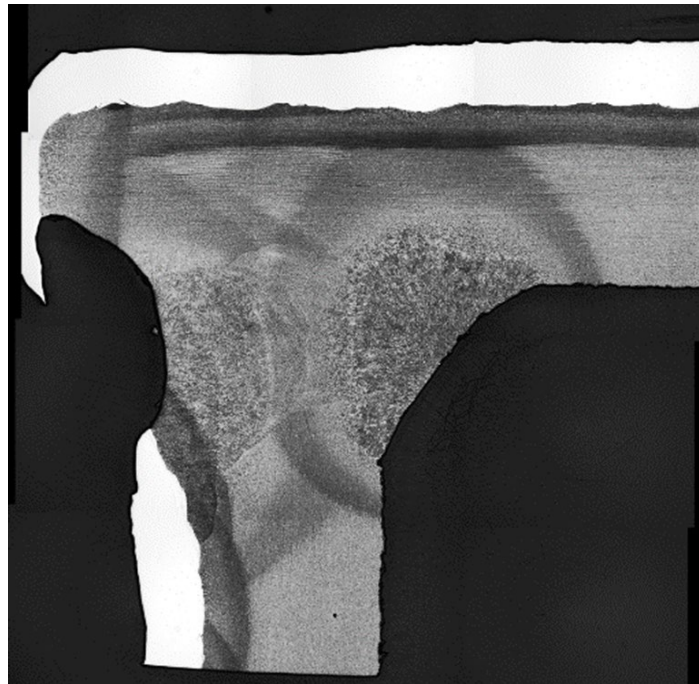
# Laitos 1 – U:n mallinen kouru

- pinnoittamattomalta kourun pohjalla suolakerrostumia sekä pieniä, matalia säröjä
- pinnoitetussa jättöpäässä syöpymäkuoppa
- ajojakso 12 kk

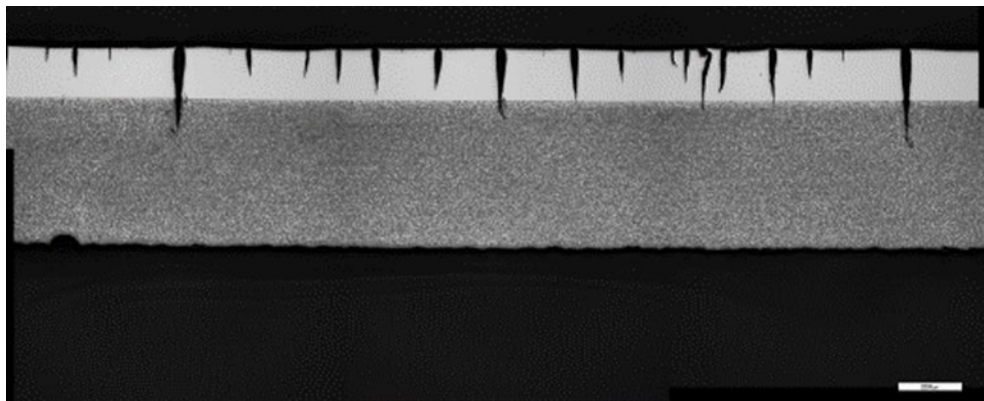
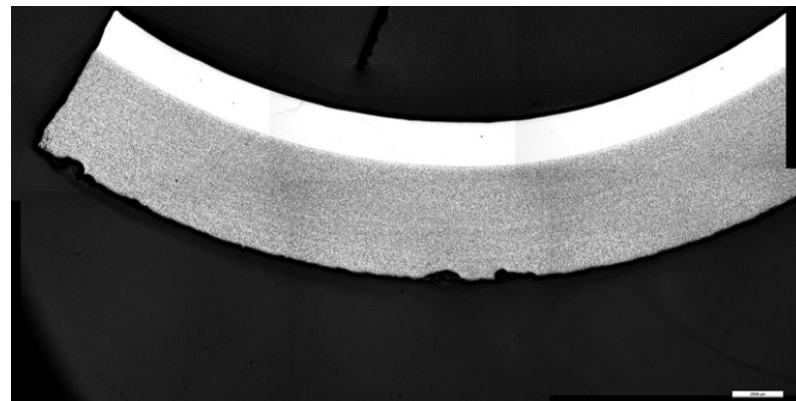
## Laitos 2 – V:n mallinen compound -kouru

- seinämällä perusaineeseen ulottuvia säröjä, syvimät yli 3000  $\mu\text{m}$
- ajojakso 18 kk

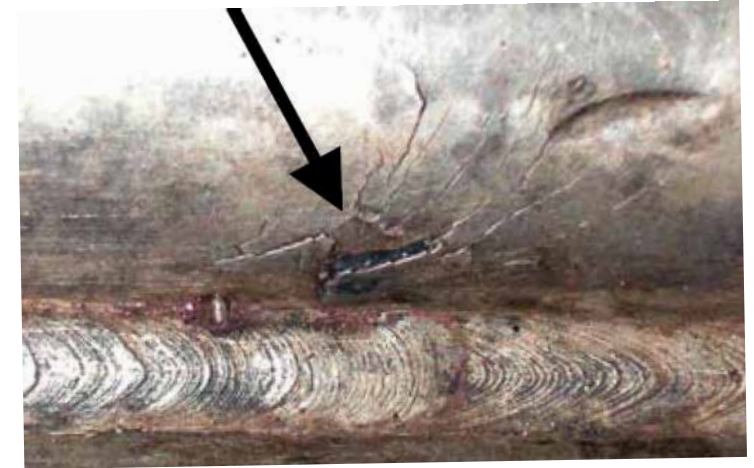
1. Stress corrosion cracking of composite floors

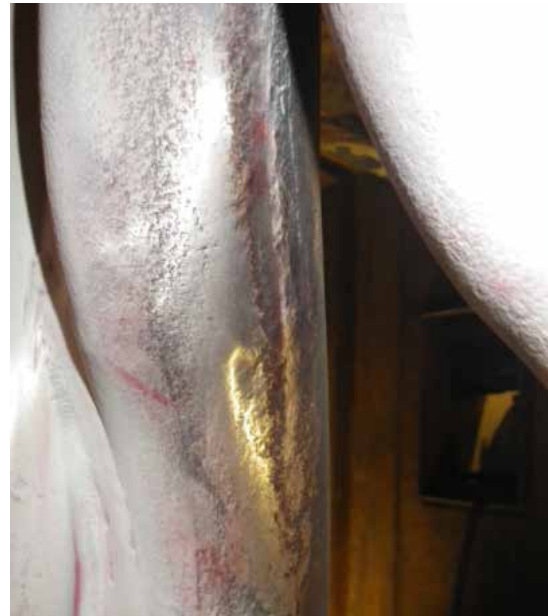
2. "Cold side" NaOH corrosion of primary air ports

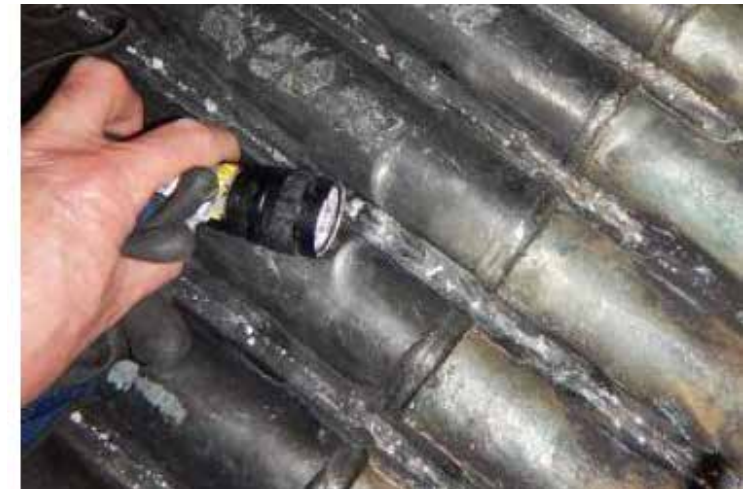
3. "Galvanic"-corrosion of the carbon-composite butt-welds in the floor tubes

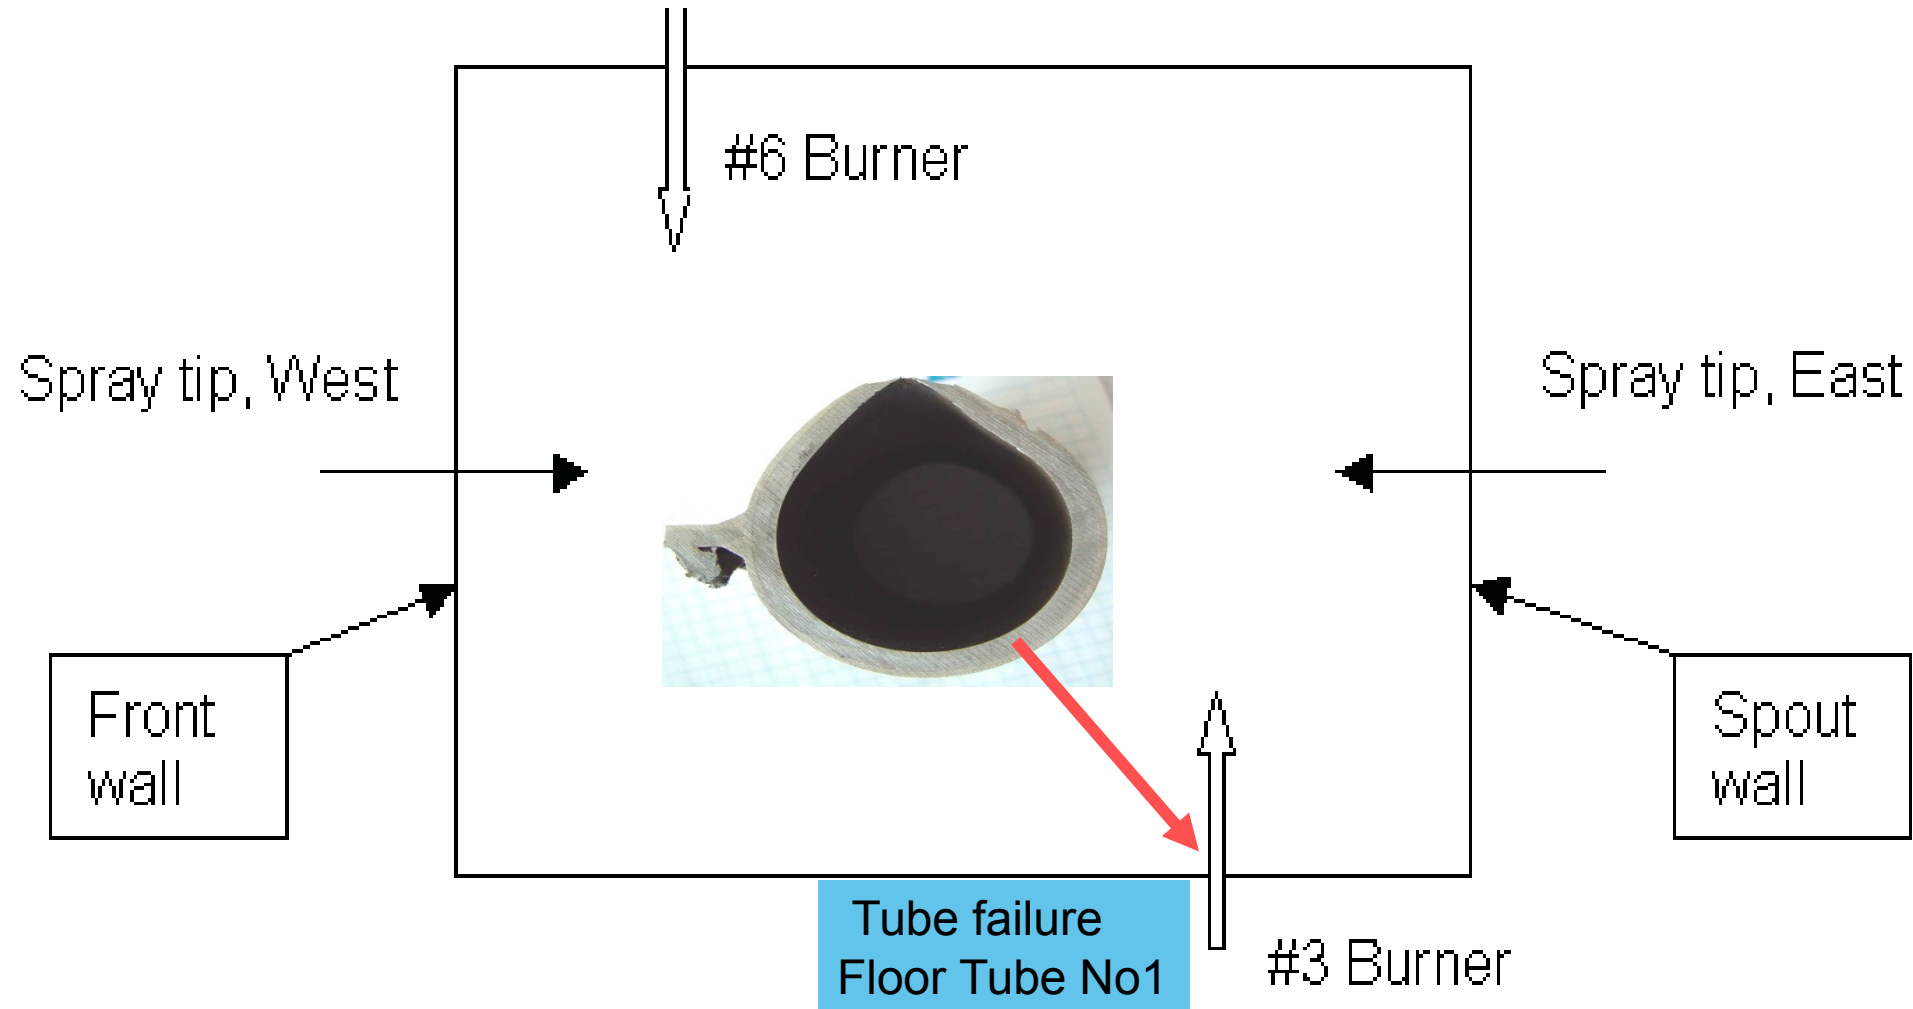
Local floor tube cracks and a leak due to tube material overheating. *Local high char bed, "hot spot"*

Rec. Boiler 800 tds/d, DS 70%, splash plates

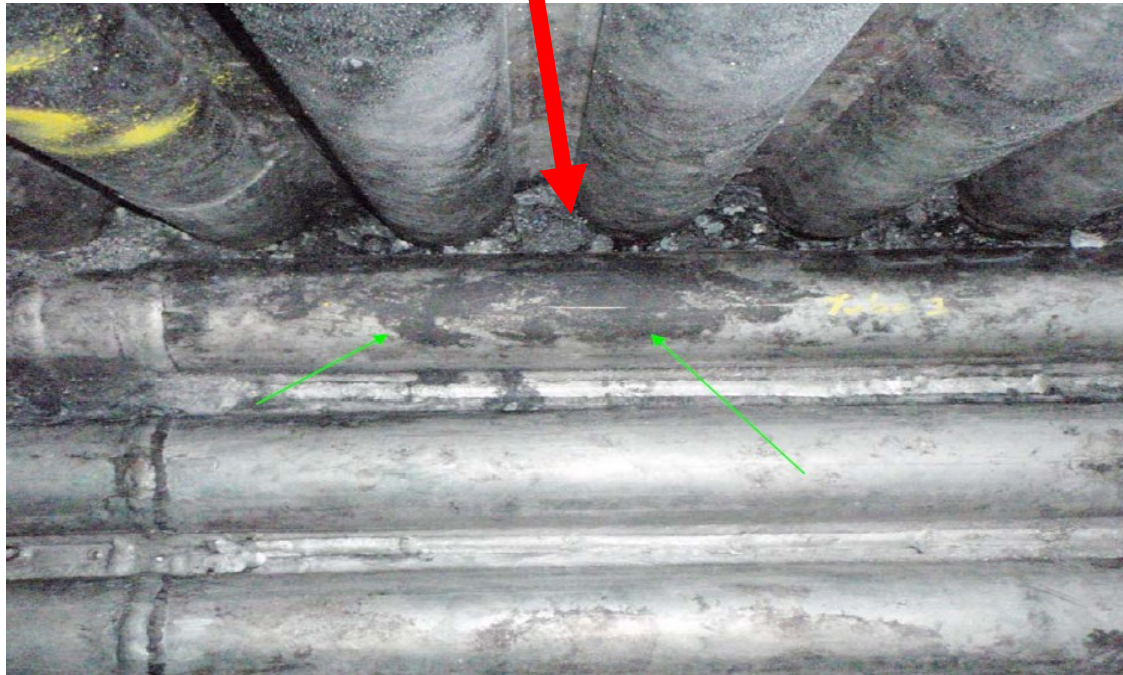
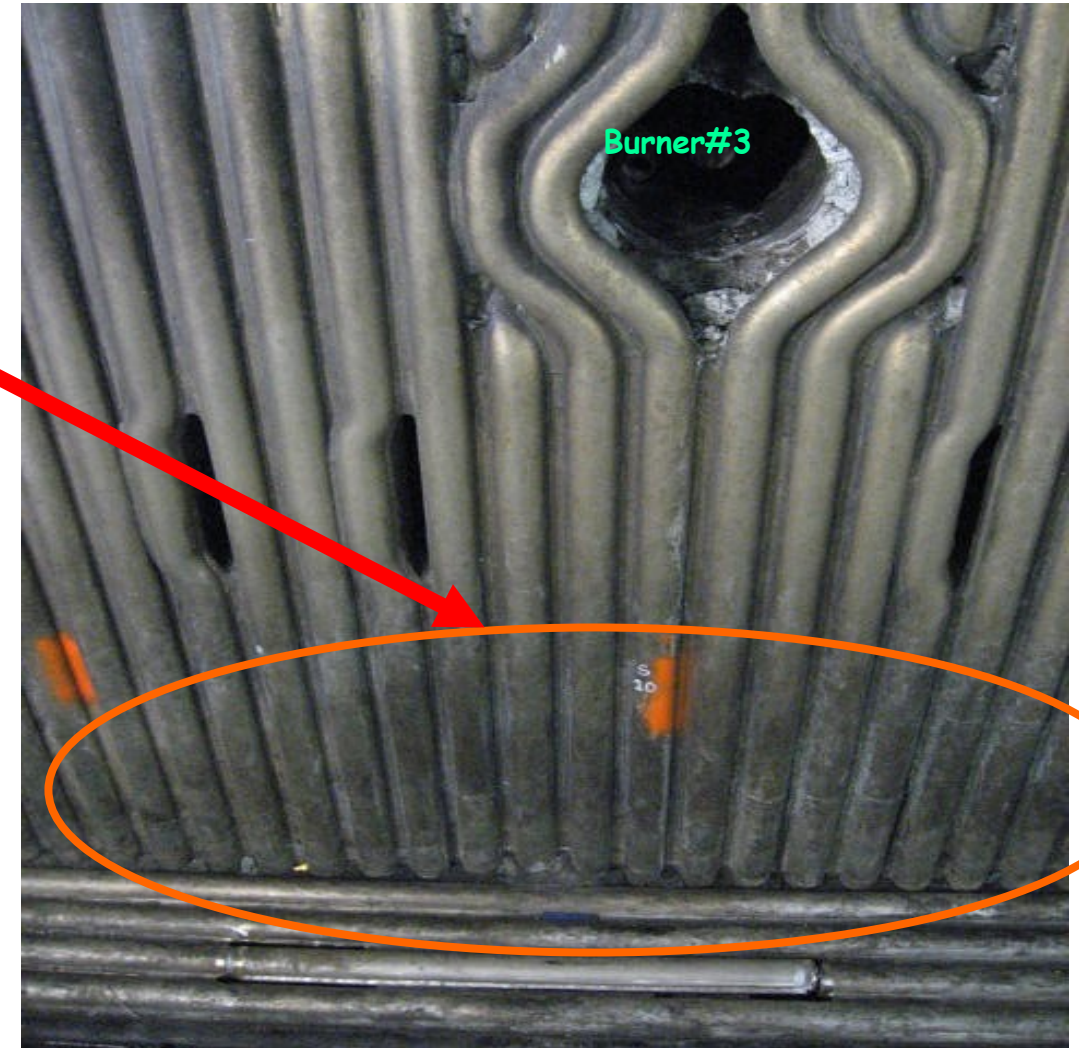
Floor tube cracks caused by local overheating (high char bed)  
Recovery Boiler 800 tds/d, DS 70% , splash plates

Furnace tubes below the burner were discolored black.

High heat flux to floor tubes and floor – sidewall sealing

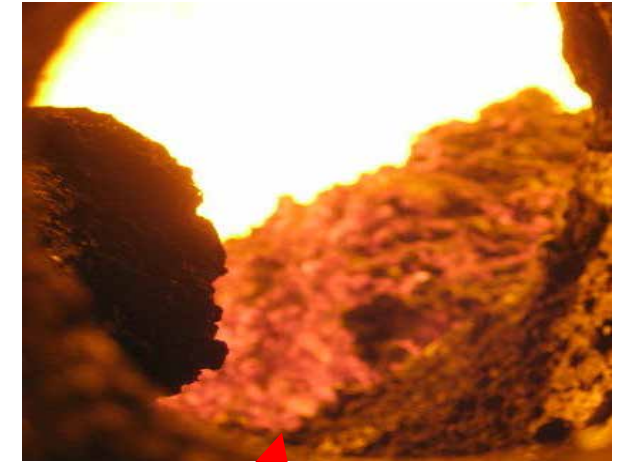
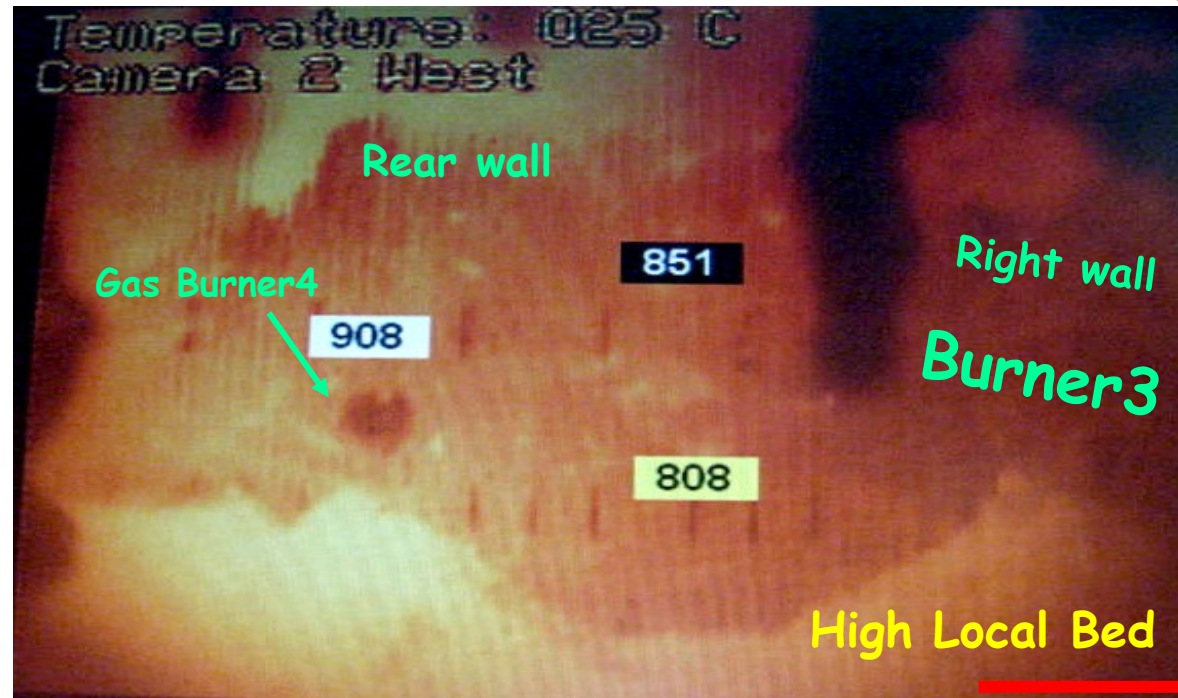
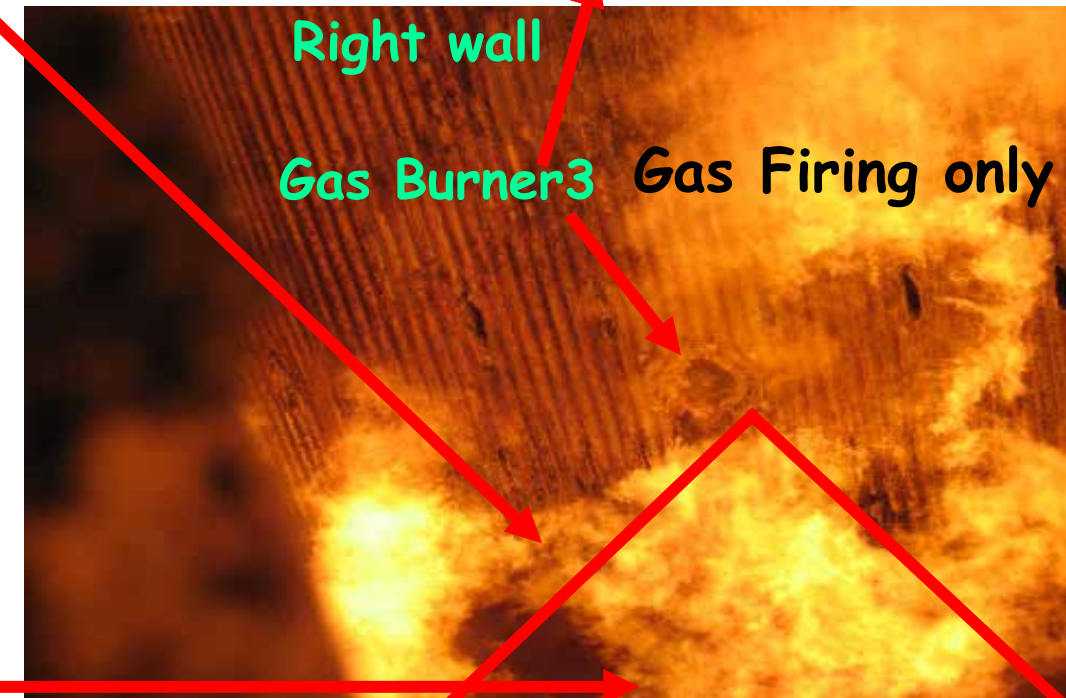
*Floor tube overheating because of high local bed, "hot spot". No corrosion indications elsewhere.*

High local bed (hot spot) in front of gas burners 3 at right side wall. Air jets inside furnace throw more particles to that spot. Also gas burner 3 flame bends down touching floor tubes in this same spot.

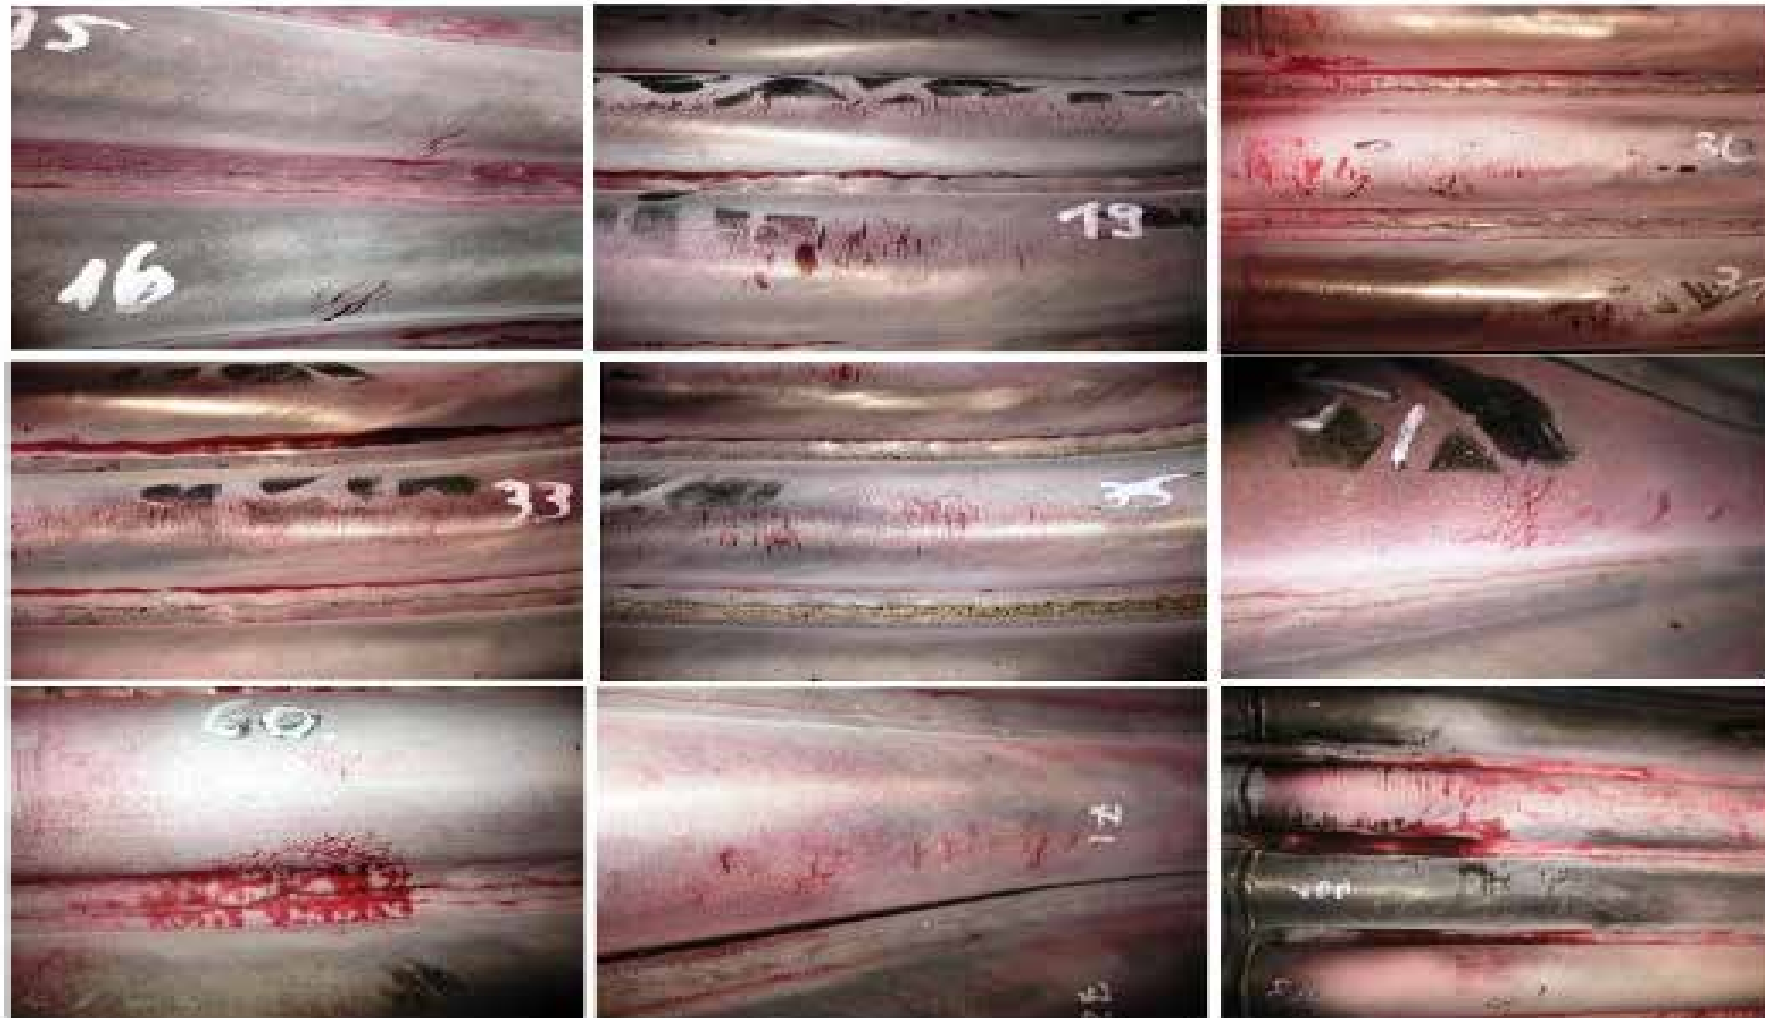
Local floor tube cracks and a leak caused by thermal fatigue.  
High local char bed, "hot spot"  
Recovery Boiler 3500 tds/d, DS 75% , splash plates

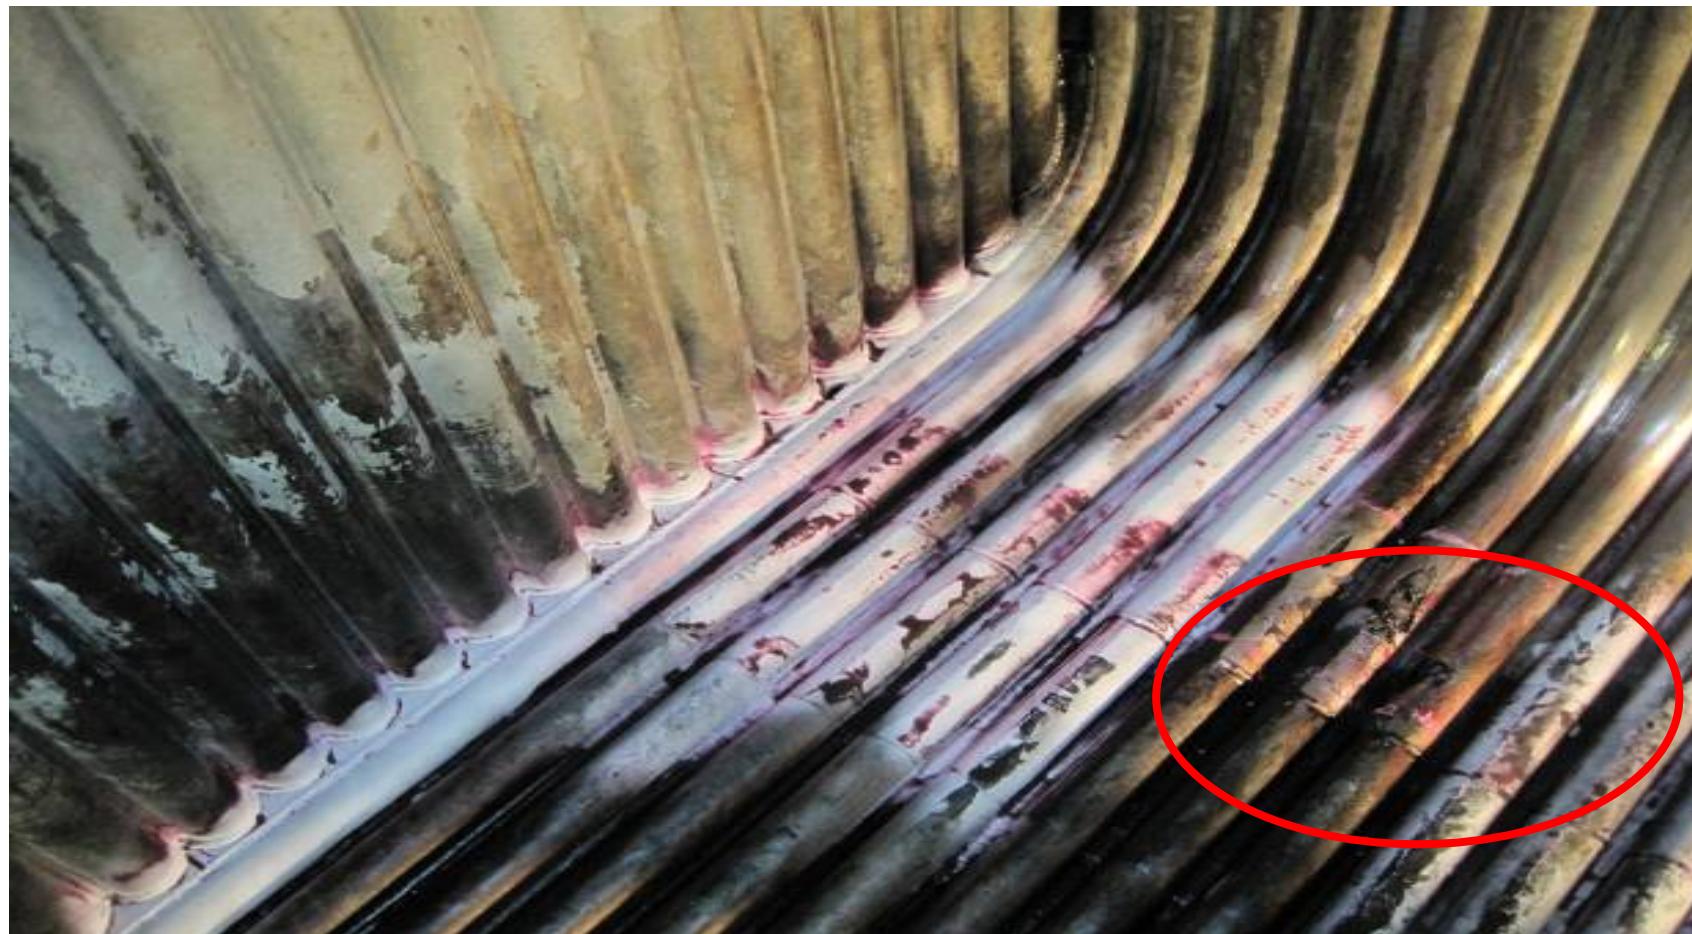
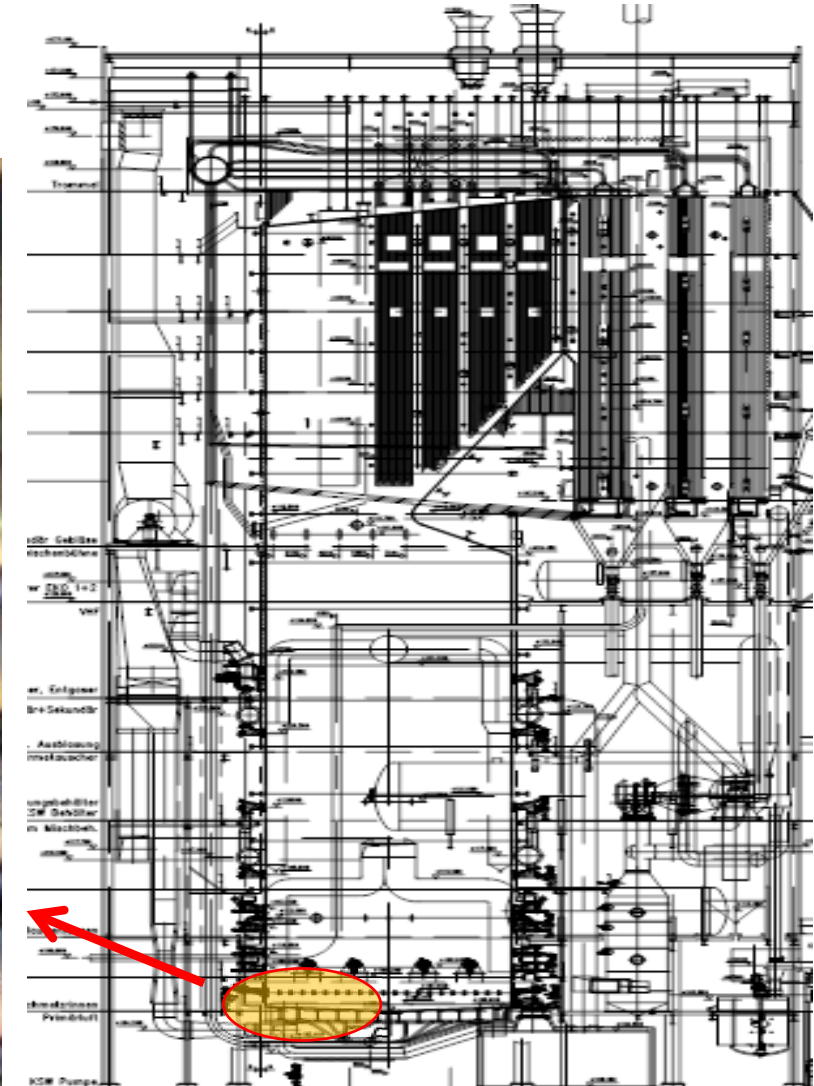
Leak at Recovery boiler floor

# Local floor tube cracks and a leak caused by thermal fatigue

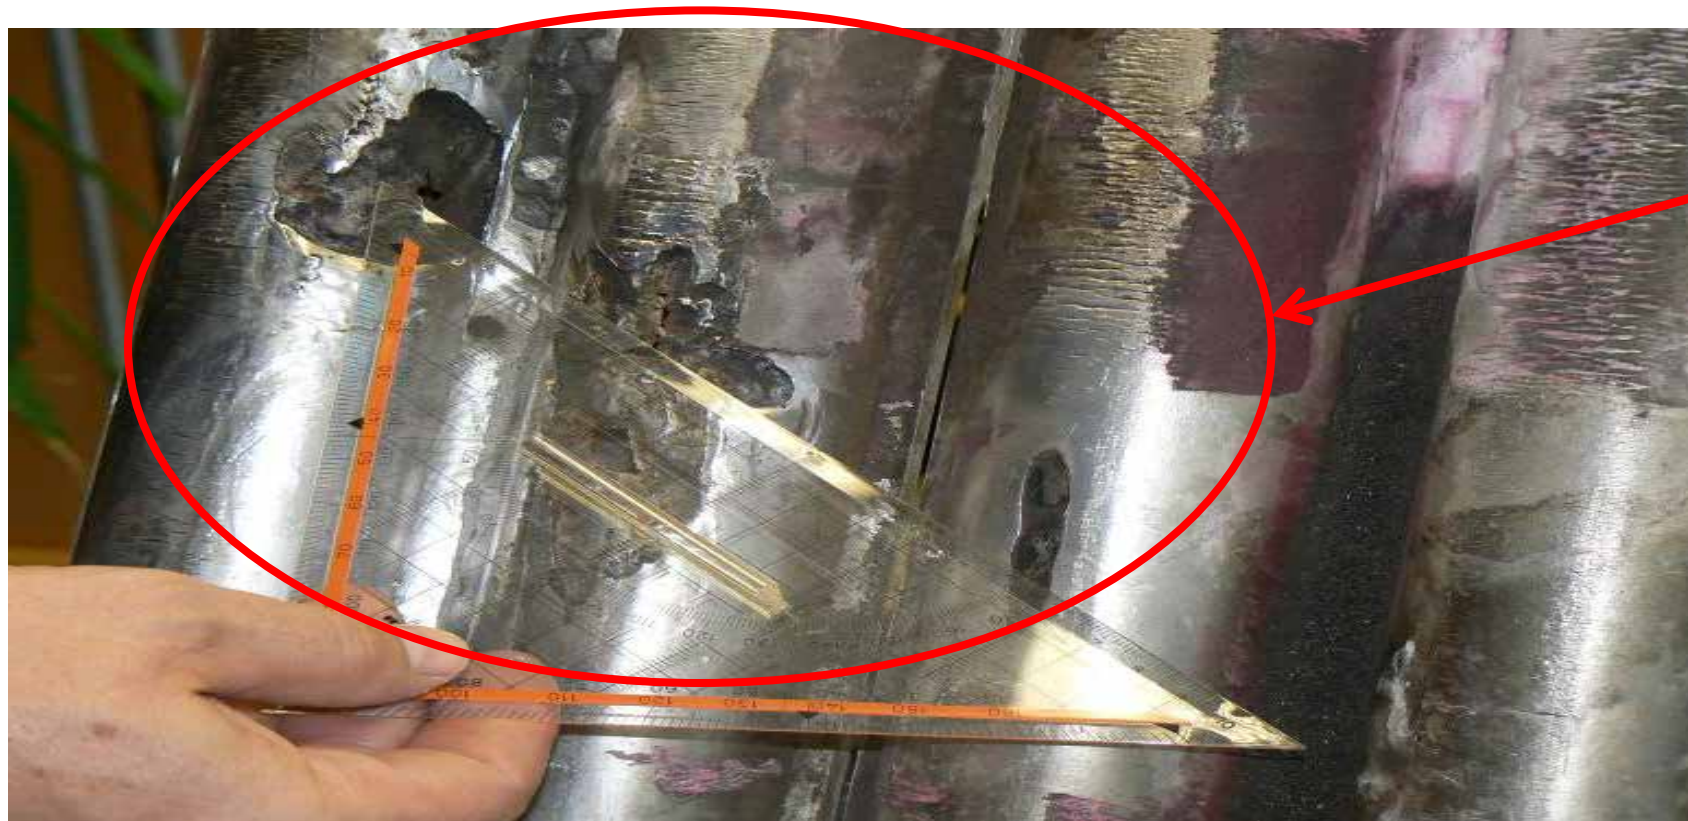
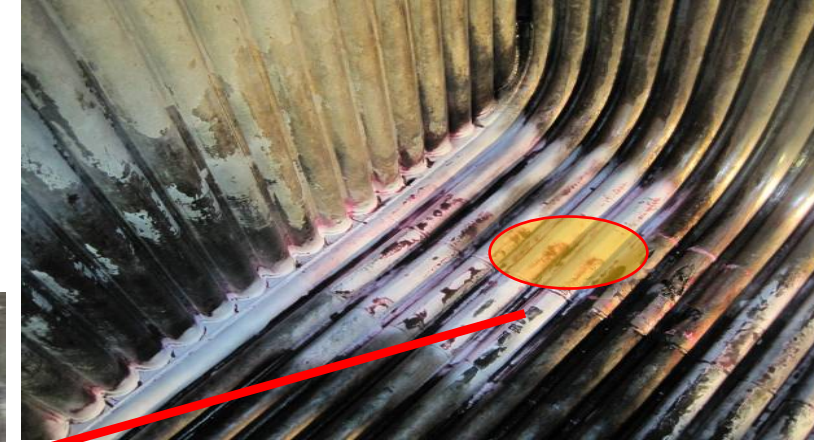
Leak at Recovery boiler floor

# Local floor tube cracks and a leak caused by thermal fatigue

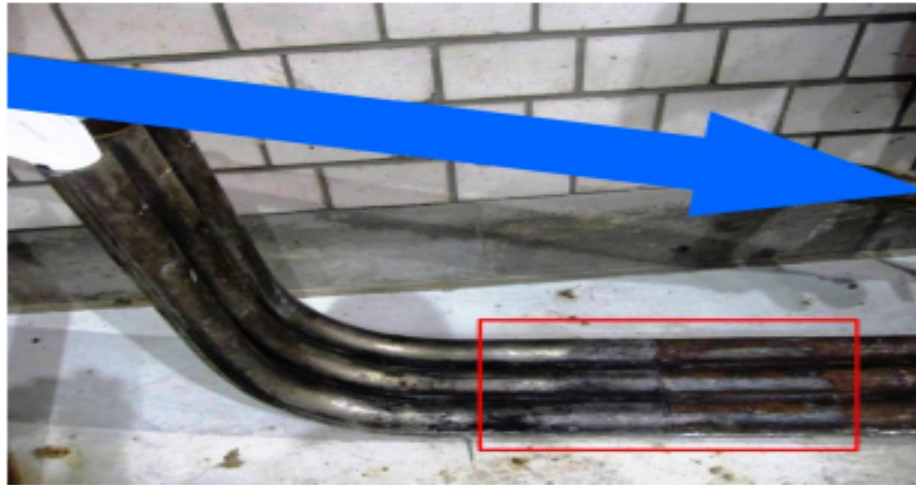
The damaged tubes must have been exposed to high heat flux from the top. Visually it looks that the furnace is hotter and more char burning at the spots where damages locate. Also the primary air port sleeves have been corroded in the same locations. In the October shutdown totally 18 pieces of cast air nozzles had to be replaced:

The damaged primary air cast sleeves located exactly at the spots where furnace temperature is higher and char is burning just in front of the primary air ports. The indications and cracks are located near the front wall just under the primary air jets. What is the impact of the primary air?

Fig. 11 Primary air jet vs. location of tube damages at the front wall

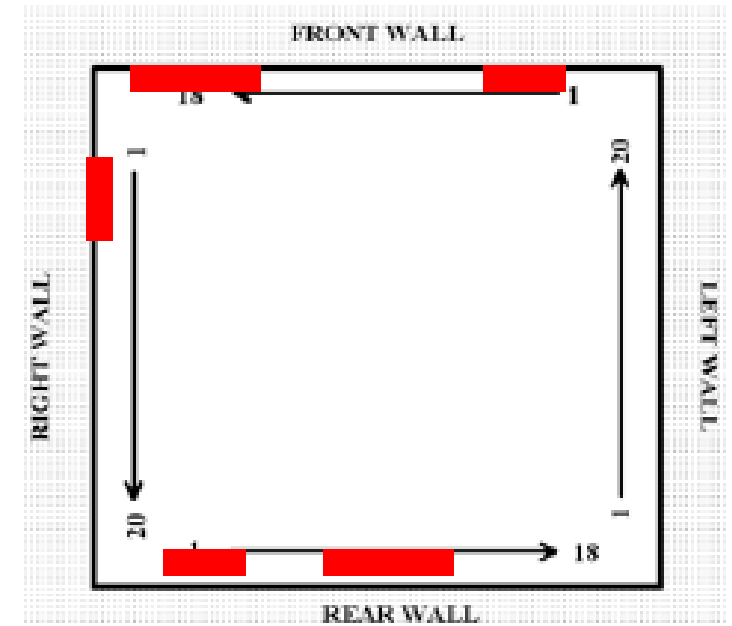
Damaged primary air opening sleeves

A lot of burnt primary air port sleeves in same location than cracks in the floor tubes

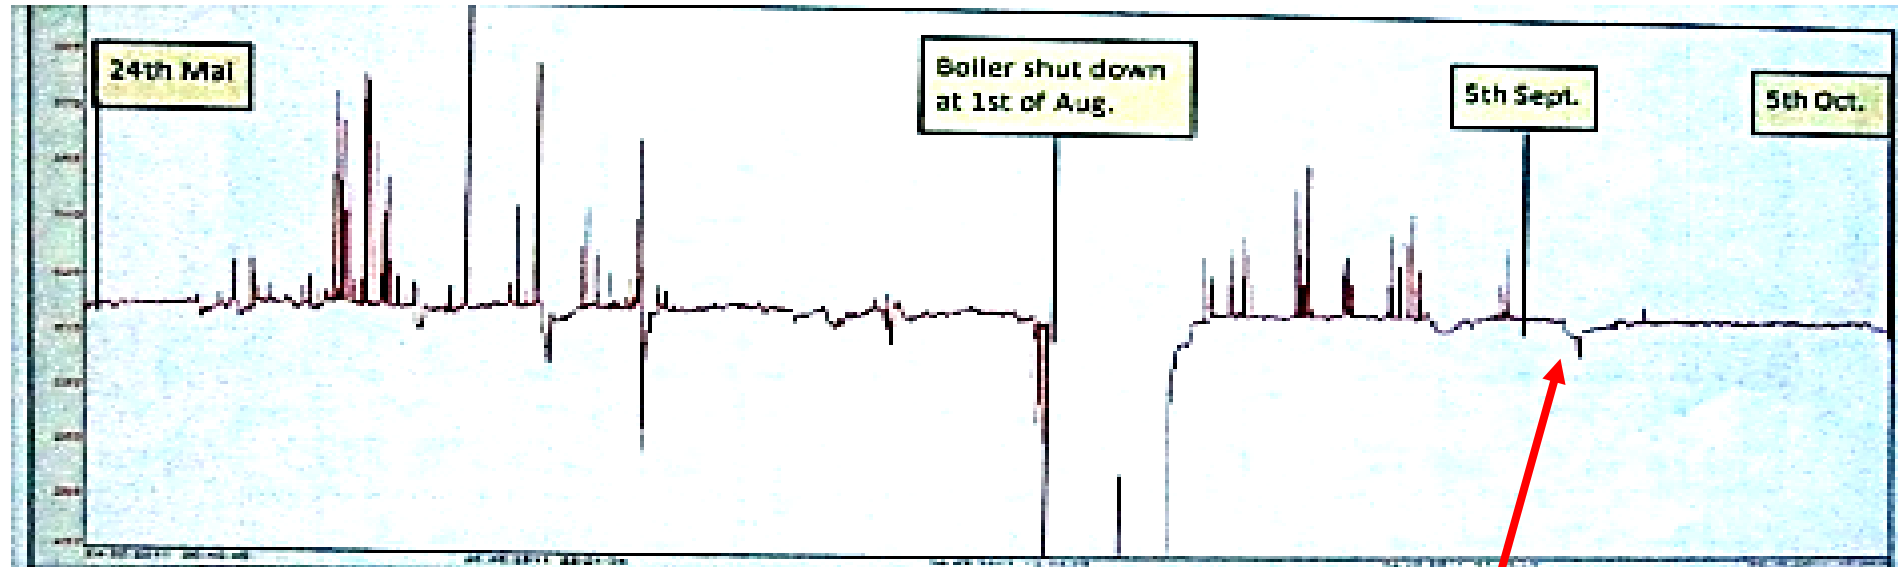
Fig. 5 Floor temp spikes in failed area, scale 250 – 400°C, normal 316°C

Floor tube temperature spiking (=thermal fatigue condition) disappeared when operation was tuned in September.

High char bed and "hot spot" –conditions could be fixed.

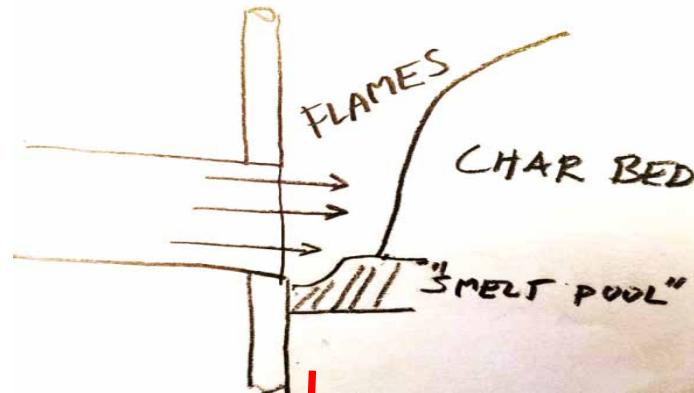
1. Smelt contact to primary air port tubes causes high heat flux and thermal fatigue cracks

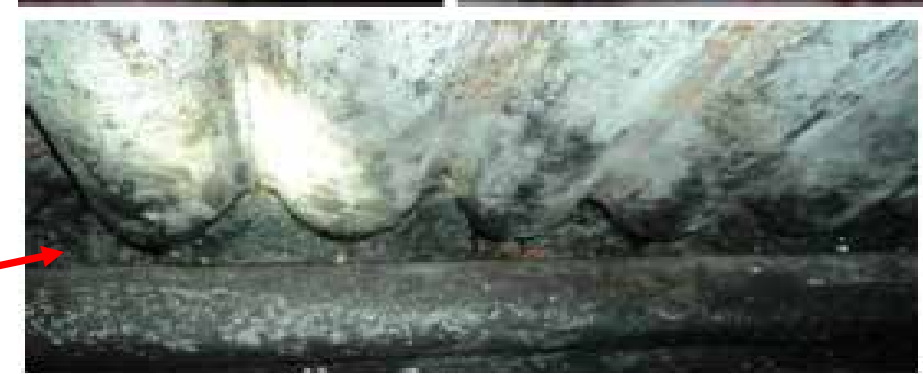
2. Smelt flows down, burns floor-sidewall seal membrane

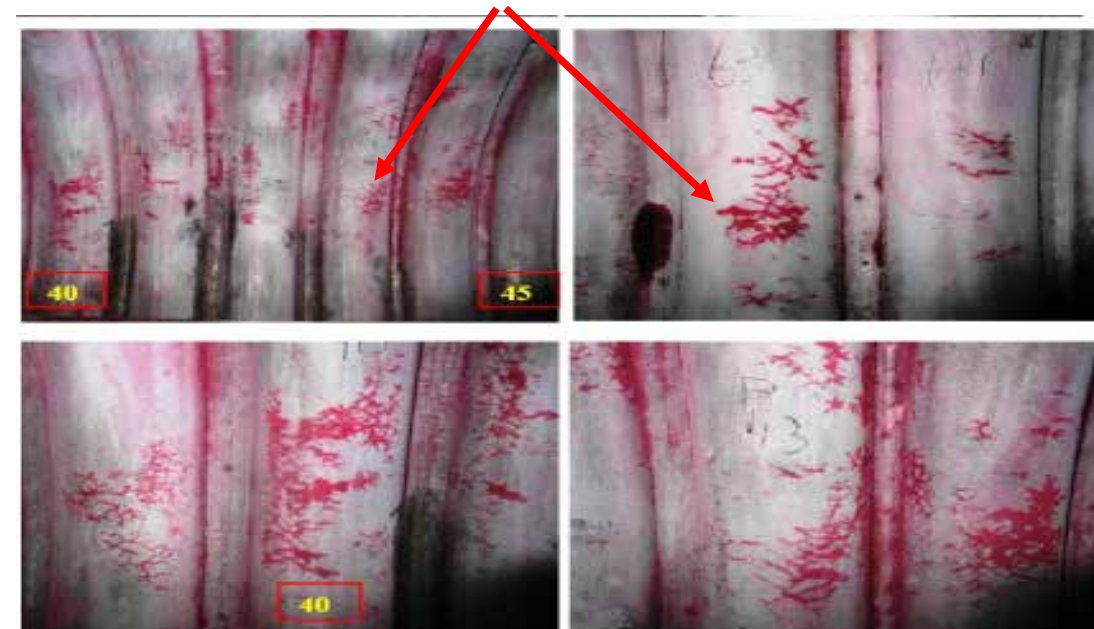
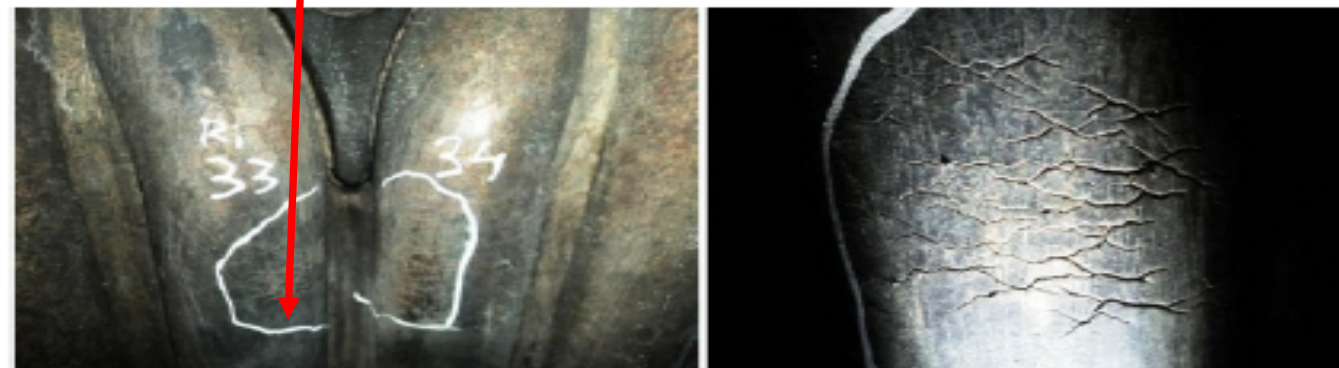
Same kind of damages has been found from also from (304L) composite tubes in a recovery boiler in Spain. More damages occurred at the walls where burning char was practically in the contact with primary air ports. See the photos below.

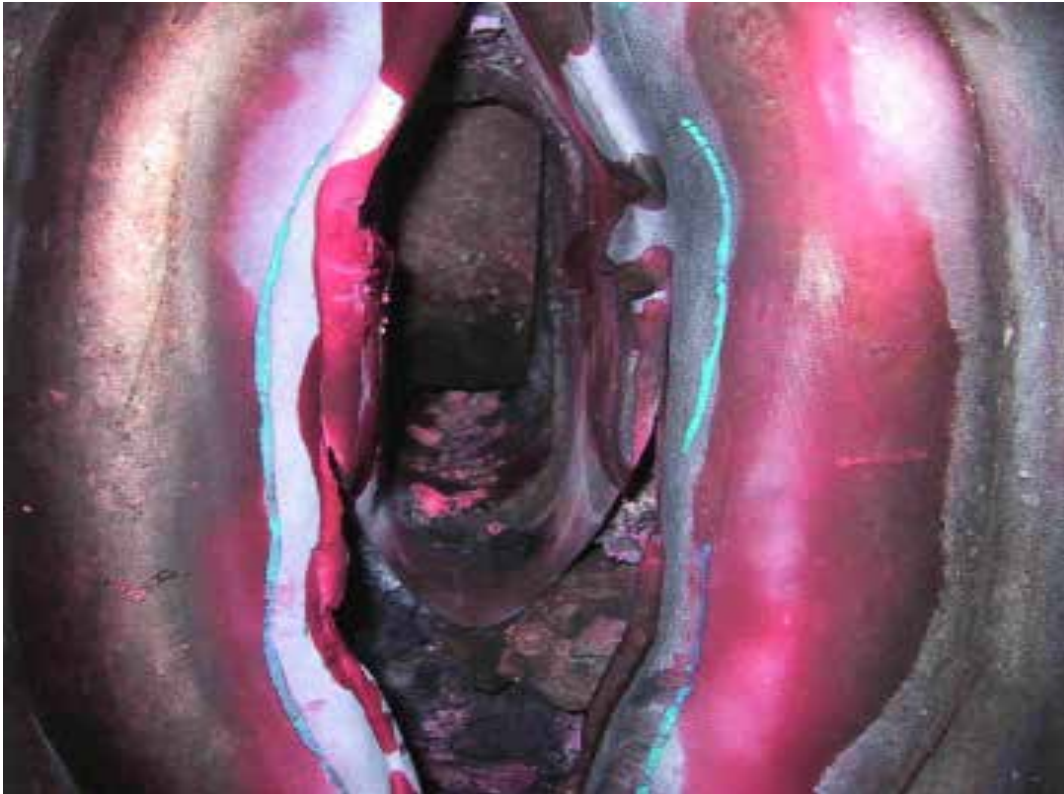
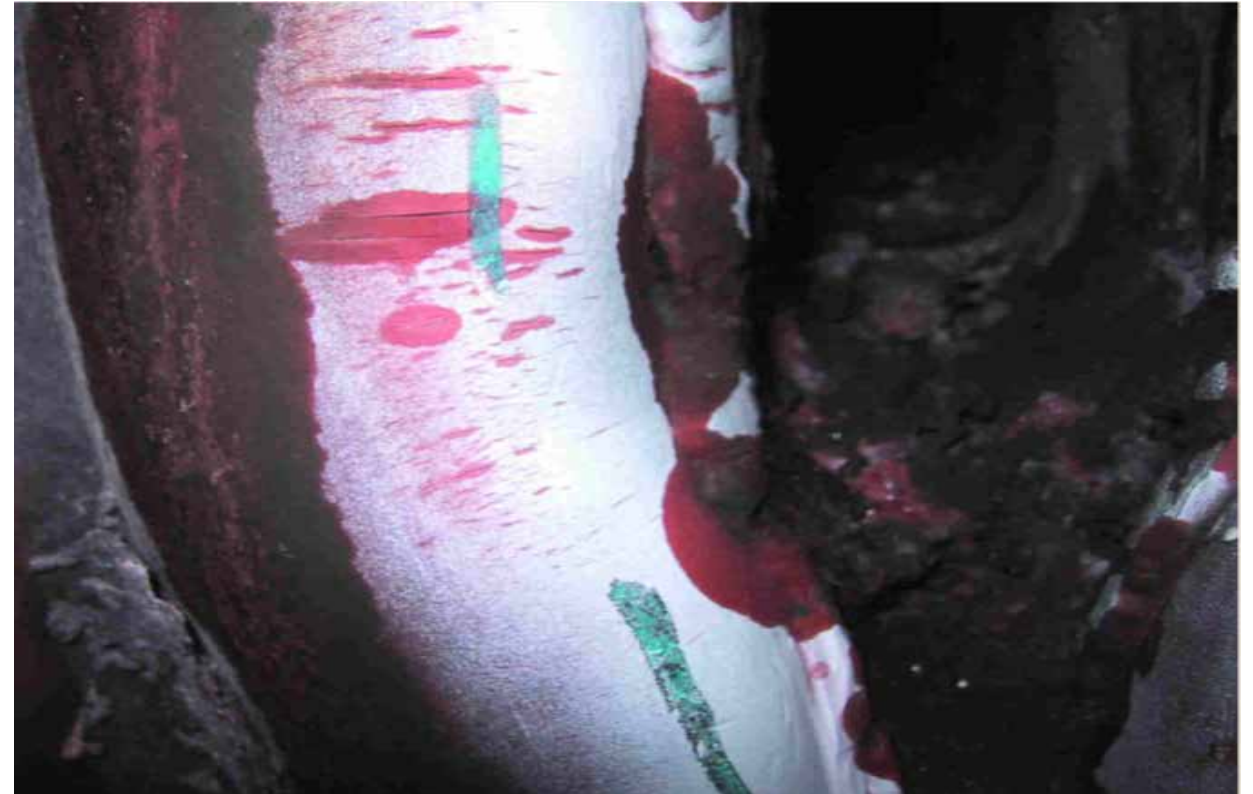
Damaged primary air port sleeves, cracks in the tubes  
Recovery Boiler 700 tds/d, DS 63%, splash plates

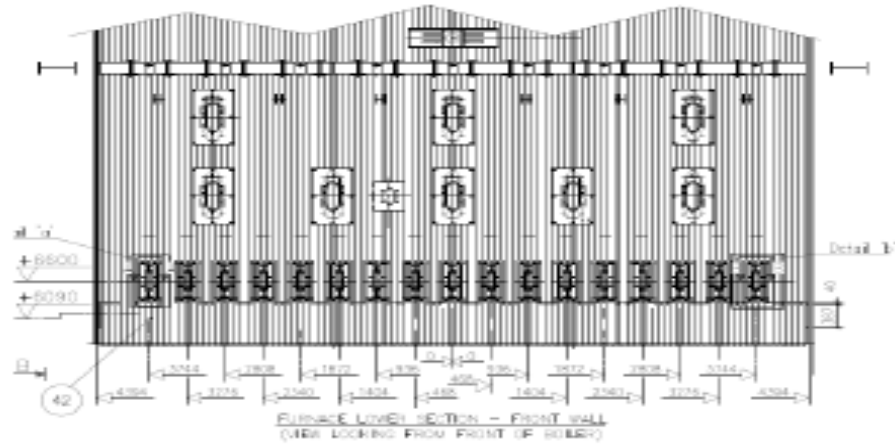
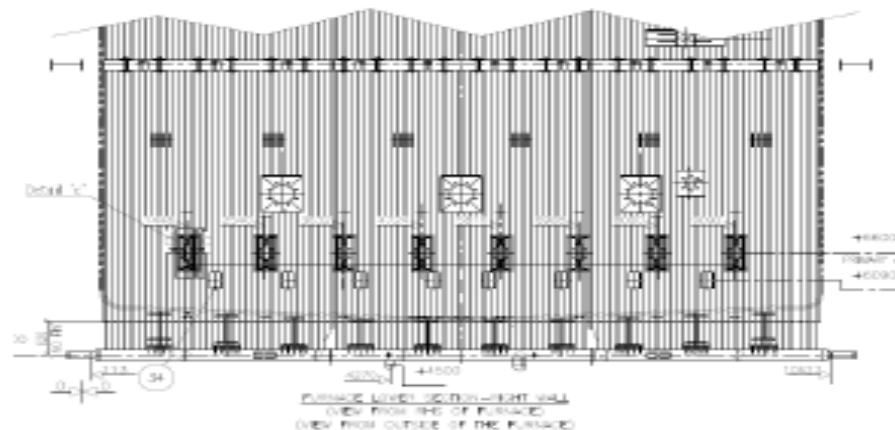
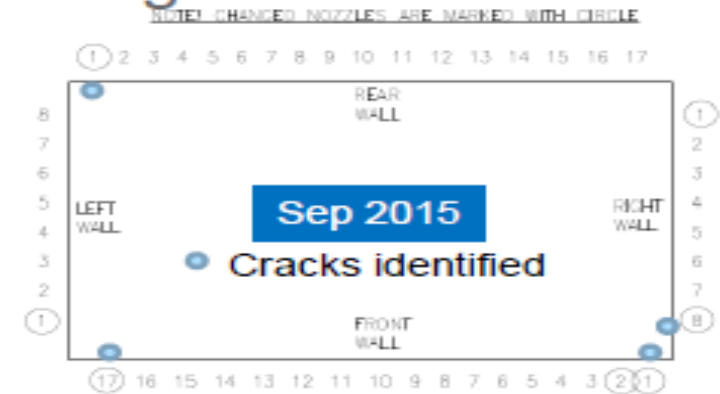
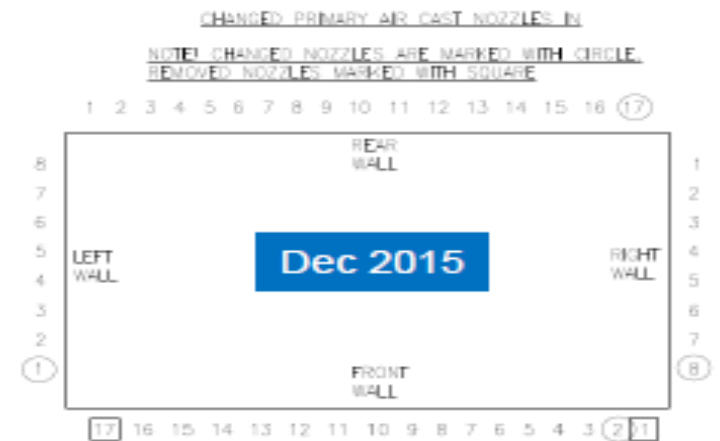
## Cracks and burnt nozzles in corner openings

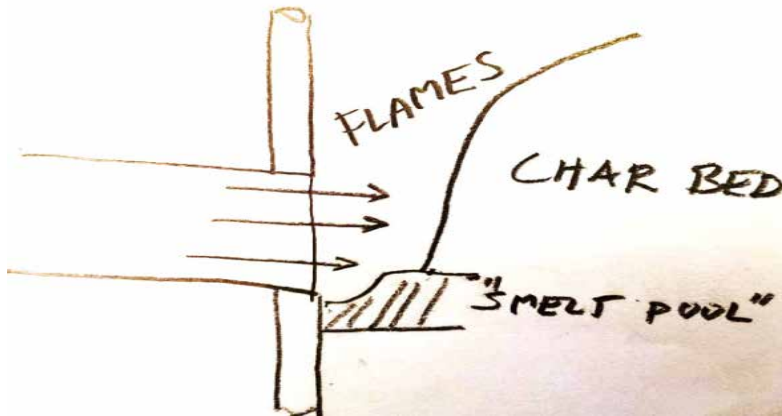
No cracks in the opening tubes but in the second tubes

San38 tubes = no cracks  
304L tubes = cracks
