**Sulakourujen materiaalitutkimus, VTT – KMP esitys 23.1.2020**

# Sulakourujen materiaalitutkimus

Konemestaripäivät 23.01.2020  
Sanni Yli-Olli  
Satu Tuurna

# SOODAKATTILAN AJO-OLOSUHTEET JA TULIPESÄN ALAOSAN KORROOSIO

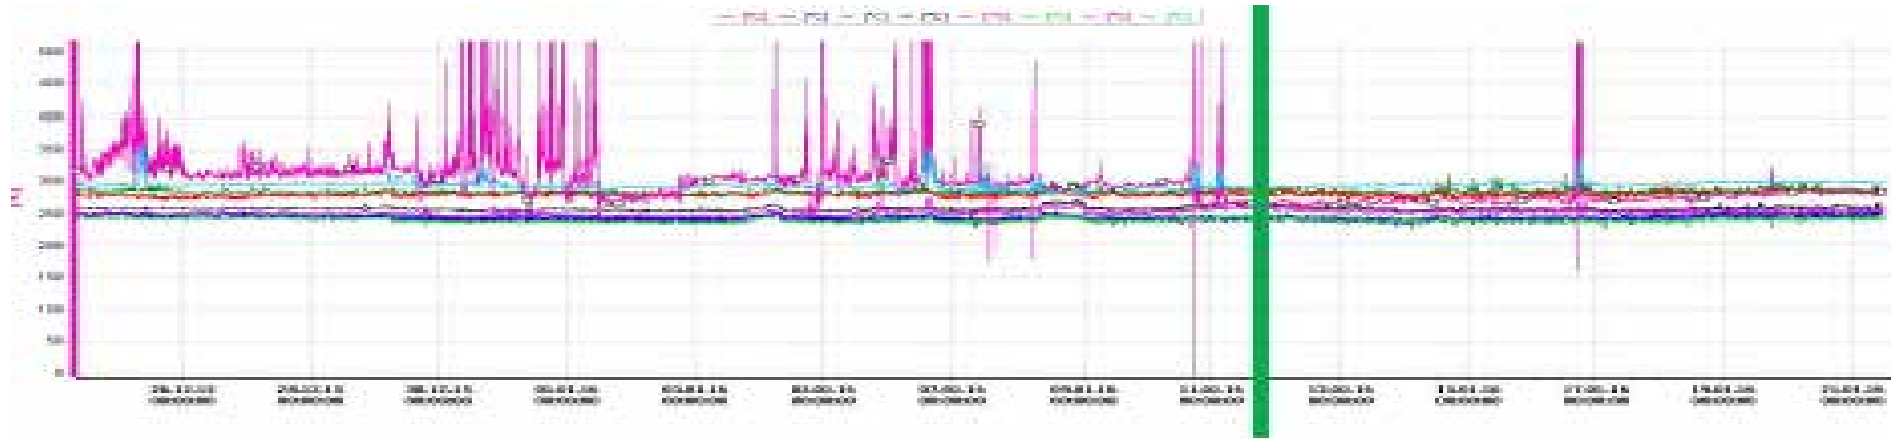
## Thermocouples installed, high temperature spikes monitored

Floor tube temperature spiking (= thermal fatigue condition) disappeared when operation was tuned in September.

High char bed and "hot spot" –conditions could be fixed.

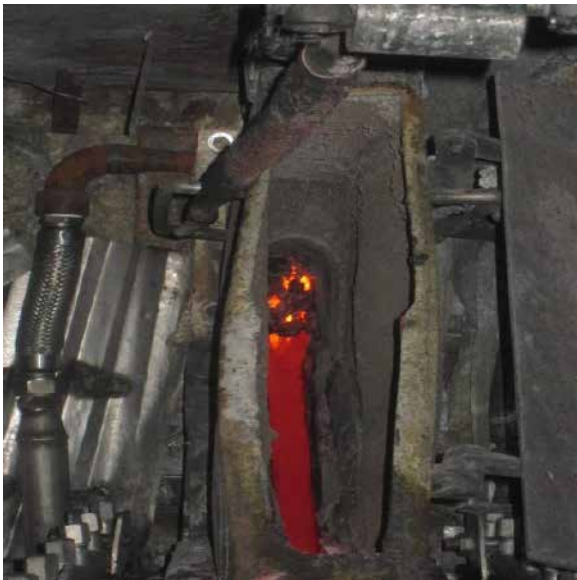
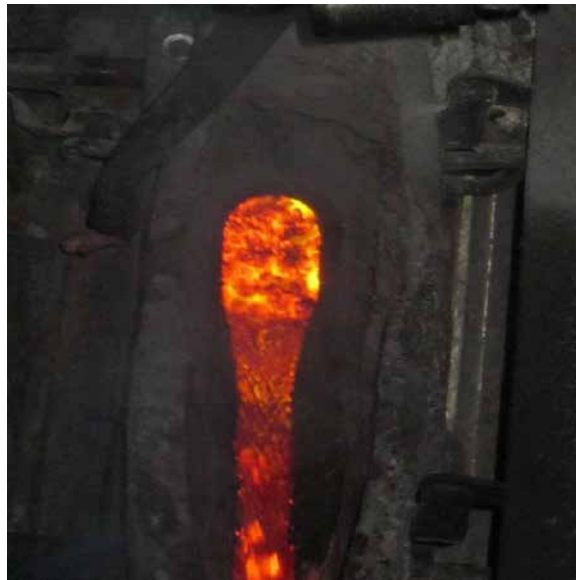
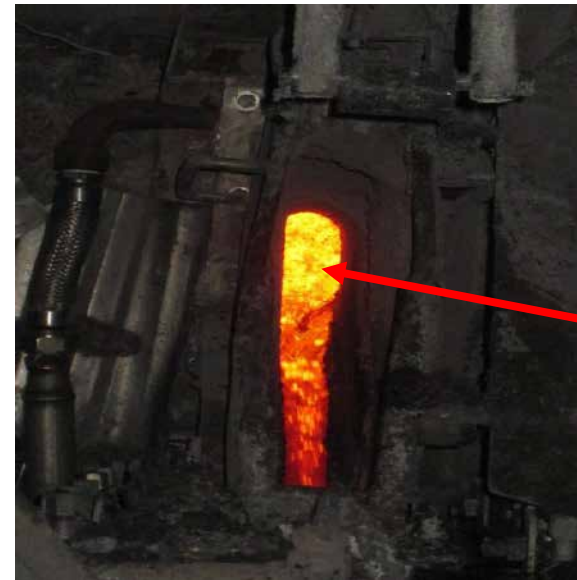
High bed and a pile of char  
in front of spouts

No air flow to keep  
openings clean.

Burning char and smelt is in  
contact with tubes

Operation tuning fixed all these problems. New operation practically stopped the corrosion in the lower furnace.

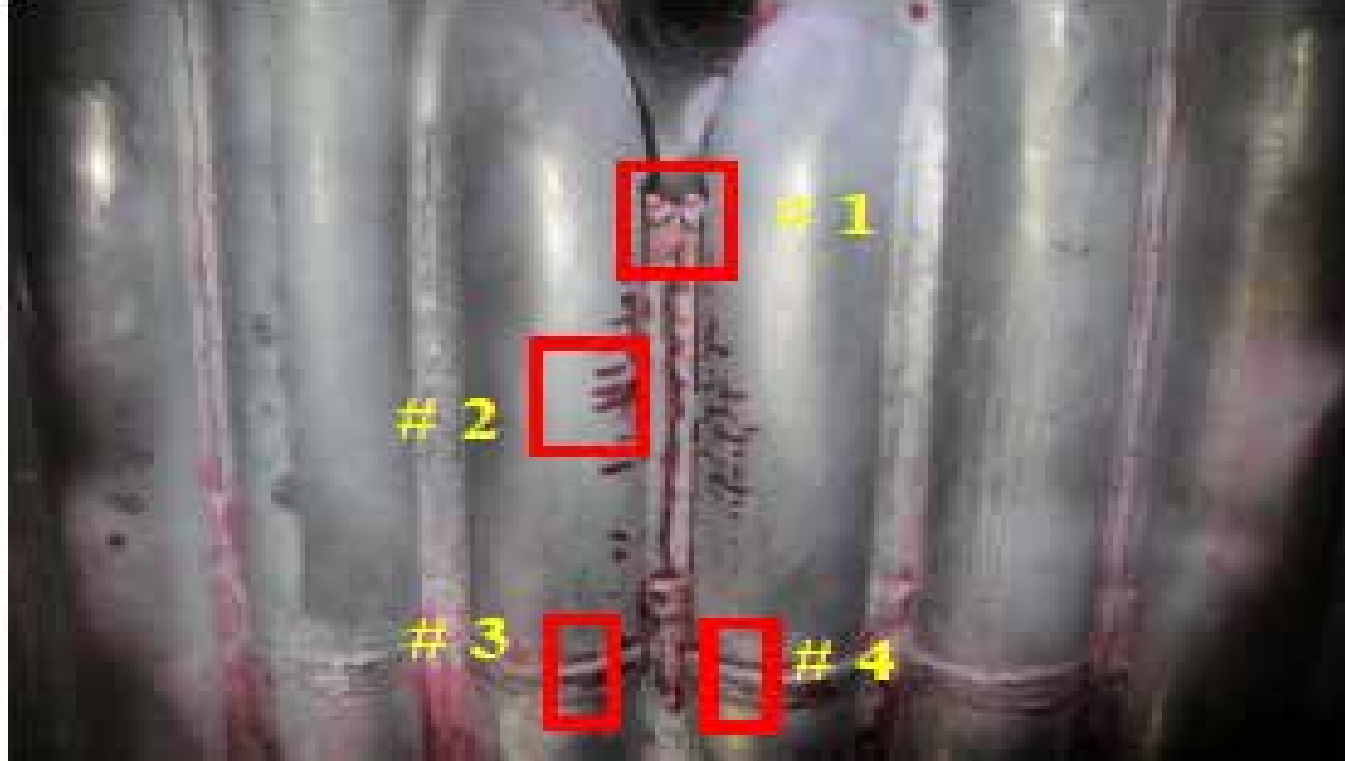
Primary airport tube cracks

Recovery Boiler 1200 tds/d, DS 75%, splash plates

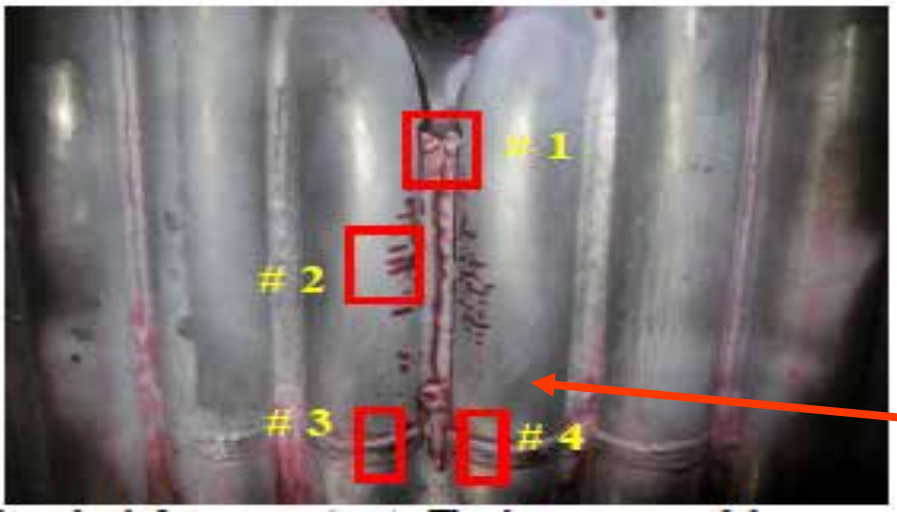
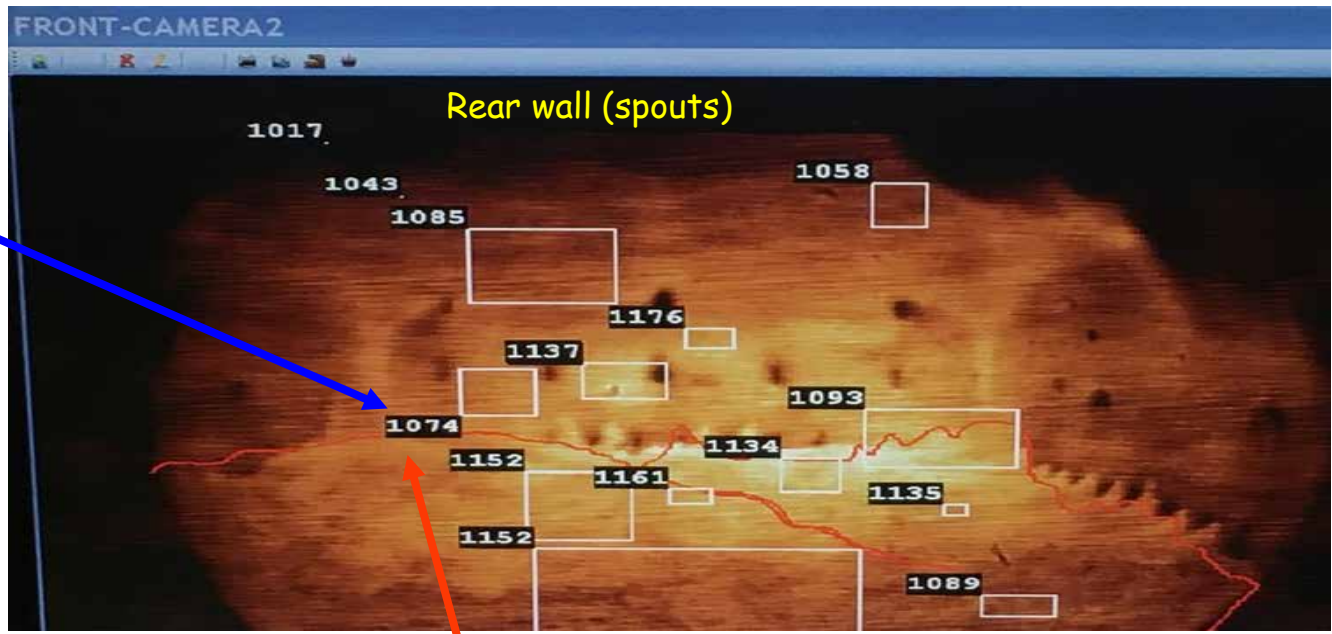
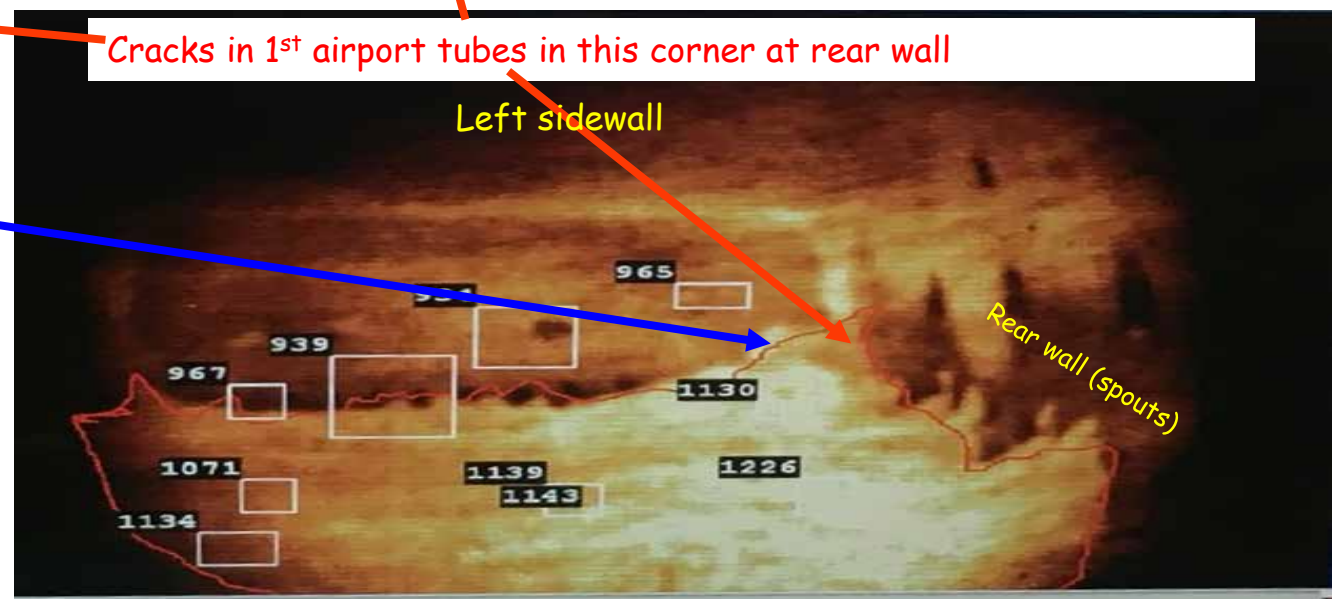
Cracks in 1<sup>st</sup> airport tubes in this corner at rear wall

It is easier to see from right sidewall camera, that hot char bed is burning close to the rear wall corner ports

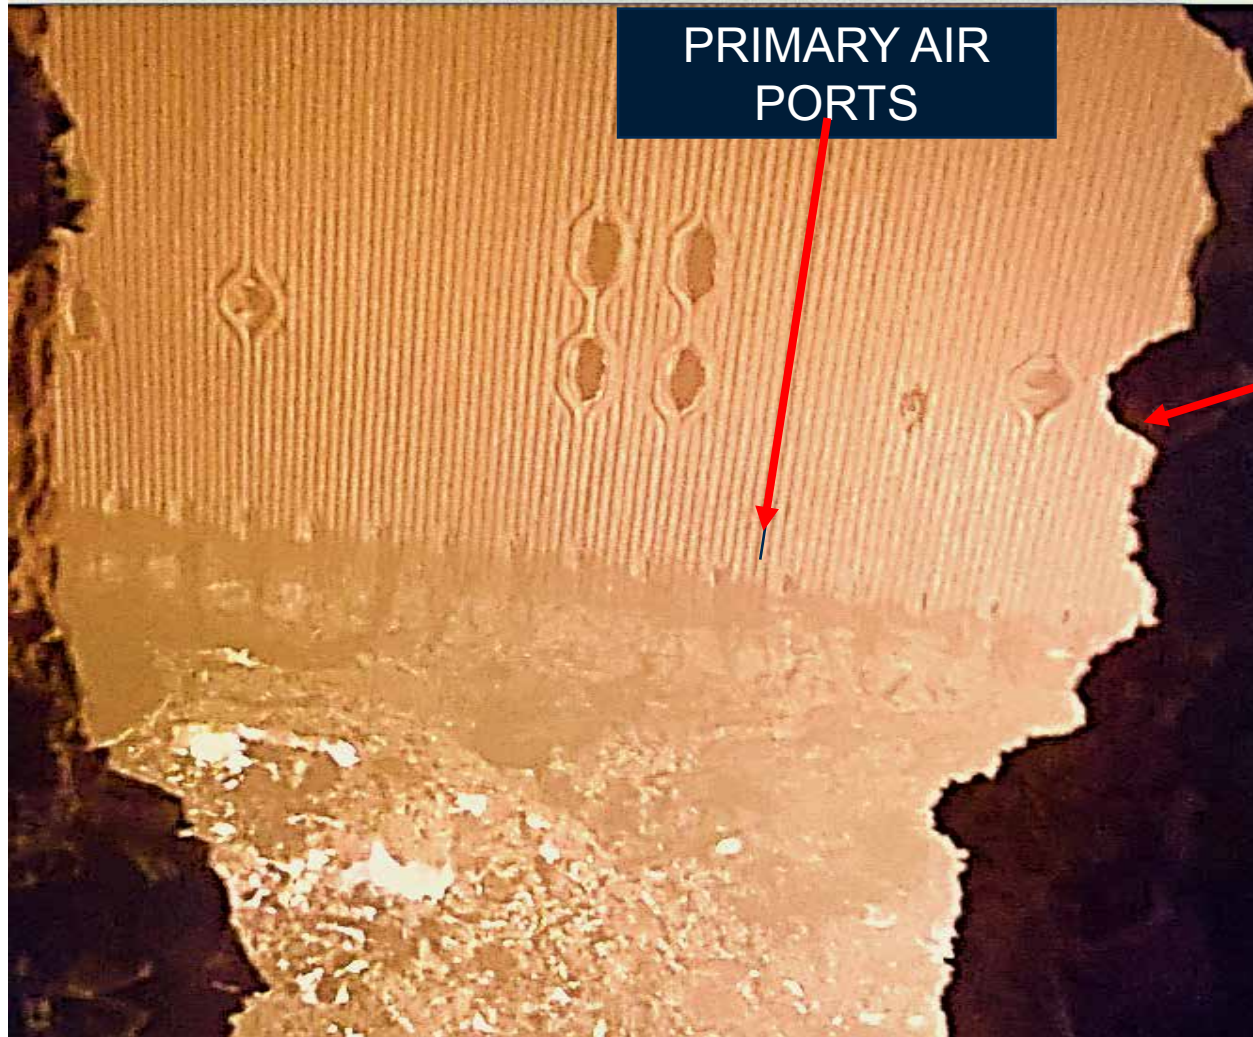
There have been a lot of problems with primary ports cracking at Front wall primary airport tubes.

Photo from 2013 shutdown reveals that hot char bed has been burning close to the front wall primary airports.
