# **The Recovery Boiler in the Future II – Material Sulphidation Tests, Analysis of Probe Samples**

Sanni Yli-Olli, Pekka Pohjanne, Tuomo Kinnunen

Confidentiality	Confidential	
Espoo, 30 October 2006		
Liisa Heikinheimo Research Manager	Sanni Yli-Olli Researcher	Satu Tuurna Researcher
VTT contact information PB 1000, 02044 VTT (postal address Kemistintie 3)		
Distribution (clients and VTT) Finnish Recovery Boiler Committee, Esa Vakkilainen 3, VTT 3		
<p><i>The use of the name of VTT in advertising or publication of this report in part is possible only with the written permission from VTT.</i></p>

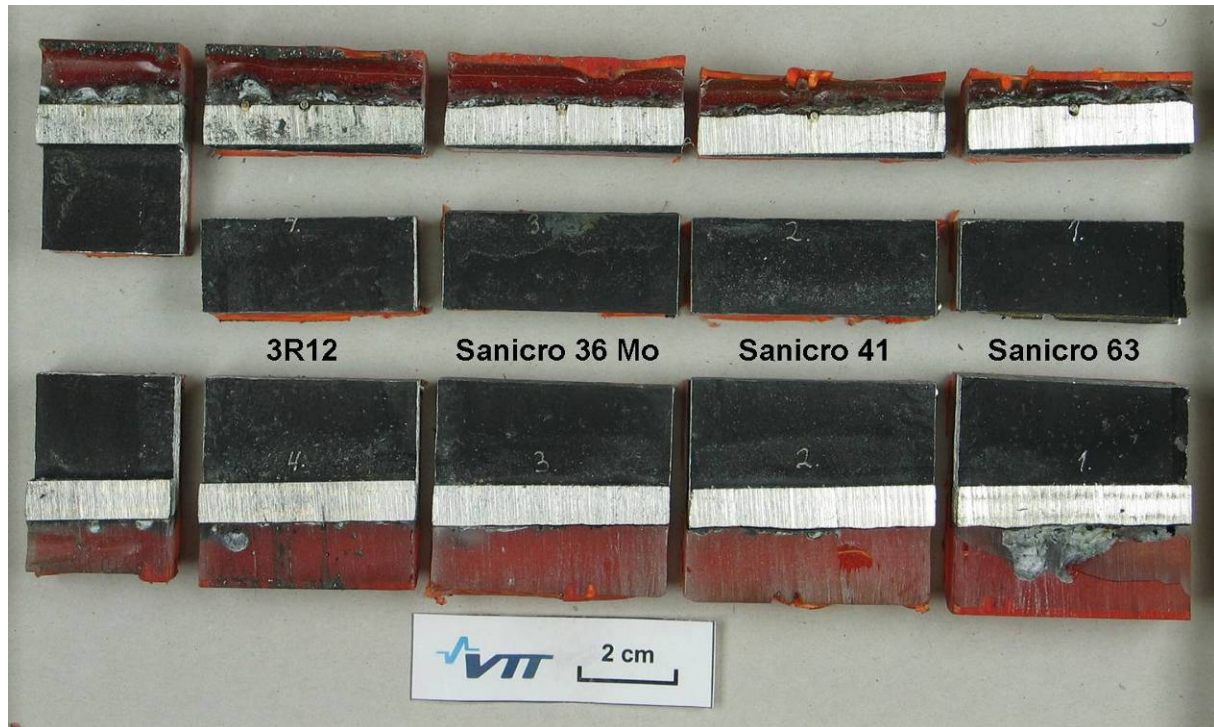
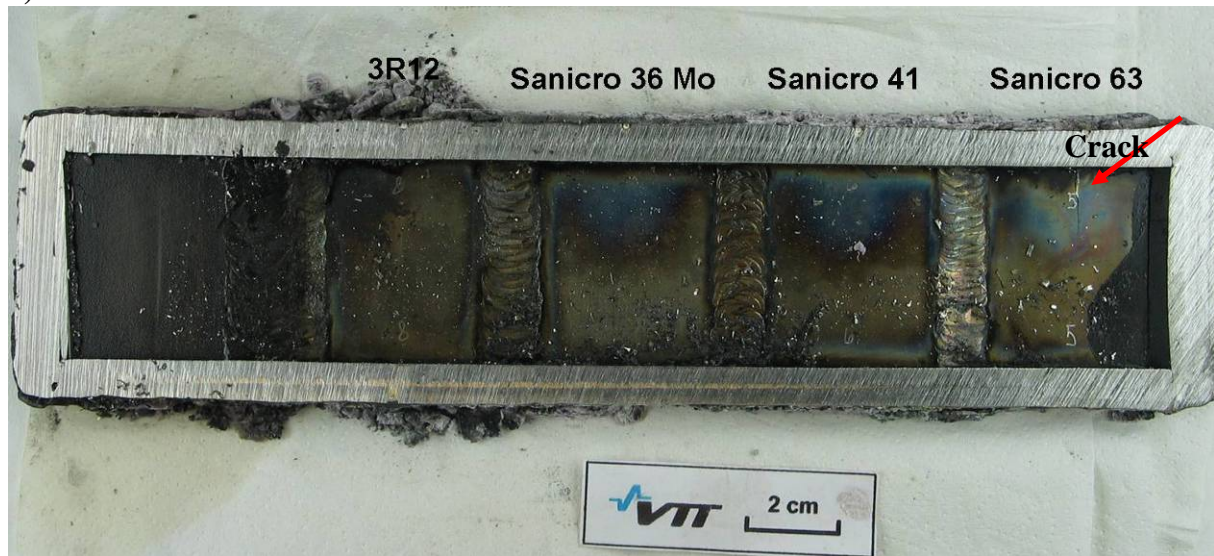
Figure 1. Separated probe samples a) after Test 3 cast in epoxy, and b) after Test 4.

Sanicro 63 had cracked around the drill hole in both tests (Figure 2 a and b). In Test 4 the material had cracked visibly, as seen in Figure 1b). The crack continued deep inside the sample (Figure 2b).

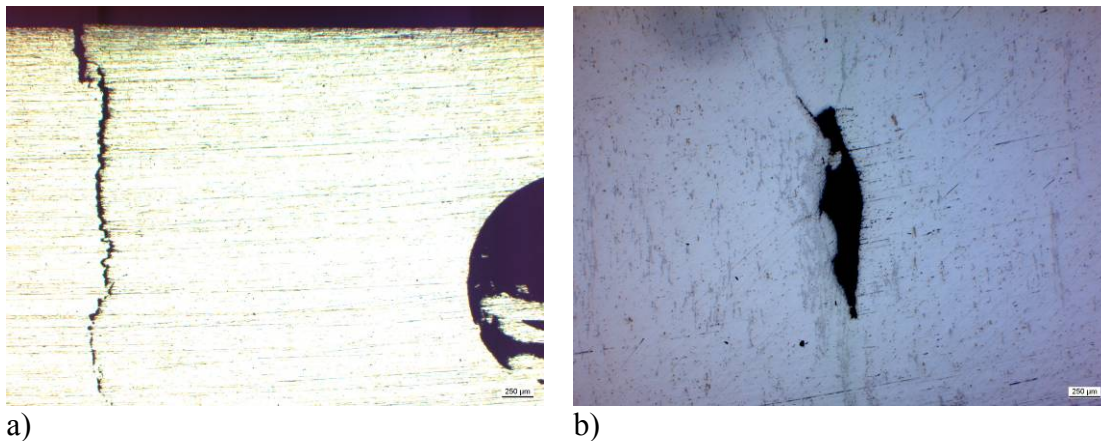
Figure 2. Cracking of the Sanicro 63 sample a) Test 3 and b) Test 4.

In materials Sanicro 63, Sanicro 41 and Sanicro 36 Mo cracking was observed after probe Test 3 near the hole drilled for the thermo sensor. Cracking was most pronounced with material Sanicro 63 and it was observed also in the shorter Test 4. This indicates that cold reduction exposes materials to cracking. At worst, cracks advanced through the 5.5 mm thick Sanicro 63 material in less than 500 hours. 3R12 was the only one of the materials in which no cracking was observed.

We recommend that further laboratory tests be carried out under salt deposits and with controlled gas atmosphere using test coupons. In addition, we recommend stress corrosion tests under the same circumstances to investigate cracking. The additional tests recommended in the previous subproject [1] of the influence of water vapour content, time and carbon monoxide on sulphidation are also recommended.

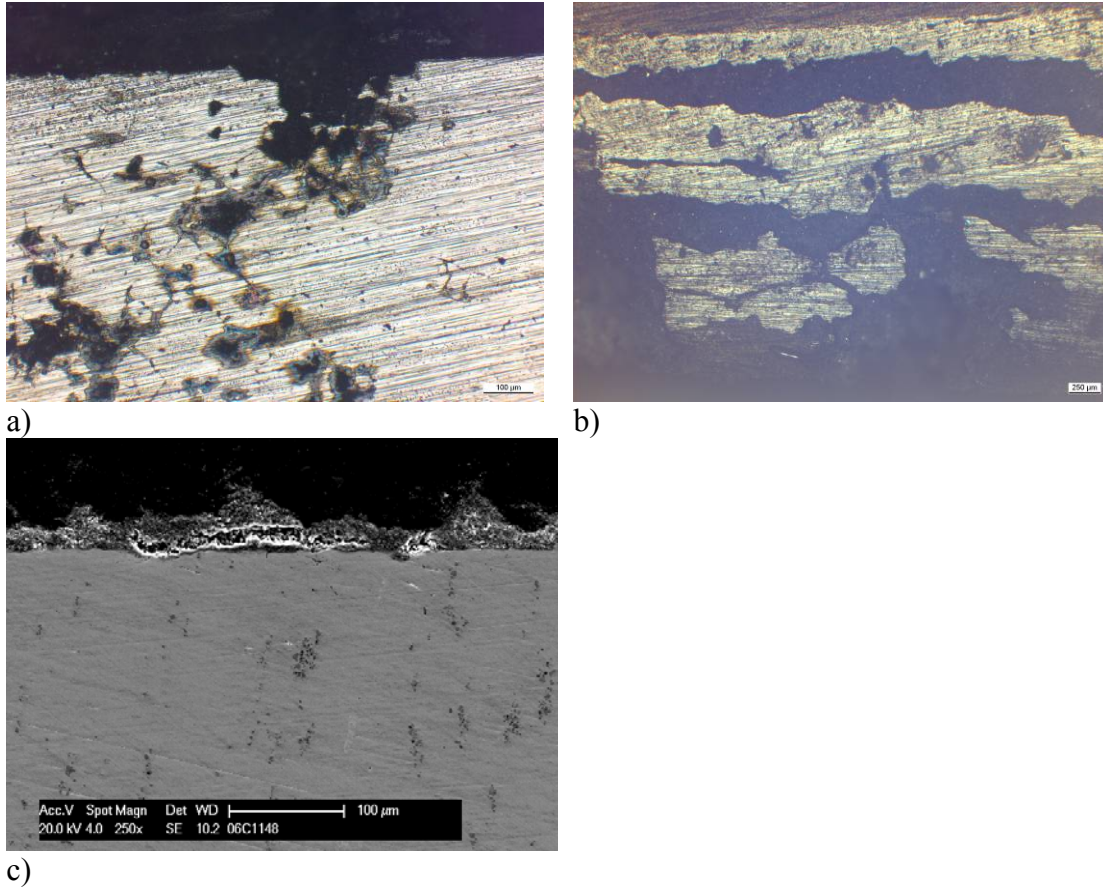
In addition, in Test 3 surface corrosion was observed (Figure 3a) and at the sample surface there was a thick and brittle salt deposit (Figure 3b). The deposit consisted primarily of salt accumulated on the surface of the sample, but the layer closest to the surface also had a high content of chromium, as well as traces of nickel and iron (Figure 4). Based on this, the conclusion can be drawn that the salt deposit formed during Test 3 had started to corrode the surface, in places even severely.

*Figure 3. Salt deposit and corrosion at the surface of the Sanicro 63 samples a) and b) after Test 3 and c) after Test 4.*

In Test 4, equally severe surface corrosion was not observed; however, there were signs of corrosion as well as a clear deposit (Figure 3 c). As in the previous test, this deposit was formed mainly by salt (K, Na, S), although the innermost layer also contained small amounts of metals (Ni, Cr, Fe) (Figure 5).

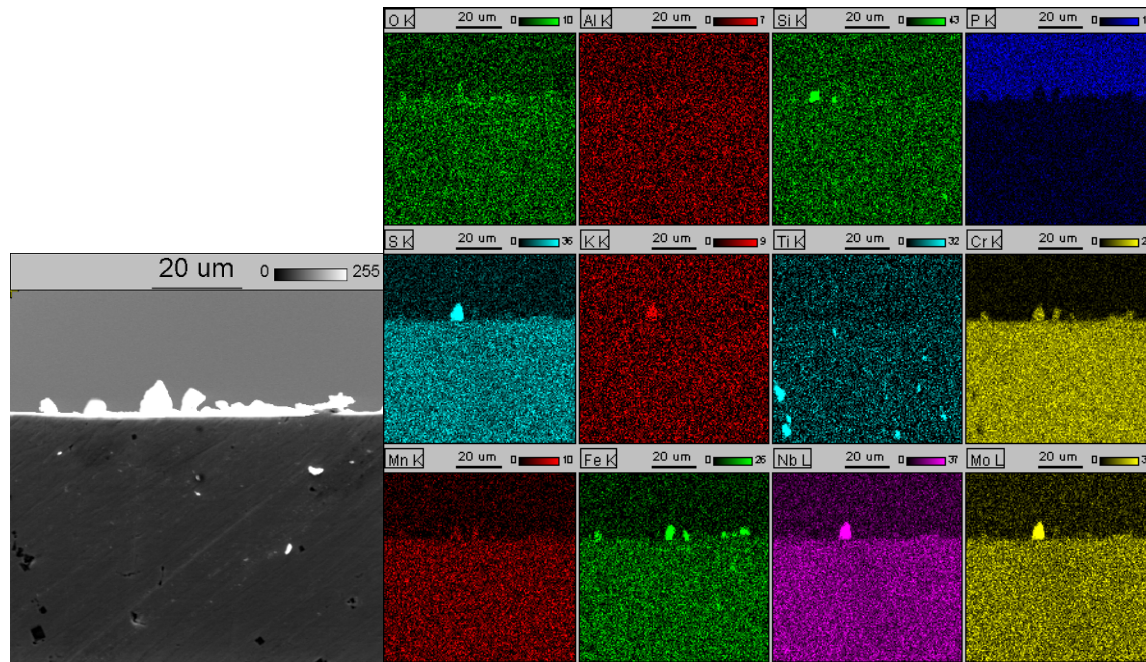
Figure 4. Element map of the surface of the Sanicro 63 sample after Test 3.

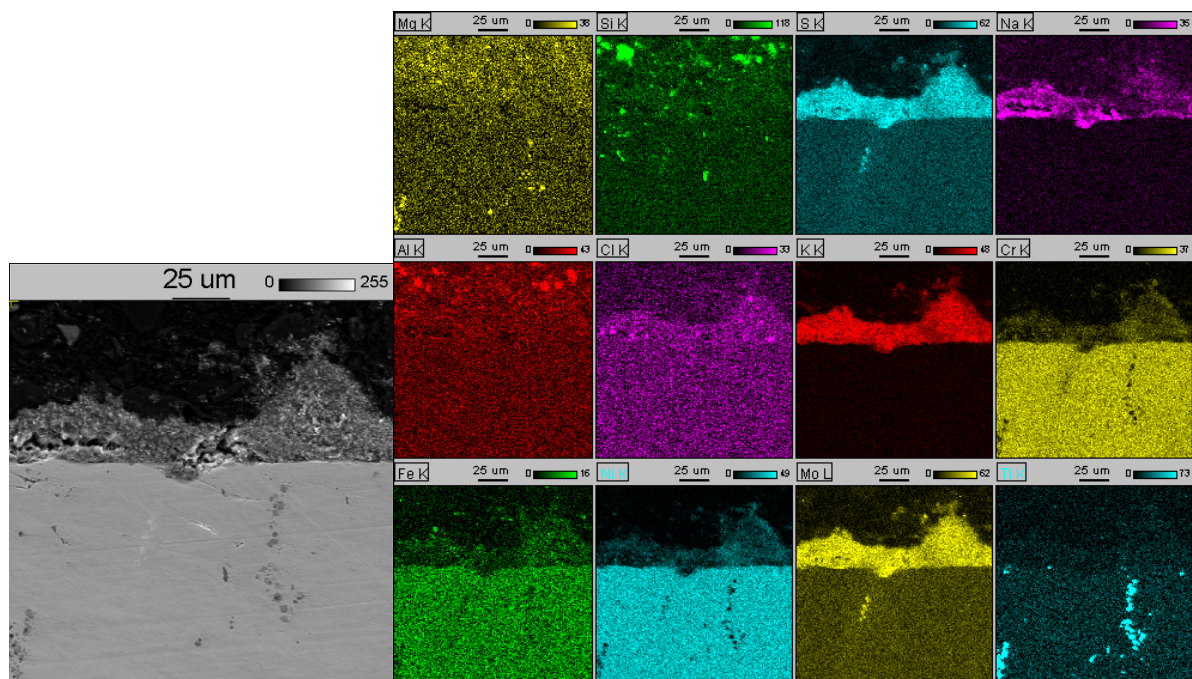
Figure 5. Element map of the surface of the Sanicro 63 sample after Test 4.

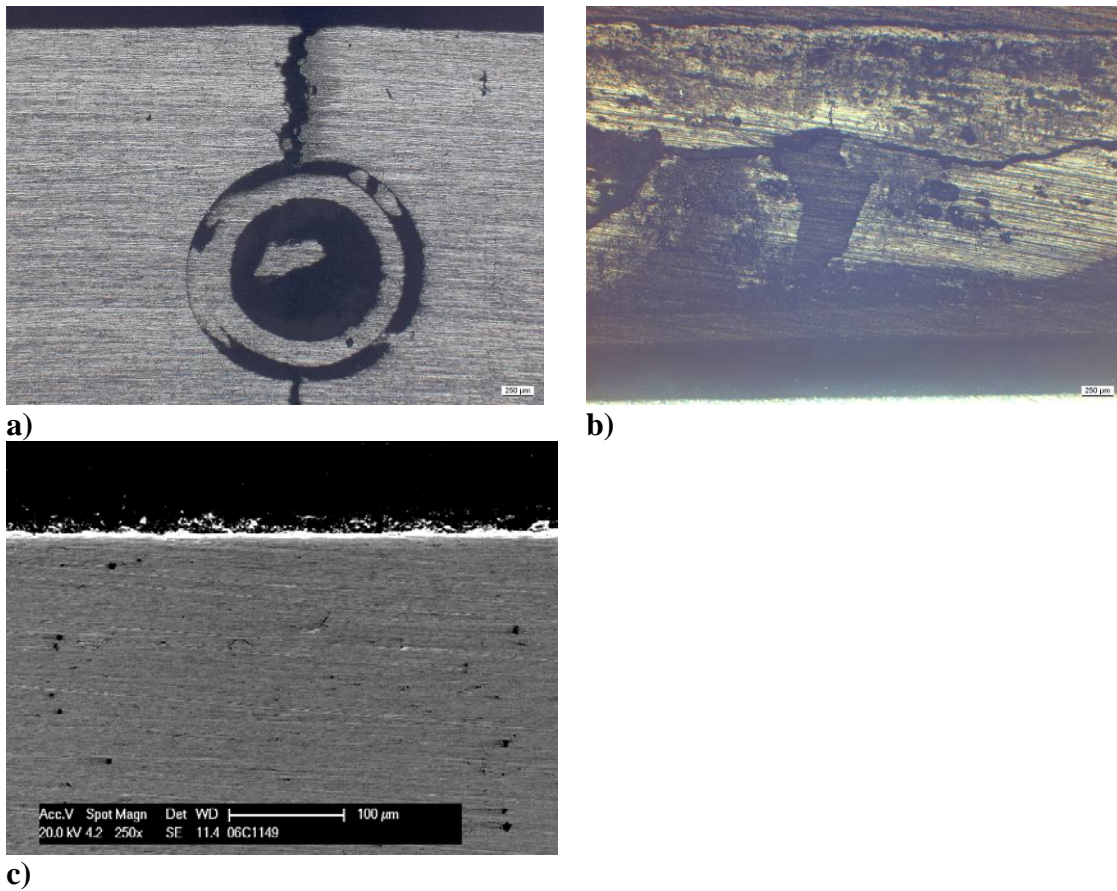
In Test 3, Sanicro 41 had cracked at the upper part of the drill hole? (Figure 6a). The sample was covered with a thick layer of brittle salt after Test 3 (Figure 6b). The deposit closest to the metal surface also consisted primarily of salt (S, Na, K), containing, however, also small amounts of nickel, iron and chromium (Figure 7). Some irregularity was also observed in the surface, which is an indication of early surface corrosion.

Figure 6. Sample of Sanicro 41 a) and b) after Test 3 and c) after Test 4

After Test 4, no cracking close to the drill hole was observed in the Sanicro 41 sample, or at least not to the extent shown in Test 3. At first, a thick brittle salt layer covered the sample also after Test 4. However, in the process of preparing the sample, only the thickest layer was left on the surface of the sample (Figure 6c). In addition to salt, this dense layer also contained in particular chromium. The surface of this sample was also irregular, indicating early corrosion.

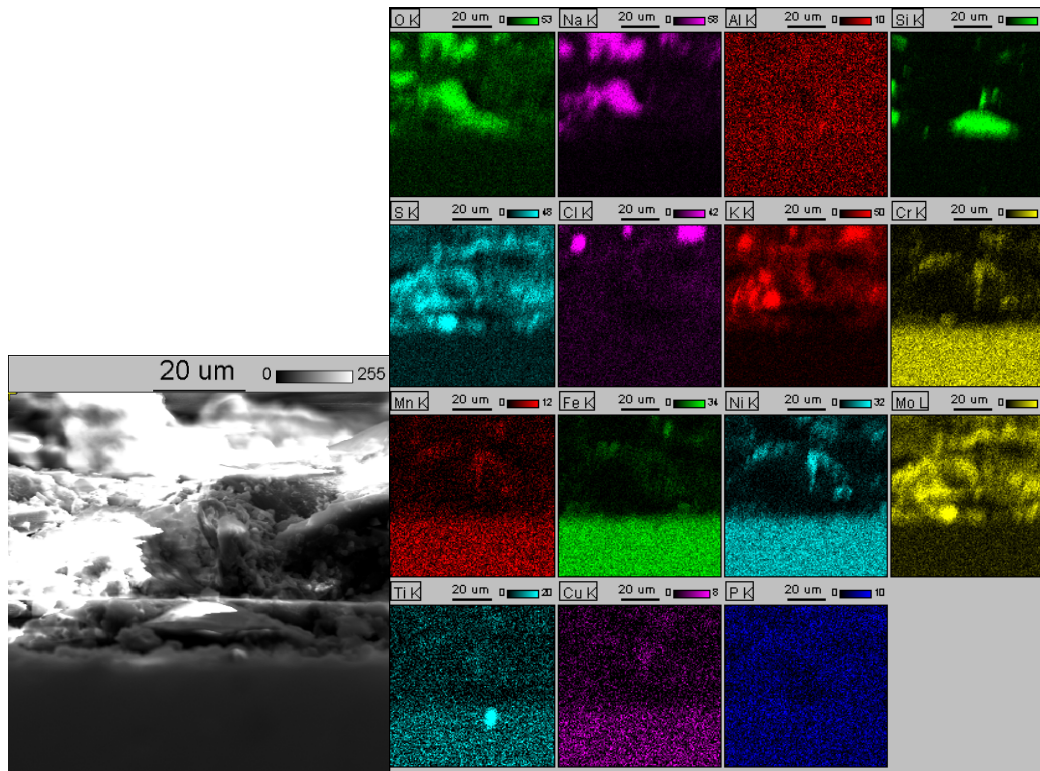
Figure 7. Element map of the surface of the Sanicro 41 sample after Test 3.

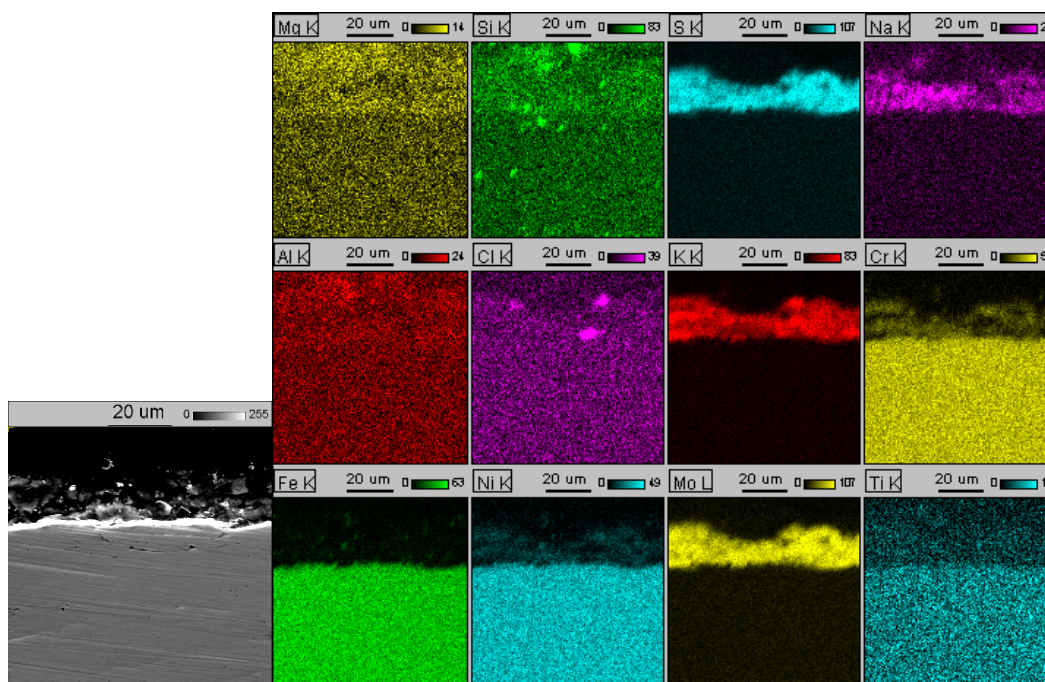
Figure 8. Element map of the surface of the Sanicro 41 sample after Test 4

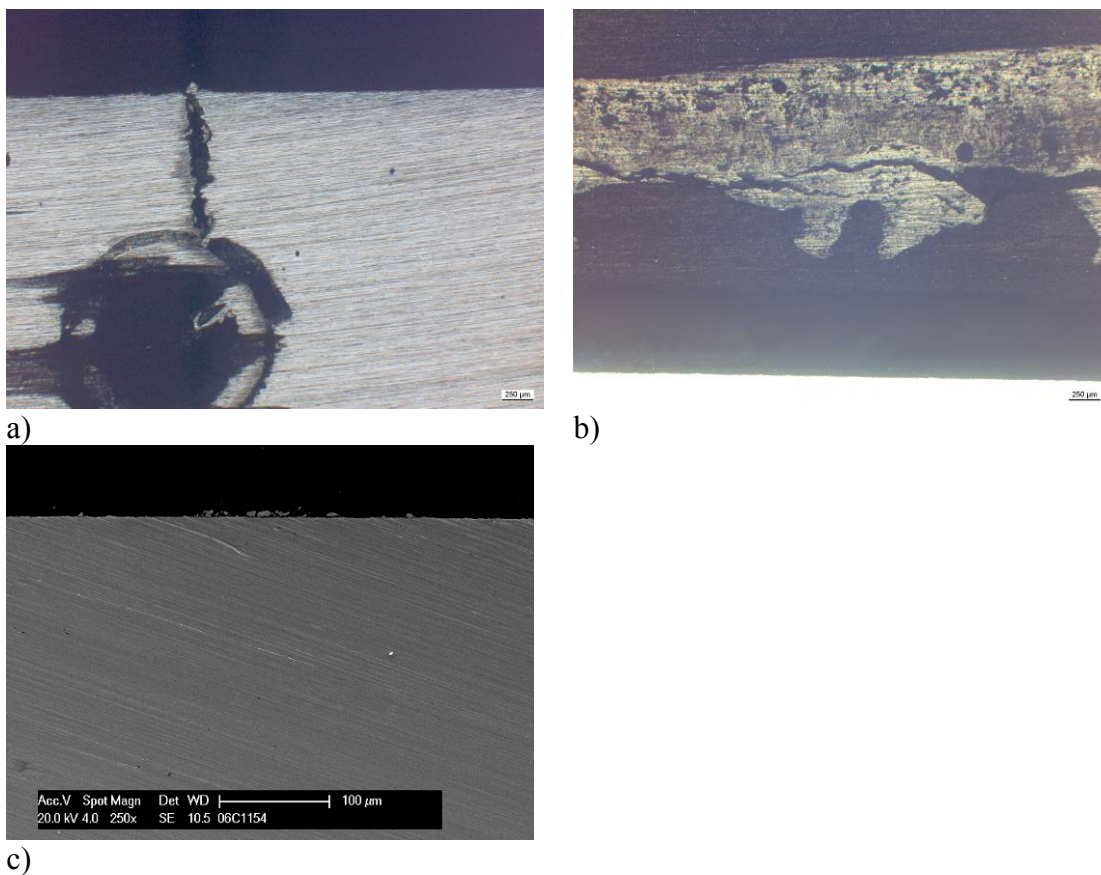
Also Sanicro 36 Mo had cracked at the forefront of the drill hole (Figure 9a) in Test 3. In Test 4 no similar cracking was observed. The sample was covered by a thick brittle salt layer after Test 3 (Figure 9b). The deposit closest to the metal surface was also principally composed of salt (S, Na, K), containing, in addition, also much chromium and small amounts of nickel and iron (Figure 10).

After Test 4 there was also a thick layer of salt in the sample, but the salt had not yet reacted with the metal, since after the preparation of the metallographic sample no significant deposit at the surface of the sample and no corrosion of the surface were observed (Figure 9c). The deposit formed may have scaled off from the metal surface. Since there was no deposit, no element map was made of the material after Test 4.

Figure 9. Sample of Sanicro 36 Mo a) and b) after Test 3 and c) after Test 4.

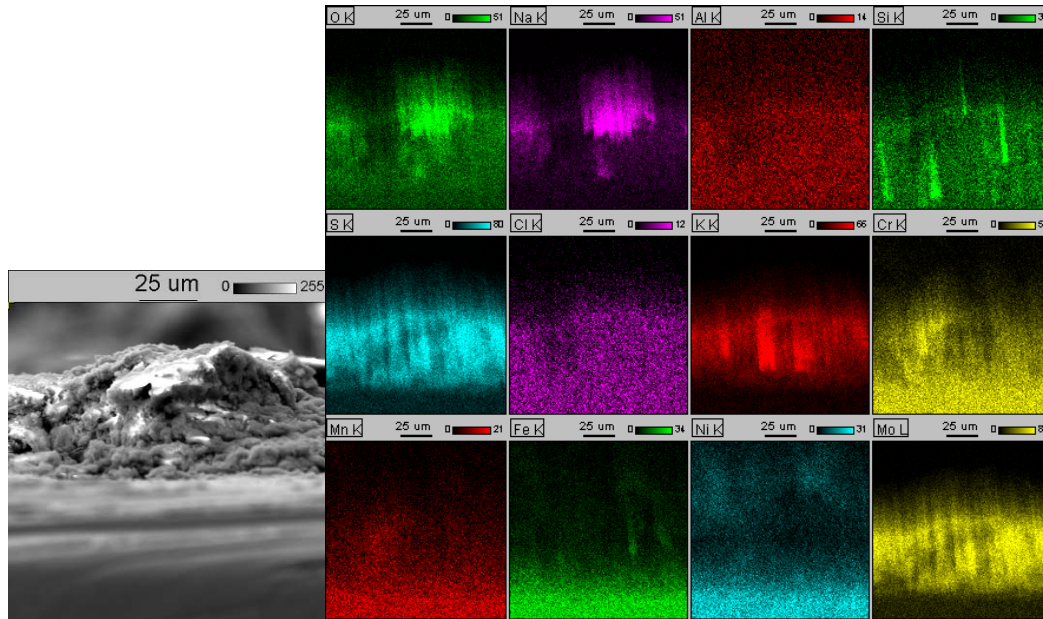
Figure 10. Element map of the surface of the Sanicro 36 Mo sample after Test 3

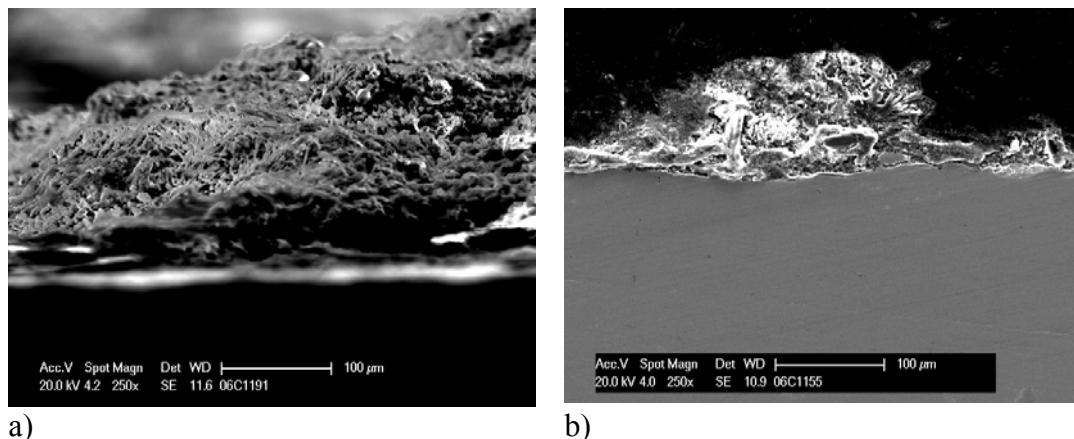
Material 3R12 (304L) was the only sample that did not present any cracking in either of the tests. Indeed, the sample was covered by a thick, brittle salt layer after Test 3 (Figure 11a). The deposit closest to the metal surface was composed of salt (K, S, Na) as well as of very small amounts of chromium, nickel and iron (Figure 12). However, the metal content of the deposit was very low, indicating an insignificant reaction between the salt deposit and the metal. Some surface irregularity was still observed, indicating early corrosion. In Test 4 the deposit was composed purely of salt (Figure 13). Admittedly, some surface irregularity was observed also after this test.

Figure 11. Surface of sample 3R12 a) after Test 3 and b) after Test 4.

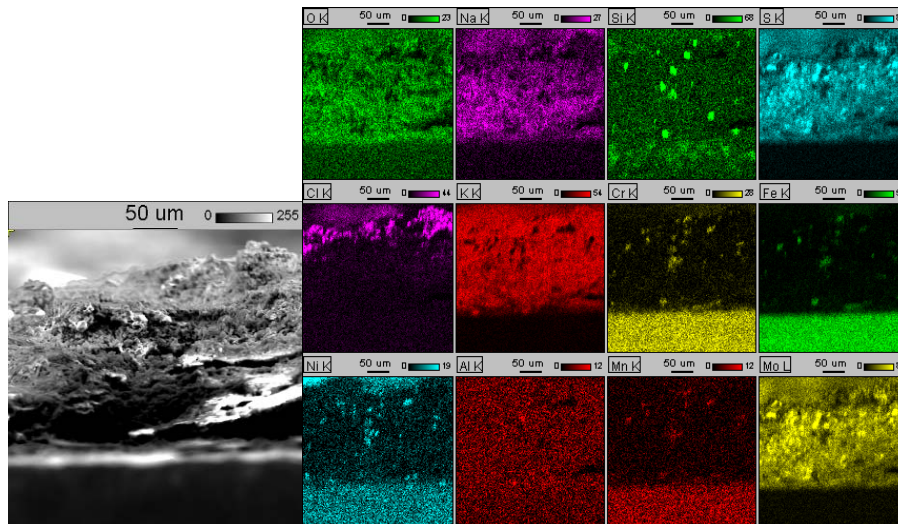
Figure 12. Element map of the surface of sample 3R12 after Test 3

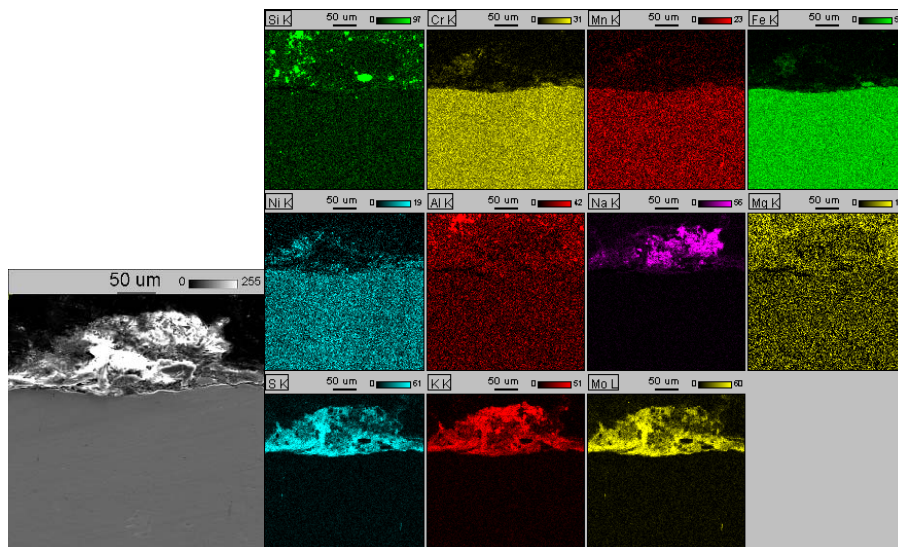
Figure 13. Element map of the surface of sample 3R12 after Test 4
