Paper presented by Pauli Harila, Oy Metsä-Botnia Ab, Kemi, Finland,  
at the Recovery Boiler Day 1992 arranged by the Finnish Recovery Boiler Committee in  
Helsinki, October 22, 1991

## WATER SOOTBLOWER EXPERIMENT IN THE BABCOCK & WILCOX KRAFT RECOVERY BOILER AT OY METSÄ-BOTNIA AB, KEMI MILLS

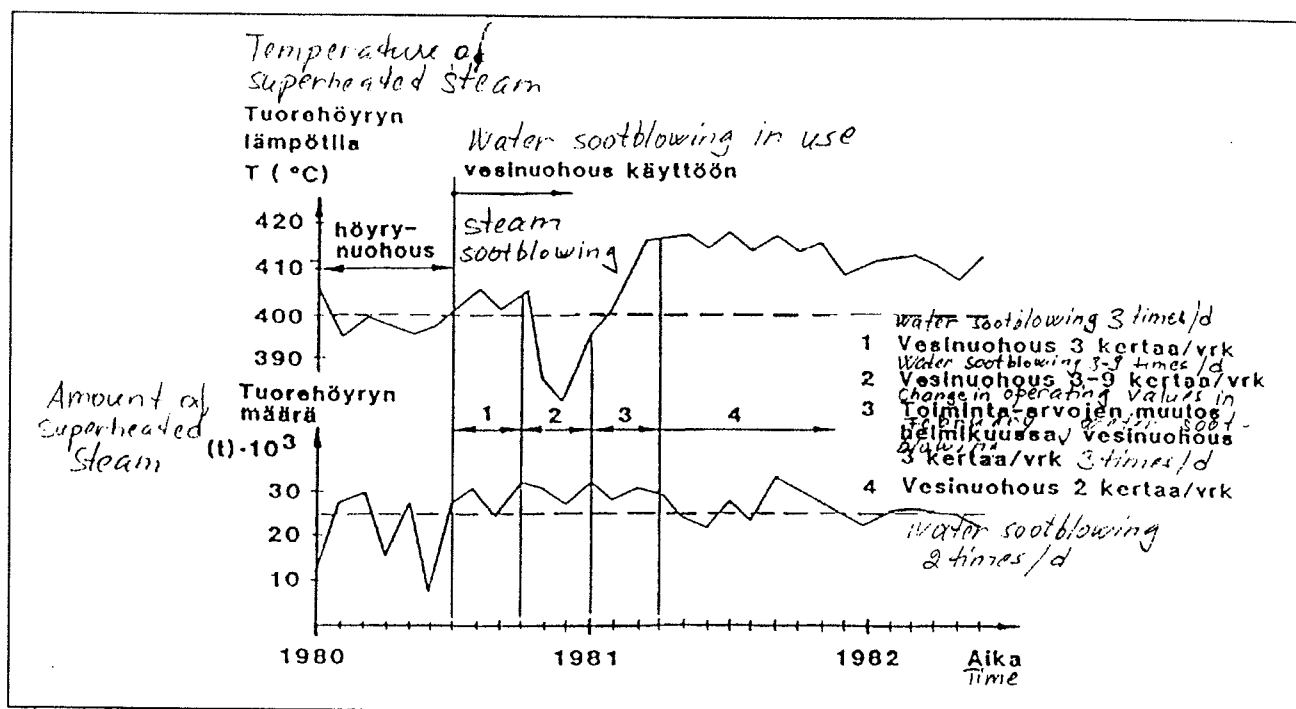
Fig. 1 Monthly averages of temperature and amount of superheated steam

The sootblowing efficiency was followed by means of the temperature of superheated steam. Figure 1 shows the monthly temperature averages of superheated steam from the testing period. The temperature of superheated steam during water sootblowing was about 17°C (even 50°C, 1983-1990) higher than in steam sootblowing. The amount of water was about 20% of the amount of steam needed for sootblowing.

The amount of sootblowing water for the superheater was about 12 t/d less than the amount of sootblowing steam. The result of sootblowing was better with water than with steam.

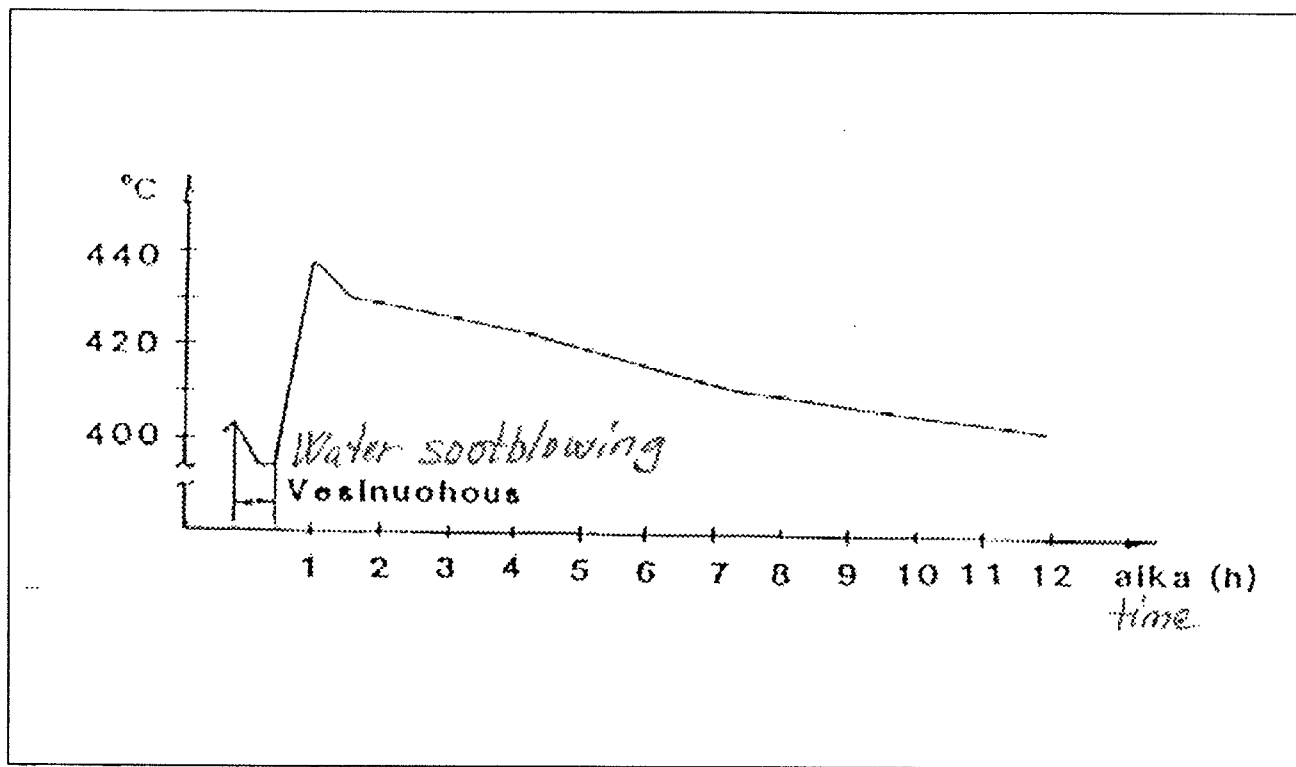
**Fig. 2** Temperature of superheated steam during and after water sootblowing

The changes in the temperature of superheated steam during and after water sootblowing are shown in fig. 2.
