# Characterisation of probe test samples exposed to BLRB lower furnace environments

Author: Pekka Pohjanne

Report's title Characterisation of probe test samples exposed to BLRB lower furnace environments	
Customer, contact person, address Soodakattilayhdistys ry.	Order reference
Project name SKYREC Sondi	Project number/Short name 33189
Author(s) Pekka Pohjanne	Pages 70/
Keywords	Report identification code VTT-R-02472-13
<p><b>Abstract</b></p> <p>Current trend to increase electricity generation of recovery boilers possess new demands for the tube materials, when the material temperatures are increased due to higher steam values. Operational experiences from current boilers have shown that the AISI 304 L compound tubes suffer from accelerated corrosion in furnace wall, when the material temperatures are increased from normal values due to the internal surfaces scales. This indicates that the AISI 304L might be unsuitable cladding material for the future high pressure boilers.</p> <p>The goal of this study was to test different potential cladding materials in actual recovery boiler lower furnace conditions, but at higher than current temperatures, in order to determine what material

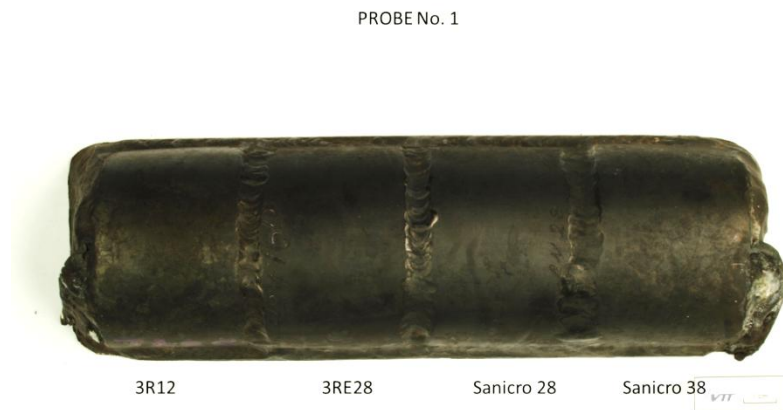
Total test duration of the test No. 1 was 1006 hours, from which 906 hours at the target temperature of 440 °C. The test materials in this exposure were 3R12, 3RE28, Sanicro 28 and Sanicro 38, Figure 3. According to visual inspection all samples were in good condition after testing i.e. neither marked general or localised corrosion nor deposits or oxide scales were observed either on outer or inner surfaces.

Figure 3. Macrographs taken from the probe No. 1 head after exposure: a) outer surface exposed to the furnace side and b) inner surface exposed to the cooling liquid.

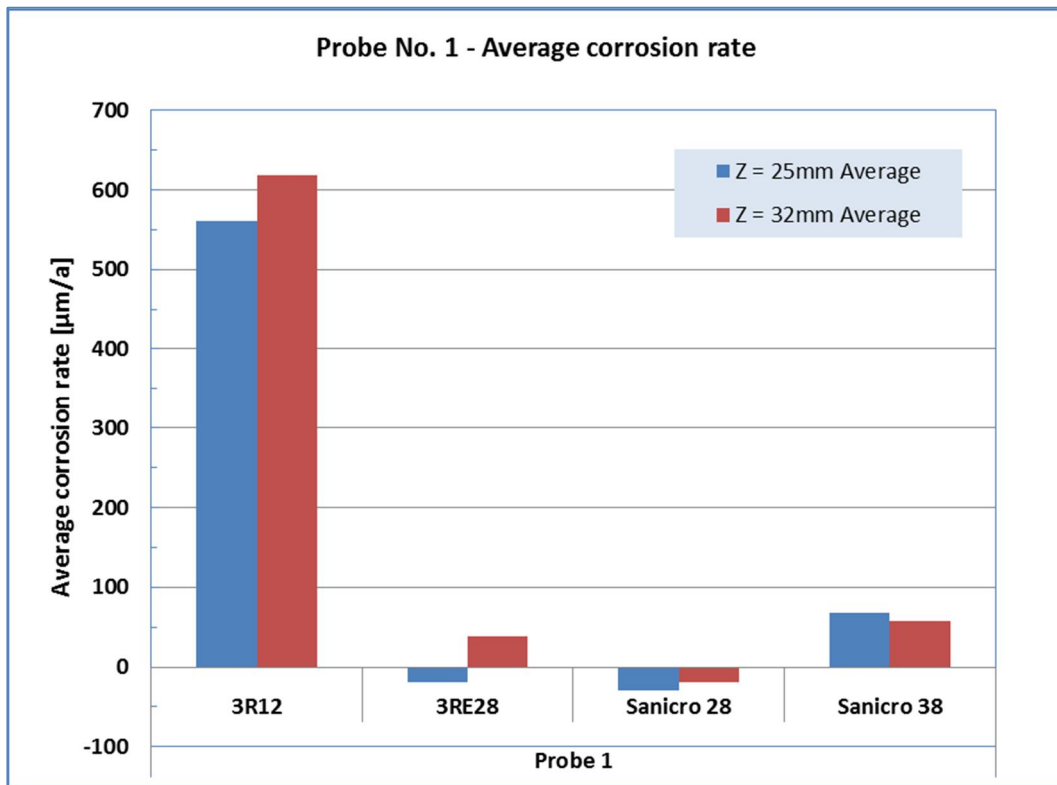
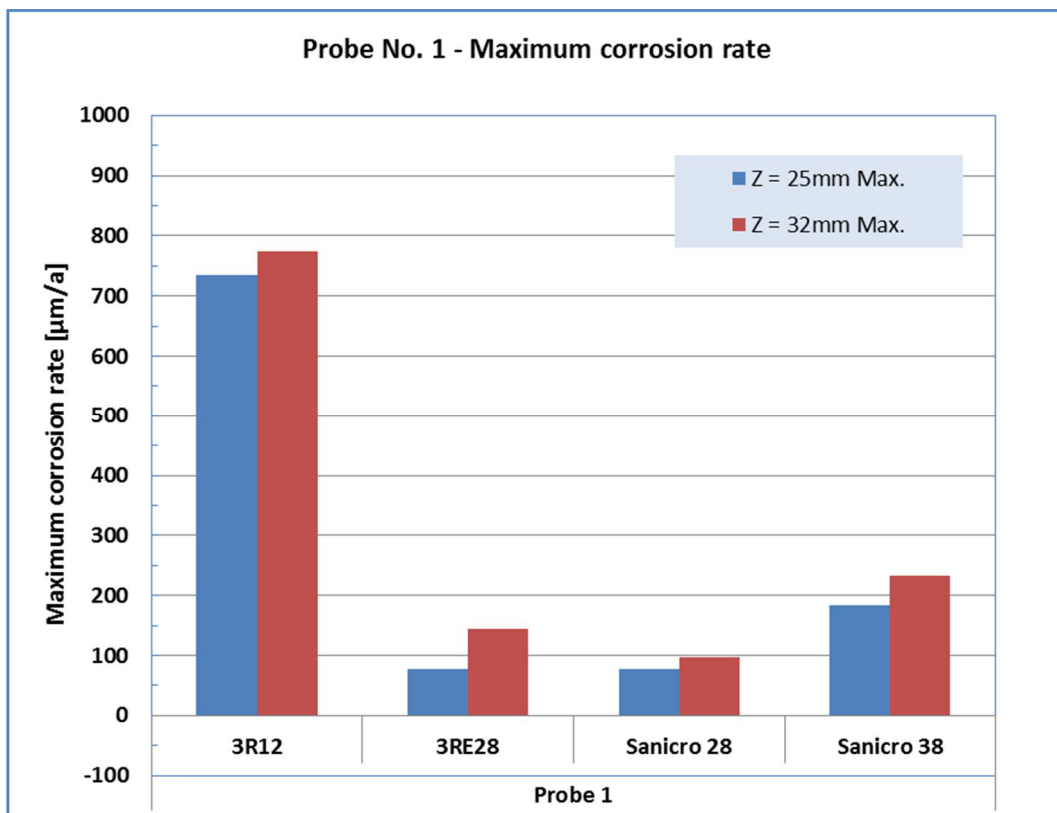
The average and maximum corrosion rates calculated on the basis of the wall thickness measurements are presented in Figure 12. In this test highest corrosion rate, order of 0.7 mm/a, was measured for the 3R12 material. Corrosion rate was next highest in the Sanicro 38, for which a maximum corrosion rate of ca. 0.2 mm/a was determined. The maximum corrosion rates of Sanicro 28 and 3RE28 materials were in the order of 0.1 mm/a and they were best performing materials in this test.

Figure 12. a) Average and b) maximum corrosion rates of the test materials calculated on the basis of the wall thickness measurements after 906 h exposure in lower furnace at 440 °C (Probe test No. 1).

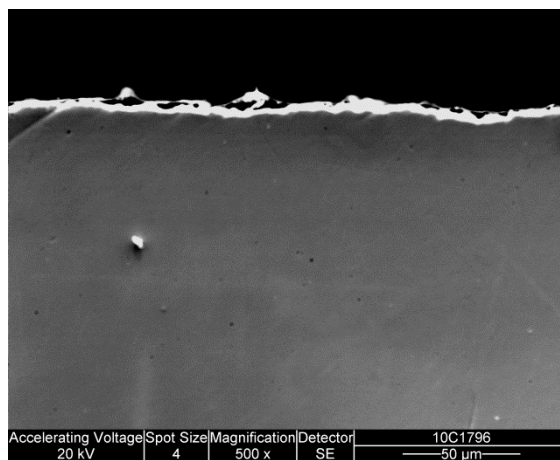
After the tests the samples were examined with optical microscope and/or SEM to determine the type of the corrosion attack. All samples had suffered from general thinning and no marked deposits or oxide/sulphide scales were observed, Figure 13. According to the EDS analysis (Figure 14) the thin layers (thickness ca. 5  $\mu\text{m}$ ) on 3RE28 and Sanicro 28 were depleted in iron and nickel and enriched in chromium and contained also high amounts of sulphur. Whereas the composition of thin layer on 3R12 was similar to the base material and no sulphur was detected.

Figure 13. Cross sections from a) 3R12, b) 3RE28, c) Sanicro 28 and d) Sanicro 38 after 906 h exposure in lower furnace at 440 °C (Probe test No. 1).

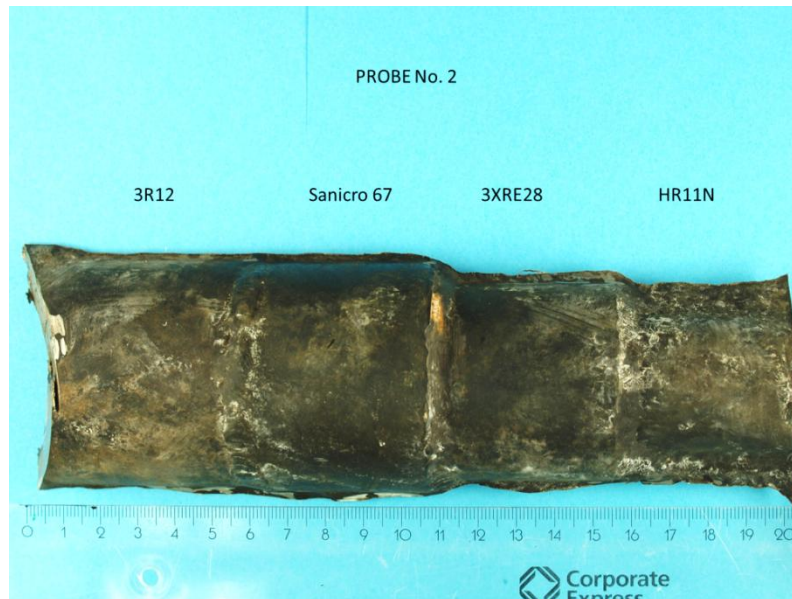
Total test duration of the test No. 2 was 1023 hours from which 744 hours at the target temperature of 440 °C. The test materials in this exposure were 3R12, 3XRE28, HR11N and Sanicro 67, Figure 15. According to visual inspection the inner surfaces of the specimens were in good condition after testing i.e. neither marked general or localised corrosion nor deposits or oxide scales were observed. The outer surfaces of the specimens appeared to be in good condition, but the thin dark and white deposits on the surfaces hindered accurate examinations.

Figure 15. Macrographs taken from the probe No. 2 head after exposure: a) outer surface exposed to the furnace side and b) inner surface exposed to the cooling liquid.

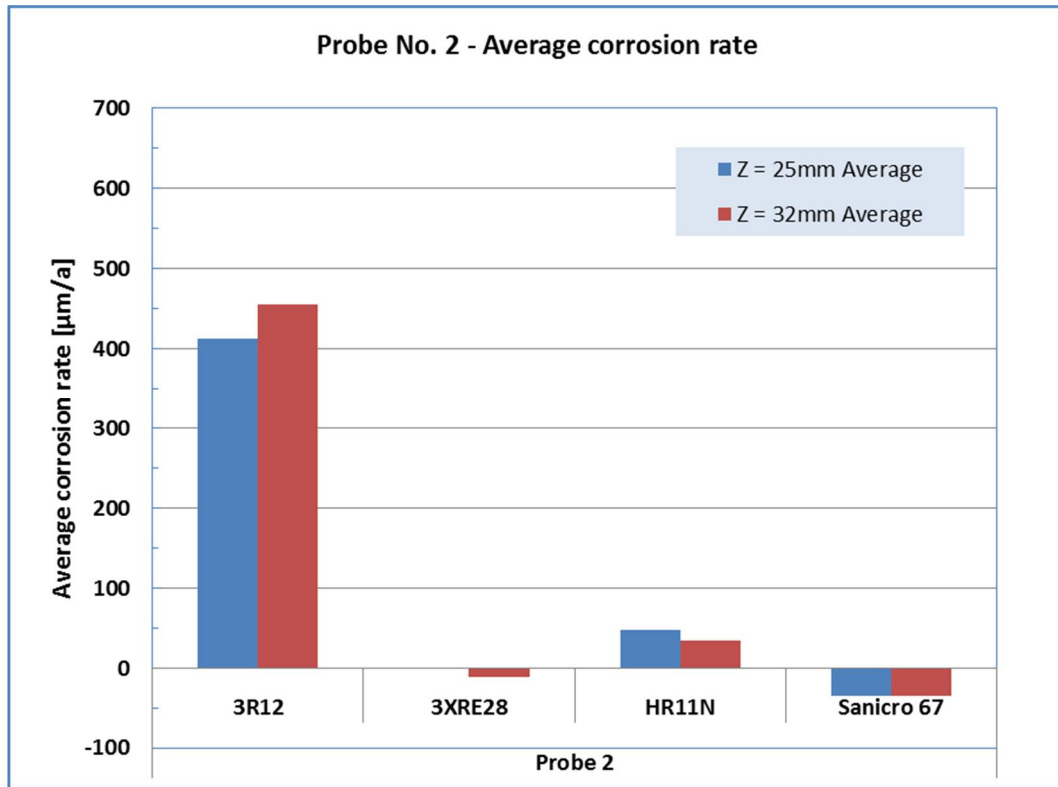
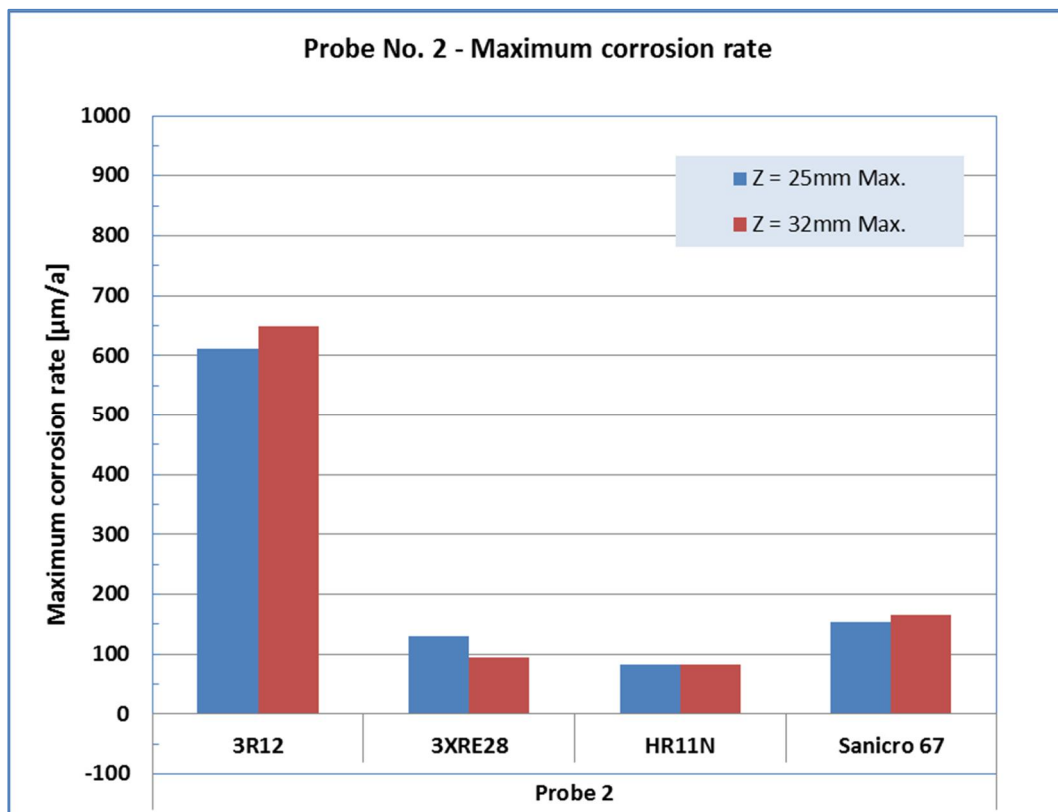
The results of the wall thickness profile measurements and the wall thinning curves derived from them are presented in Figures 16...23. The results showed that marked wall thinning had taken place on the 3R12 specimen and to some extent also on the HR11N specimen. The data of the 3XRE28 and Sanicro 67 materials was more scattered showing that wall thinning and deposit formation (increase in wall thickness) had taken place locally. Measurements showed also that the wall thickness variations were smaller in the machined HR11N specimen, than in the other specimens tested in as received condition. The average and maximum corrosion rates calculated on the basis of the wall thickness measurements are presented in Figure 12. In this test highest corrosion rate in the order of 0.6 mm/a was measured for the 3R12 material. The corrosion resistance of the 3XRE28, HR11N and Sanicro 67 was practically at the same level.

Figure 24. a) Average and b) maximum corrosion rates of the test materials calculated on the basis of the wall thickness measurements after 744 h exposure in lower furnace at 440 °C (Probe test No. 2).

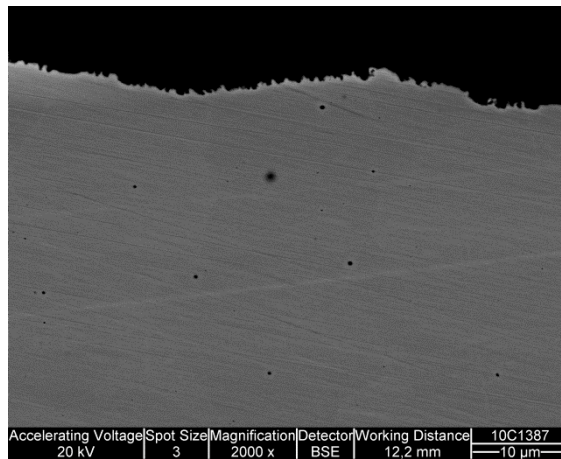
After the tests the samples were examined with optical microscope and/or SEM to determine the type of the corrosion attack. All samples had suffered from general thinning and no marked deposits or oxide/sulphide scales were observed on the surfaces, Figure 25. According to the EDS analysis (Figure 26) the thin, a few  $\mu\text{m}$  thick layer, observed on 3XRE28 was depleted in iron and nickel and enriched in chromium and contained also high amounts of sulphur. Similar thin layer (thickness ca. 3  $\mu\text{m}$ ) on Sanicro 67 contained high amounts of sulphur and was depleted in nickel and iron whereas chromium content was at the same level than in the base material.

Figure 25. Cross sections from a) 3R12, b) 3XRE28, c) HR11N and d) Sanicro 67 after 744 h exposure in lower furnace at 440 °C (Probe test No. 2).

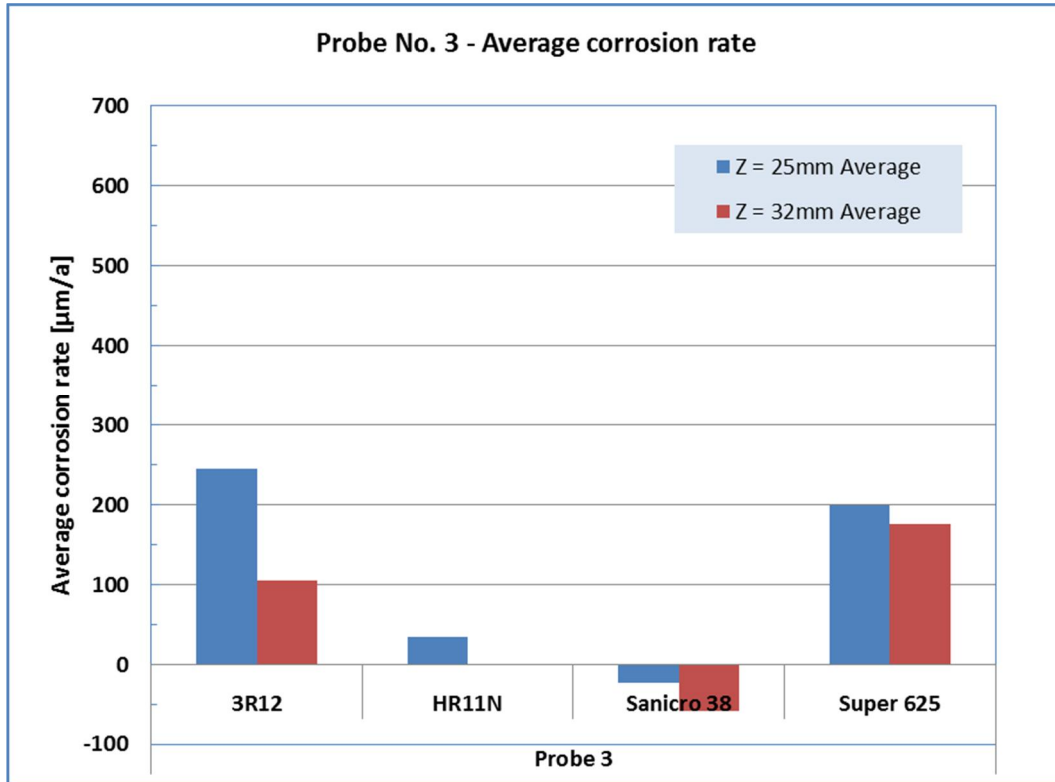
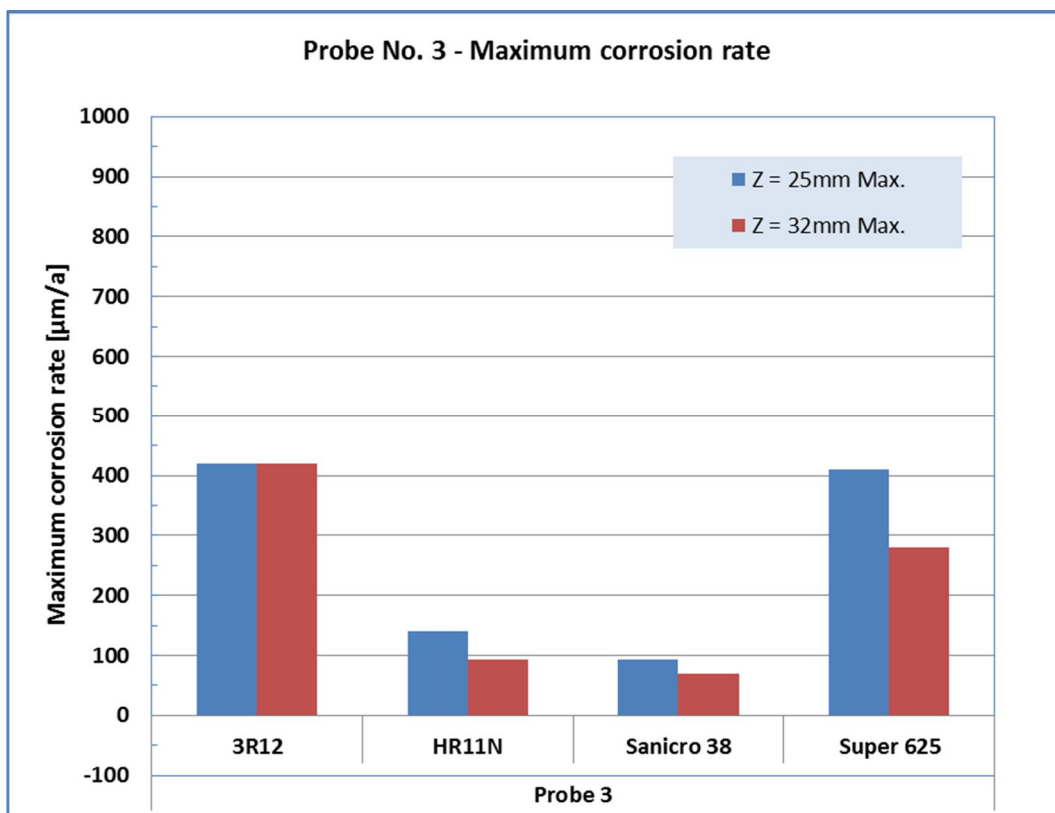
The average and maximum corrosion rates calculated on the basis of the wall thickness measurements are presented in Figure 36. In this test the corrosion rate of 3R12 was in the order 0.4 mm/a, i.e. about 0.2 mm/a lower than in the first two tests, most probably due the lower effective probe temperature. The corrosion rate of the Super 625 was unexpectedly high ca. 0.3...0.4mm/a. The maximum corrosion rates of HR11N and Sanicro 38 were in the order of 0.1 mm/a, and they were best performing materials in this test.

Figure 36. a) Average and b) maximum corrosion rates of the test materials calculated on the basis of the wall thickness measurements after 750 h exposure in lower furnace at 430 °C (Probe test No. 3).

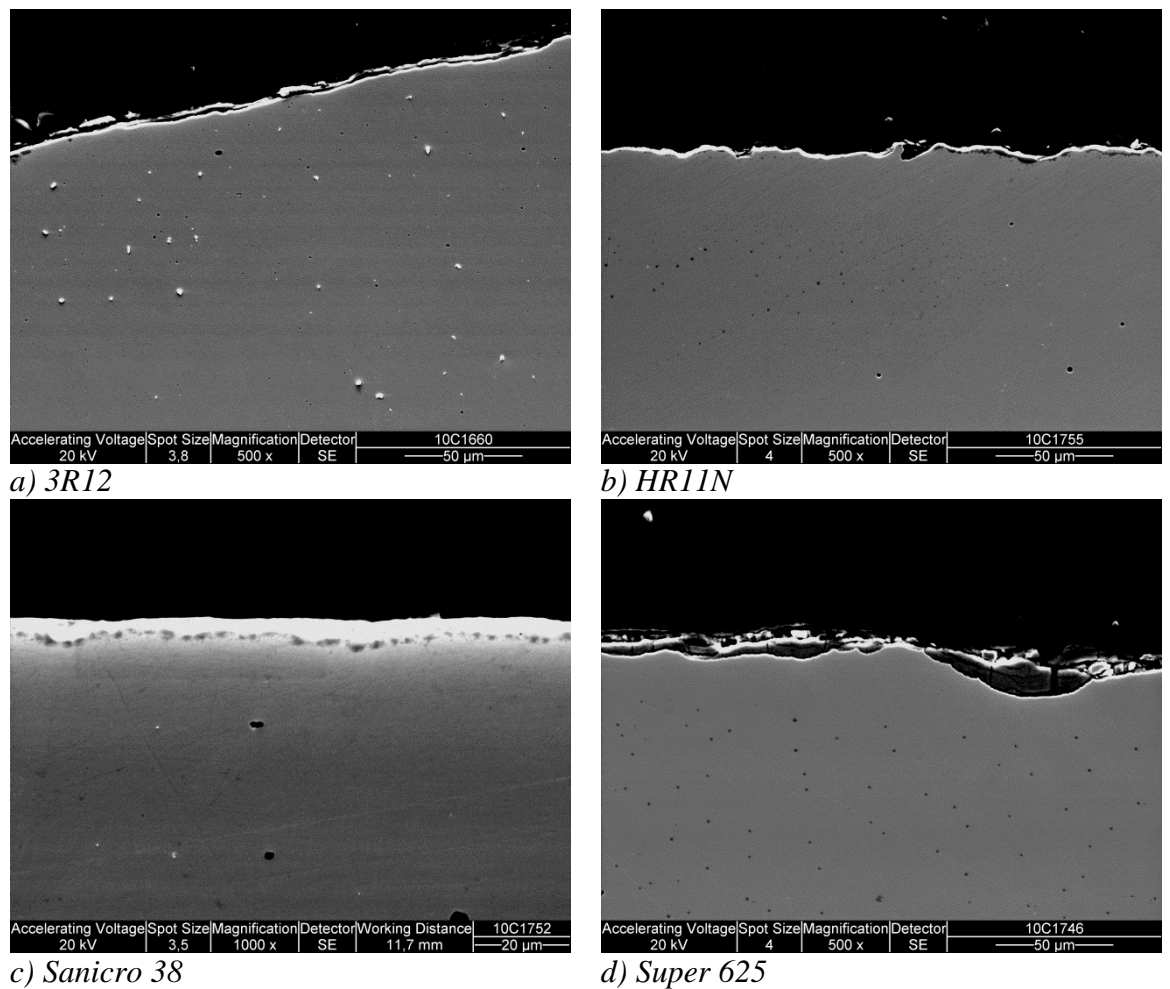
After the tests the samples were examined with optical microscope and/or SEM to determine the type of the corrosion attack. All samples had suffered from general thinning. The layers formed on 3R12, HR11N and Sanicro 38 were thin ca. 5  $\mu\text{m}$  in thickness. Whereas on the Super 625 ca. 10...20  $\mu\text{m}$  thick peeling like scale was observed.

Figure 37. Cross sections from a) 3R12, b) HR11N, c) Sanicro 38 and d) Super 625 after 750 h exposure in lower furnace at 430 °C (Probe test No. 3).

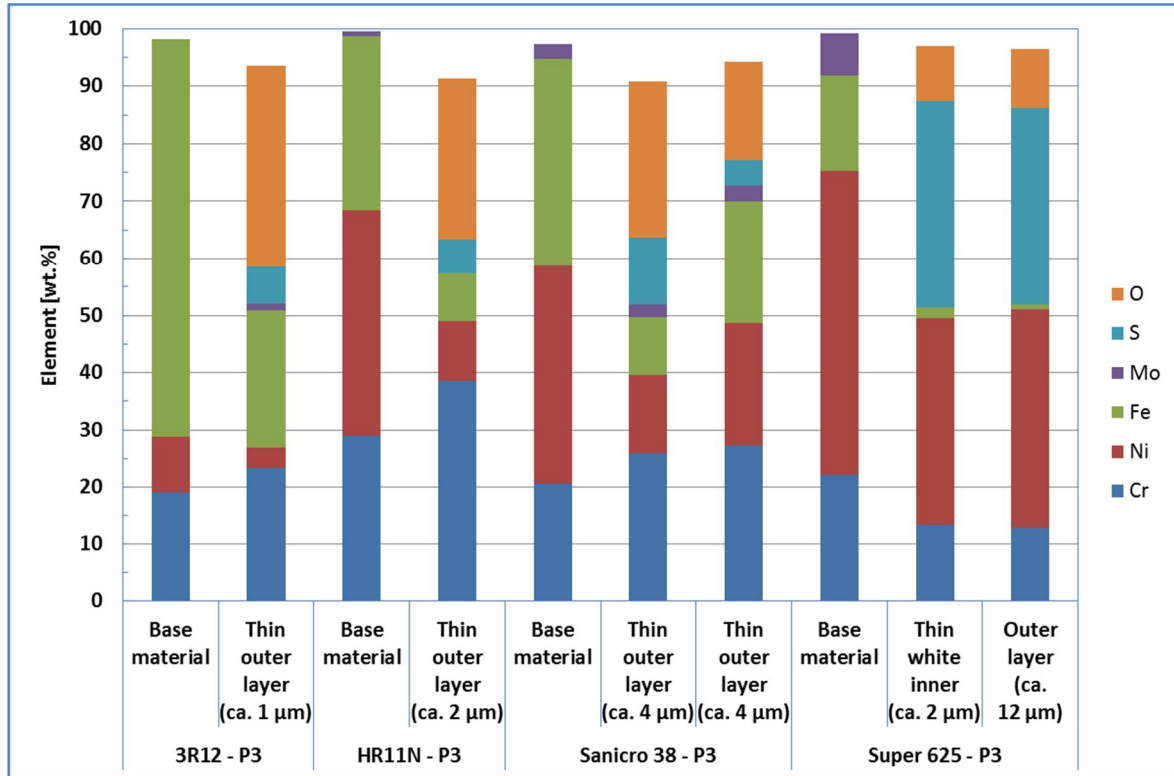
According to the EDS analysis (Figure 38) the layers on 3R12, HR11N and Sanicro 38 were depleted in iron and nickel and enriched in chromium and contained also sulphur. The layers on the Super 625 were depleted in iron, nickel, molybdenum and chromium and contained high amounts of sulphur. Reference analysis made from unexposed reference samples showed that the depleted/enriched layers are formed during exposure and do not originate from the specimen manufacturing process.

Figure 38. Results from the EDS analysis performed for the 3R12, HR11N, Sanicro 38 and Super 625 specimens after 750 h exposure in lower furnace at 430 °C (Probe test No. 3). Note: Quantitative results from cross sections, carbon excluded. Data from layers are from point analysis, whereas area analysis was used for base materials.

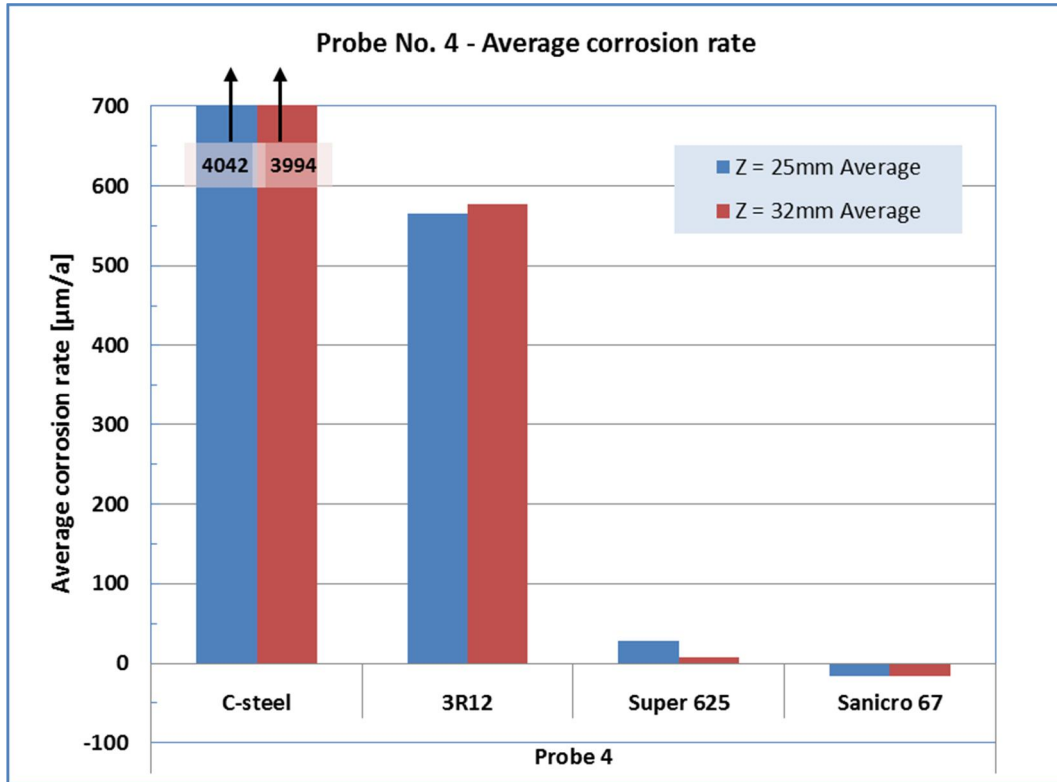
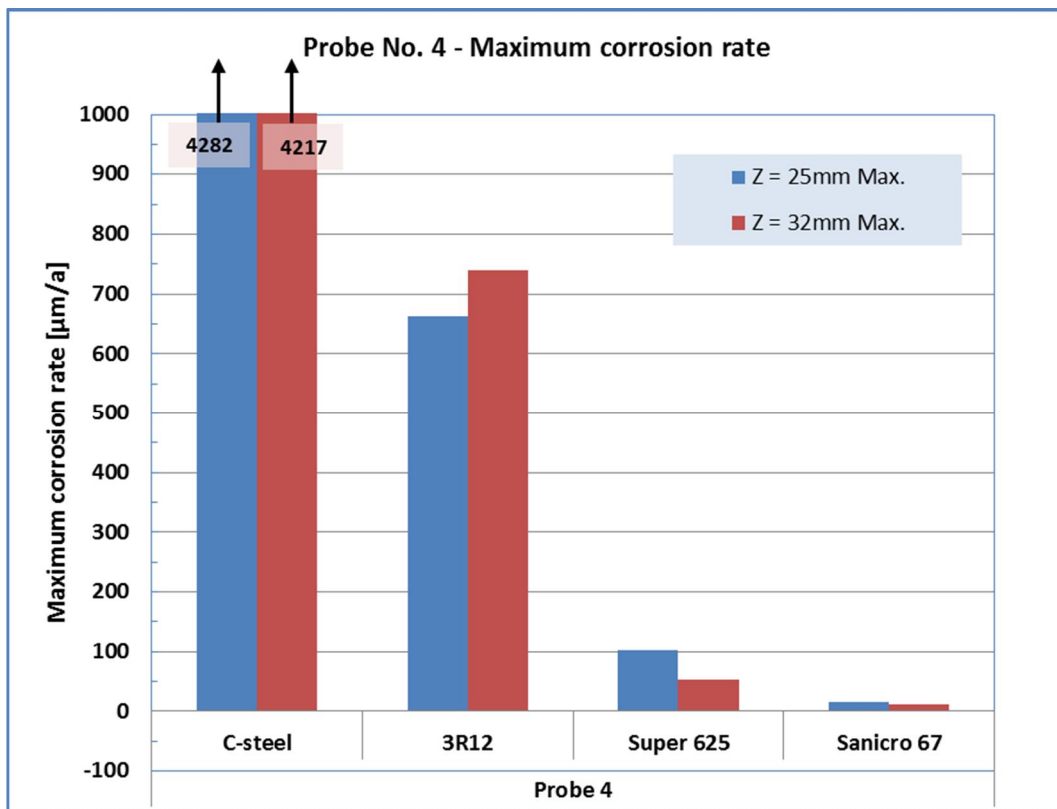
The average and maximum corrosion rates calculated on the basis of the wall thickness measurements are presented in Figure 48. Highest corrosion rates, ca. 4 mm/a, were measured for the carbon steel as expected. The 3R12 had the second highest corrosion rates, order of 0.6 mm/a. Maximum corrosion rate of the Super 625 was in the order 0.1 mm/a in this test, i.e. significantly lower than in the test No.3, where a maximum corrosion rate of 0.2...0.3 mm/a was observed. The best material in this test was Sanicro 67, its maximum corrosion rate was only about 0.02 mm/a.

Figure 48. a) Average and b) maximum corrosion rates of the test materials calculated on the basis of the wall thickness measurements after 2154 h exposure in lower furnace at 440 °C (Probe test No. 4).

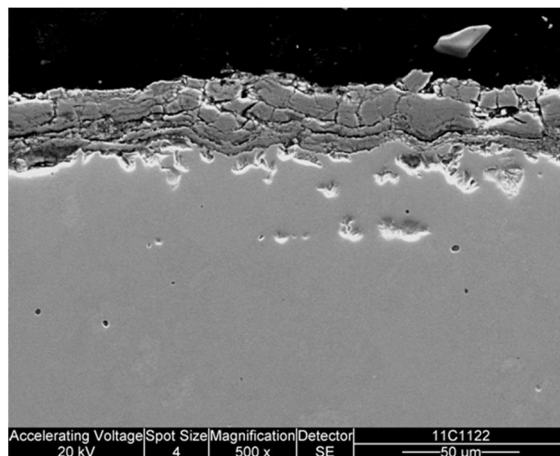
After the tests the samples were examined with optical microscope and/or SEM to determine the type of the corrosion attack. All samples had suffered from general thinning, Figure 49. The carbon steel showed scale thickness of about 25  $\mu\text{m}$  after 2700 h exposure. The layers formed on 3R12 and Sanicro 67 were thin ca.5  $\mu\text{m}$  in thickness. Whereas on the Super 625 ca. 10...20  $\mu\text{m}$  thick peeling like scale was observed.

Figure 49. Cross sections from a) carbon steel b) 3R12, c) Sanicro 67 and d) Super 625 after 2154 h exposure in lower furnace at 440 °C (Probe test No. 4). Note: scale is incorrect in Fig. 49b.

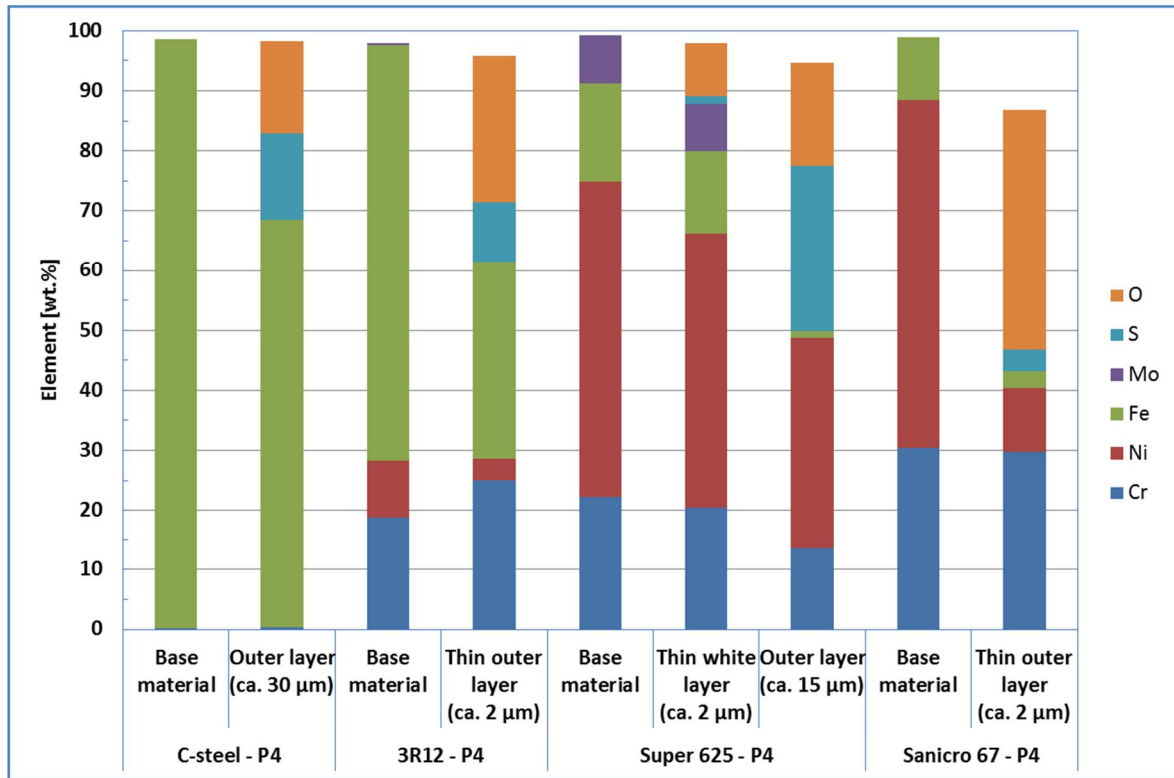
According to the EDS analysis (Figure 50) the layer on 3R12 was depleted in iron and nickel and enriched in chromium and contained also sulphur. The layer on Sanicro 67 contained sulphur and was depleted in iron and nickel, but the chromium content was at the same level than in the base material. The outermost layers on the Super 625 were depleted in iron, nickel, molybdenum and chromium and contained high amounts of sulphur.

Figure 50. Results from the EDS analysis performed for the carbon steel, 3R12, Sanicro 67 and Super 625 after 2154 h exposure in lower furnace at 440 °C (Probe test No. 4). Note: Quantitative results from cross sections, carbon excluded. Data from layers are from point analysis, whereas area analysis was used for base materials.

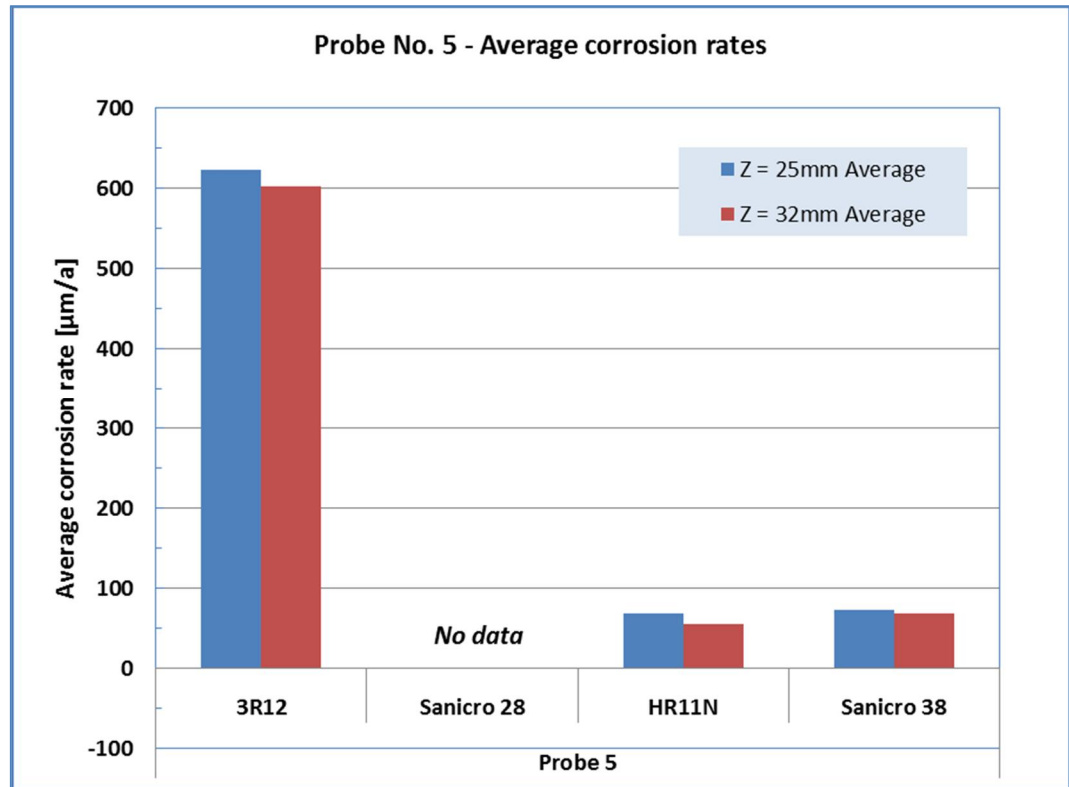
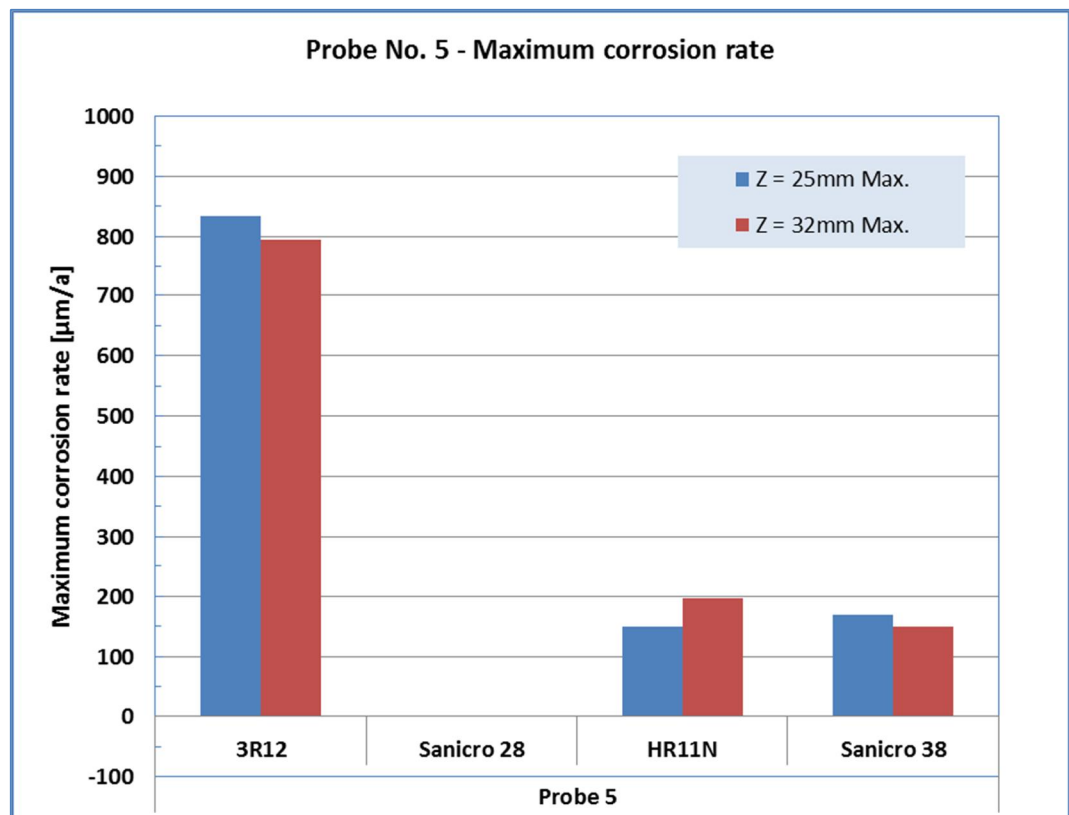
The average and maximum corrosion rates calculated on the basis of the wall thickness measurements are presented in Figure 48. In this test the corrosion rate of the 3R12 was in the order 0.8 mm/a. The maximum corrosion rates of HR11N and Sanicro 38 were in the order of 0.15 mm/a, i.e. at the same range than in the previous tests.

Figure 58. a) Average and b) maximum corrosion rates of the test materials calculated on the basis of the wall thickness measurements after 2157 h exposure in lower furnace at 440 °C (Probe test No. 5).

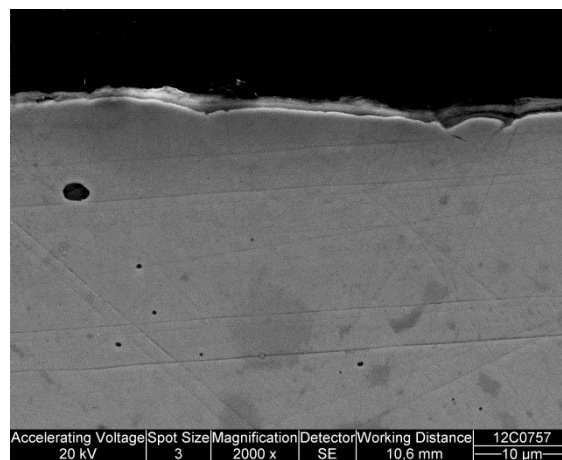
After the tests the samples were examined with optical microscope and/or SEM to determine the type of the corrosion attack. All samples had suffered from general thinning and no marked deposits or oxide/sulphide scales were observed on the surfaces, Figure 49. The layers found on 3R12, Sanicro 28, HR11N and Sanicro 38 were very thin ca. 2  $\mu\text{m}$  in thickness. EDS analysis showed that iron and nickel depletion and chromium enrichment had taken place in some locations in all materials and that in these locations sulphur was also detected (Figure 50).

Figure 59. Cross sections from a) 3R12, b) Sanicro 28, c) HR11N and d) Sanicro 38 after 2157 h exposure in lower furnace at 440 °C (Probe test No. 5).

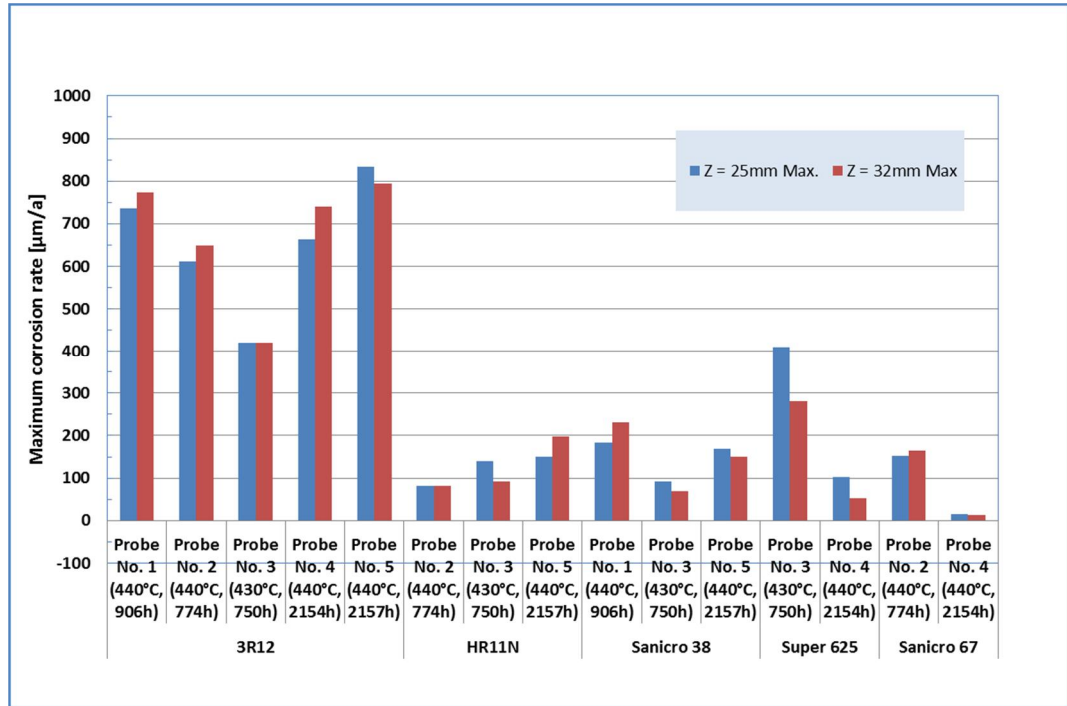
In current tests no marked differences were observed between Sanicro 38 and HR11N. Their maximum corrosion rates were in the order of 0.15...0.2 mm/a in the long term (>2000 h) test, i.e. about four times lower than that of the 3R12 (Figure 61).

Figure 61. Calculated maximum corrosion rates for the 3R12, HR11N, Sanicro 38, Super 625 and Sanicro 67 materials from the probe test No. 1 - 5.

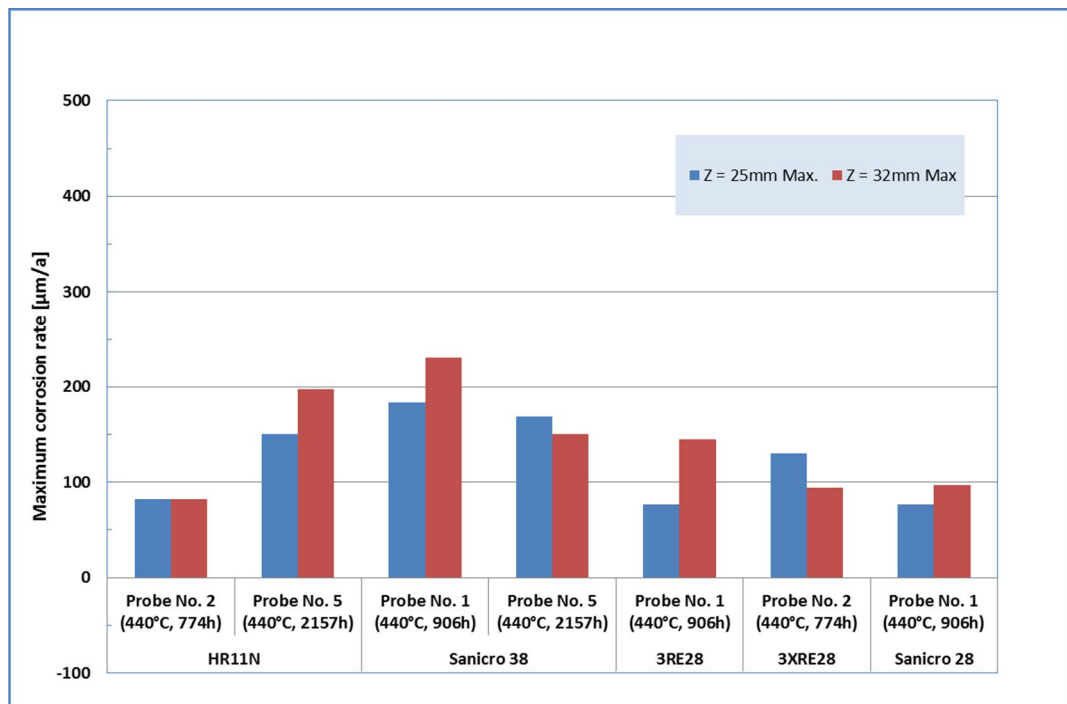
In short term (<1000 h) tests the corrosion resistance of the 3RE28, 3XRE28 and Sanicro 28 were as good as or even slightly better than that of the Sanicro 38 or HR11N (Figure 62). Because the 3RE28 and 3XRE28 were not included in the long term tests and no results were obtained for the Sanicro 28 from the long term test No. 5, due to the misplaced thermocouple, it is recommended to verify their promising performance with long term tests in the future.

Figure 62. Calculated maximum corrosion rates for the 3RE28, 3XRE28, HR11N and Sanicro 38 from the probe test No. 1-3 and 5.
