## **APPENDIX 1**

**Project budget  
5.5.2011**

# SKYREC Budget 5.5.2011

**Åbo Akademi  
Corrosion tests in reducing conditions  
Part II – revised offer  
5.5.2011**

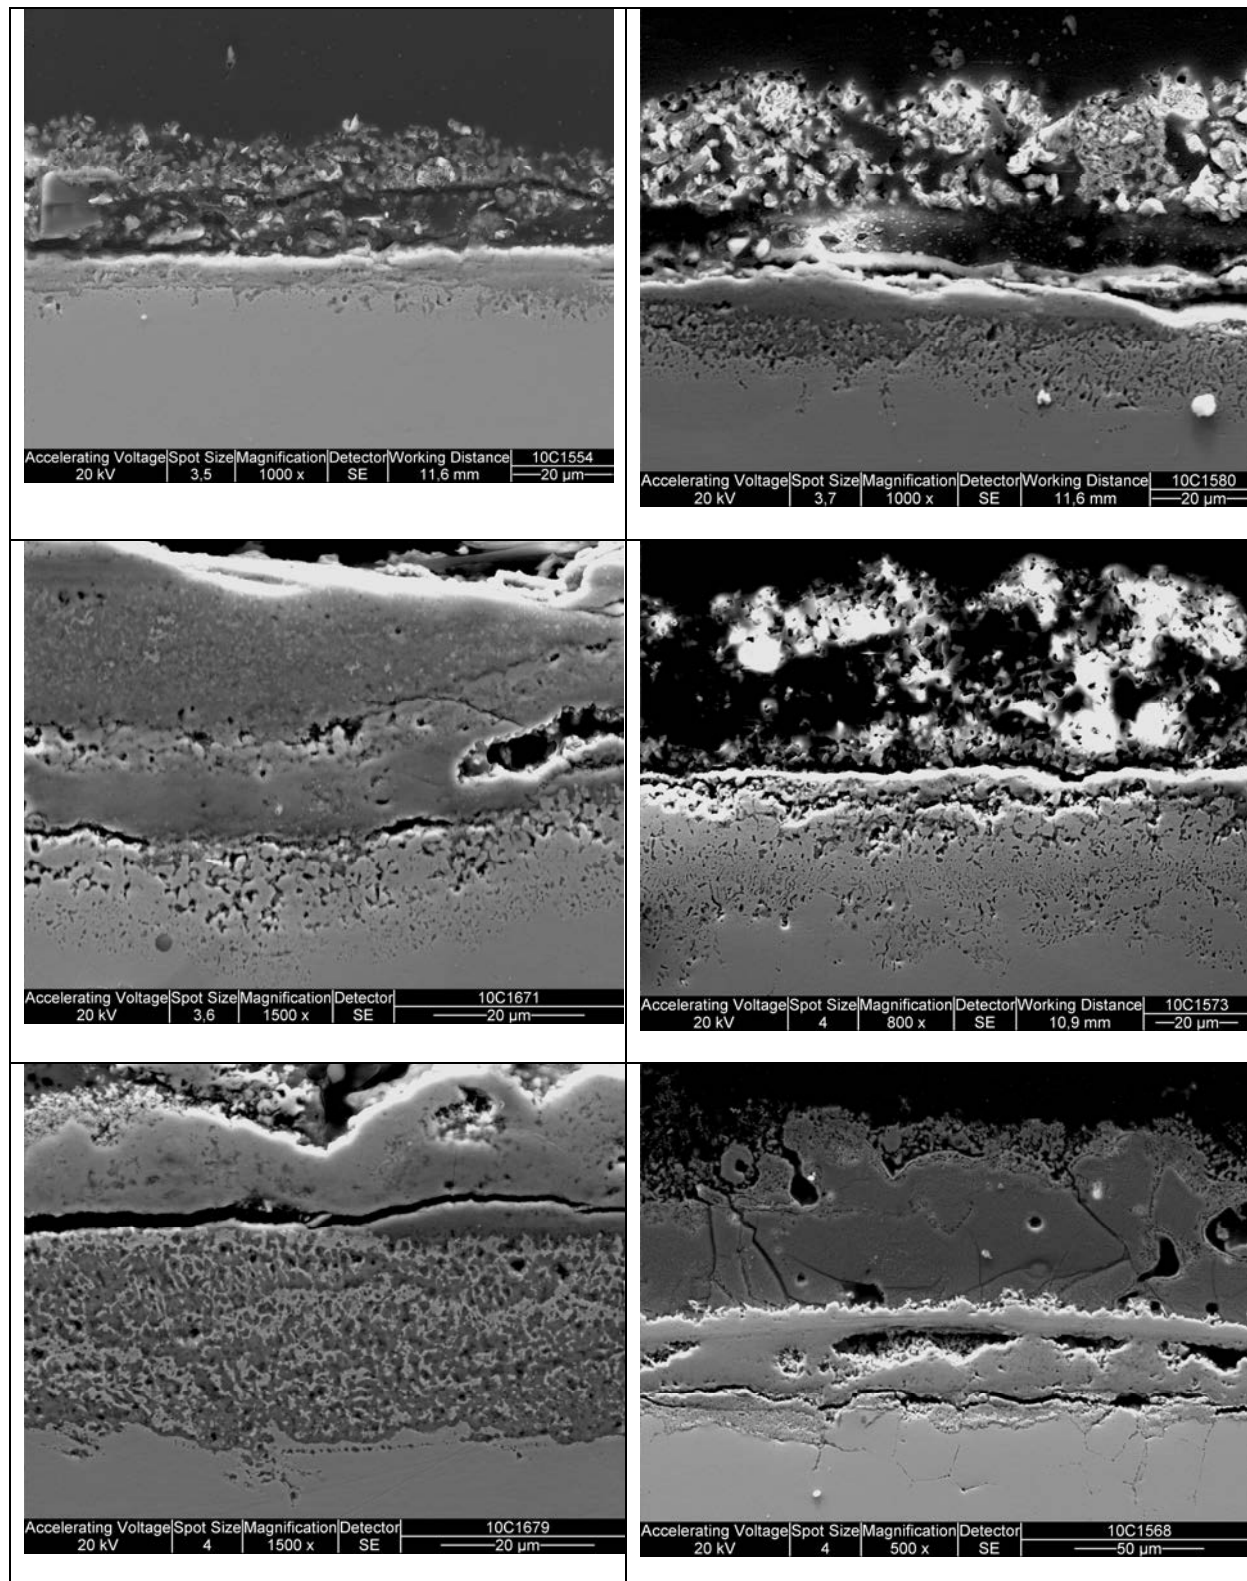
Typical corrosion morphologies for each material at various directions are shown in Figures from 13 to 16 in *Appendix*. Oxygen and/or sulphur are found at metal grain boundaries and in the composition of subsurface de-alloyed zones impoverished in respect of chromium and enriched in respect of nickel and iron. Chloride is found too but in amounts of few tens of percent only. The internal penetration depth depends on the local material temperature and deposition conditions. Total metal losses estimated in each case are given below, Table 5.

Figure 13. Cross-sectional view showing the total thickness of internally attacked zones and oxide scales observed on the Windward side for each material sample exposed in Probe 2. Left column from top to bottom: SAN 28, Super 625, AISI 310. Right column from top to bottom: HR11N, SAN 69, 347H. Note different magnifications. Material surface temperature in average 562°C. Estimated metal losses range from 0.1 mm (357H) to 0.01 mm (SAN 28).

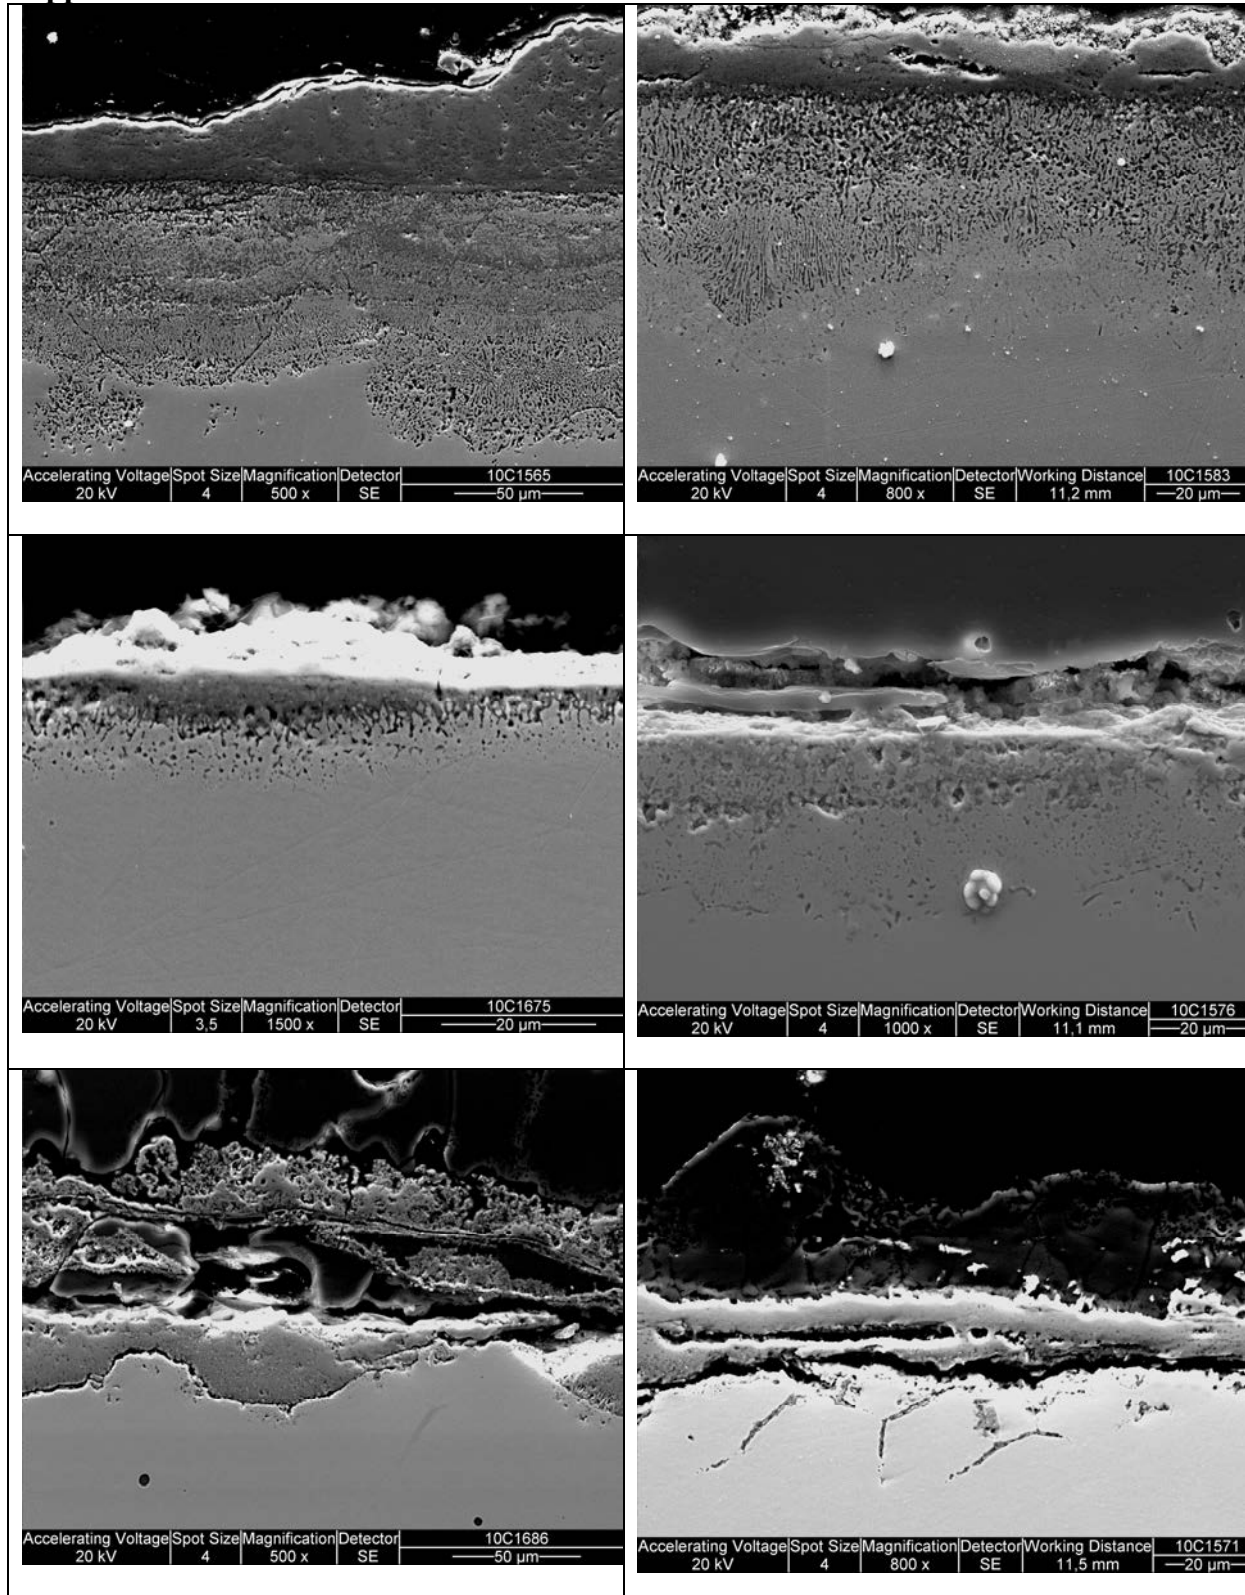
Figure 14. Cross-sectional view showing the total thickness of internally attacked zones and oxide scales observed on the Leeward side for each material sample exposed in Probe 2. Left column from top to bottom: SAN 28, Super 625, AISI 310. Right column from top to bottom: HR11N, SAN 69, 347H. Note different magnifications. Material surface temperature in average 542°C. Estimated metal losses range from 0.11 mm (SAN 28) to 0.015 mm (Super 625).

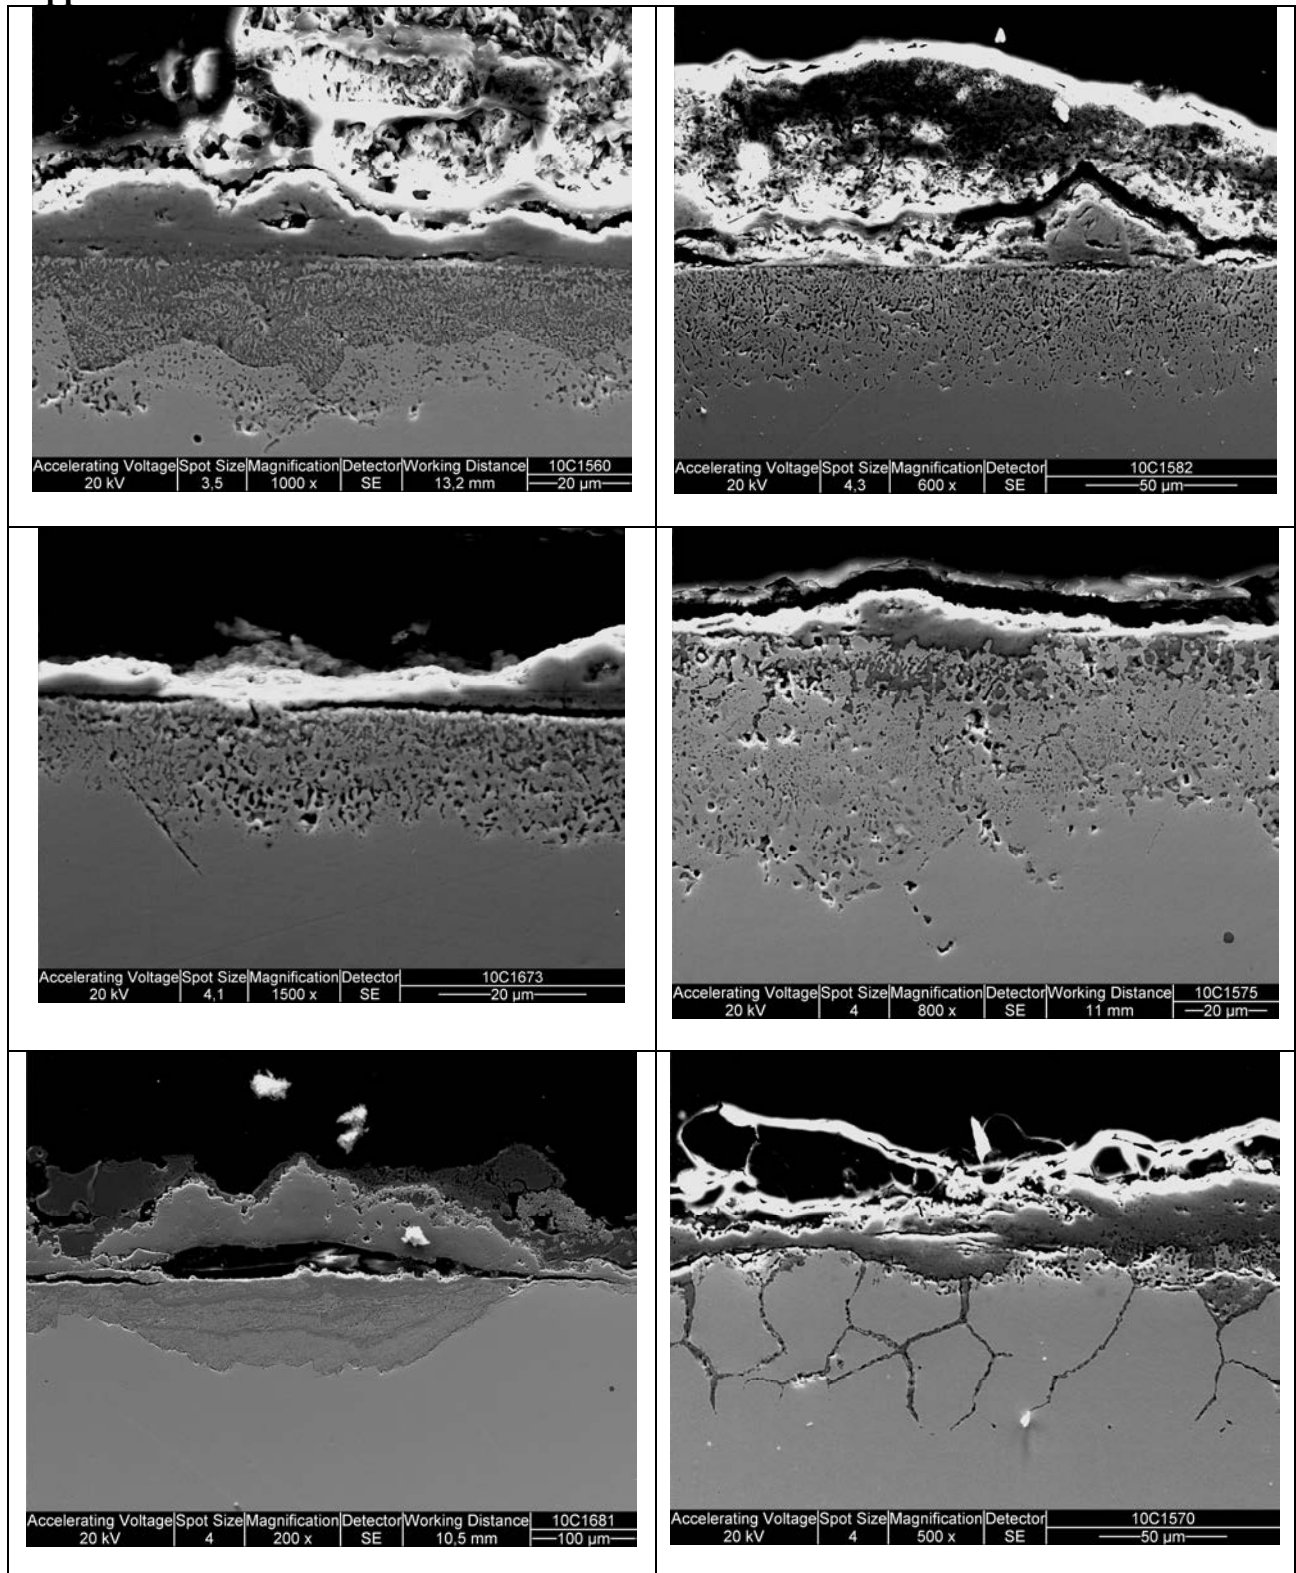
Figure 15. Cross-sectional view showing the total thickness of internally attacked zones and oxide scales observed on the Up side for each material sample exposed in Probe 2. Left column from top to bottom: SAN 28, Super 625, AISI 310. Right column from top to bottom: HR11N, SAN 69, 347H. Note different magnifications. Material surface temperature in average 518°C. Estimated metal losses range from 0.09 mm (AISI 310) to 0.025 mm (Super 625).

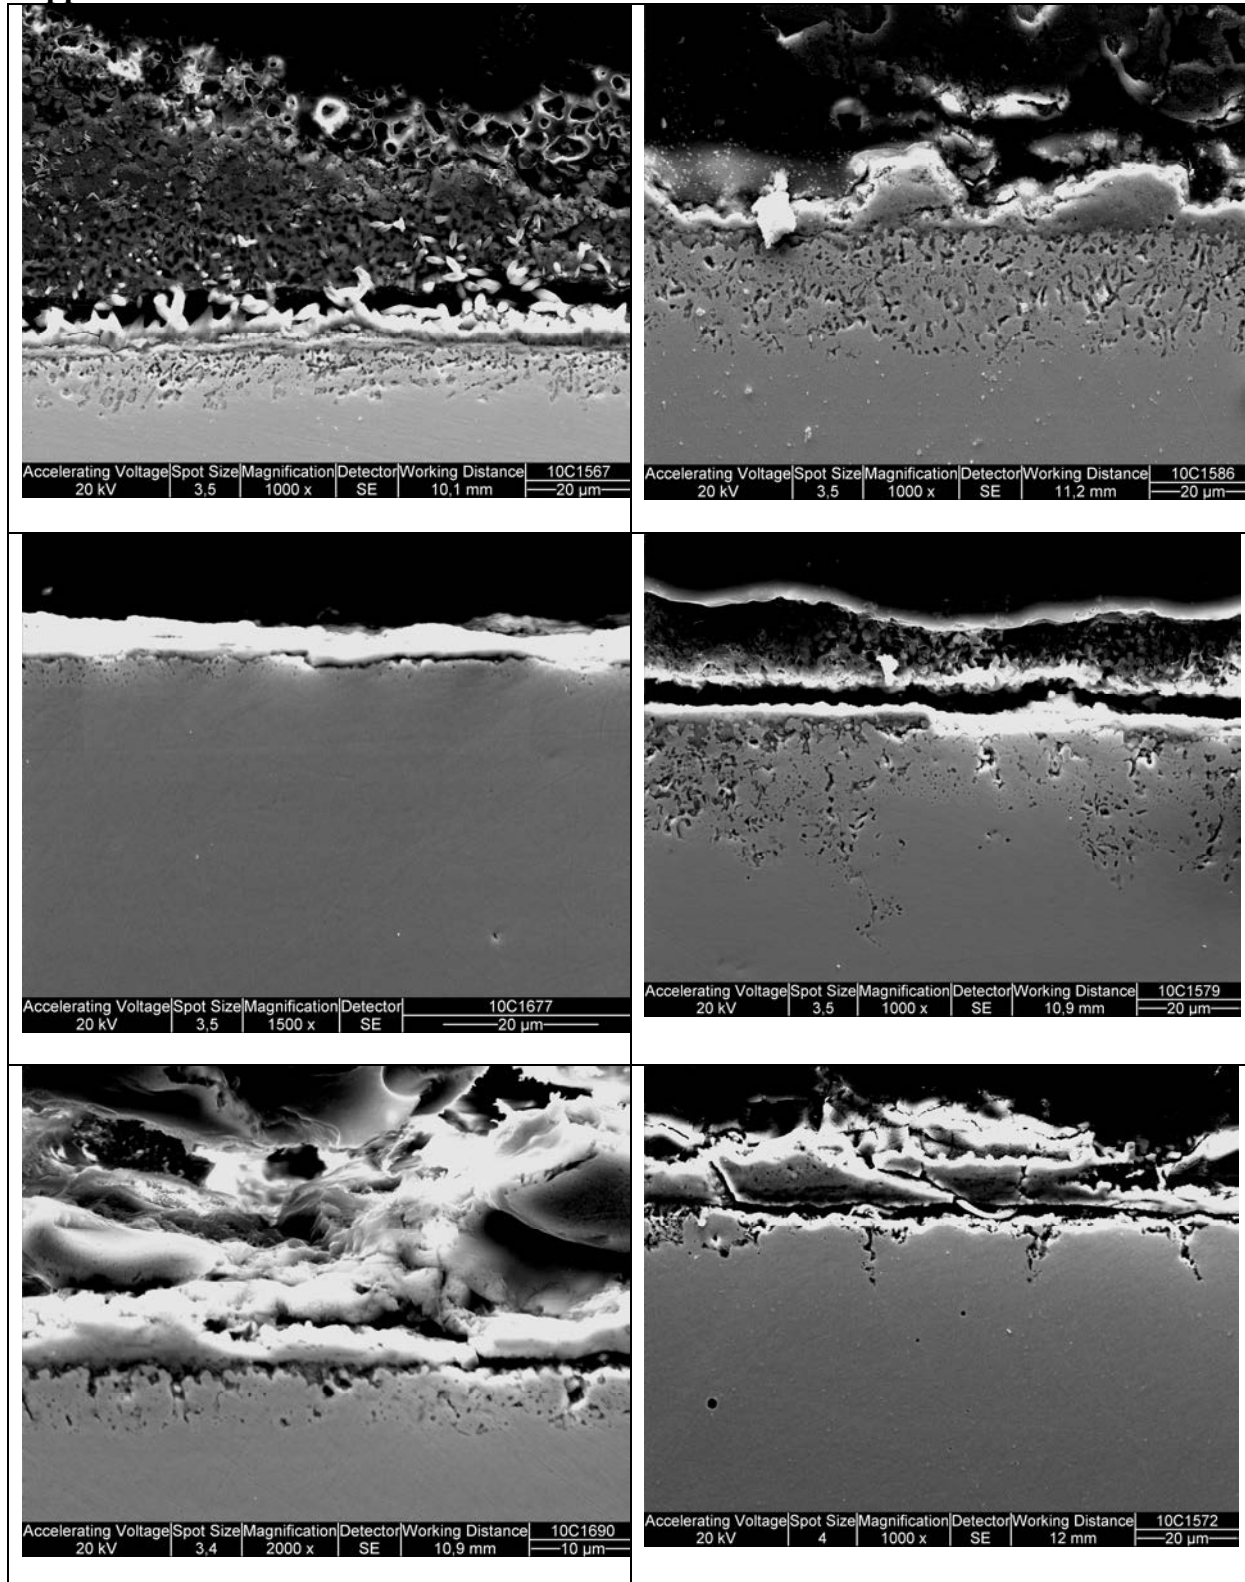
Figure 16. Cross-sectional view showing the total thickness of internally attacked zones and oxide scales observed on the Down side for each material sample exposed in Probe 2. Left column from top to bottom: SAN 28, Super 625, AISI 310. Right column from top to bottom: HR11N, SAN 69, 347H. Note different magnifications. Material surface temperature in average 508°C. Estimated metal losses range from 0.040 mm (SAN 69) to 0.005 mm (Super 625 and AISI 310).

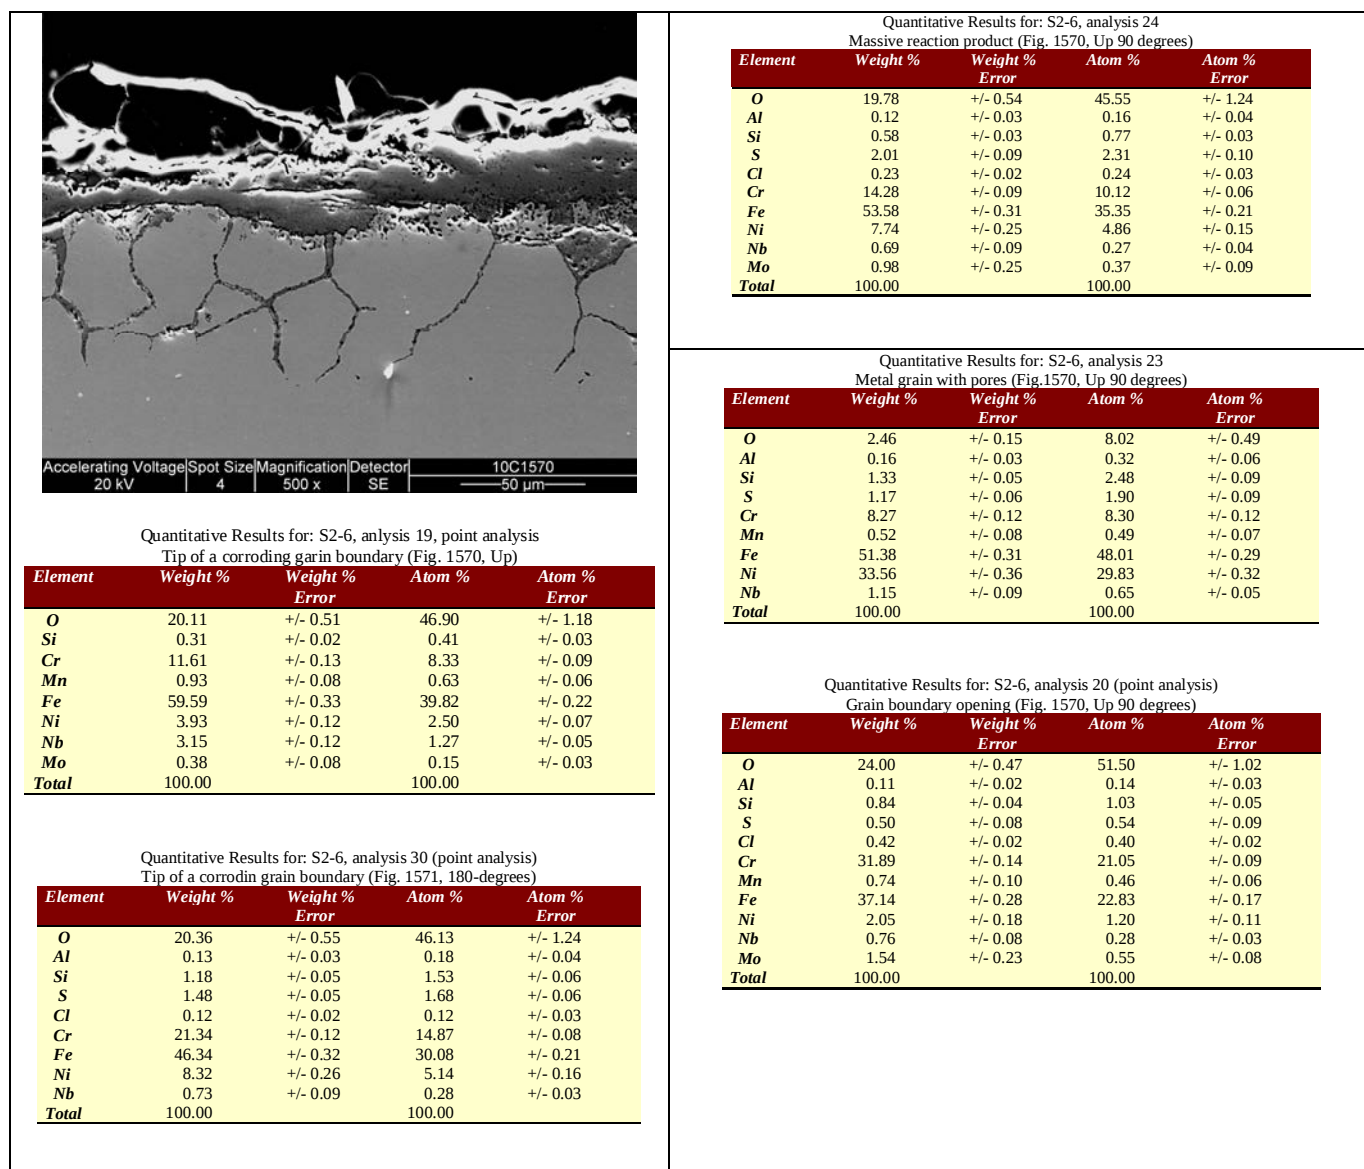
In the case of 347H grain boundary attack, de-alloying of superficial metal grains and chloride enhanced oxide scale growth are the governing modes of accelerated corrosion. Some chloride is very typically found in the areal quantitative analyses of the corrosion products. Point analyses of attacked grain boundaries did, or did sometimes not, reveal sulphur and/or chloride in addition to oxygen, see for example quantitative results found in Figure 19 in Appendix. Note that the conventional analytical limit here is 0.1 wt-% and even so for S and Cl.

Figure 19. Cross sectional view featuring morphologies and compositional characteristics of grain boundary attack, de-alloying of superficial metal grains, and enhanced oxide growth typical of the exposed sample of material 347H. Note that the conventional detection limit for Cl is 0.1 wt-%. SEM-picture.

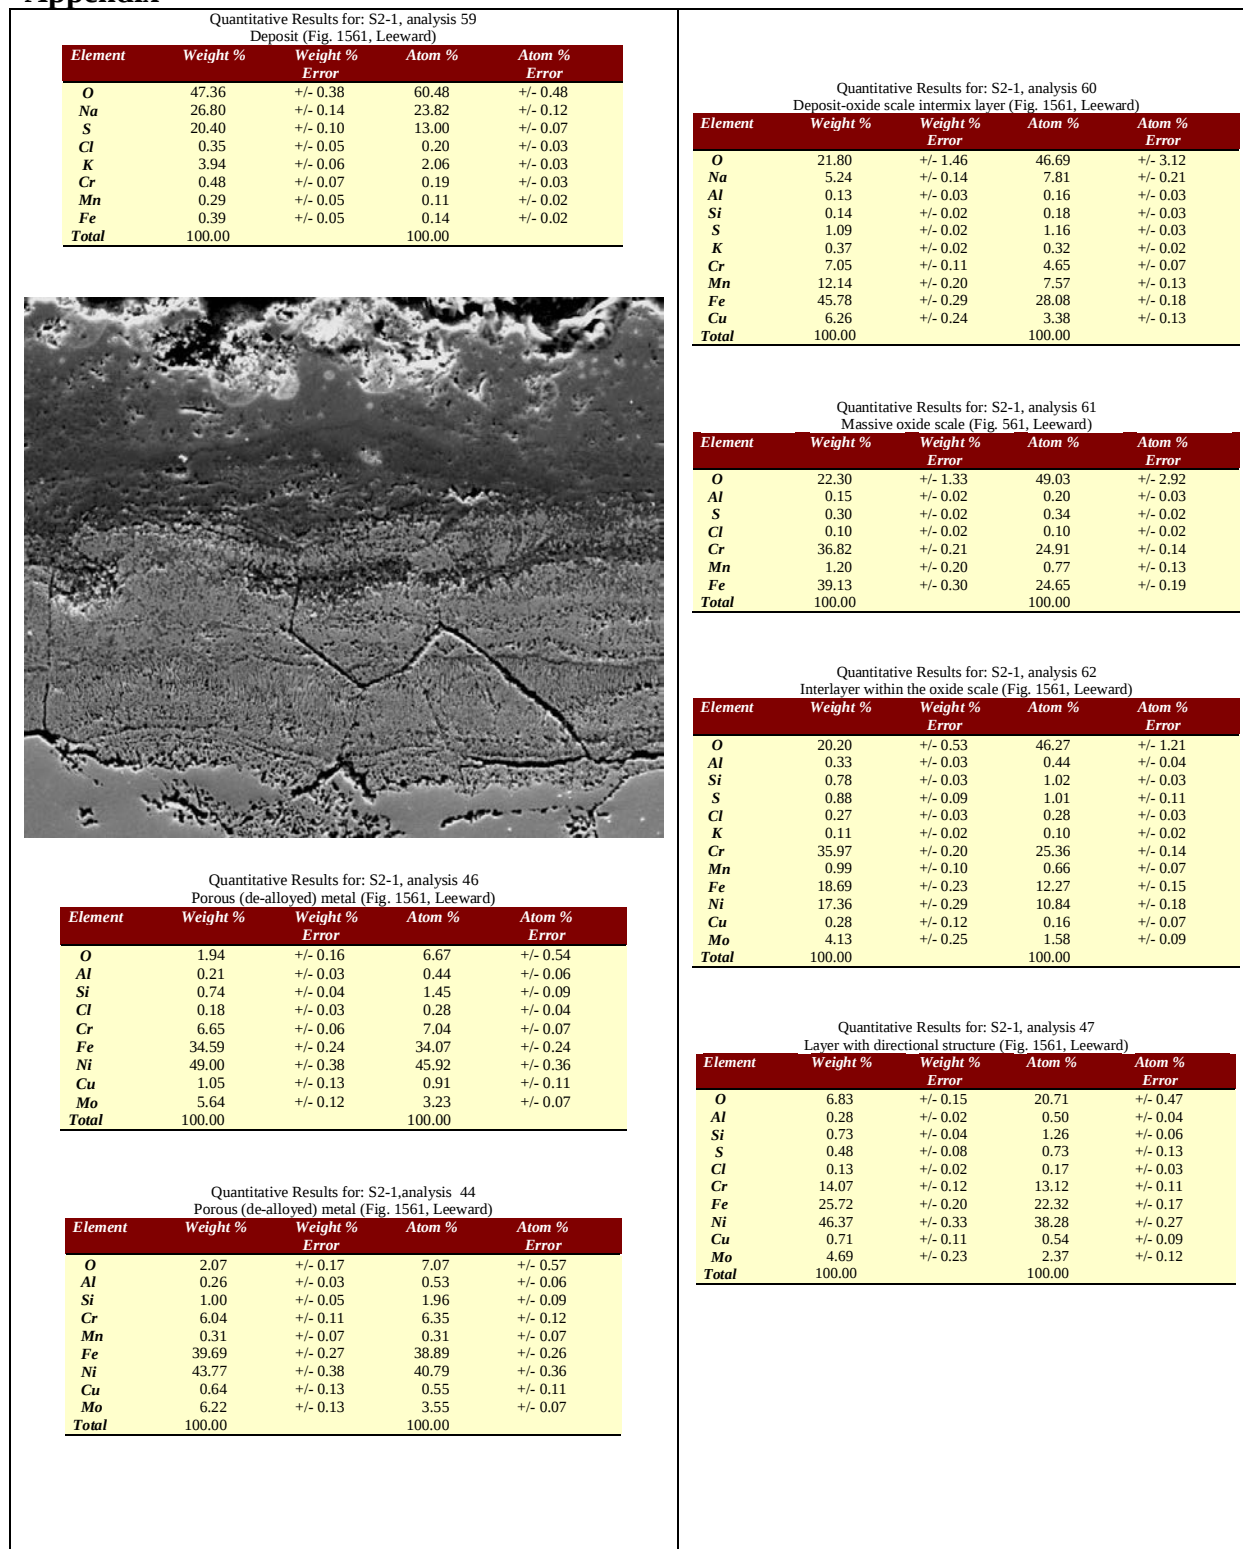
Figure 20. Cross sectional view featuring morphologies and compositional characteristics of locally enhanced corrosion of SAN 28. Outer scale of mixed iron-chromium oxide type, and various oxygen, sulphur and chlorine penetrated de-alloyed zones in the ale metal are typical also of locally enhanced corrosion of HR11N, AISI 310, SAN 69 and Super 625. Corrosion performance at high temperatures is severely reduced due to depletion of chromium.

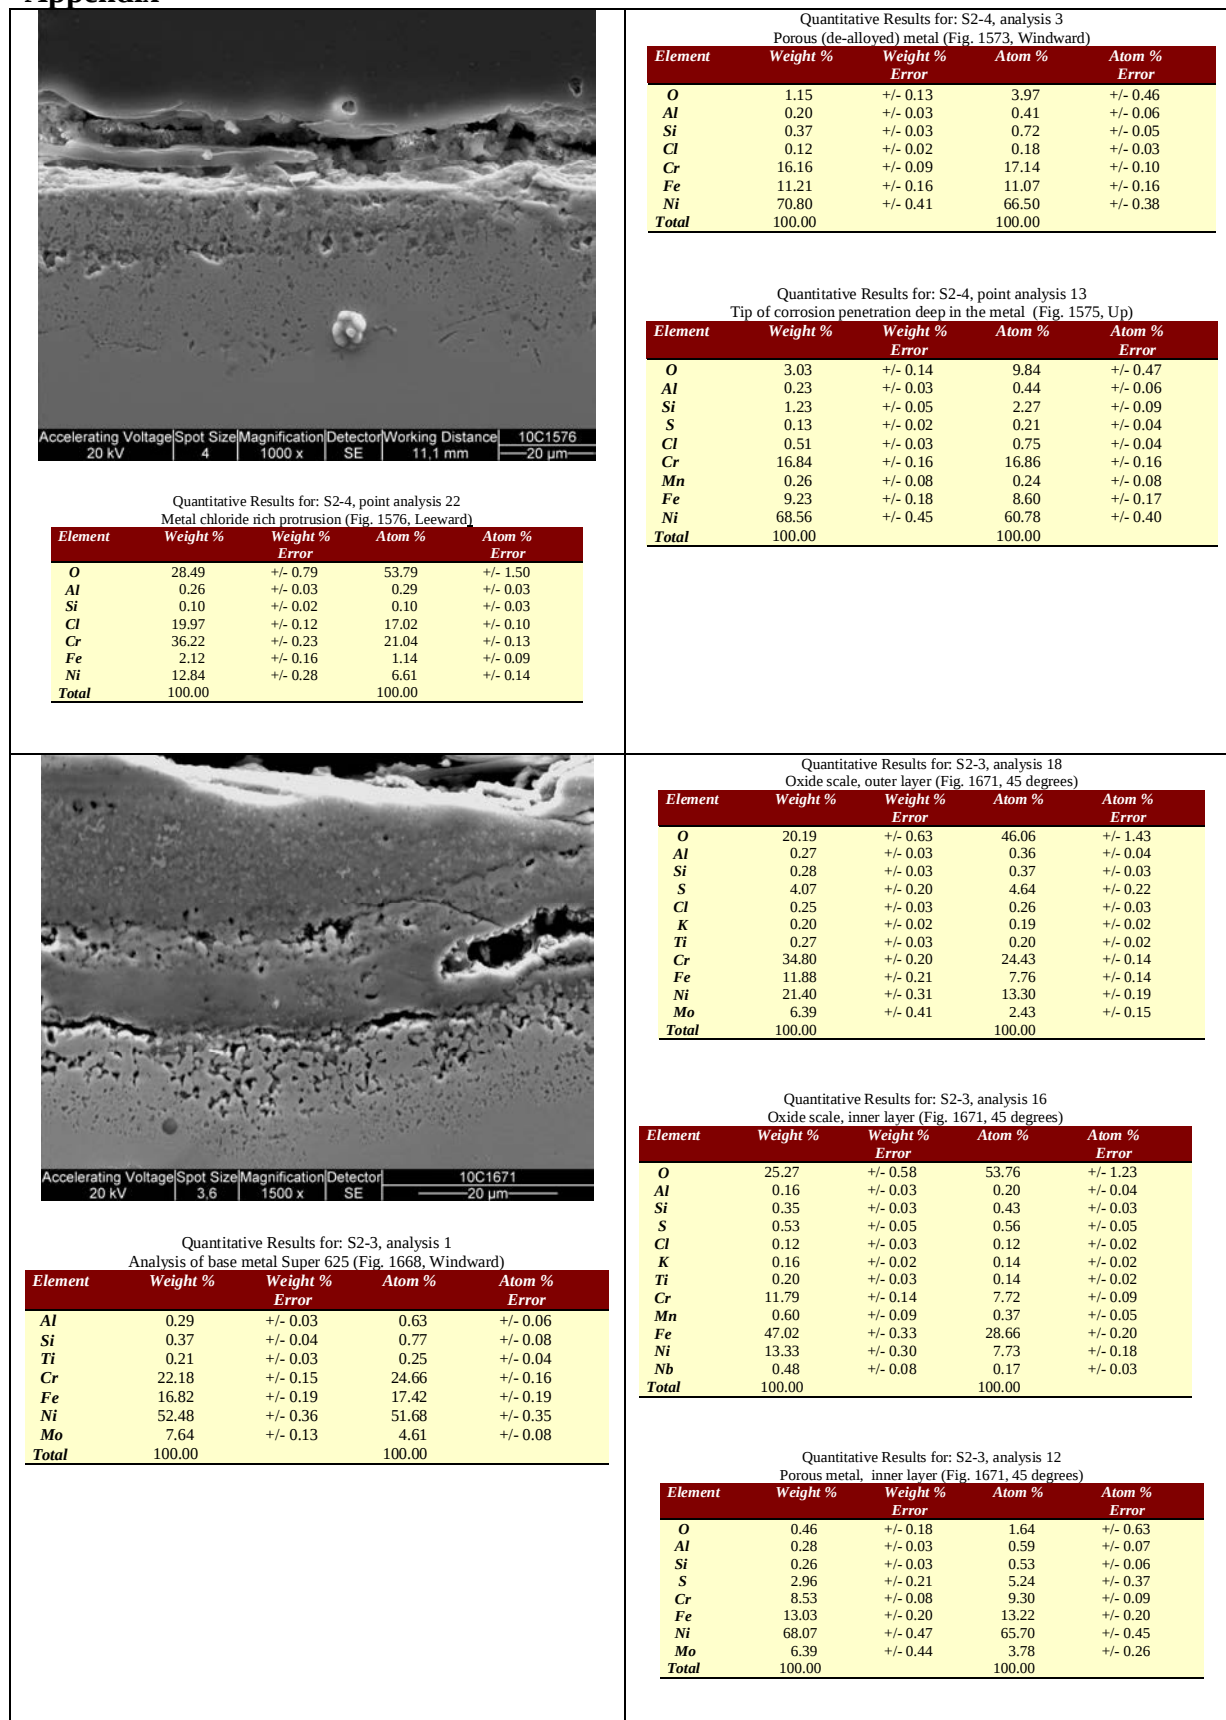
Corrosion morphologies and results of detailed quantitative elemental analyses indicated that steels and alloys alloyed highly with chromium had suffered from internal sulphidation and/or oxidation attack. Oxygen or oxygen and sulphur were found as abundant in various de-alloyed zones impoverished in respect of chromium and enriched in respect of nickel and iron, Figure 20 in *Appendix*. The content of chloride was in general low as compared to oxygen and sulphur. Localised enrichments consisting of nickel and chromium chlorides did contain up to 30 % wt-% Cl, Figure 21 in *Appendix*.

Figure 21. Cross sectional view featuring morphologies and compositional characteristics of locally enhanced corrosion of SAN 69 (top field) and Super 625 (bottom field). Mixed-type oxide scales and sub-scale zones depleted in chromium are typical.

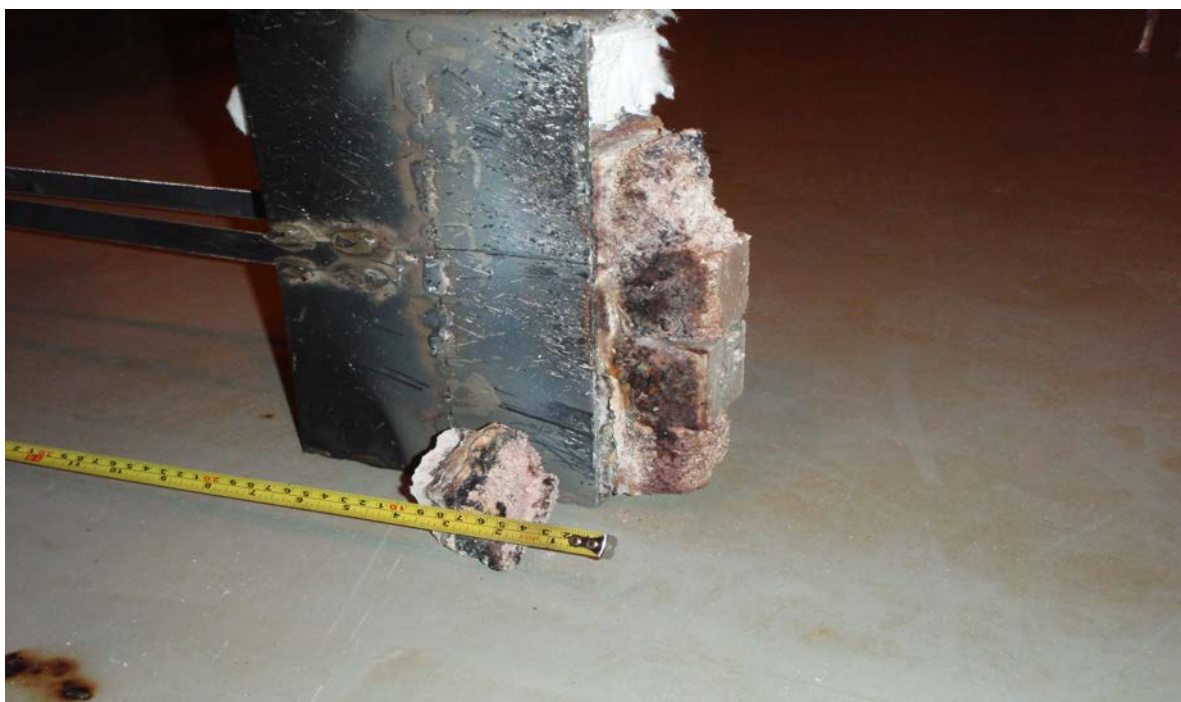
Kuva 2. Omatekoinen valmista spinelliä sisältävä massa ei ollut mekaanisesti tarpeeksi lujaa vaan katkesi kehikkoa irrotettaessa. Molemmat tiilet näyttävät hyviltä verattuna alinna vertailumateriaalina olevaan hasslen massa.

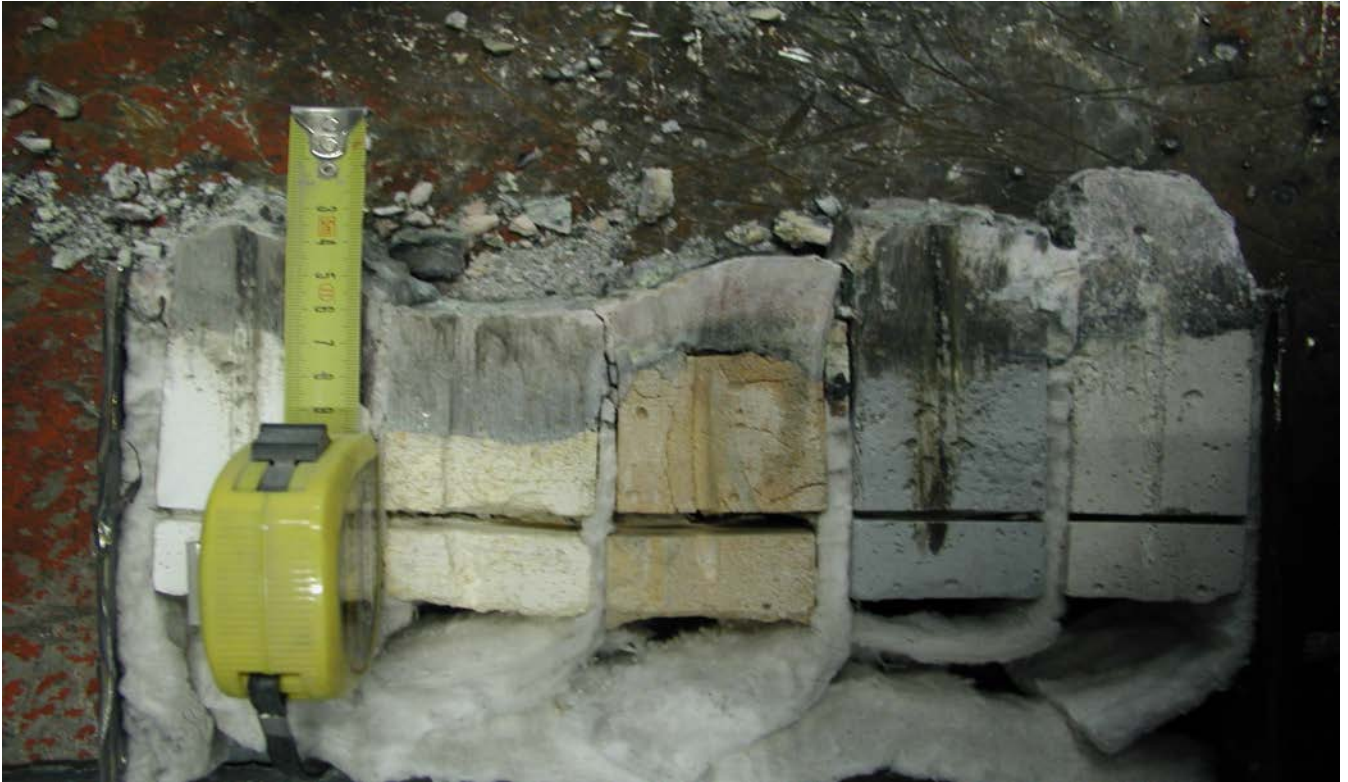
Kuva 3. Massoista parhaiten on pärjännyt alinna oleva hassle kuluma noin 10 mm. Seuraavana betker on jo huomattavasti enemmän kulunut. Siitä seuraava forsteriitti ,  $ZrO_2$  ja Ankoflo.

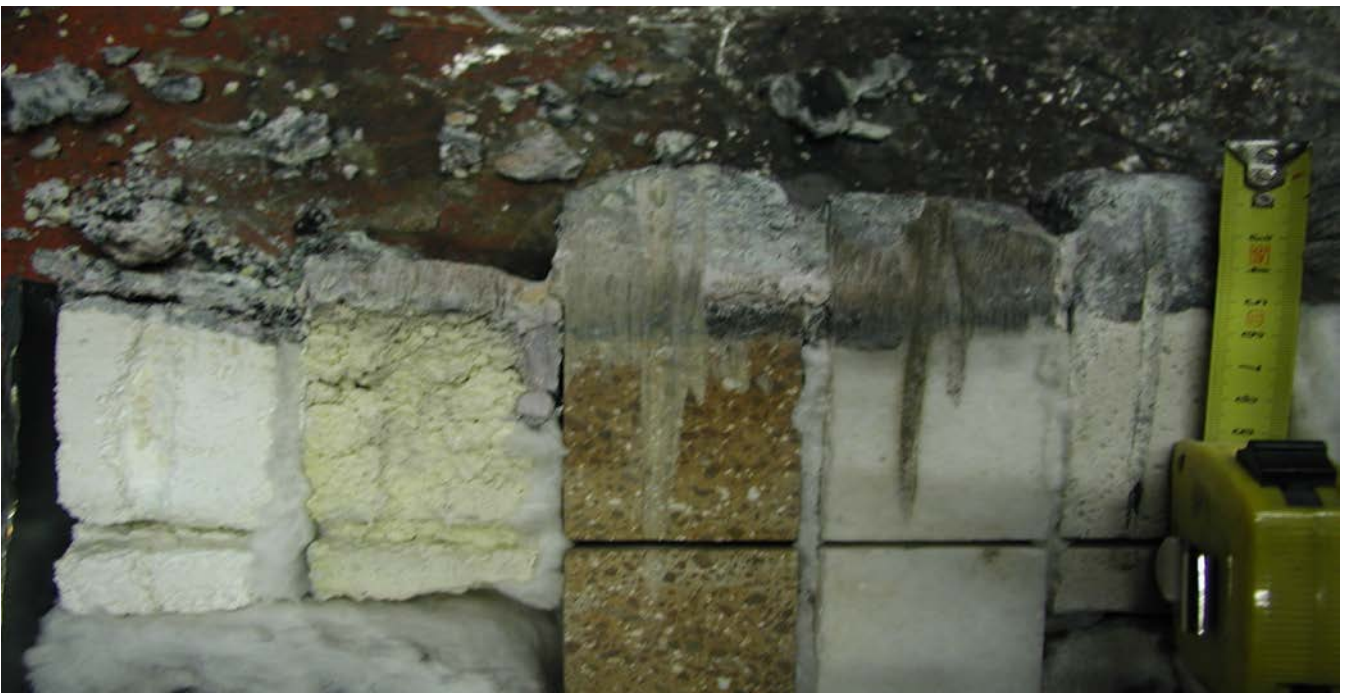
Kuva 4. Oikella oleva hasslen massa on pärjännyt  $MgO$ -rauta tiilen (keskellä) kanssa parhaiten. Niiden välissä oleva sulavalettu aloksi on heti kolmantena. Omavalmisteiset kellertävä  $CeO_2$  lisätty ja spinelliä sisältävä massa pärjäsivät huonosti.

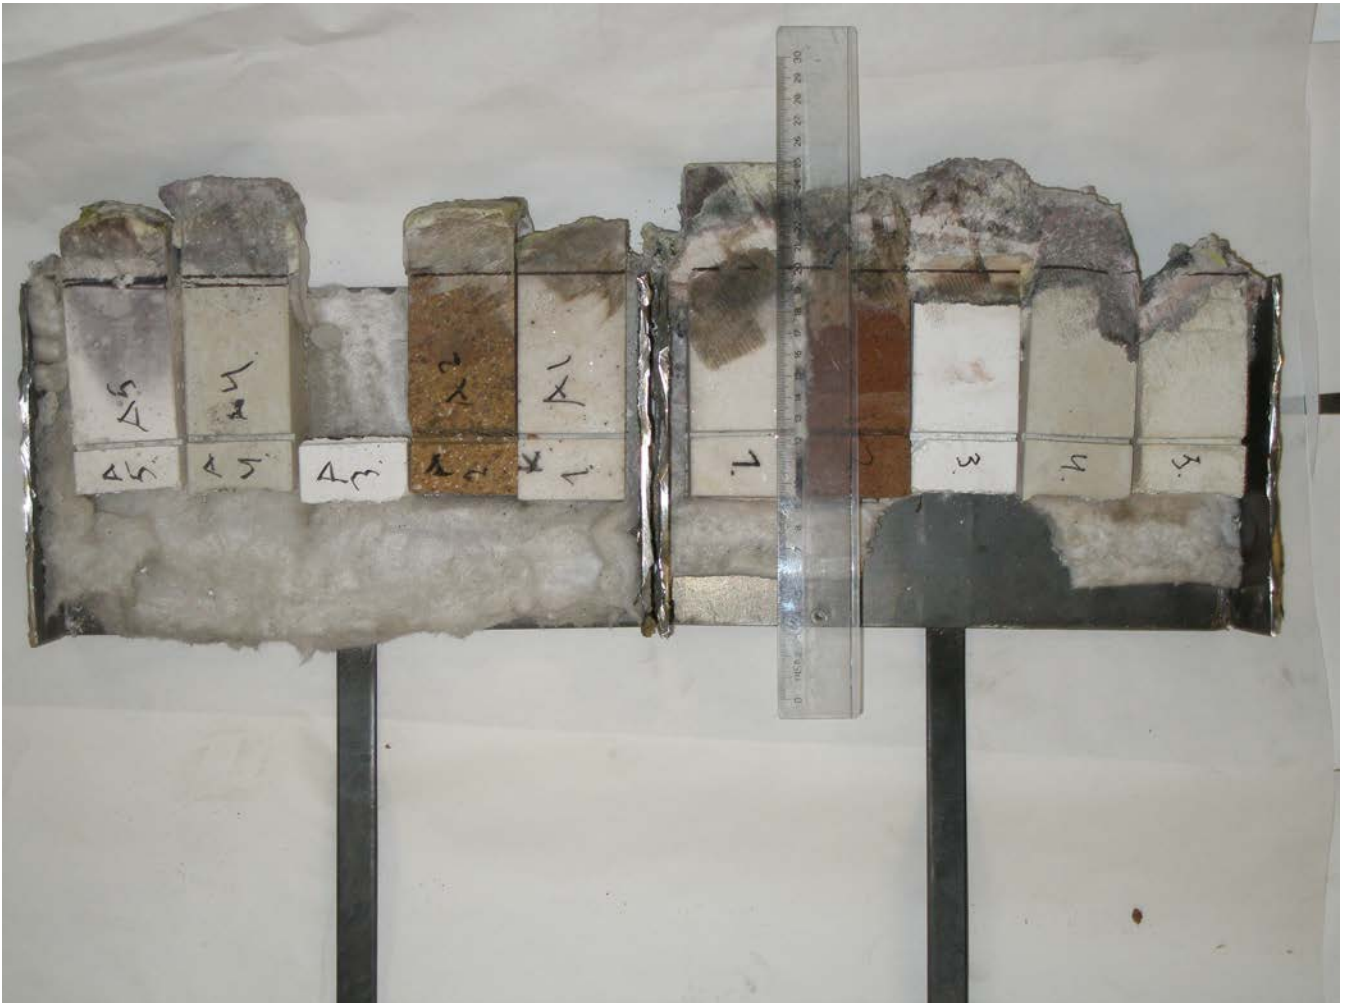
Kuva 7. Koekappaleet kokeen 2 jälkeen. Huomataan aika erilaiset kulumiset kattilan eri puolilla samoilla koemateriaaleilla. Nro 1 ja 3 ovat parhaimman näköiset toisessa ja A4 toisessa kehikossa.

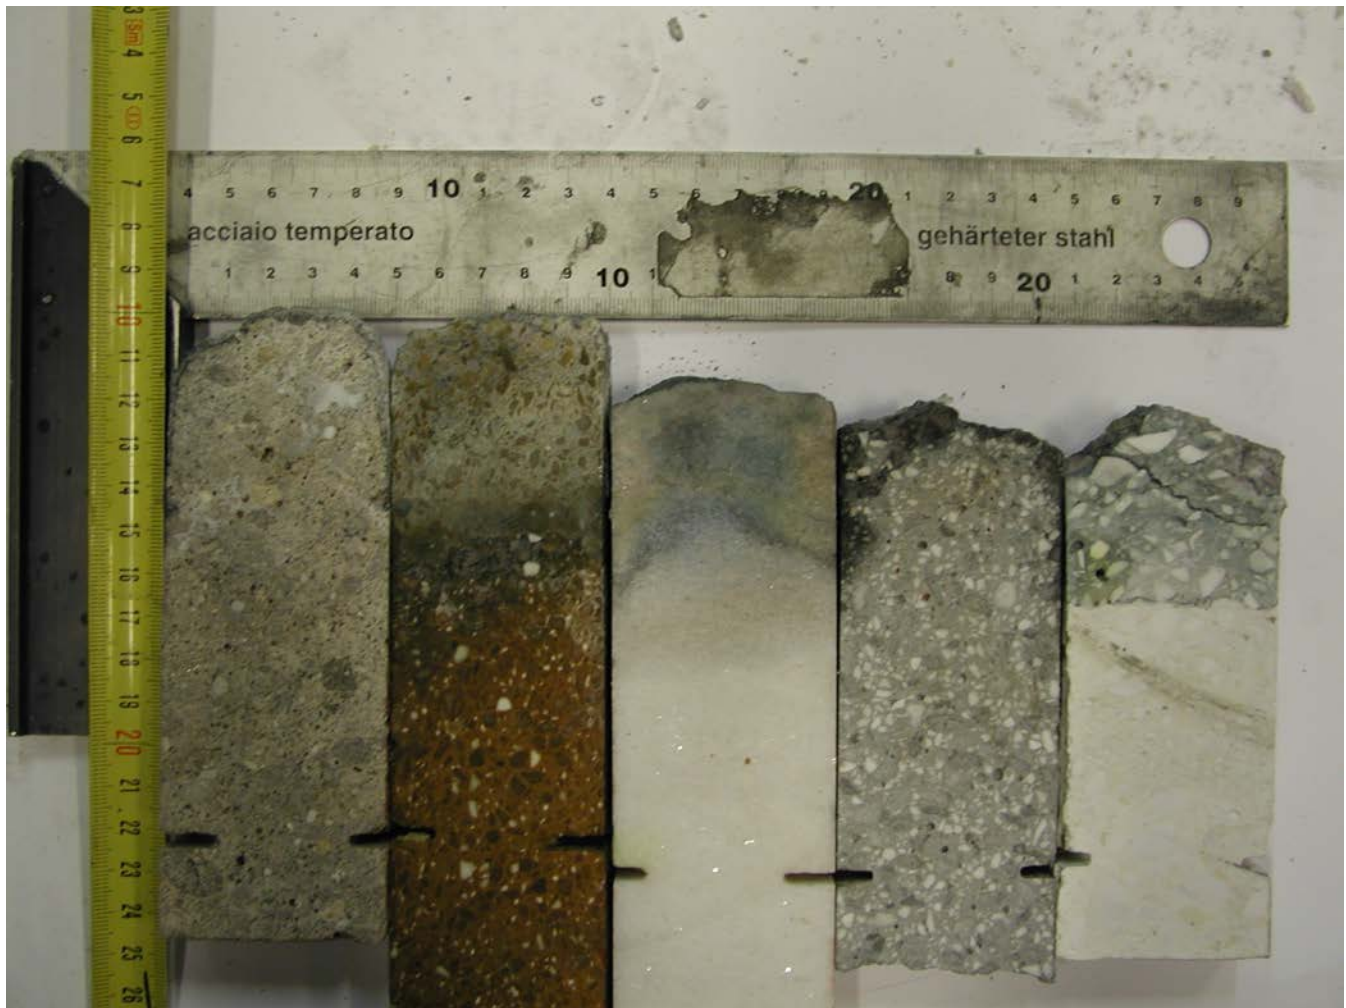
Kuva 10. Parhaiden leikkauspinnat. Vasemmalta oikealle Hassle, MgO-rauta tiili, Sulavalettu aloksi. Betker ja AnkoFlo. Huomataan silminhavaittavat diffusio / imeytymä kerrokset muissa paitsi Hasle ja Betker massoissa.

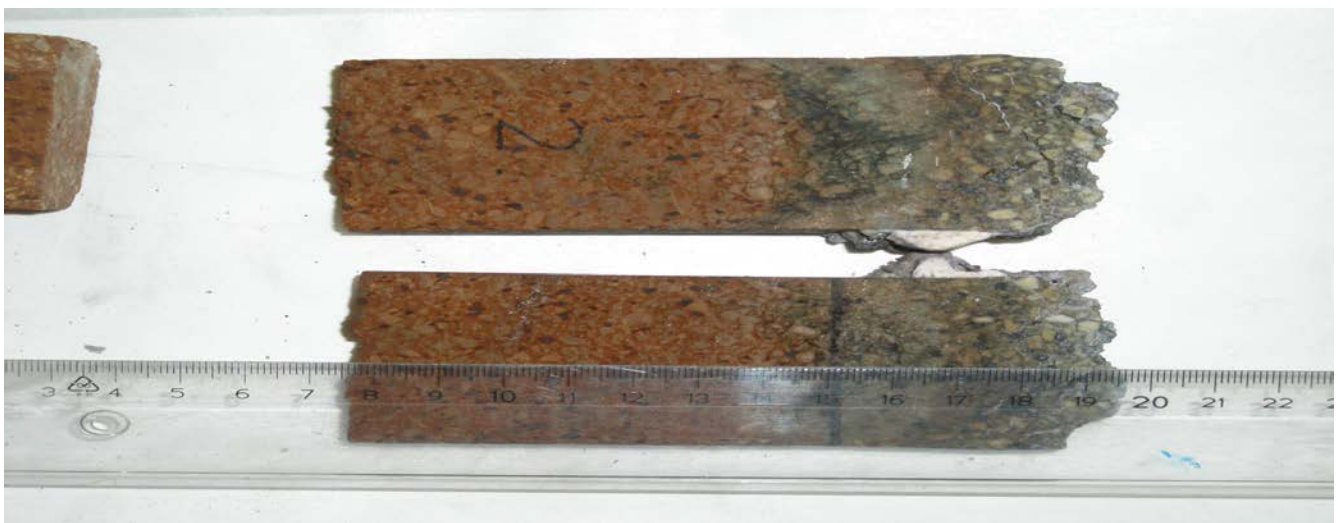
Kuva 2. MgO-rauta tiiliessä on joitain halkeamia ja sula on tunkeutunut noin 50 mm. Tiilen pinta on lohkeilleen näköinen.

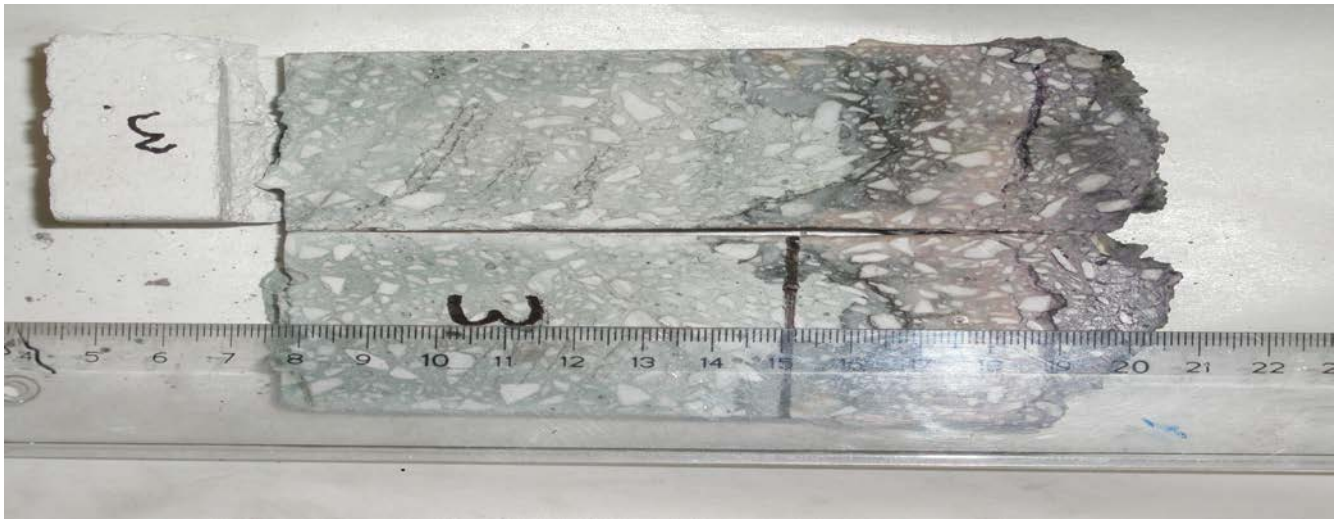
Kuva 3. Hassle B1800 on turvonnut soodakattila sulan tunkeutumisen johdosta. Pinta näyttää lohkeilevan, samoin joitain halkeamia näkyy. Sula on tunkeutunut yli puolenvälin tiiltä.

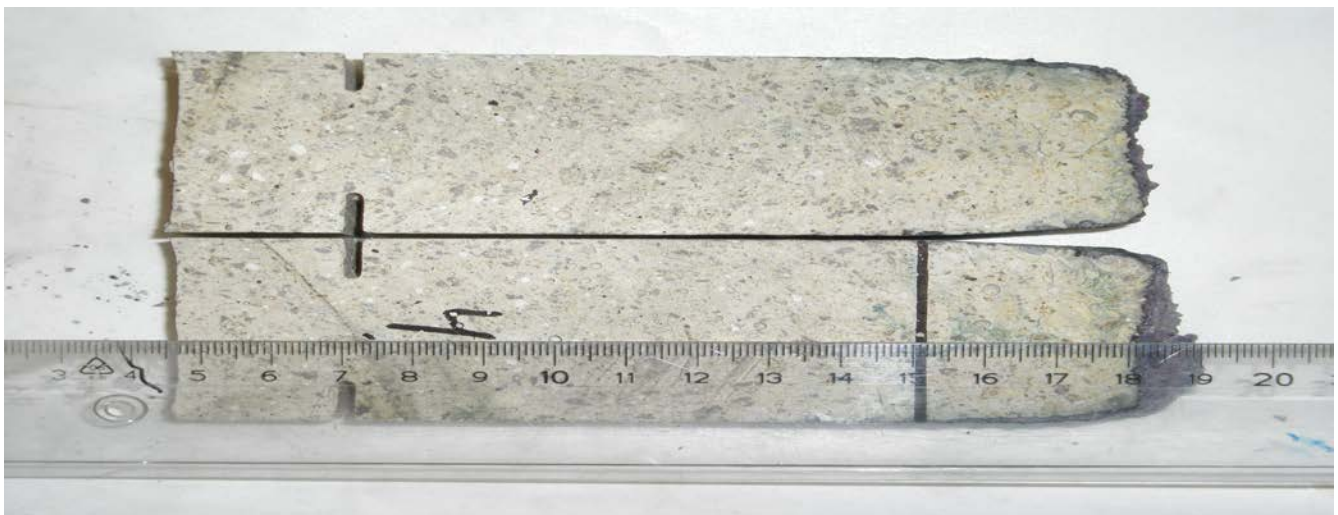
Kuva 4. Hassle D39A ei sula juurikaan tunkeudu. Joitain halkeamia näkyy ja kulumisprofiili on epätasainen.
