## **APPENDIX 1**

**Project budget  
5.5.2011**

# SKYREC Budget 5.5.2011

**Åbo Akademi  
Corrosion tests in reducing conditions  
Part II – revised offer  
5.5.2011**

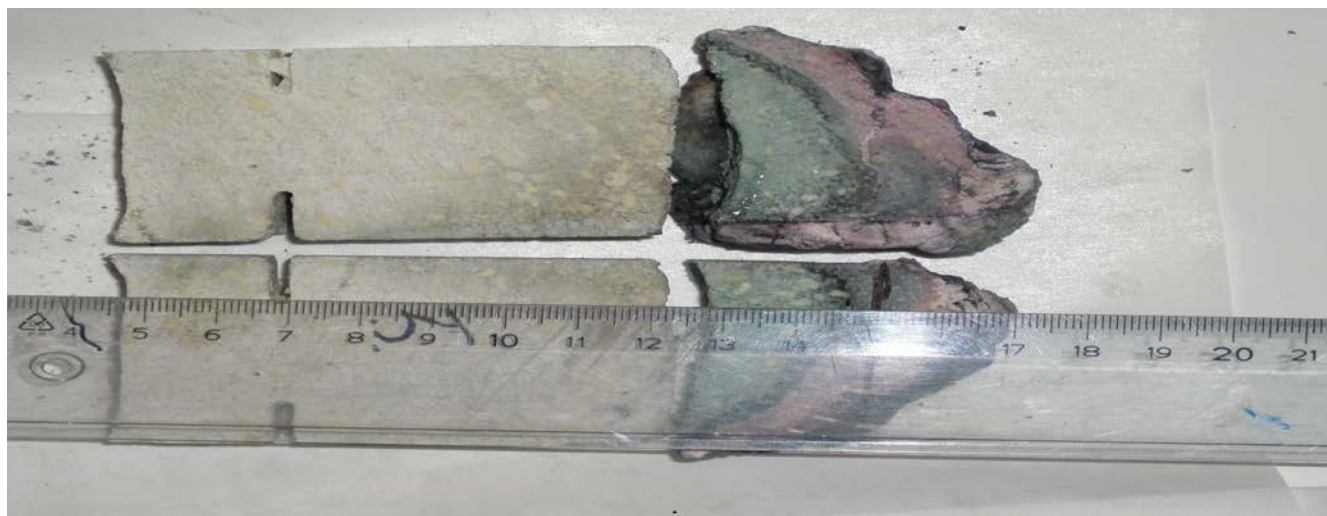
Kuva 5. Oma spinellimassa. Sula on tunkeutunut huokosiin ja sideaineeseen. Lujuus on parempi kuin kokeessa 1, mutta ei edelleenkään riittävä.

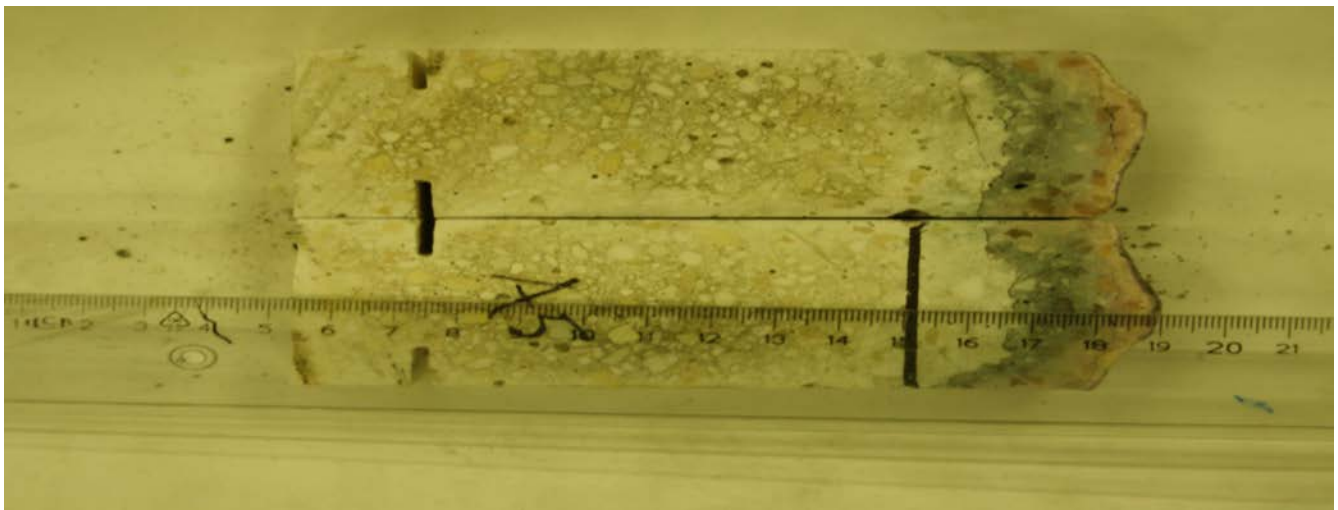
Kuva 9. Spinelliä muodostava massa. Noin 25 mm sulan tunkeuma ja epätasainen kulumispinta, joitain halkeamia näkyy myös.

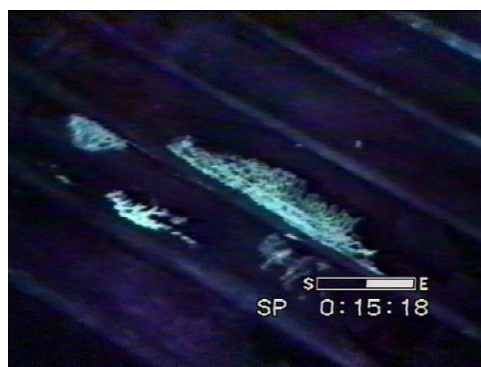
**Kuva 3.** Fluoresoivalla tunkeumanesteellä tarkastetun pohjan särönäyttämiä

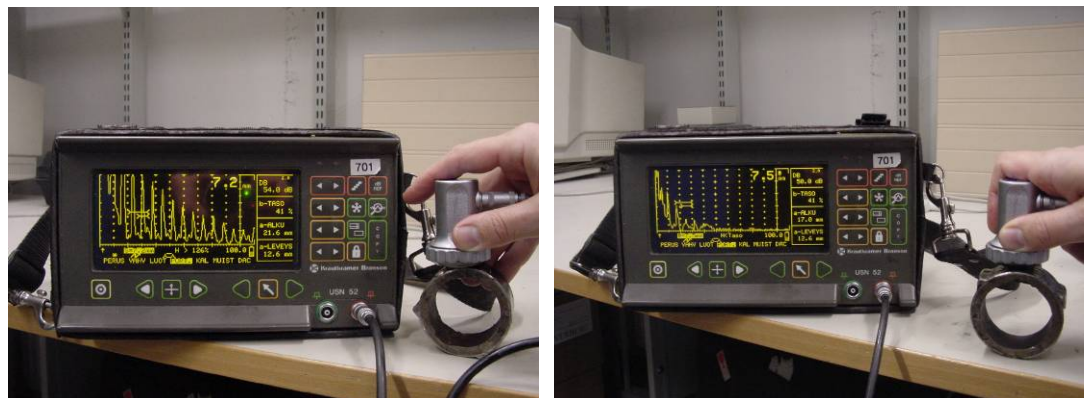
**Kuva 8.** A-näytöt ehjästä putkesta ja vetyhyökkäyskohdalta.
