**Tulistinmateriaalien laboratoriokokeet OSA 2  
alustavien kokeiden tulokset ja tarjous  
5.5.2011**

## **Corrosion tests in reducing conditions – PART II**

Laboratory of Inorganic Chemistry  
Åbo Akademi University

**May 2011**

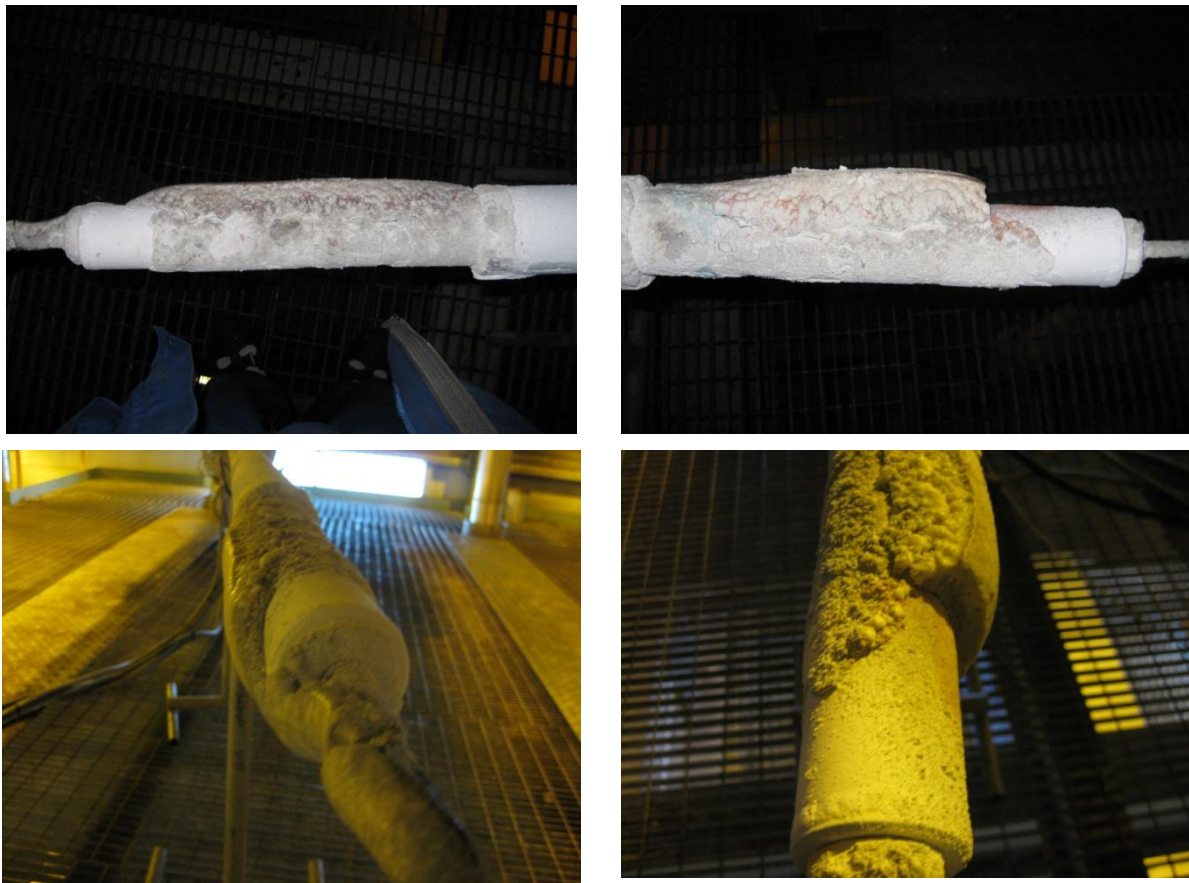
*Figure 4. Post-exposure appearance of Probe 1 and Probe 2 shown in pictures in the left and right column, respectively.*

When inspected post-exposure by plain eye several of the rings were found to be non-circular. An obvious explanation for such deformations might be impacts of lumps of material falling down in the boiler. Such impacts were noticed to occur during the time elapse from 11<sup>th</sup> to 13<sup>th</sup> October when the boiler was cooling down.

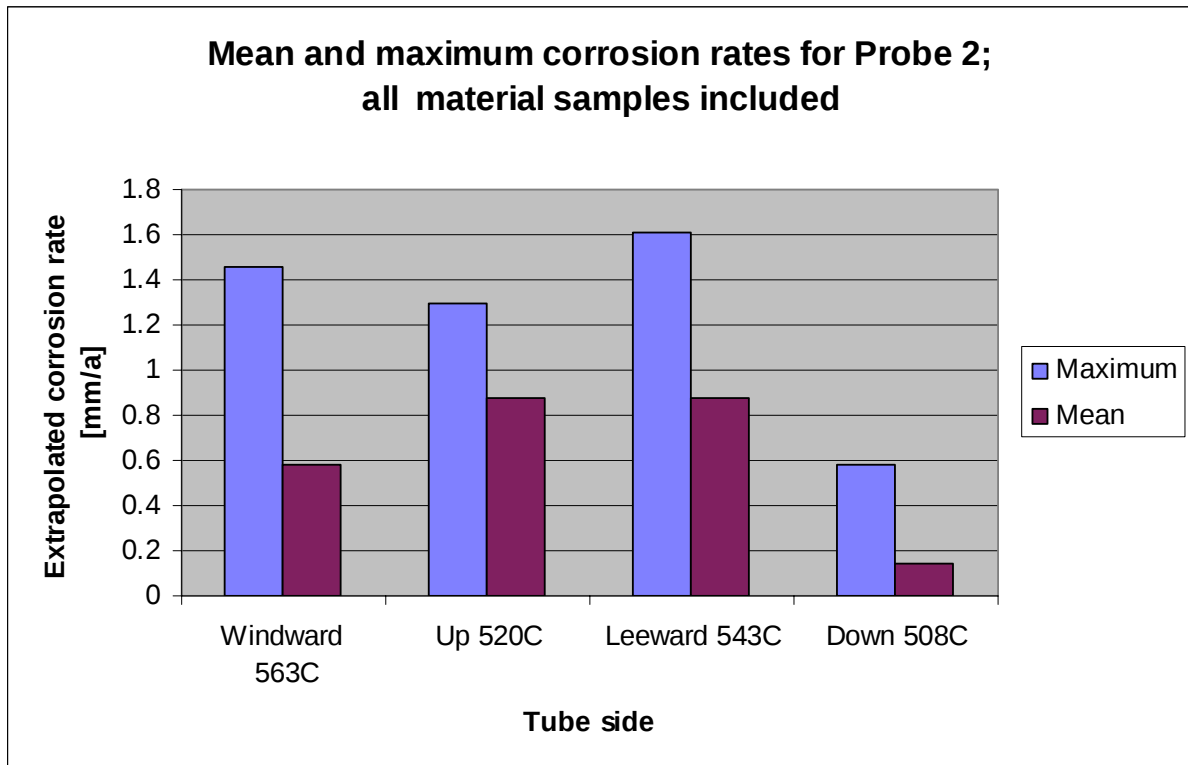
Figure 8. Mean and maximum corrosion rates in various exposure conditions for Probe 2, as estimated. All test materials are included.

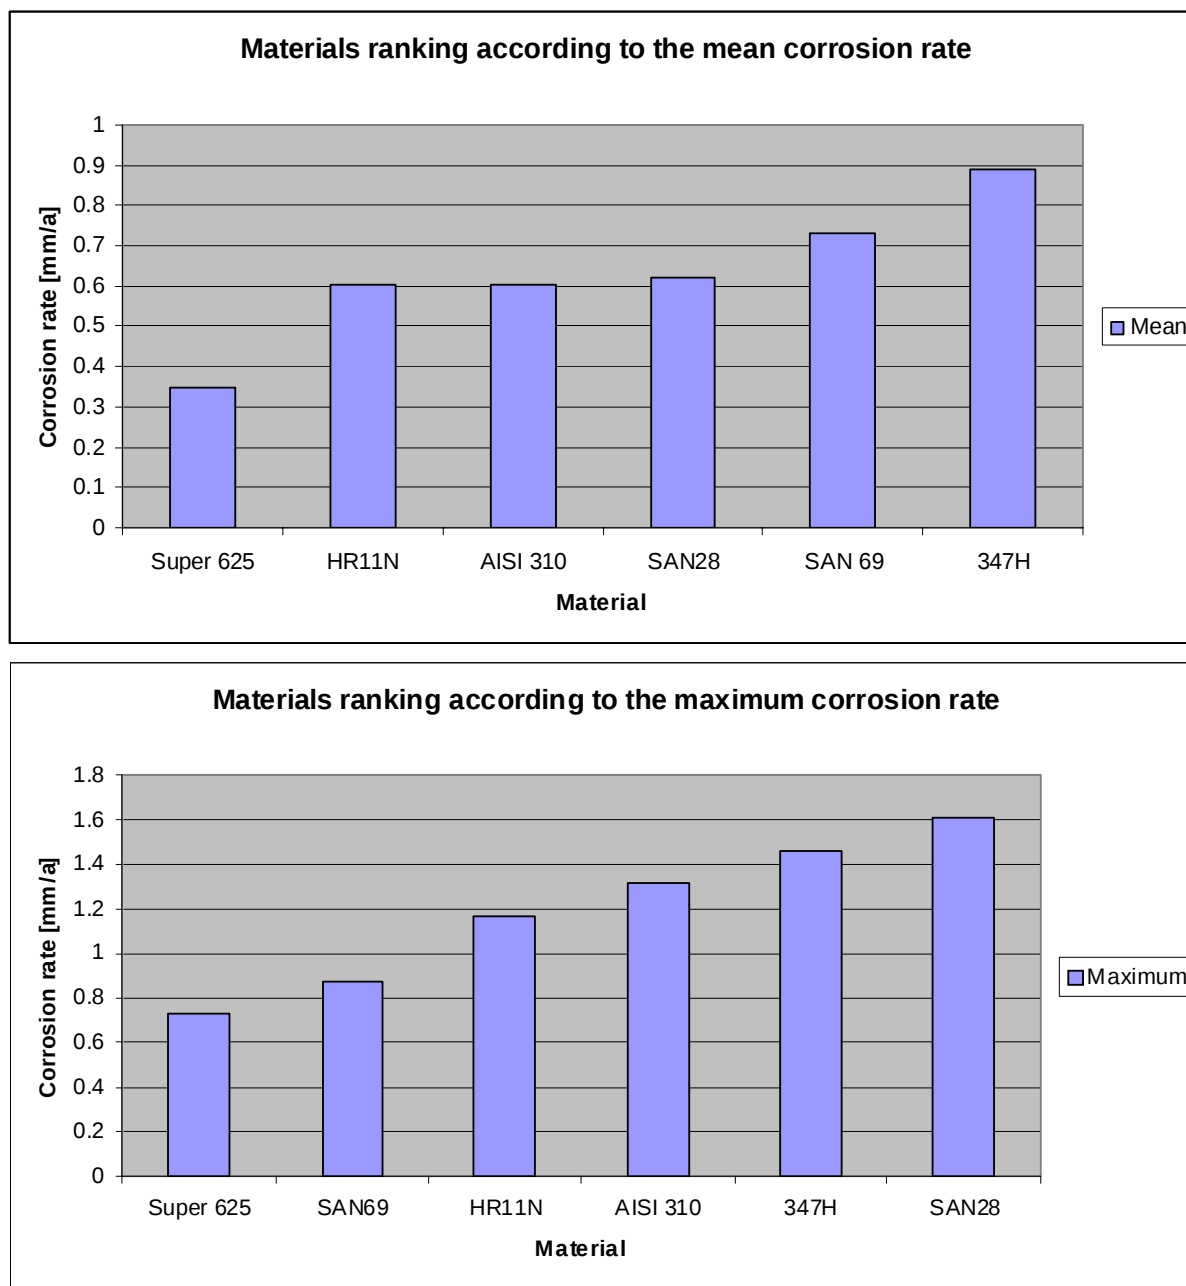
Figure 9. Materials ranking according to the mean or maximum corrosion rate estimated as explained above. Using the maximum corrosion rate as criterion all materials, except Super 625 and SAN 69, show a corrosion rate > 1 mm/a, i.e., corrode with an unacceptable rate. According to mean corrosion rate all materials corrode at a rate < 1mm/a.

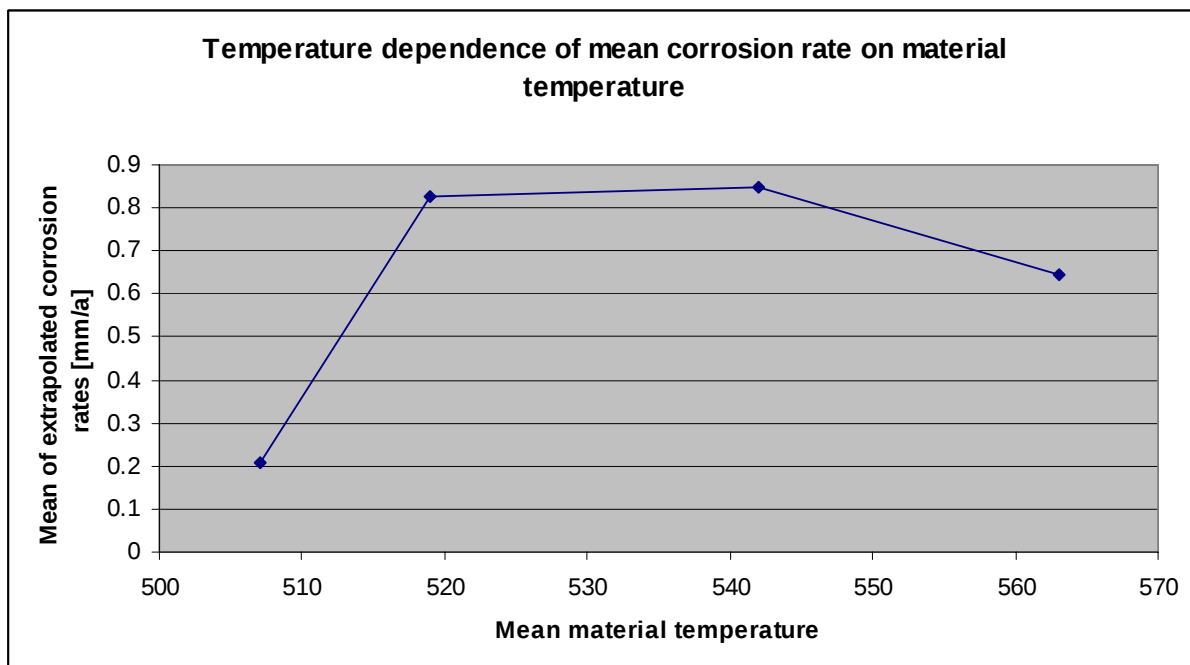
It seems that the corrosion rate is greatly enhanced at material temperatures in the range from 505 °C to 519 °C, Figure 10. Referring to the state-of-the-art theory of high temperature break-away oxidation of chromium alloyed steels and high-nickel alloys, see refs. [5,6,10] for example, one may propose that enhanced corrosion attack of the material samples tested is related here to the enhanced growth of mixed-type iron oxide – chromium oxide scales at locations exposed to high surface temperatures and some aggressive chemical conditions.

Figure 10. Dependence of mean metal loss measured on material temperature including the data for all six test materials exposed in Probe 2. See for reference Table 5.

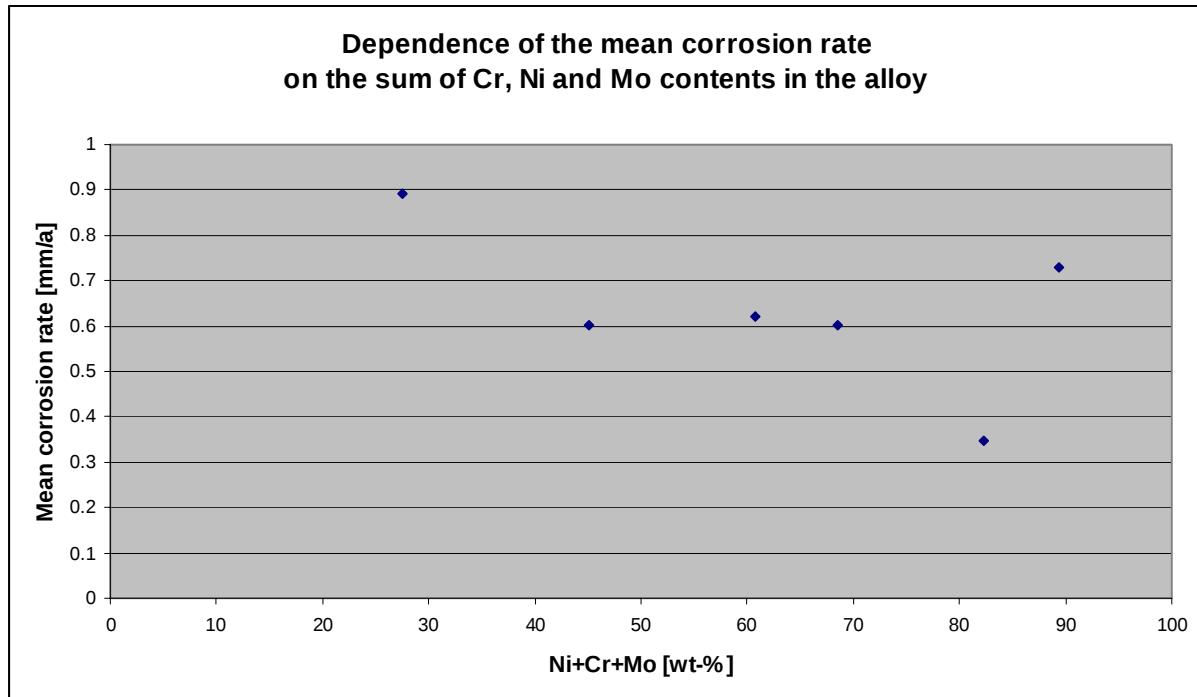
A high content of chromium in the material composition seems not to be as beneficial as could be expected, Figure 11. Initial oxidation conditions in the beginning of the exposure may have also played a role in the enhanced oxide scale growth, see for general reference Figure 12 below, and ref. [4].

Figure 11. Dependence of mean corrosion rate on the sum content wt-% Ni+wt-% Cr+ wt-% Mo in the six materials tested in Probe 2. See Figure 10 above for reference. The point most far to the right corresponds to the material with the highest content of Cr (30 wt-%).

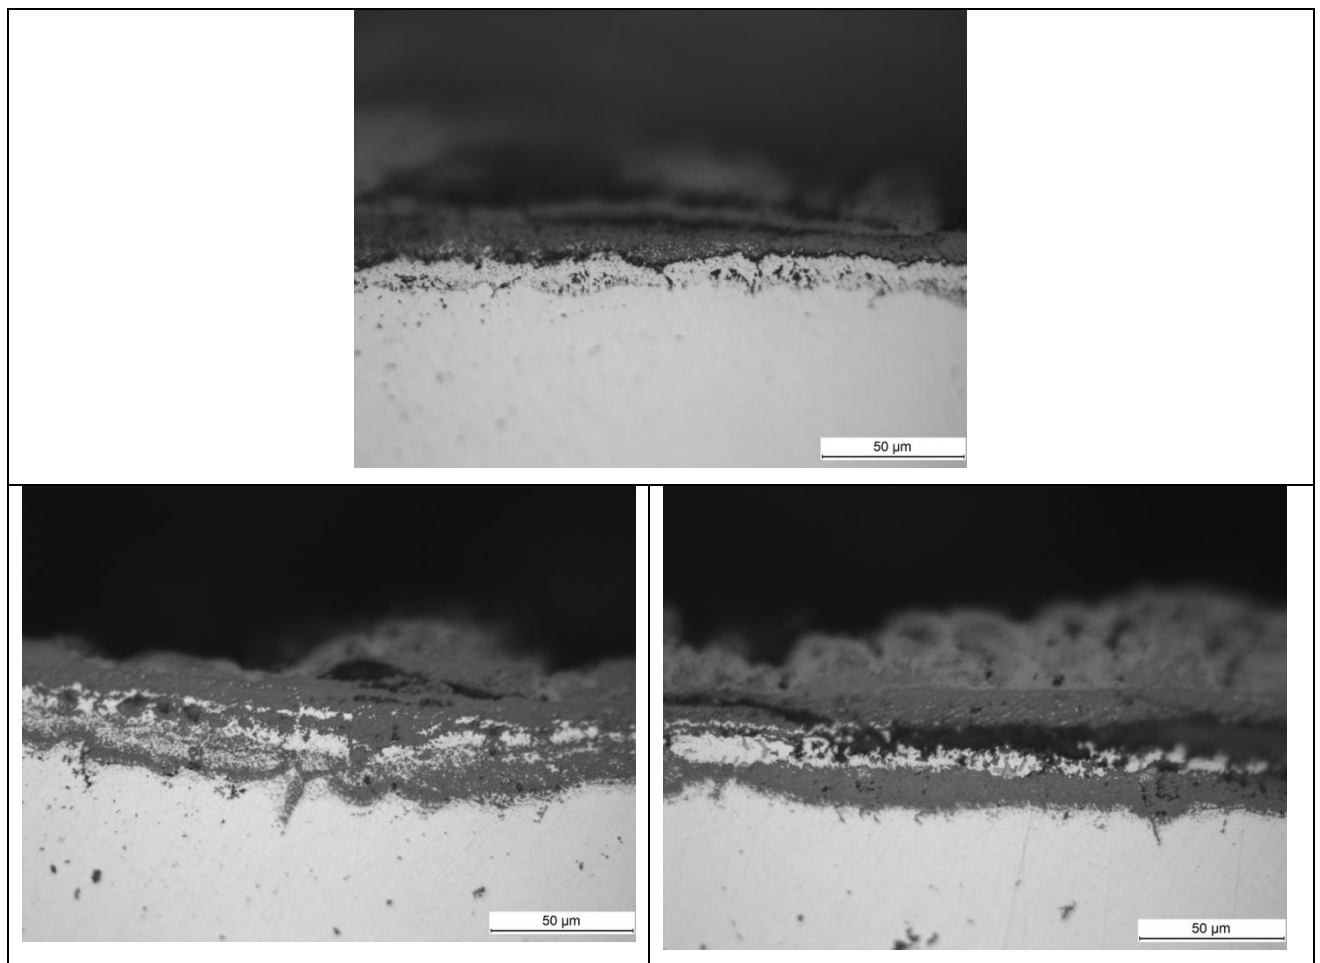
Material surface temperature on the windward and leeward side of the Probe 1 was measured to be 487°C and 526°C, respectively. There was no difference in the maximum temperature value. Examination of Figures 8 to 10 in *Appendix* leads to the suggestion that the extent of corrosion attack for various materials seems to depend more on the local deposit conditions (and on the nature of local thermo-physical stresses) than simply on the probe material surface temperature measured.

Figure 9. Cross sectional views of the material SAN 28 exposed in the Probe 1: Windward position ( $T: 526^{\circ}\text{C}$ ), top picture; Leeward position ( $T: 487^{\circ}\text{C}$ ), two bottom pictures. Un-etched specimen.

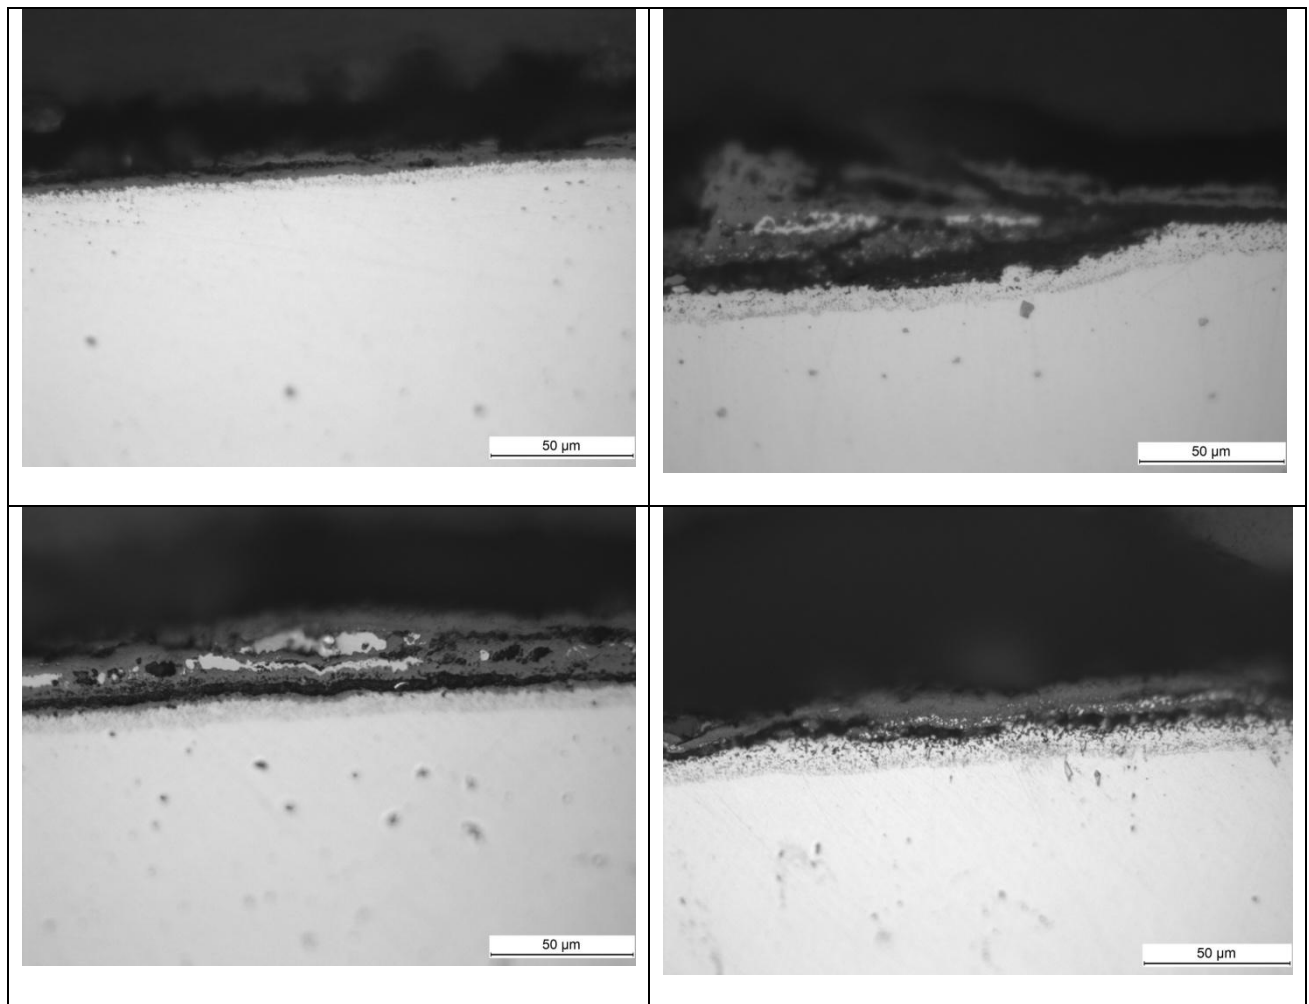
In the case of 347H material surface cross section on the Windward position appeared as little affected besides oxide growth outwards whereas on the Leeward position material had suffered from general corrosion and additionally of internal attack along open grain boundaries down to the depth of about 75  $\mu\text{m}$  from the current metal surface, see Figure 8 in *Appendix*. In the case of SAN 28 there was found internally penetrated (de-alloyed) zone and oxide scale growths on the windward and leeward position, Figure 9 in *Appendix*. Apparent metal loss totalled about 30  $\mu\text{m}$  and 75  $\mu\text{m}$  on the windward and leeward position, respectively. In the case of Super 625 the corrosion attack mode was similar to that in the case of SAN 28, but less in extent, Figure 10 in *Appendix*. Total metal loss, however, depended much of exact location examined. Apparent metal loss at the cross section locating exactly on the windward position (0 degrees) was found to be less than 10  $\mu\text{m}$  whereas at locations situated about 30 degrees sideways apparent metal loss was about 25  $\mu\text{m}$  or more. Even if still crossly circular, cross section of Super 625 showed features interpreted preliminary as marks of impaction on the Leeward side of the ring, see Figure 10 in *Appendix*.

*Figure 10. Cross sectional views of the material Super 625 exposed in the Probe 1. Top row: Windward position (T: 526 °C), left picture; Leeward position (T: 487 °C), right picture. Bottom row: 30 degrees Up from Windward position, left picture; 30 degrees Down from Windward position, right picture. Un-etched specimen. Material temperatures at positions 30 degrees away from Windward or Leeward position are actually not known.*

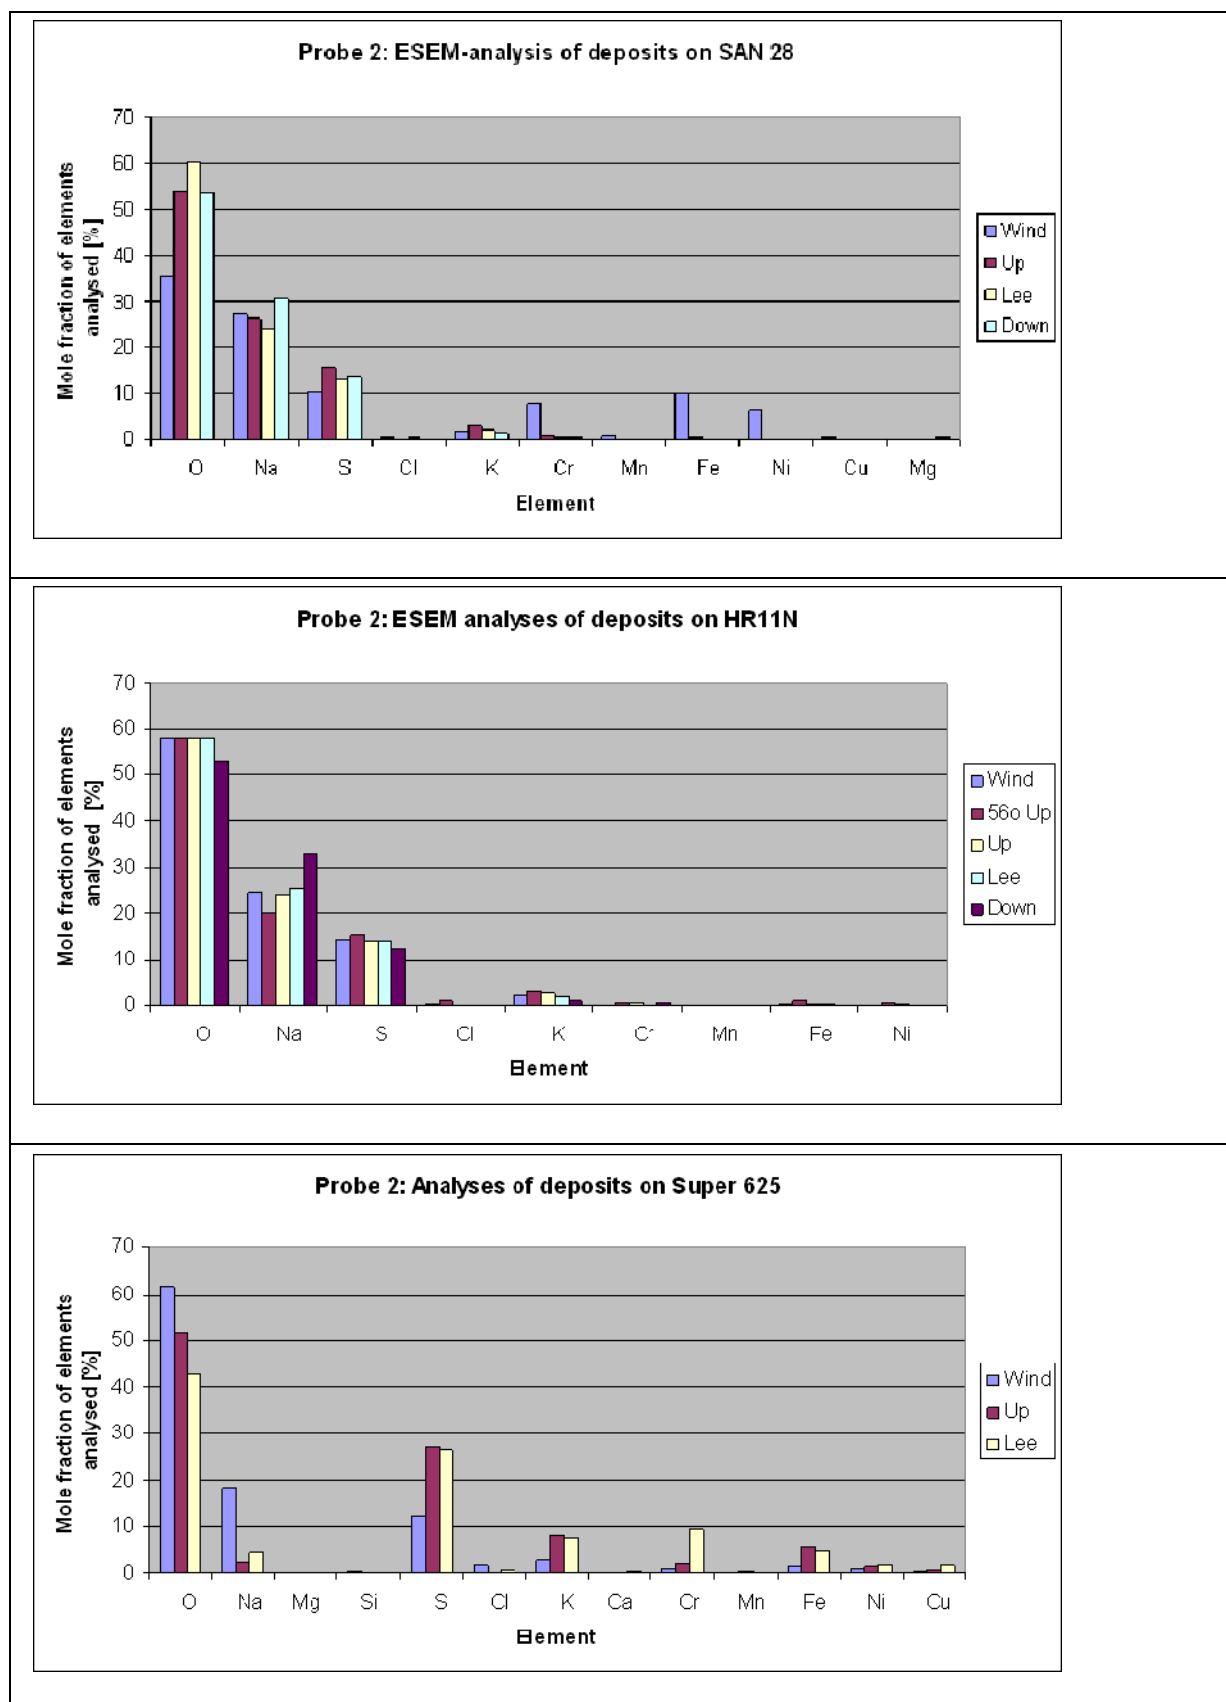
Graphs of quantitative elemental analyses of deposits present at various directions are shown, in Figures 11 and 12 in *Appendix*. Typically, oxygen, sodium, sulphur, some potassium, and some small amounts of chloride (range from  $< 0.1$  wt-% Cl to about 1 wt-% Cl) and some of chromium, iron and nickel is found in the areal analyses of deposits. In the case of high nickel alloys point analyses indicated that the mass fraction of chlorine in metal-near deposits/corrosion products may locally rise up to 10 or 25 wt-% Cl.

Figure 11. Representative deposit analyses for the material samples SAN 28, HR11N and Super 625 exposed in Probe 2.

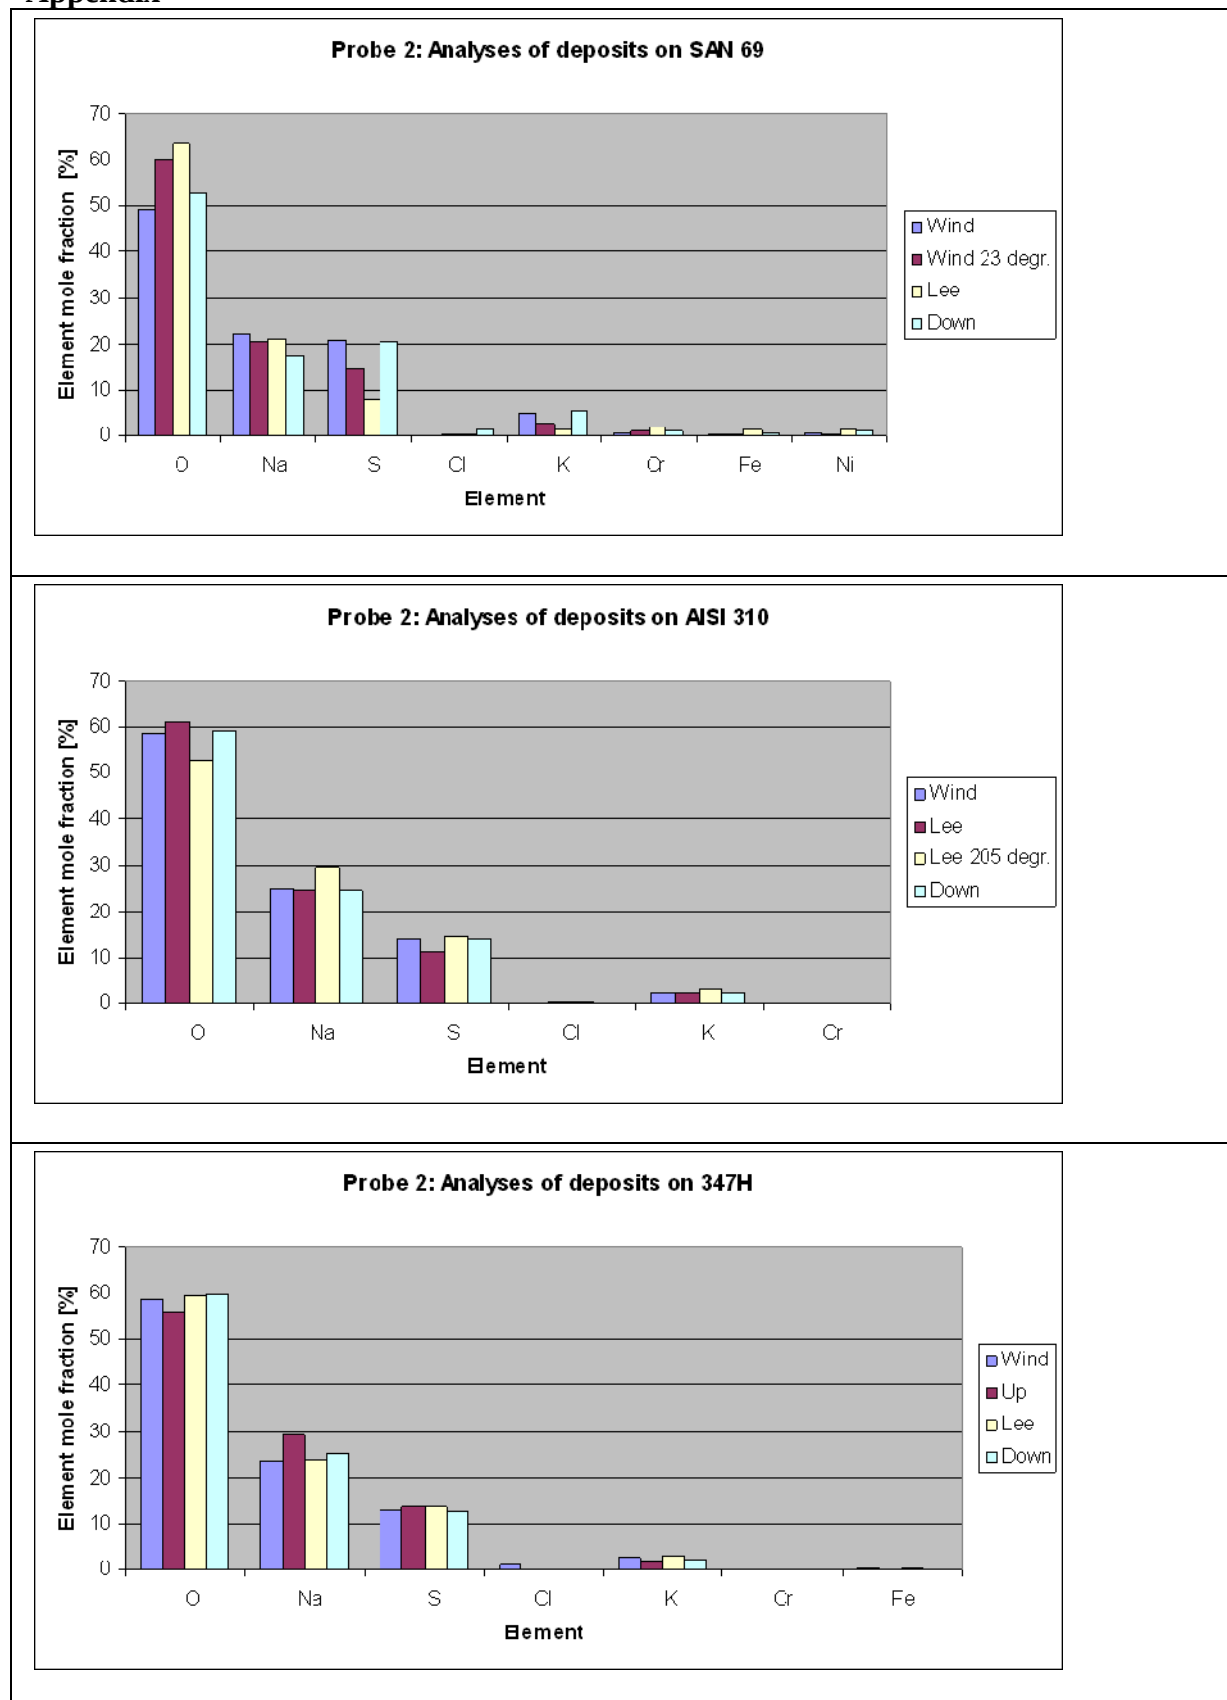
Figure 12. Representative deposit analyses for the material samples SAN 69, AISI 310 and 347H exposed in Probe 2.

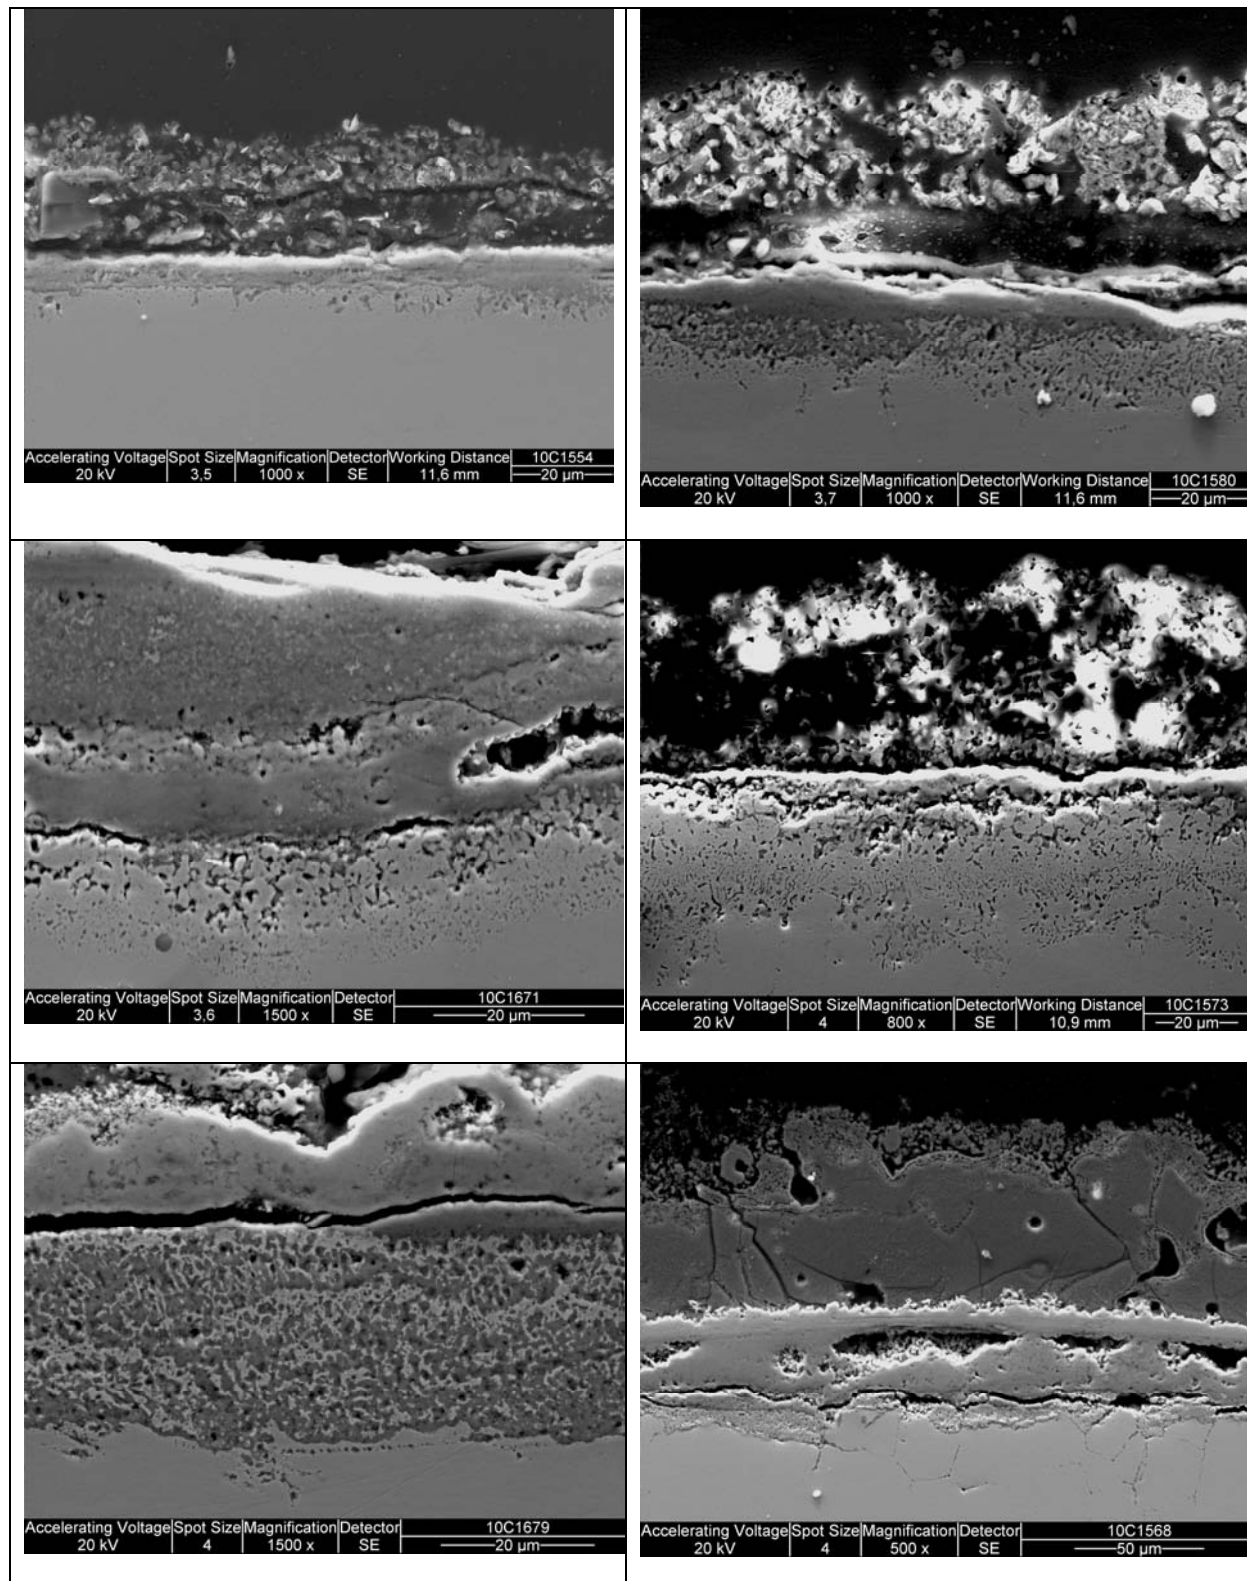
Figure 13. Cross-sectional view showing the total thickness of internally attacked zones and oxide scales observed on the Windward side for each material sample exposed in Probe 2. Left column from top to bottom: SAN 28, Super 625, AISI 310. Right column from top to bottom: HR11N, SAN 69, 347H. Note different magnifications. Material surface temperature in average 562°C. Estimated metal losses range from 0.1 mm (357H) to 0.01 mm (SAN 28).

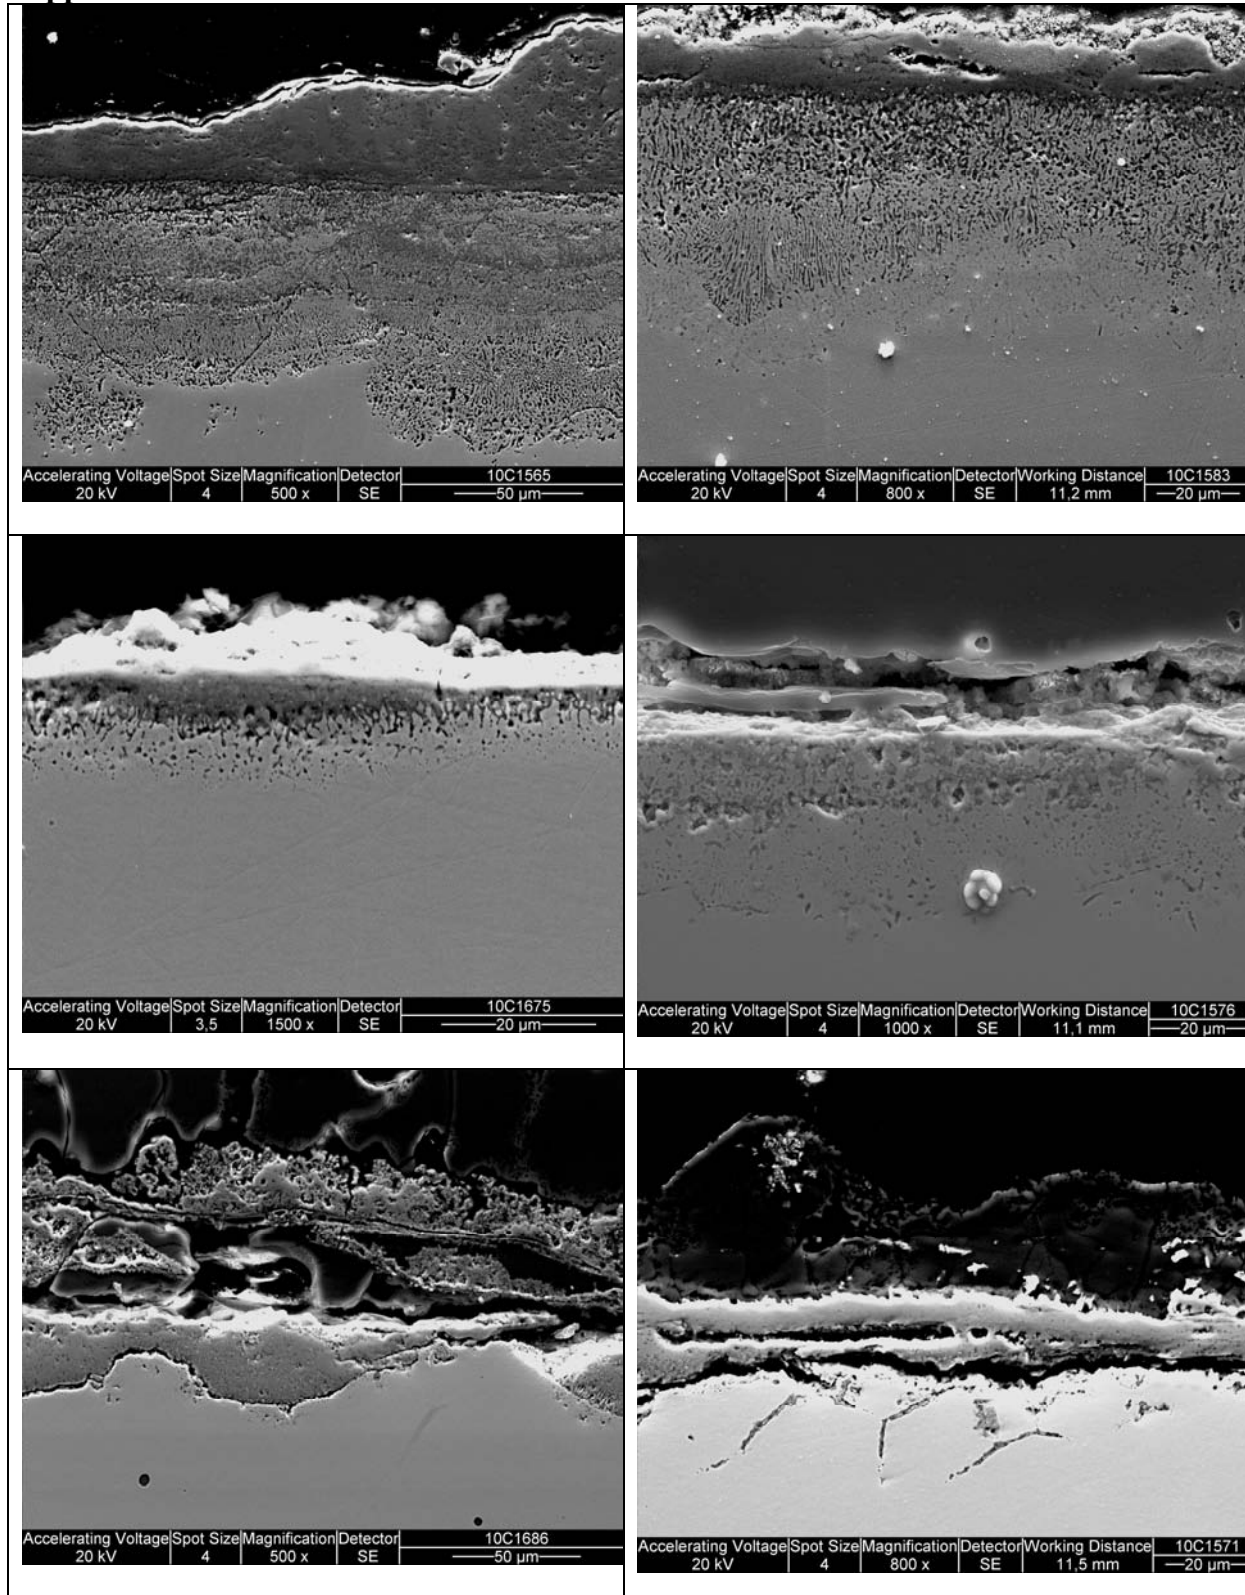
Figure 14. Cross-sectional view showing the total thickness of internally attacked zones and oxide scales observed on the Leeward side for each material sample exposed in Probe 2. Left column from top to bottom: SAN 28, Super 625, AISI 310. Right column from top to bottom: HR11N, SAN 69, 347H. Note different magnifications. Material surface temperature in average 542°C. Estimated metal losses range from 0.11 mm (SAN 28) to 0.015 mm (Super 625).

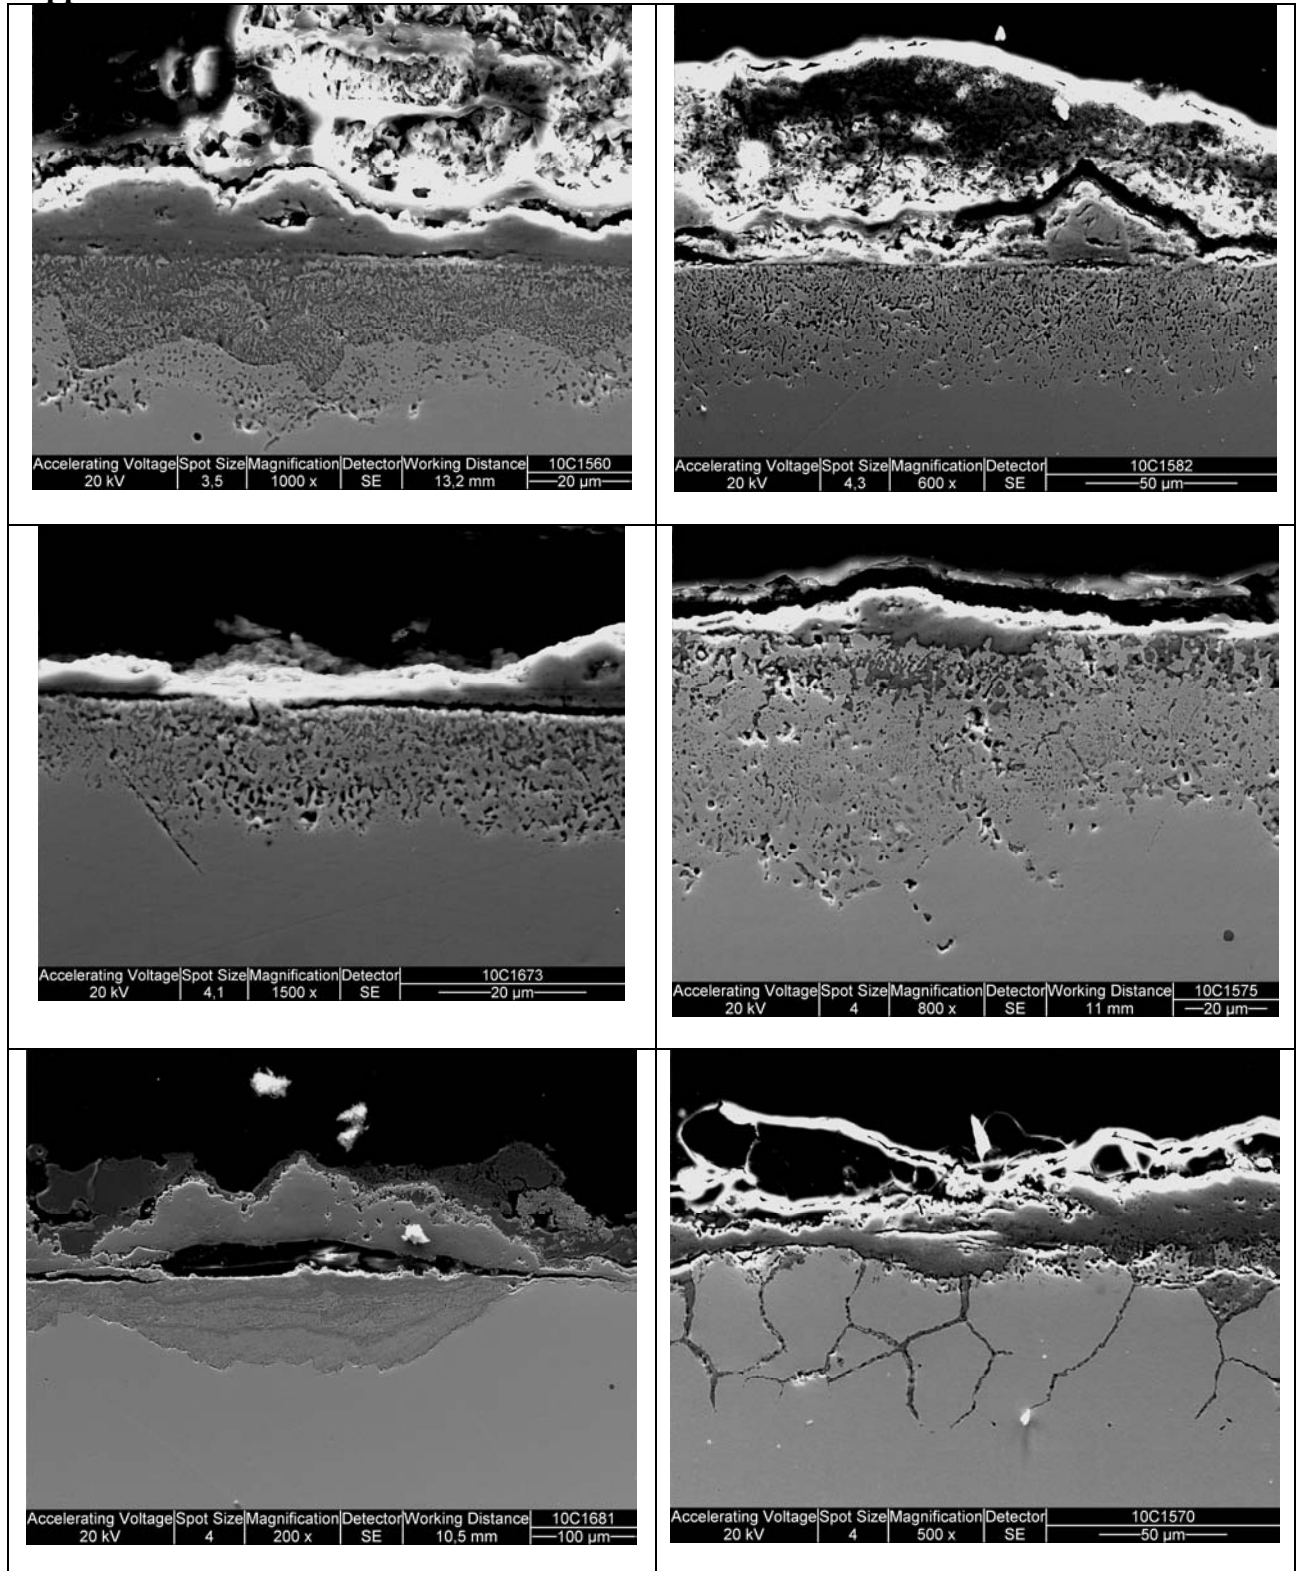
Figure 15. Cross-sectional view showing the total thickness of internally attacked zones and oxide scales observed on the Up side for each material sample exposed in Probe 2. Left column from top to bottom: SAN 28, Super 625, AISI 310. Right column from top to bottom: HR11N, SAN 69, 347H. Note different magnifications. Material surface temperature in average 518°C. Estimated metal losses range from 0.09 mm (AISI 310) to 0.025 mm (Super 625).

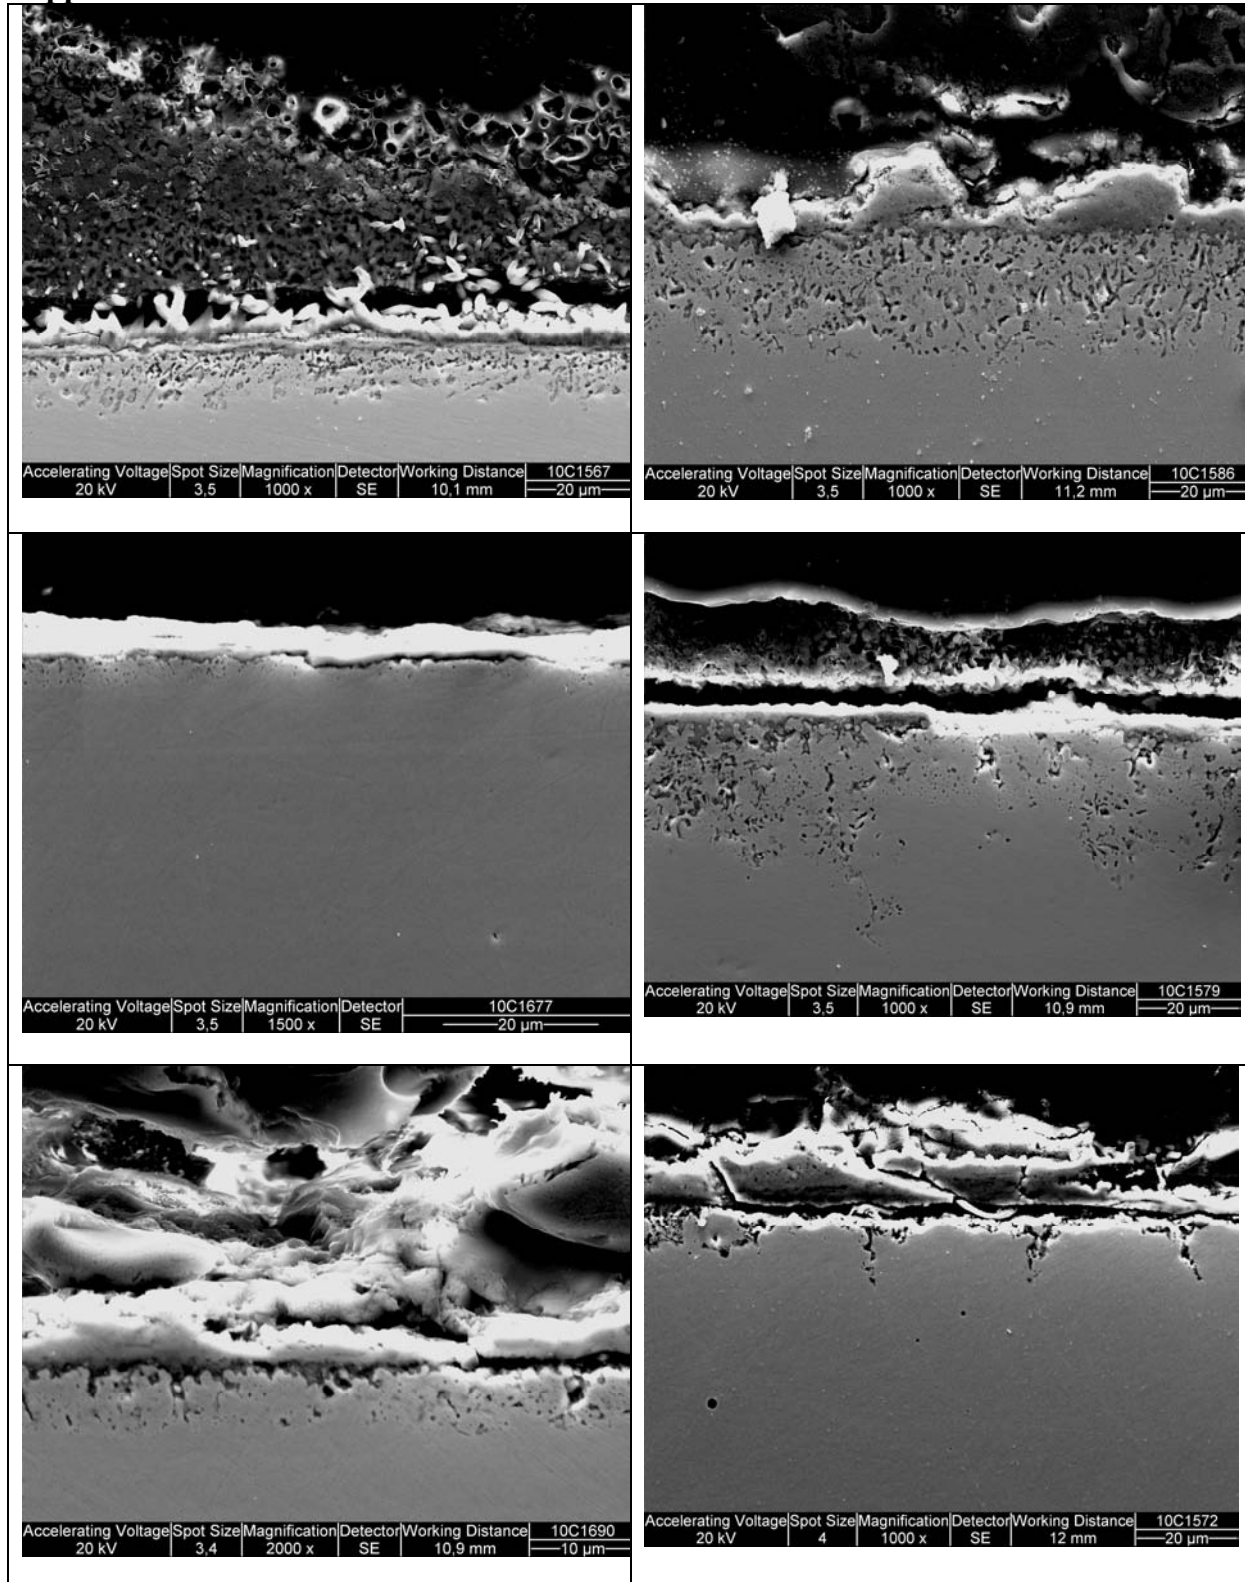
Figure 16. Cross-sectional view showing the total thickness of internally attacked zones and oxide scales observed on the Down side for each material sample exposed in Probe 2. Left column from top to bottom: SAN 28, Super 625, AISI 310. Right column from top to bottom: HR11N, SAN 69, 347H. Note different magnifications. Material surface temperature in average 508°C. Estimated metal losses range from 0.040 mm (SAN 69) to 0.005 mm (Super 625 and AISI 310).
