**Tulistinmateriaalien laboratoriokokeet OSA 2  
alustavien kokeiden tulokset ja tarjous  
5.5.2011**

## **Corrosion tests in reducing conditions – PART II**

Laboratory of Inorganic Chemistry  
Åbo Akademi University

**May 2011**

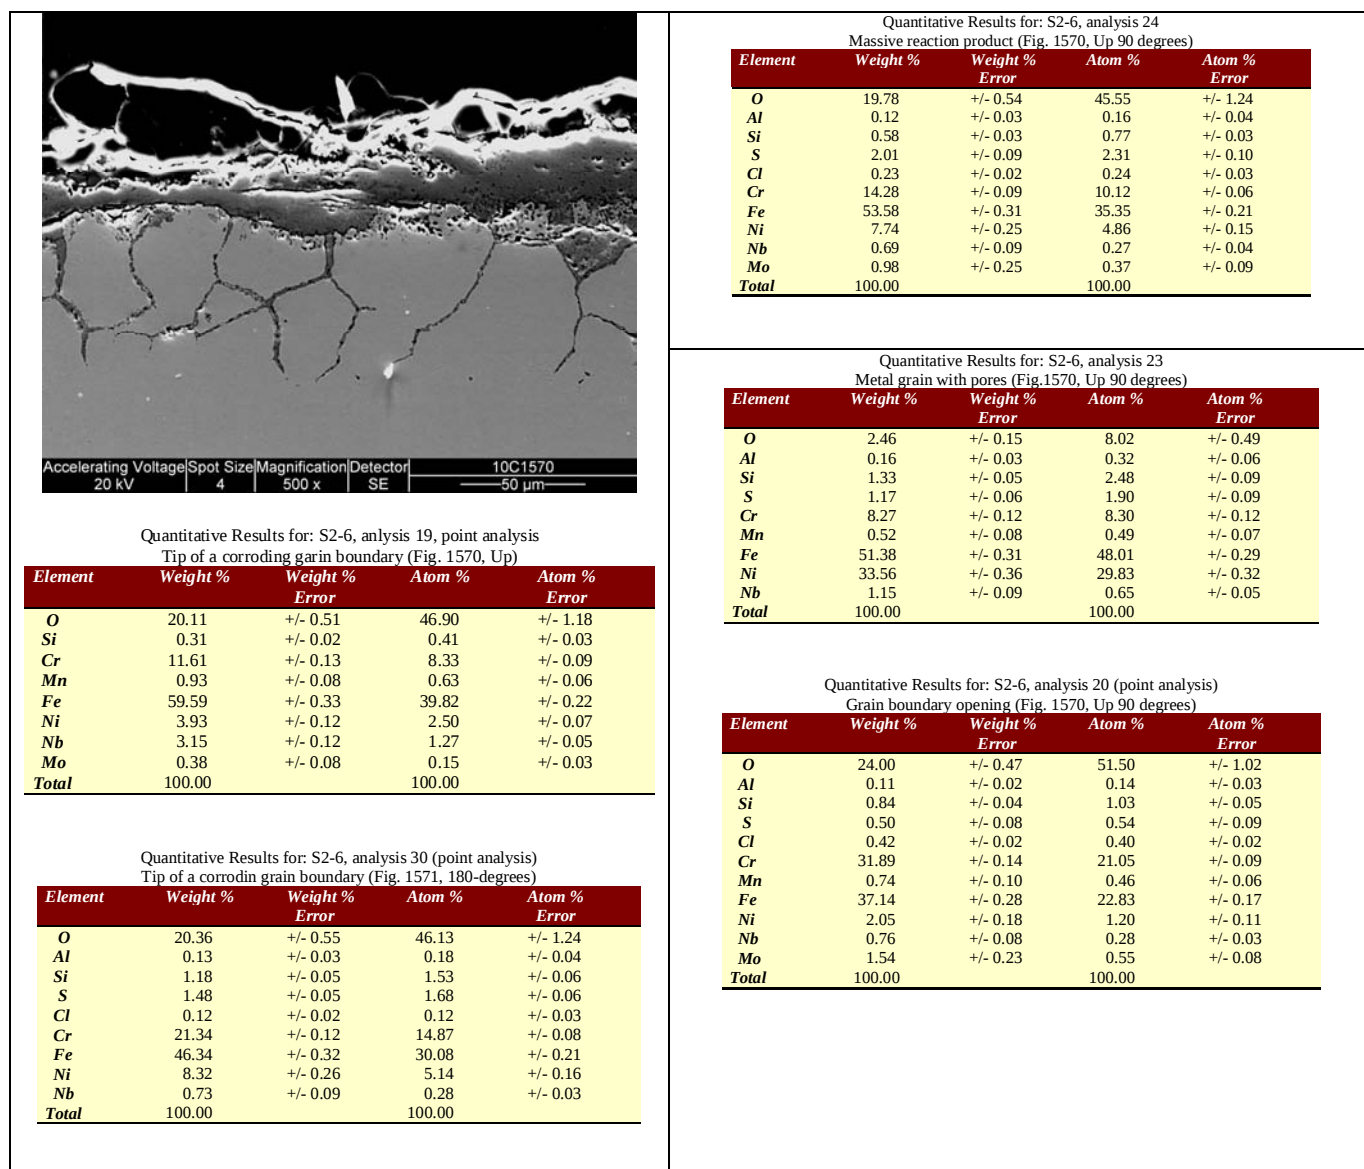
In the case of 347H grain boundary attack, de-alloying of superficial metal grains and chloride enhanced oxide scale growth are the governing modes of accelerated corrosion. Some chloride is very typically found in the areal quantitative analyses of the corrosion products. Point analyses of attacked grain boundaries did, or did sometimes not, reveal sulphur and/or chloride in addition to oxygen, see for example quantitative results found in Figure 19 in Appendix. Note that the conventional analytical limit here is 0.1 wt-% and even so for S and Cl.

Figure 19. Cross sectional view featuring morphologies and compositional characteristics of grain boundary attack, de-alloying of superficial metal grains, and enhanced oxide growth typical of the exposed sample of material 347H. Note that the conventional detection limit for Cl is 0.1 wt-%. SEM-picture.

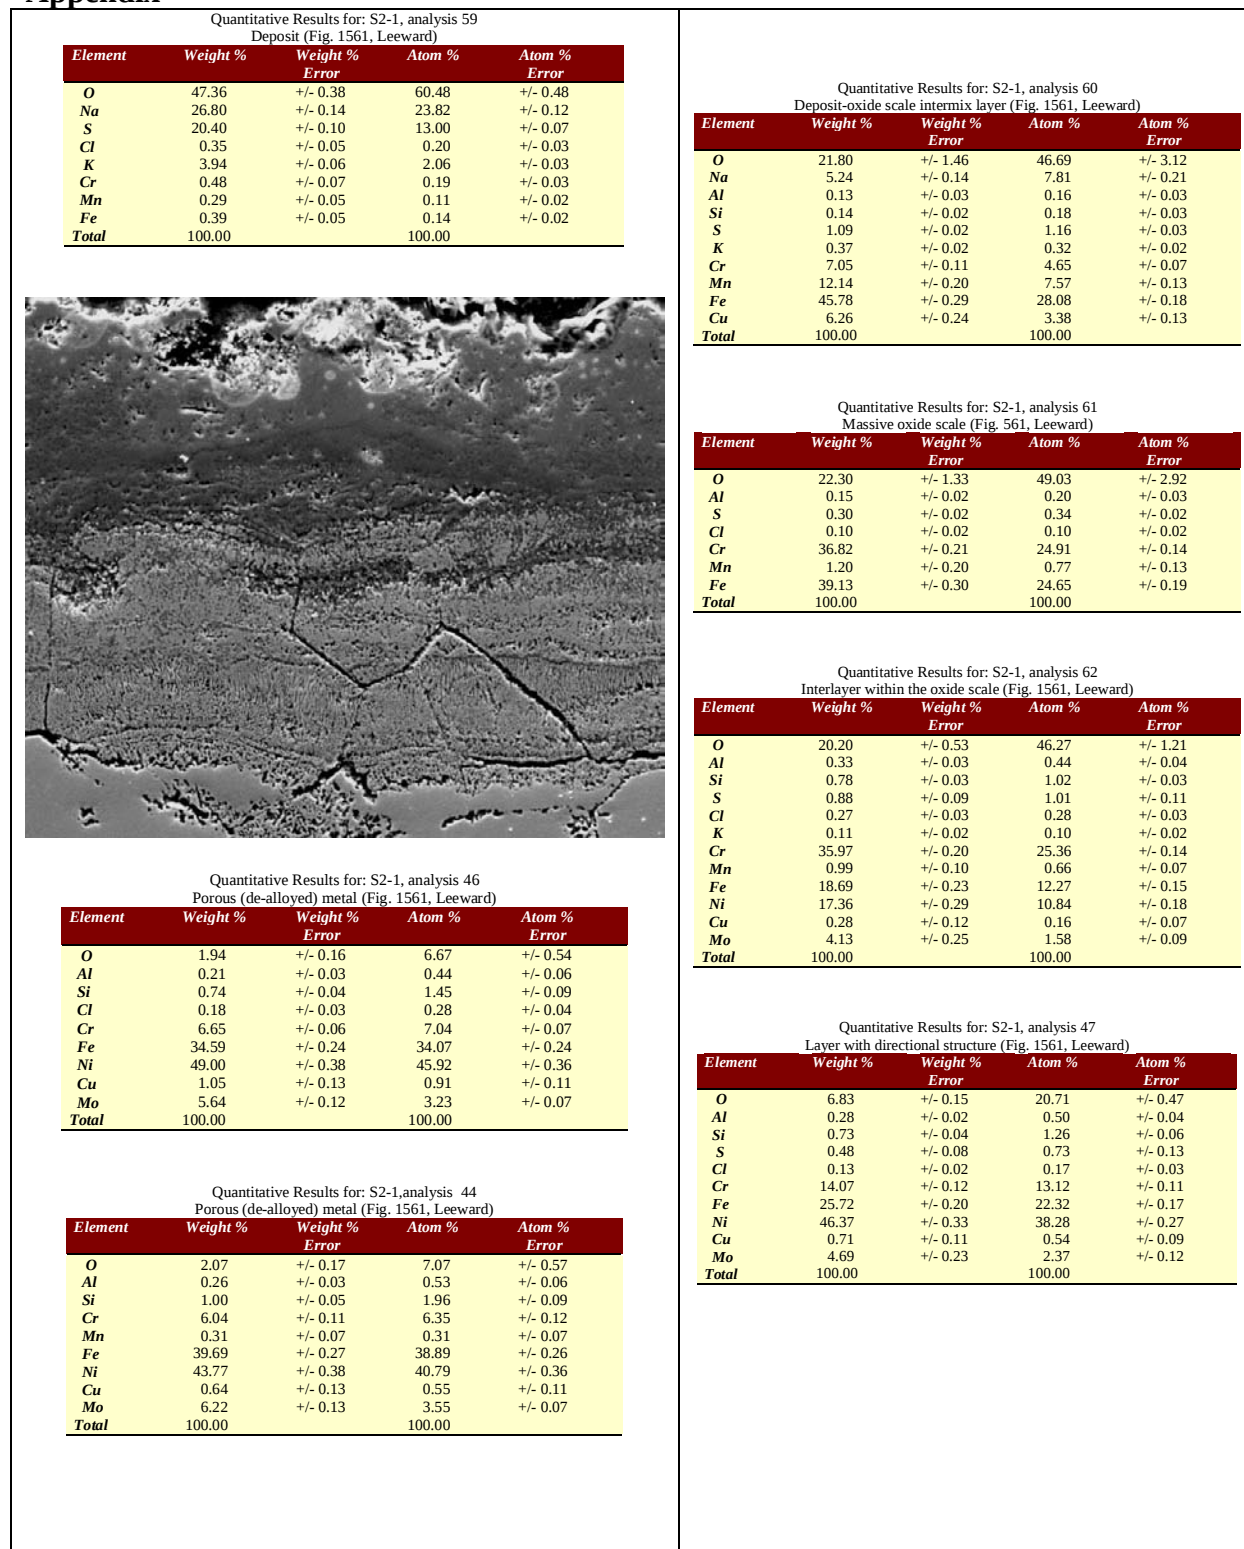
Figure 20. Cross sectional view featuring morphologies and compositional characteristics of locally enhanced corrosion of SAN 28. Outer scale of mixed iron-chromium oxide type, and various oxygen, sulphur and chlorine penetrated de-alloyed zones in the ale metal are typical also of locally enhanced corrosion of HR11N, AISI 310, SAN 69 and Super 625. Corrosion performance at high temperatures is severely reduced due to depletion of chromium.

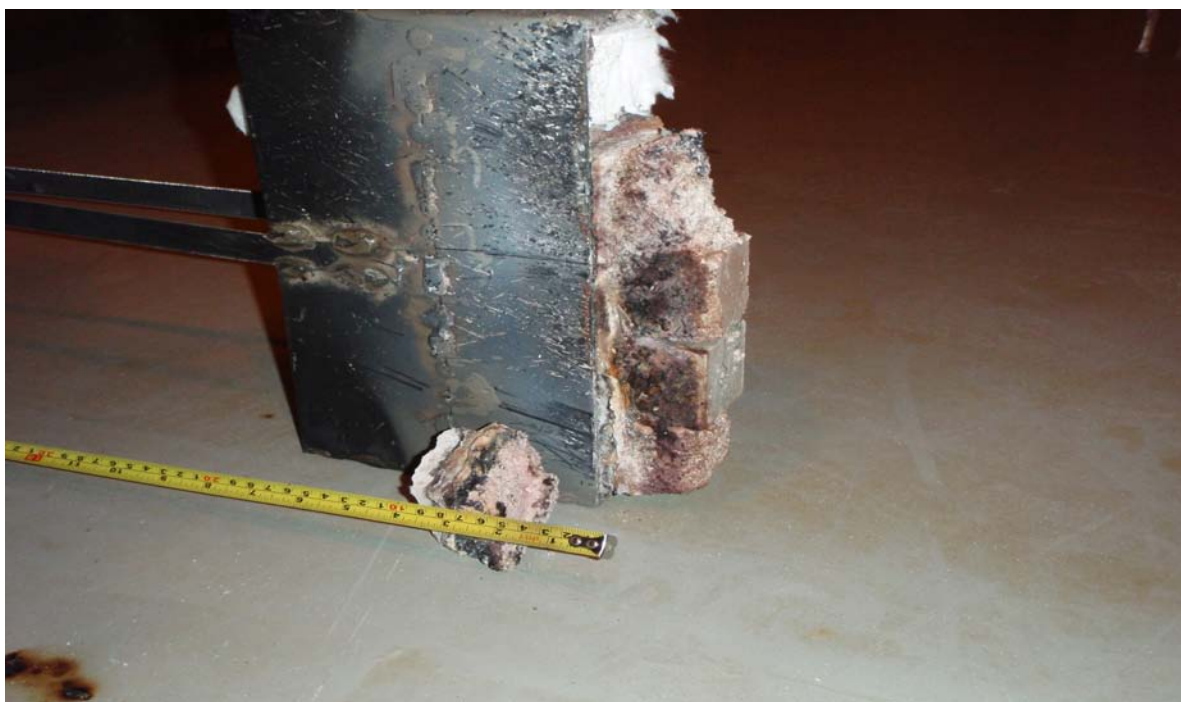
Kuva 2. Omatekoinen valmista spinelliä sisältävä massa ei ollut mekaanisesti tarpeeksi lujaa vaan katkesi kehikkoa irrotettaessa. Molemmat tiilet näyttävät hyviltä verattuna alinna vertailumateriaalina olevaan hasslen massa.

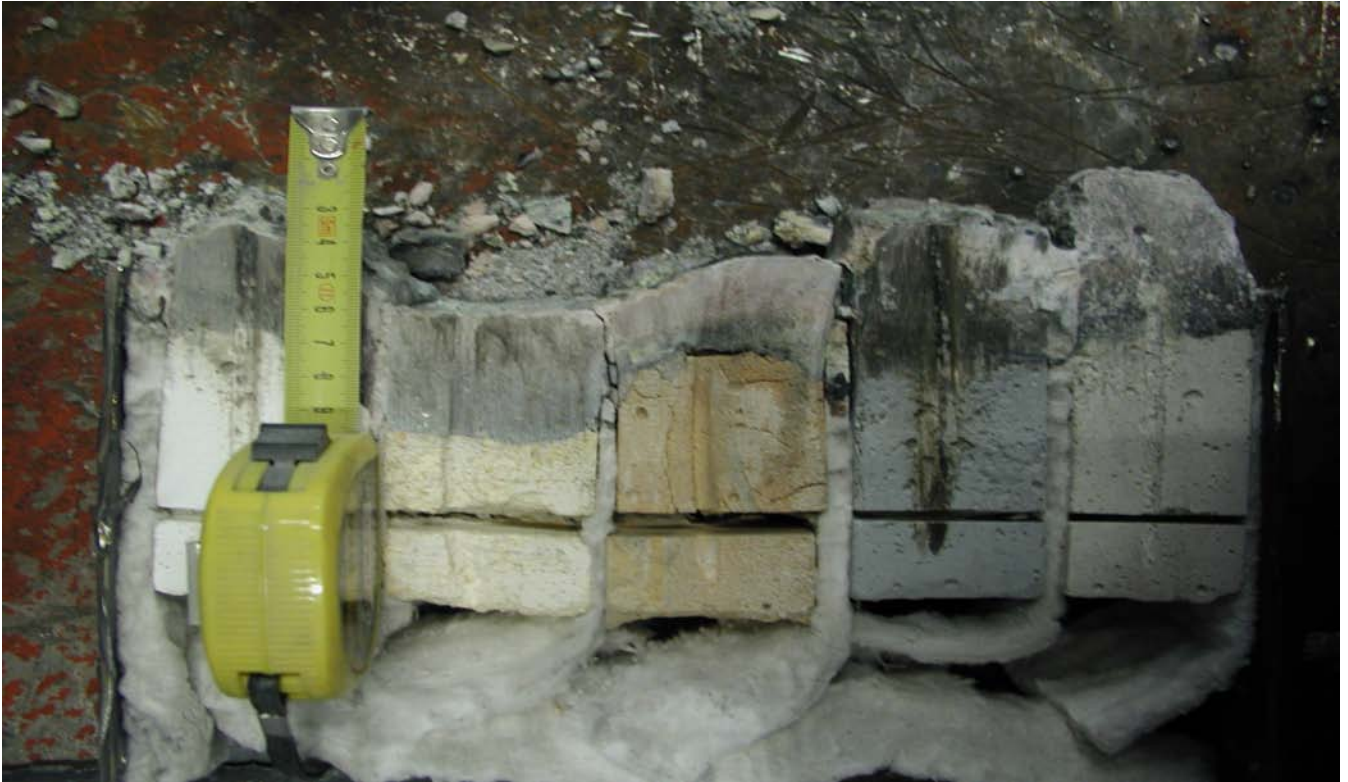
Kuva 3. Massoista parhaiten on pärjännyt alinna oleva hassle kuluma noin 10 mm. Seuraavana betker on jo huomattavasti enemmän kulunut. Siitä seuraava forsteriitti ,  $ZrO_2$  ja Ankoflo.

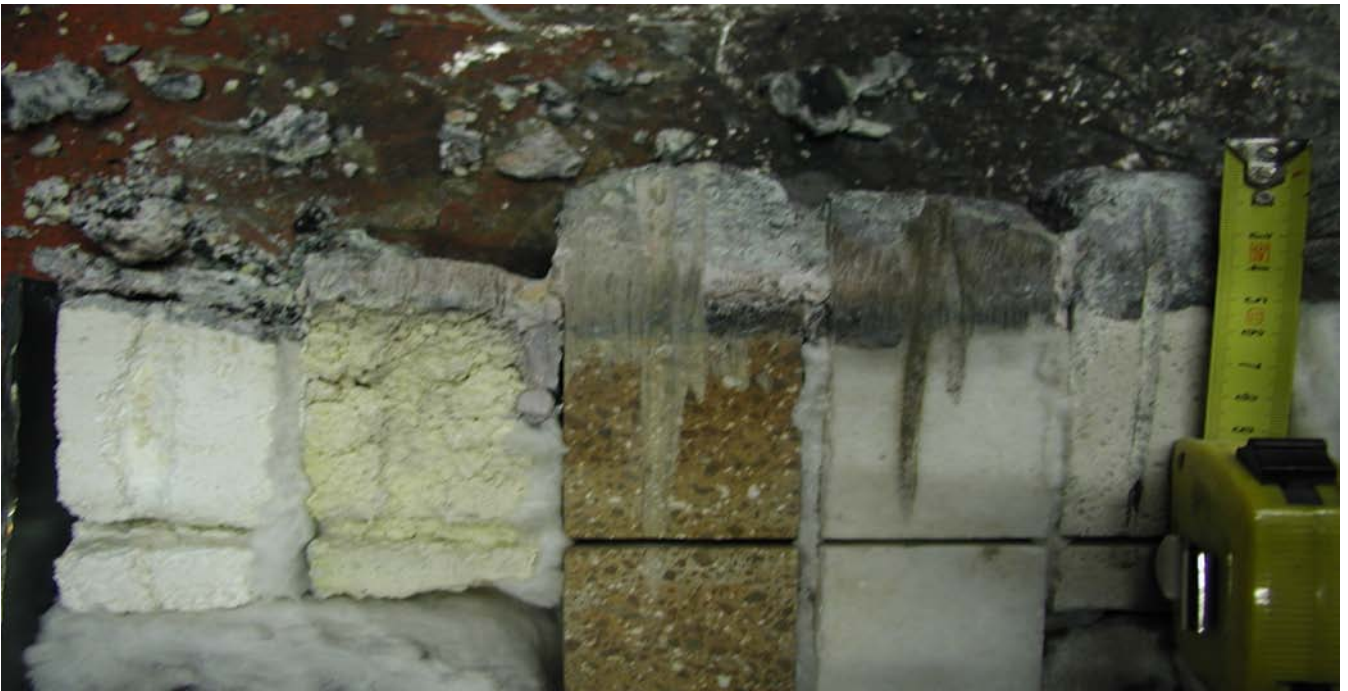
Kuva 4. Oikella oleva hasslen massa on pärjännyt  $MgO$ -rauta tiilen (keskellä) kanssa parhaiten. Niiden välissä oleva sulavalettu aloksi on heti kolmantena. Omavalmisteiset kellertävä  $CeO_2$  lisätty ja spinelliä sisältävä massa pärjäsivät huonosti.

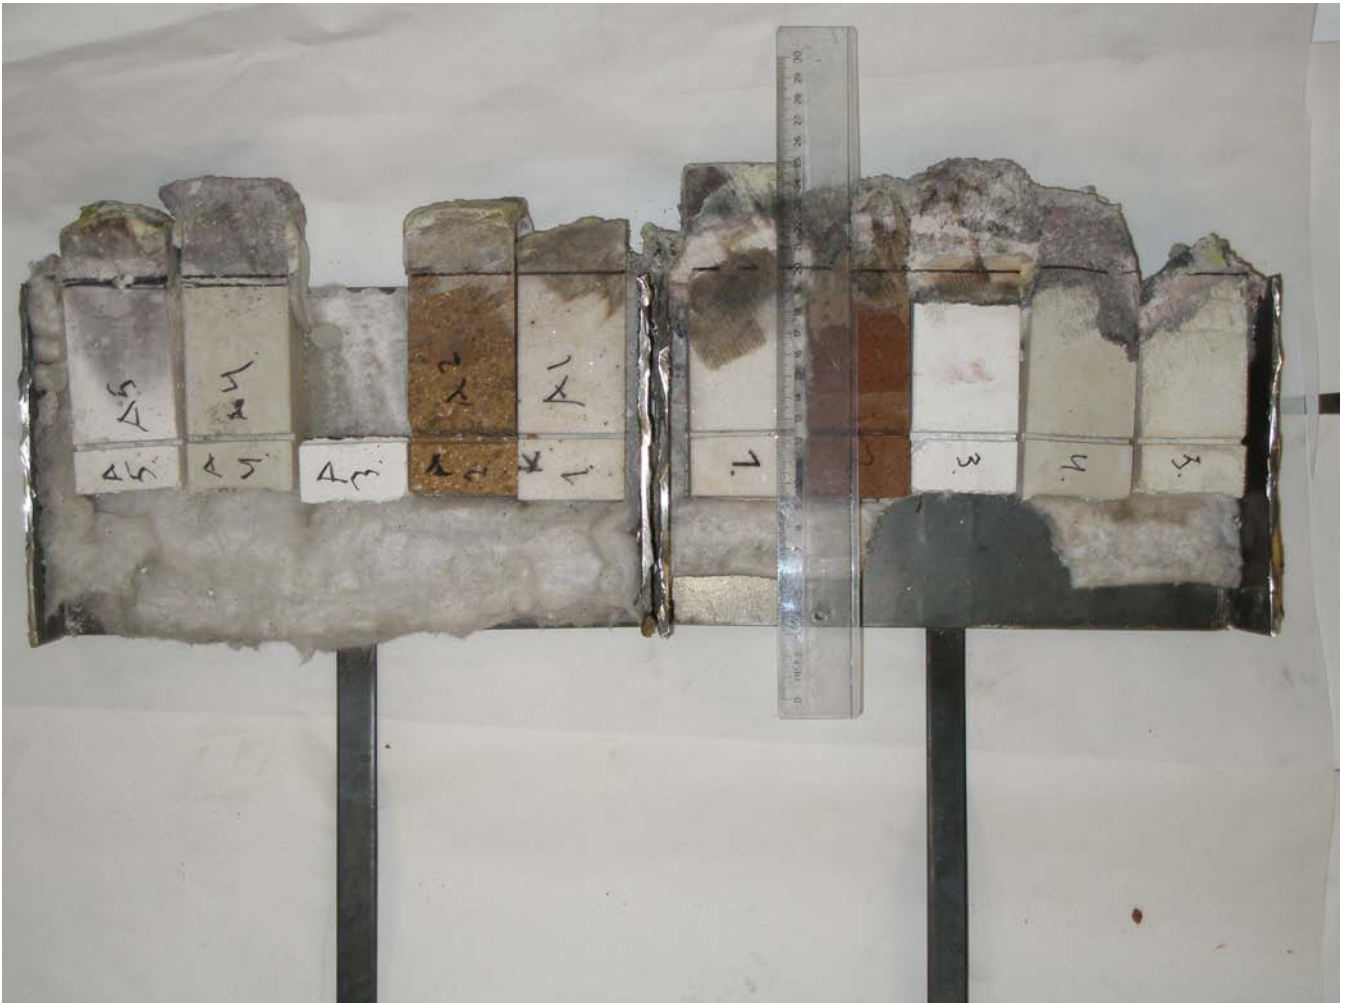
Kuva 7. Koekappaleet kokeen 2 jälkeen. Huomataan aika erilaiset kulumiset kattilan eri puolilla samoilla koemateriaaleilla. Nro 1 ja 3 ovat parhaimman näköiset toisessa ja A4 toisessa kehikossa.

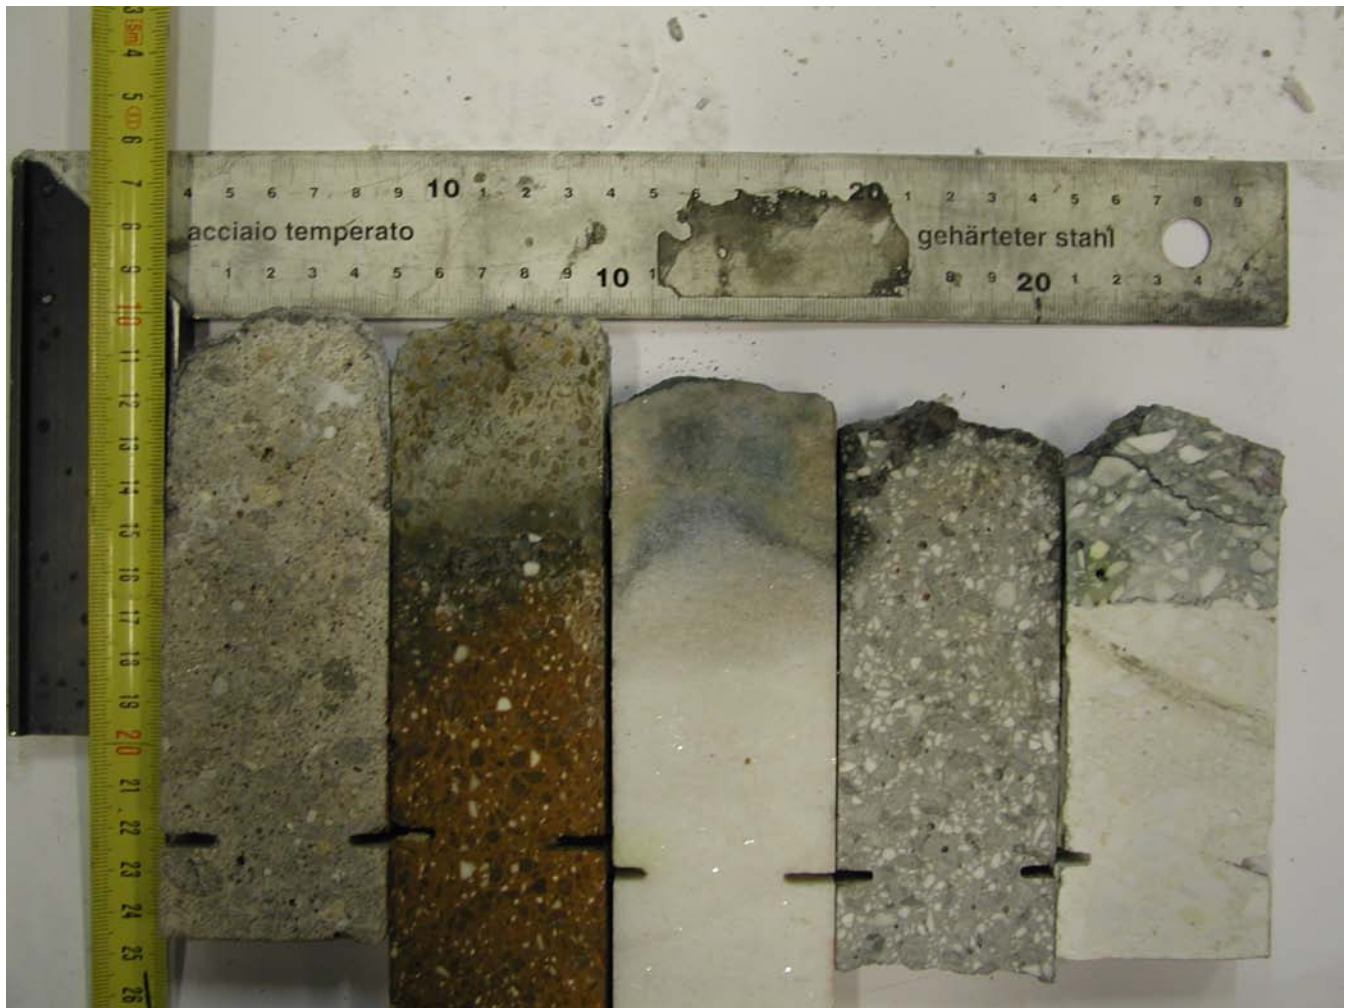
Kuva 10. Parhaiden leikkauspinnat. Vasemmalta oikealle Hassle, MgO-rauta tiili, Sulavalettu aloksi. Betker ja AnkoFlo. Huomataan silminhavaittavat diffusio / imeytymä kerrokset muissa paitsi Hasle ja Betker massoissa.

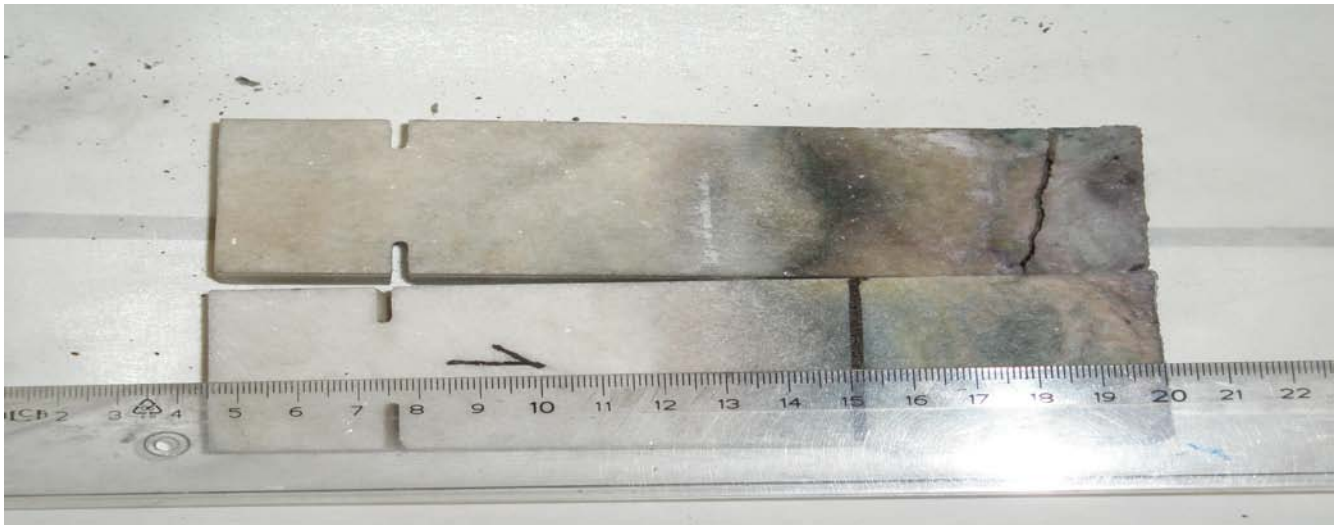
Kuva 1. Sulavalettu aloksitiili näyttää hyvältä päällepäin mutta sahatessa se halkesi ja soodakattilasulan on tunkeutunut melkein puoleenväliin tiiltä.

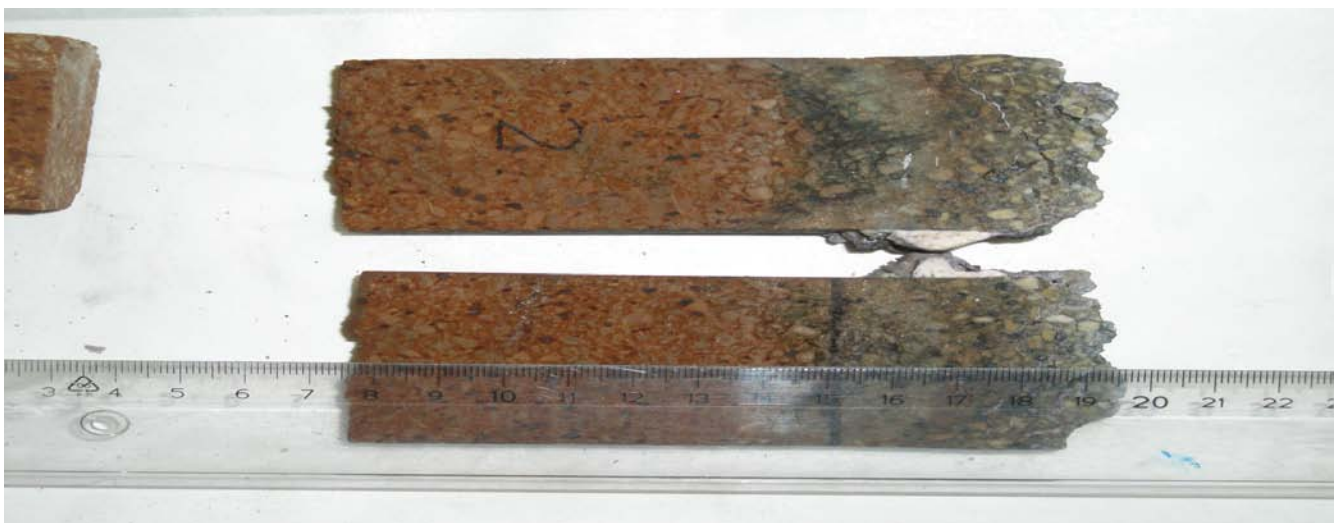
Kuva 2. MgO-rauta tiiliessä on joitain halkeamia ja sula on tunkeutunut noin 50 mm. Tiilen pinta on lohkeilleen näköinen.

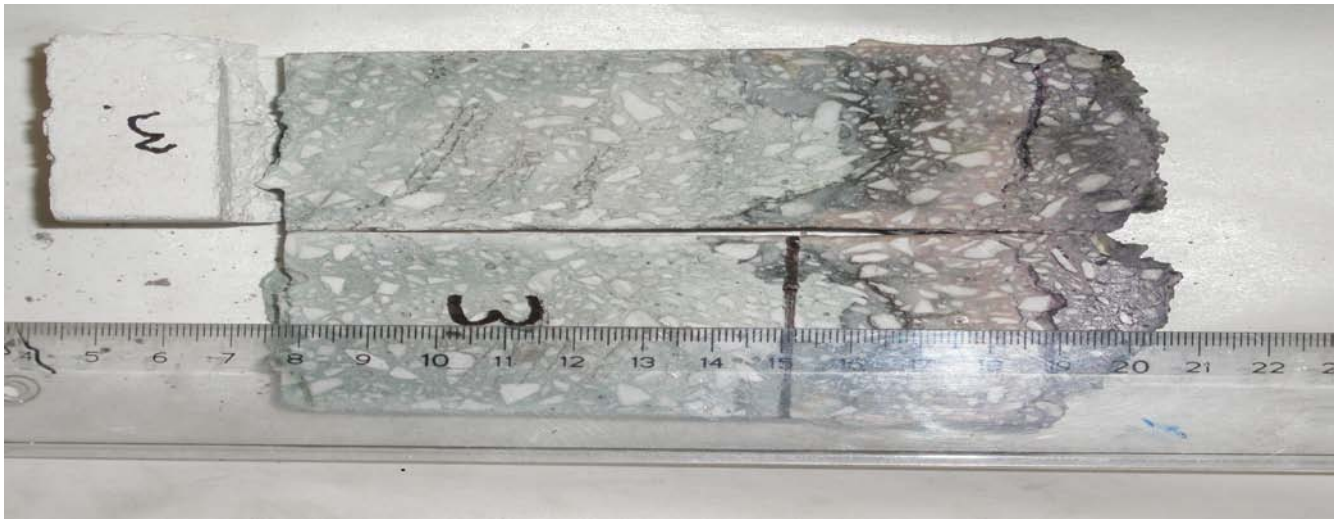
Kuva 3. Hassle B1800 on turvonnut soodakattila sulan tunkeutumisen johdosta. Pinta näyttää lohkeilevan, samoin joitain halkeamia näkyy. Sula on tunkeutunut yli puolenvälin tiiltä.

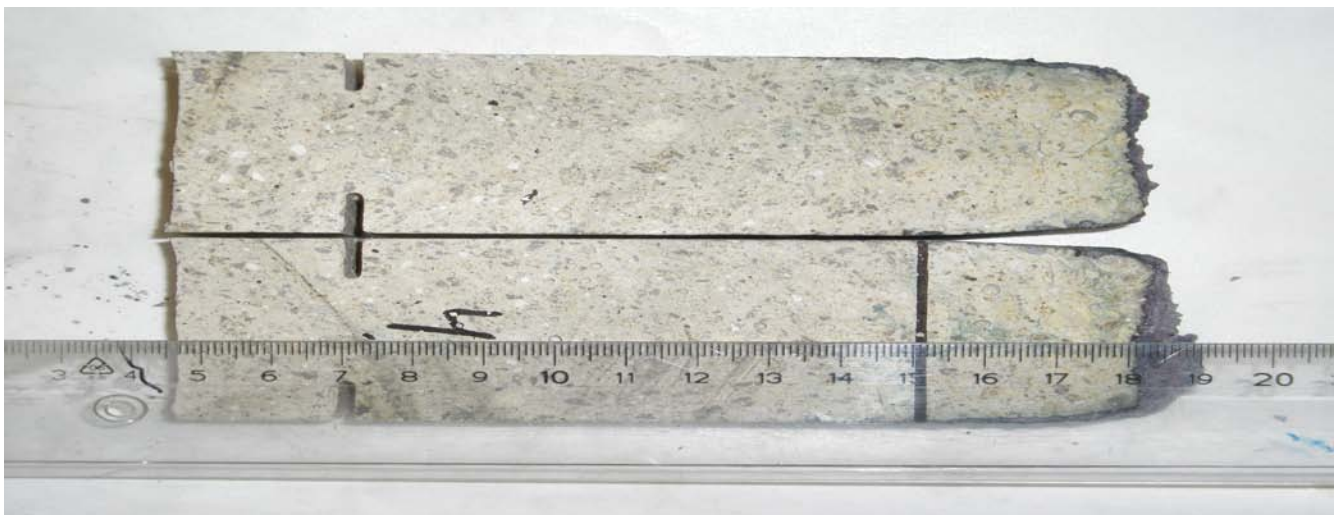
Kuva 4. Hassle D39A ei sula juurikaan tunkeudu. Joitain halkeamia näkyy ja kulumisprofiili on epätasainen.

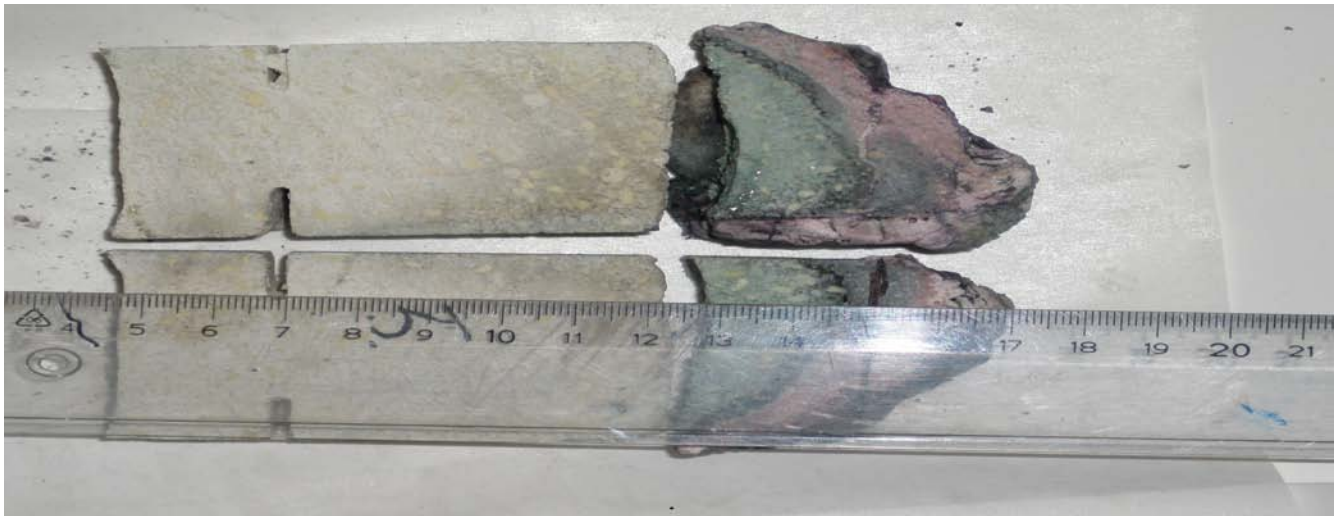
Kuva 5. Oma spinellimassa. Sula on tunkeutunut huokosiin ja sideaineeseen. Lujuus on parempi kuin kokeessa 1, mutta ei edelleenkään riittävä.

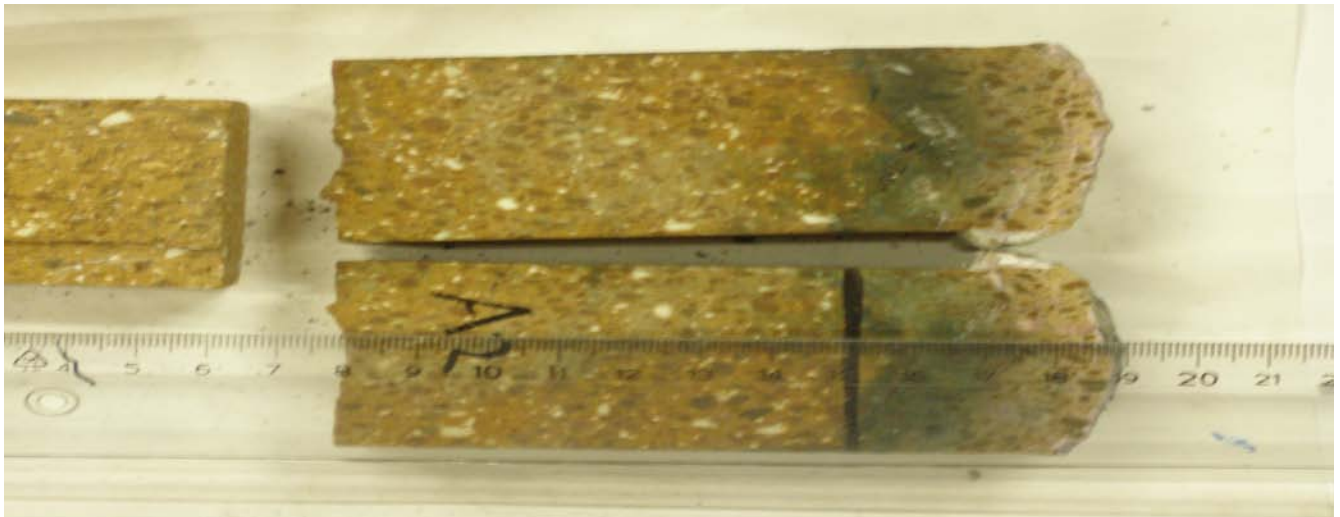
Kuva 7. MgO-rauta tiilessä sula on tunkeutunut noin 50 mm. Tiilen pinta on melko pyöreä.

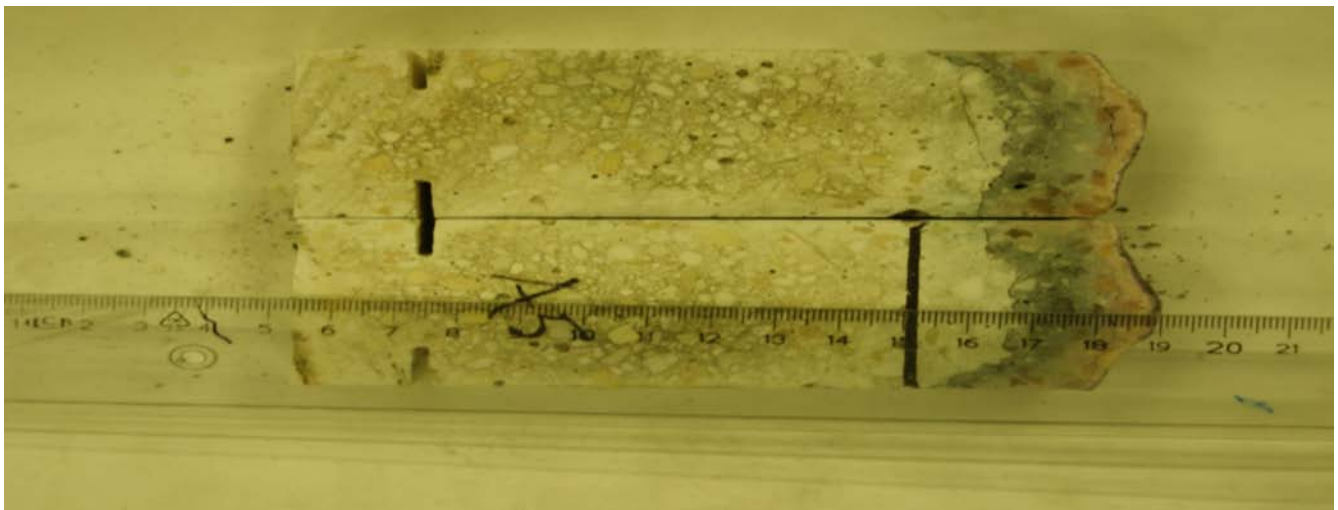
Kuva 9. Spinelliä muodostava massa. Noin 25 mm sulan tunkeuma ja epätasainen kulumispinta, joitain halkeamia näkyy myös.

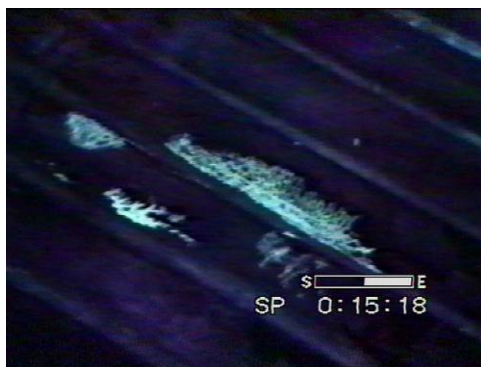
**Kuva 3.** Fluoresoivalla tunkeumanesteellä tarkastetun pohjan särönäyttämiä

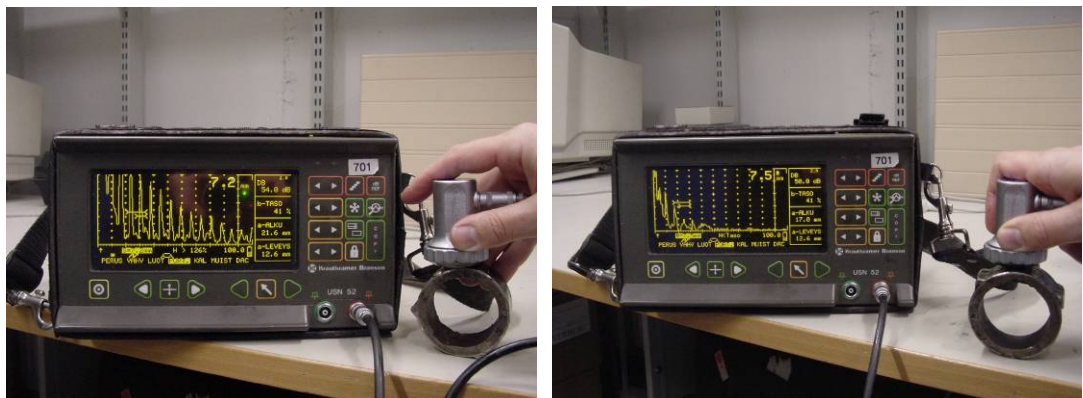
**Kuva 8.** A-näytöt ehjästä putkesta ja vetyhyökkäyskohdalta.

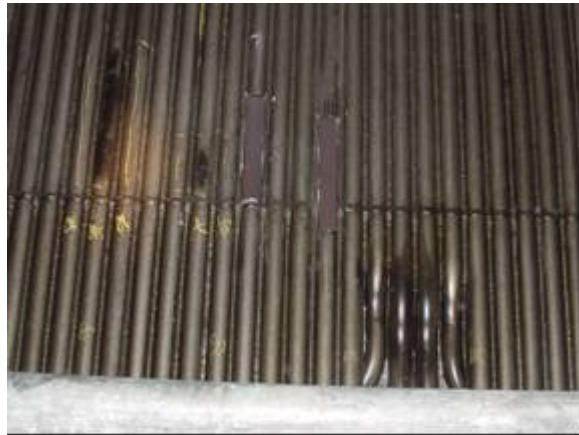
**Kuva L 1.** Värimuutoksia seinällä

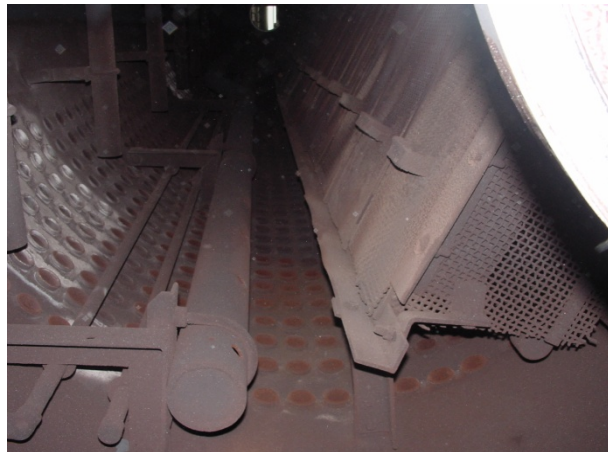
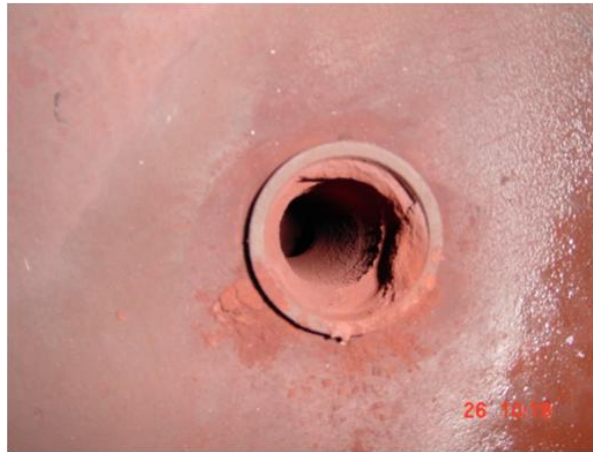
**Kuva L 2.** Lieriössä epäpuhtauksia ja värimuutoksia

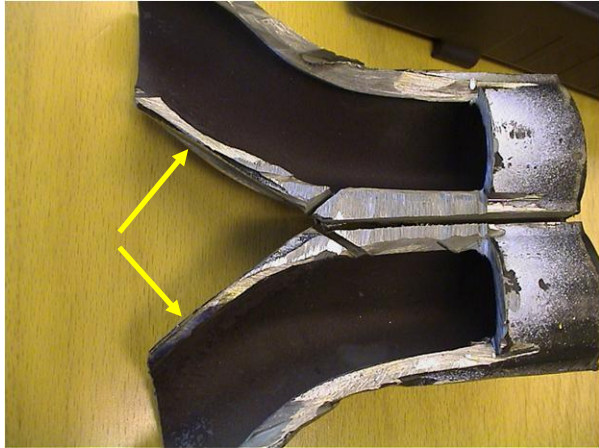
**Kuva L 3.** Korroosioaurio ilma-aukon ohitusputkissa. Vikakohdat merkitty nuolilla

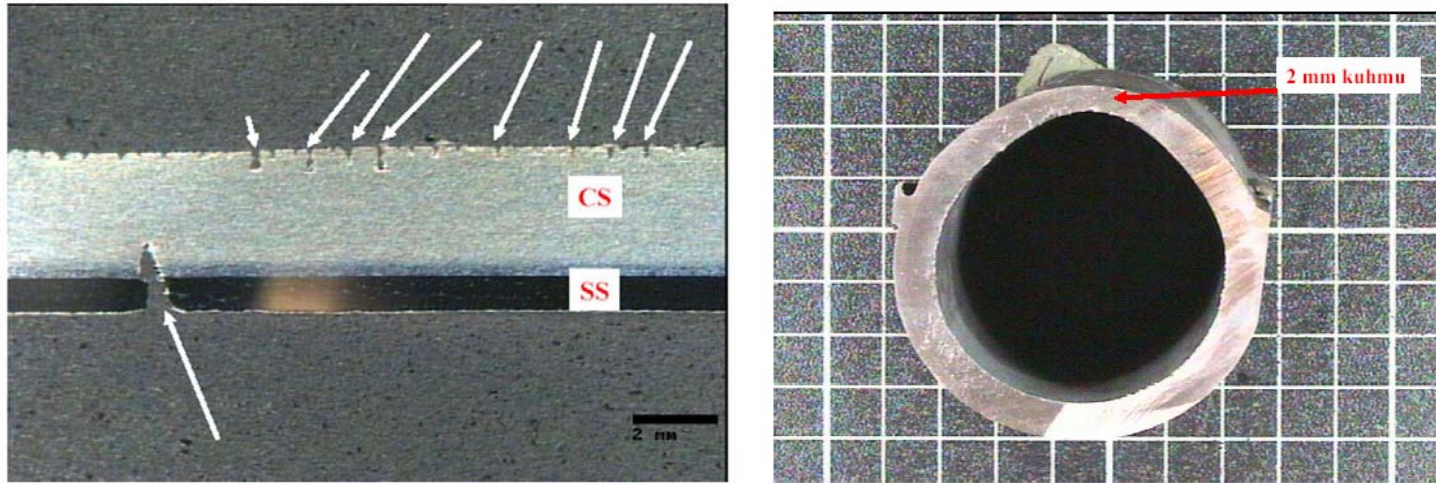
**Kuva L 5.** Kuvassa kiertohäiriön aiheuttama ylikuumeneminen pohjaputkessa, joka on aiheuttanut jopa muodonmuutoksen putkeen
