BLACK LIQUOR RECOVERY BOILER

ADVISORY COMMITTEE

MINUTES OF MEETING

April 2, 3 & 4, 2012

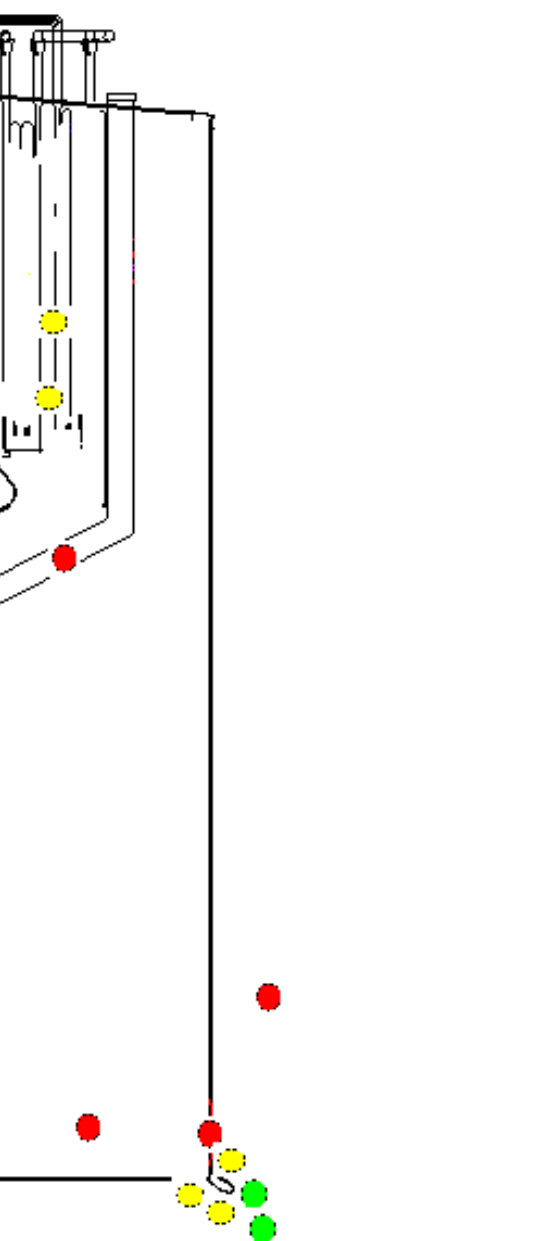
The general locations of the leaks for boilers in North America are shown in Figure 1, which displays a typical boiler, not representing any particular style or model. The yellow marks are the non-critical incidents and the red marks indicate the location of the critical incidents. The two spout leaks are indicated by green dots at the spout level and were both classified as non-critical. One incident reported a Steam Coil Air Heater Leak that was classified as critical and is represented by the red dot outside the furnace.

The leaks locations are summarized as follows:

- 9 – Economizer
- 2 – Superheater
- 5 – Boiler Bank / Steam Drum
- 5 – Upper Furnace
- 2 – Screen
- 1 – Lower Furnace
- 1 – Steam Coil Air Heater
- 2 – Smelt Spout Failure

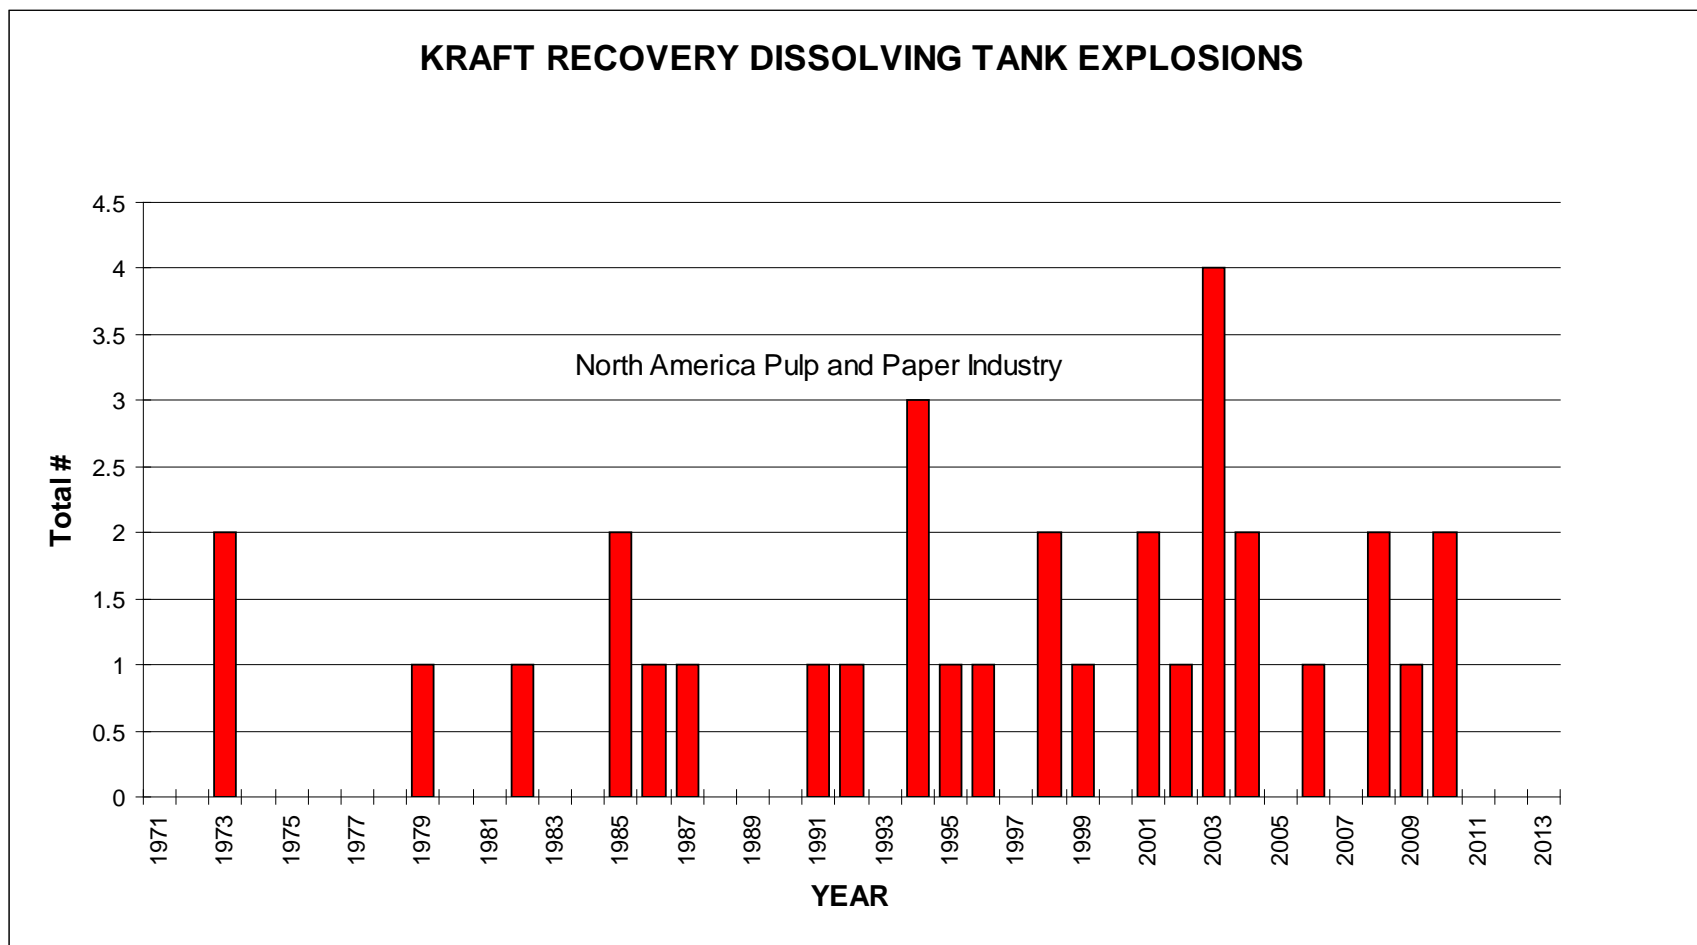
Figure 5 shows the history of dissolving tank explosions and there were none reported this year. But recent history indicates that dissolving tank explosions continue to be a problem. Following the recommendations from Section 10 of the Safe Firing of Black Liquor document would prevent many of the reported dissolving than incidents that have occurred in the past.
