Project budget and schedule 14.12.2012

ÅA, Probe Study of Corrosion in the Economizers of a Kraft Recovery Boiler Corrosion – presentation 19.12.2012 PROCESS CHEMISTRY CENTRE

Probe Study of Corrosion in the Economizers of a Kraft Recovery Boiler

Draft Report: Probe Study of Corrosion in the Economizers of a Kraft Recovery Boiler

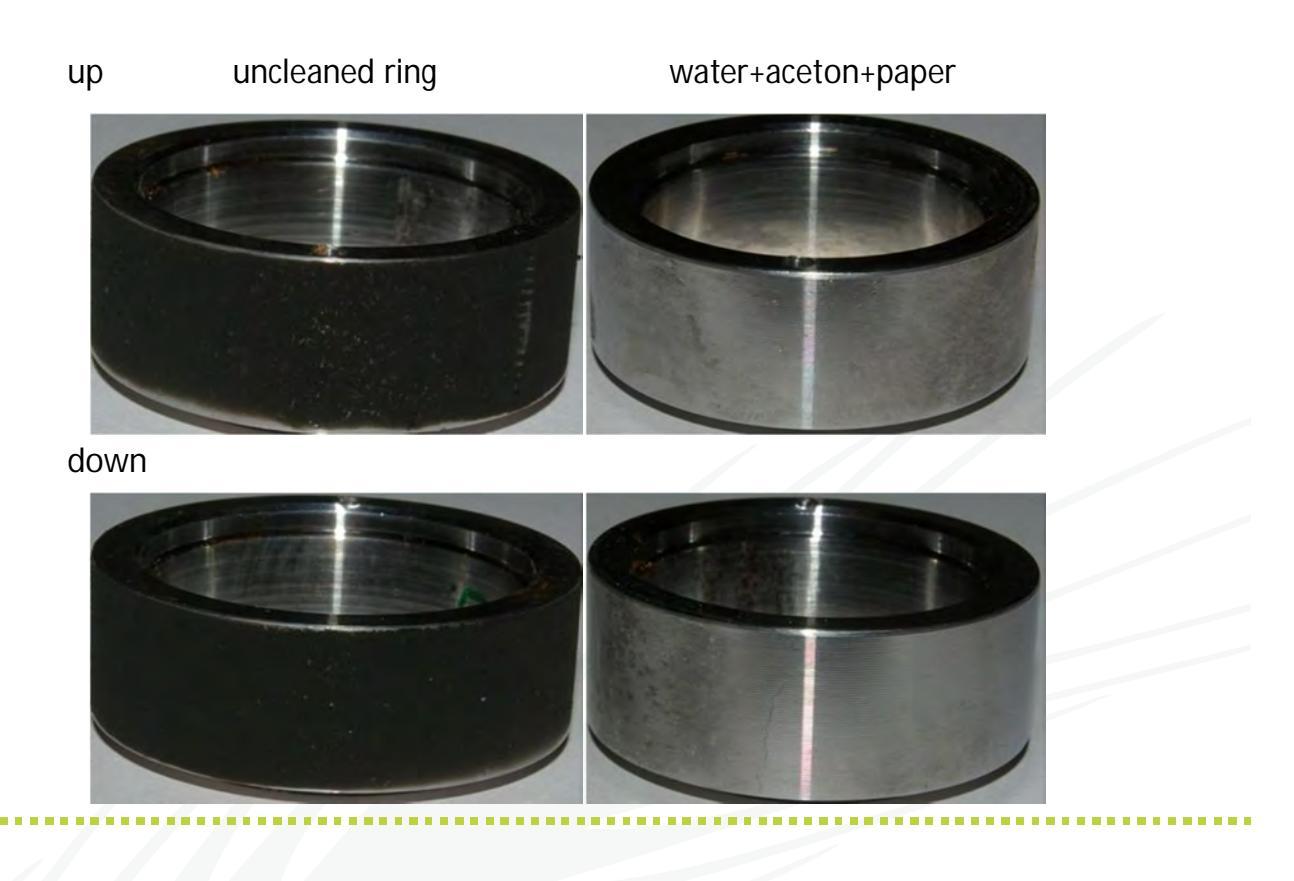
Ring after 2h exposure during oil burning

- Dew point and SO₃ were measured during oil burning
- A 2h probe (90 °C) study was also made

• No acid dewpoint was found in the dewpoint measurement

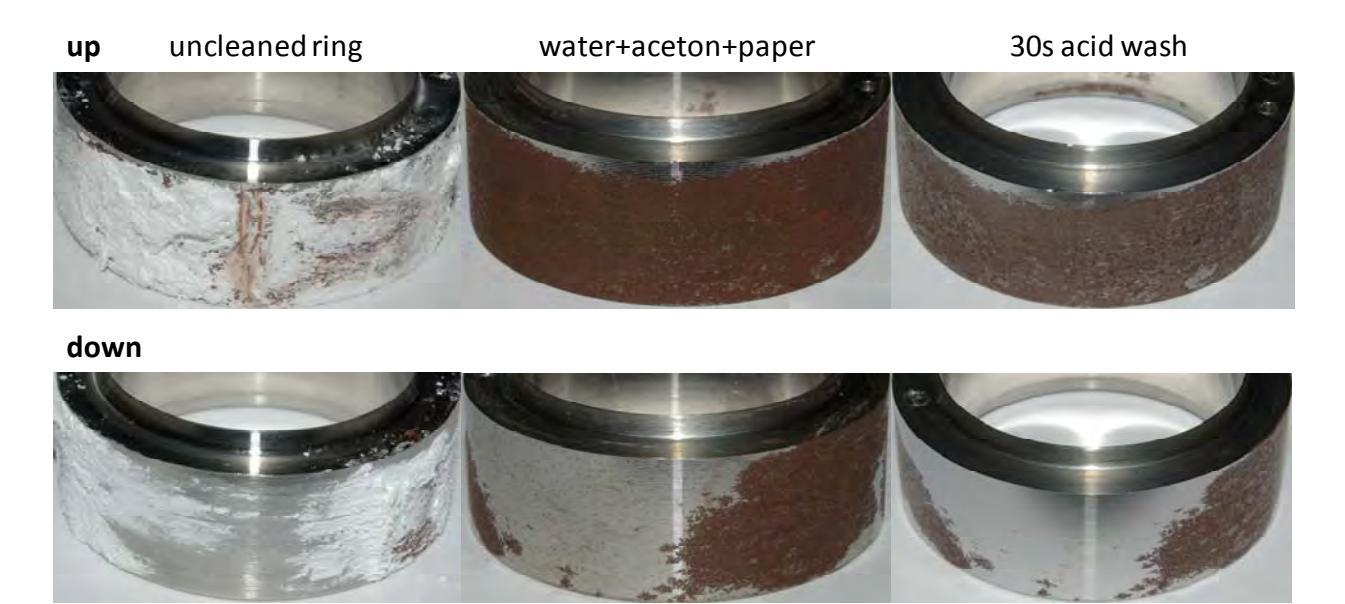
Figure 6. Ring after 811h normal operation. No iron oxide was found on the bottom edge of the probe.

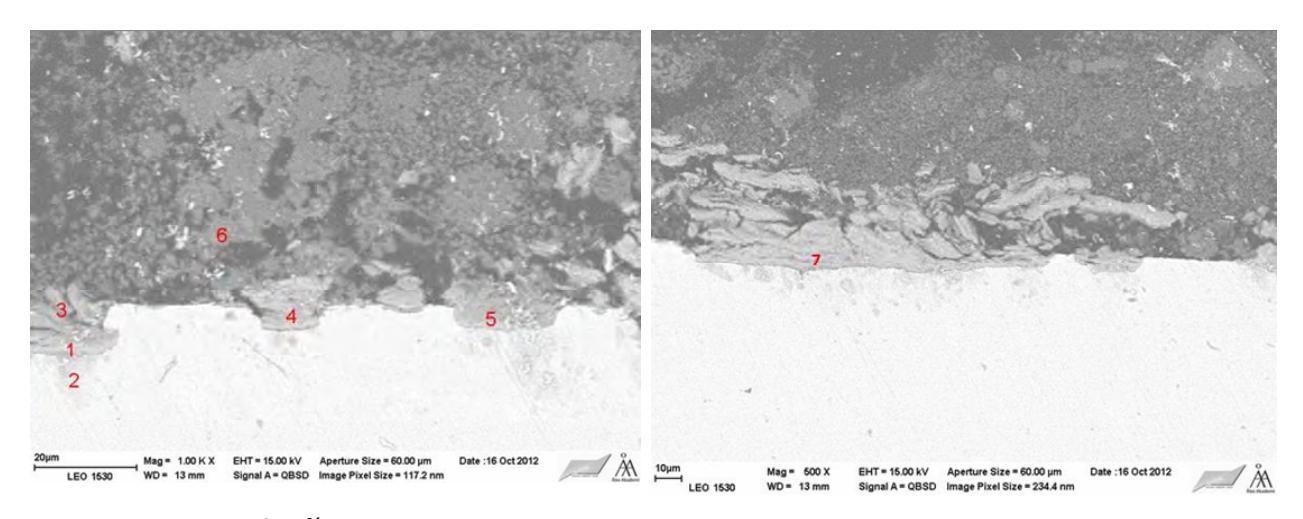
Figure 7. Spot analysis of corrosion layer from probe pulled out after 811 hours of normal operation (before water wash). In spots 2 and 7, the Cl is not balanced by Na or K.

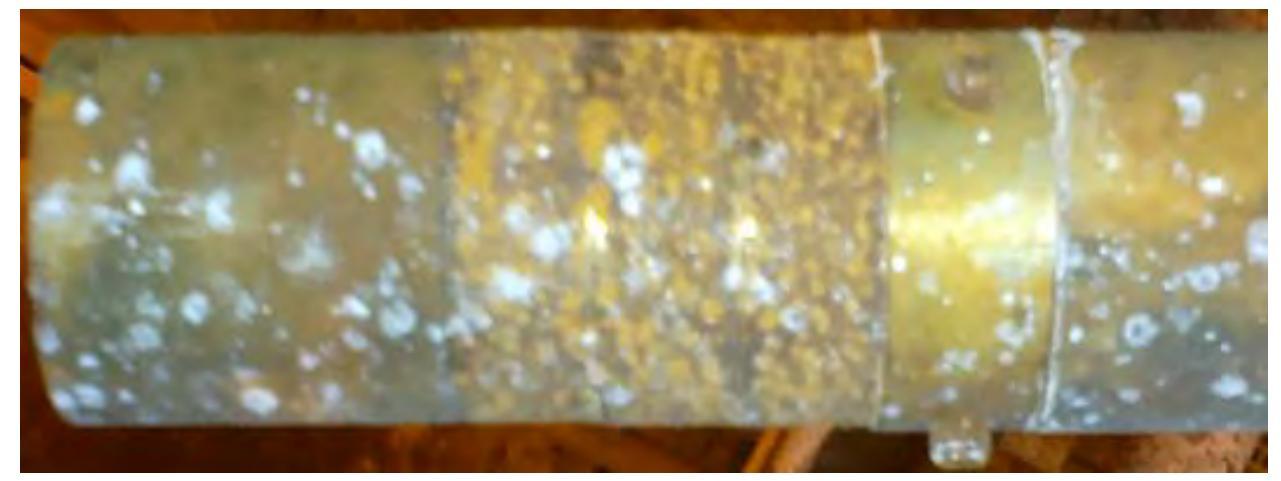
The probe that was pulled out after the water wash, Figure 8, had more corrosion than the probe pulled out before the water wash, but there was still virtually no corrosion, Figure 9. Again, the bottommost

Figure 8. Probe after water wash - 1124h total (811h "normal" operation + water wash)

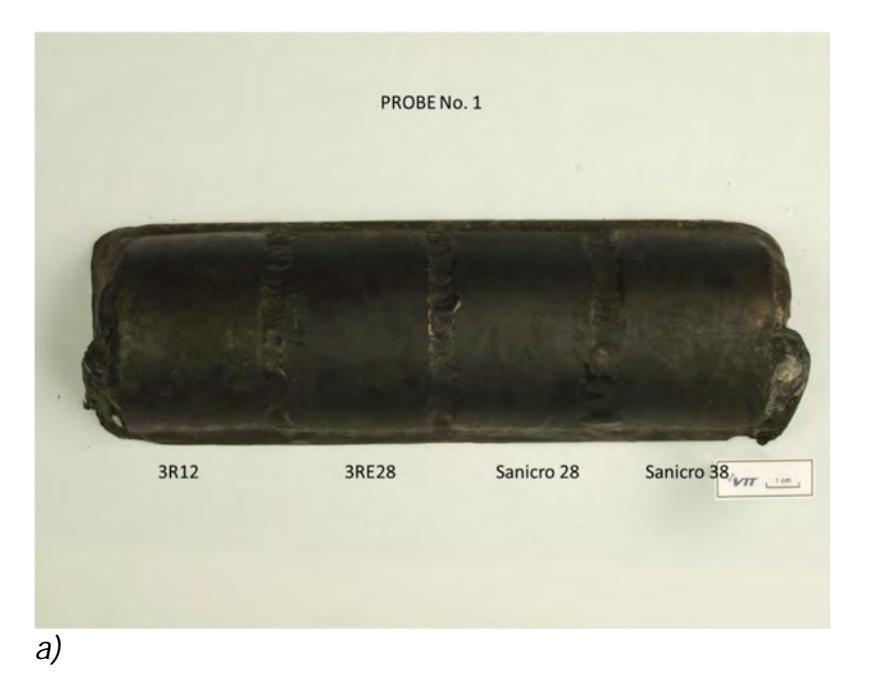
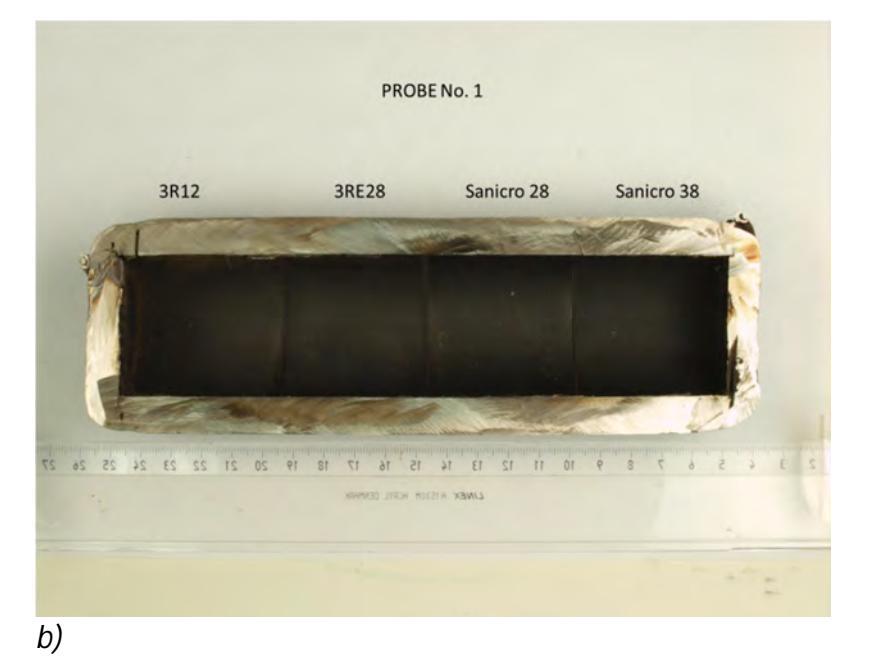
Total test duration of the test No. 1 was 1006 hours from which 906 hours at the target temperature of 440 °C. The test materials in this exposure were 3R12, 3RE28, Sanicro 28 and Sanicro 38, Figure 3. According to visual inspection all samples were in good condition after testing i.e. neither marked general or localised corrosion nor deposits or oxide scales were observed either on outer or inner surfaces.

Figure 3. Macrographs taken from the probe No. 1 head after exposure: a) outer surface exposed to the furnace side and b) inner surface exposed to the cooling liquid.

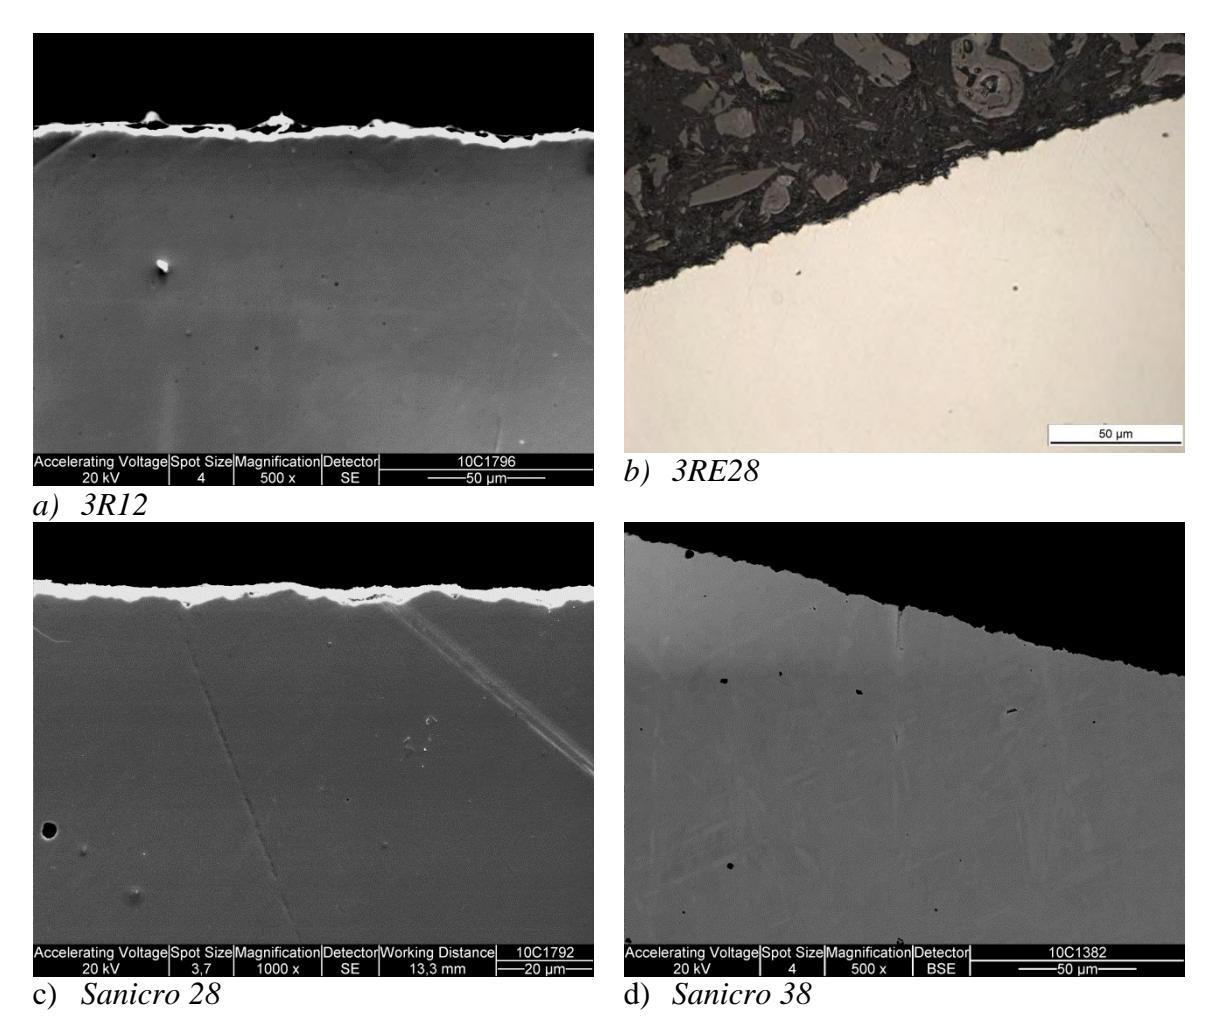
After the tests the samples were examined with optical microscope and/or SEM to determine the type of the corrosion attack. All samples had suffered from general thinning and no marked deposits or oxide/sulphide scales were observed, Figure 13. According to the EDS (Figure 14) analysis the thin layers (thickness ca. 5 μ m) on 3RE28 and Sanicro 28 were depleted in iron and nickel and enriched in chromium and contained also high amounts of sulphur. Whereas the composition of thin layer on 3R12 was similar to the base material and no sulphur was detected.

Figure 13. Cross sections from a) 3R12, b) 3RE28, c) Sanicro 28 and d) Sanicro 38 after 906 h exposure in lower furnace at 440 °C (Probe test No. 1)

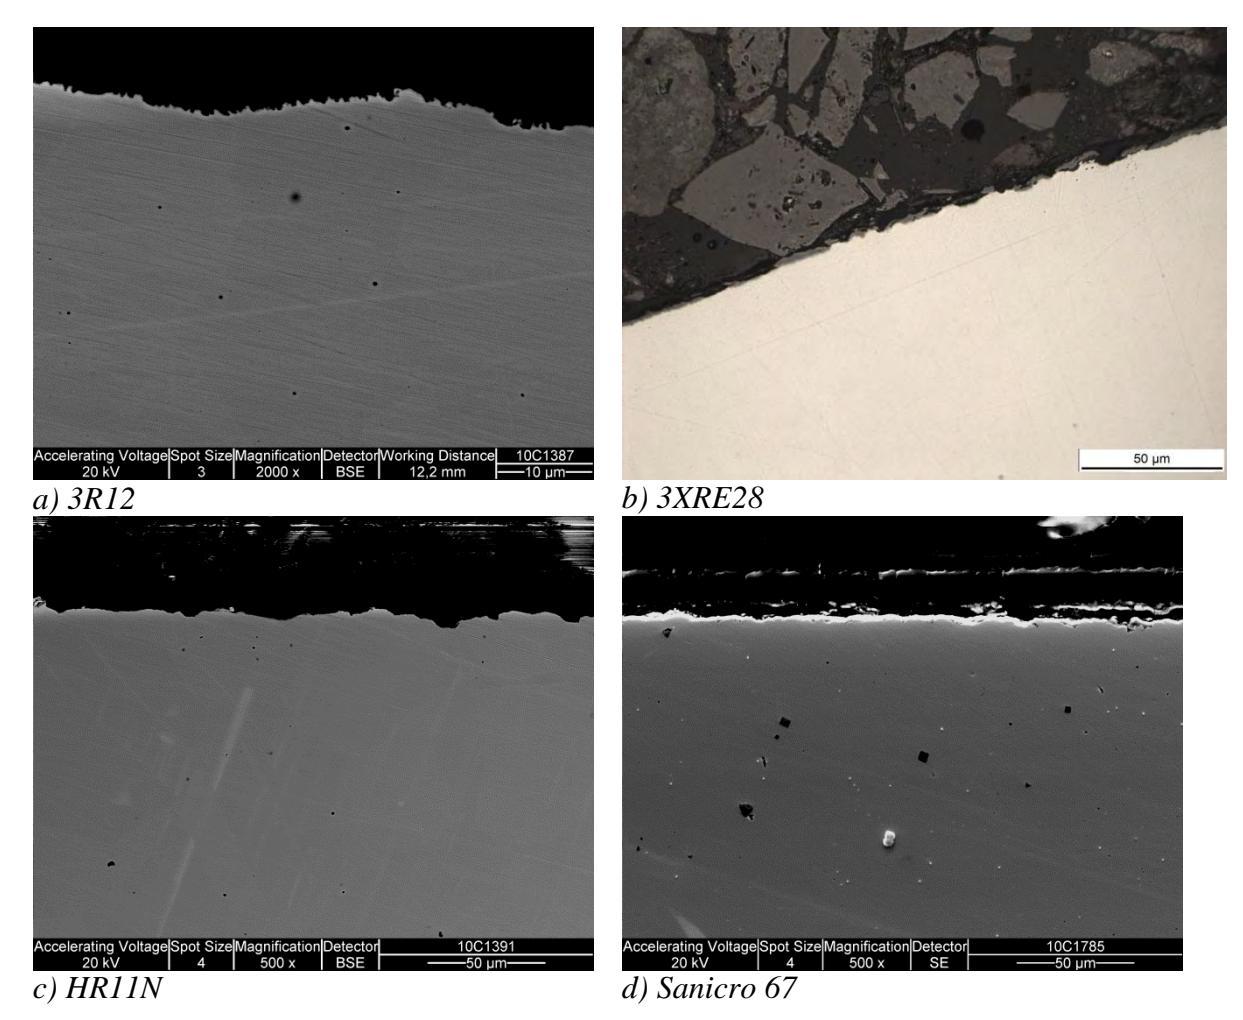
After the tests the samples were examined with optical microscope and/or SEM to determine the type of the corrosion attack. All samples had suffered from general thinning and no marked deposits or oxide/sulphide scales were observed on the surfaces, Figure 25. According to the EDS analysis (Figure 26) the thin, a few μ m thick layer, observed on 3XRE28 was depleted in iron and nickel and enriched in chromium and contained also high amounts of sulphur. The similar thin layer on Sanicro 67 contained high amounts of sulphur and was depleted in nickel and iron whereas chromium content was at the same level than in the base material.

Figure 25. Cross sections from a) 3R12, b) 3XRE28, c) HR11N and d) Sanicro 67 after 744 h exposure in lower furnace at 440 °C (Probe test No. 2)

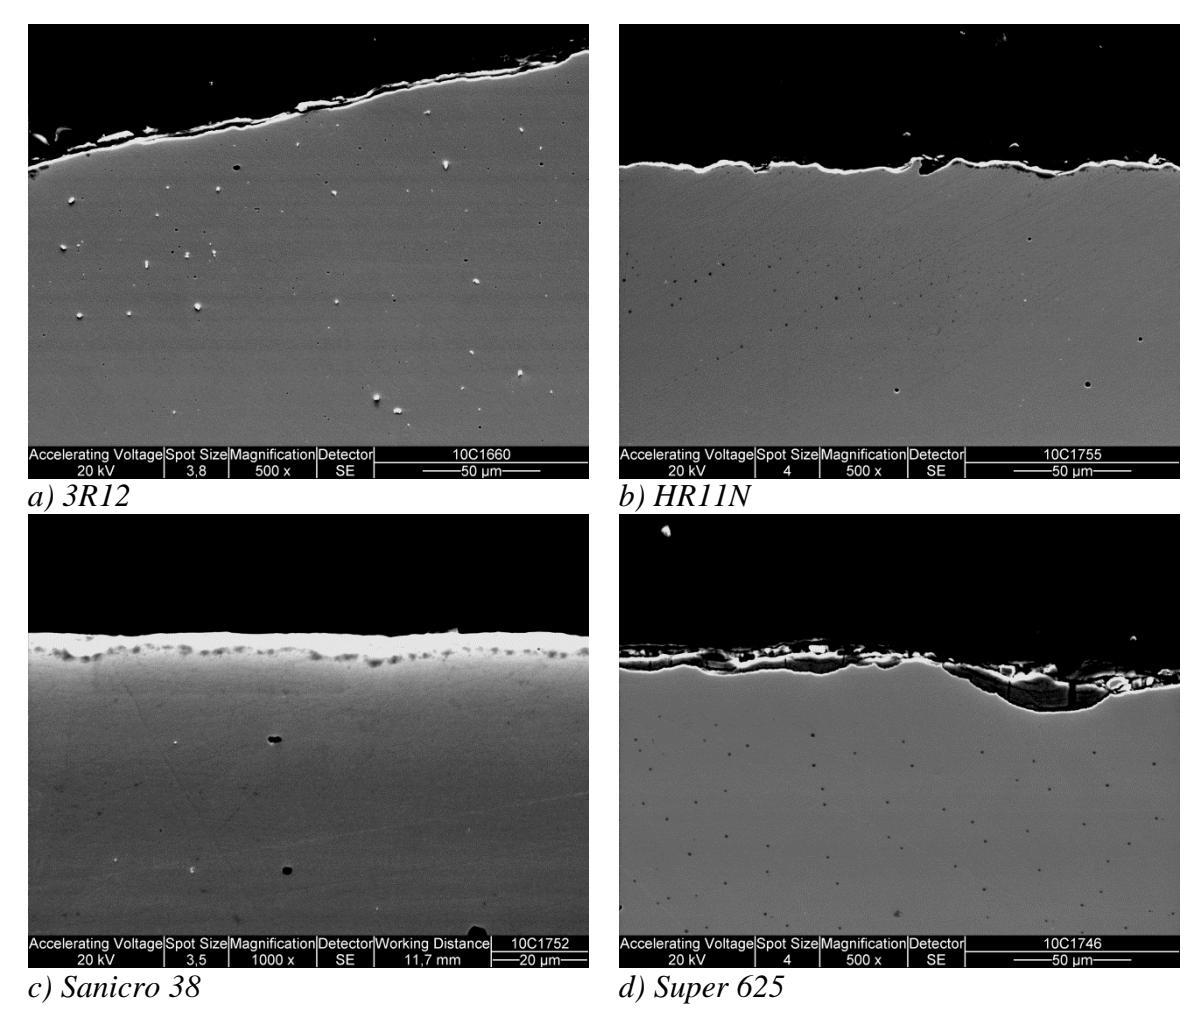
According to the EDS analysis (Figure 38) the layers on 3R12, HR11N and Sanicro 38 were depleted in iron and nickel and enriched in chromium and contained also sulphur. The layers on the Super 625 were depleted in iron, nickel, molybdenum and chromium and contained high amounts of sulphur. Reference analysis made from unexposed reference samples showed that the depleted/enriched layers are formed during exposure and do not originate from the specimen manufacturing process.

Figure 37. Cross sections from a) 3R12, b) HR11N, c) Sanicro 38 and d) Super 625 after 750 h exposure in lower furnace at 430 °C (Probe test No. 3)

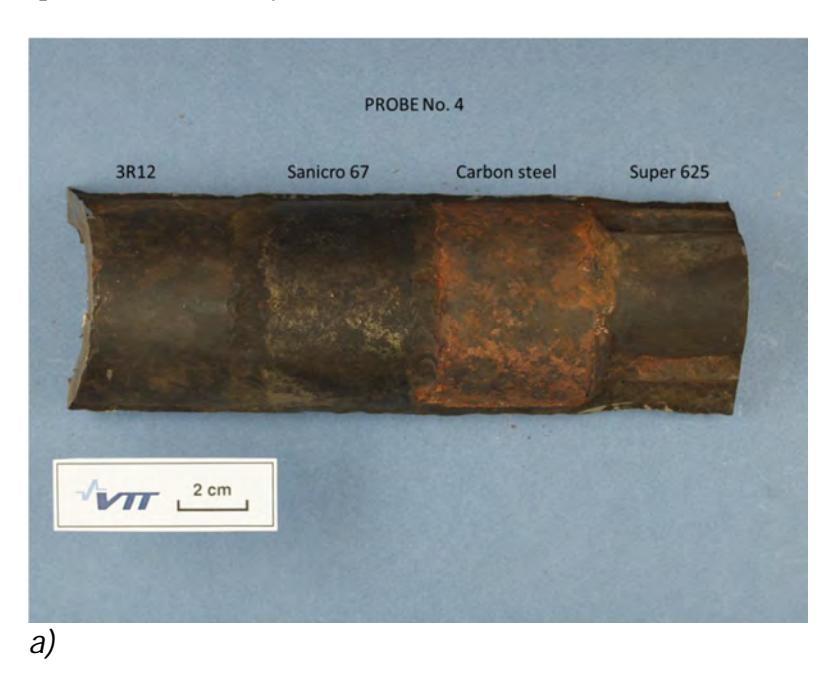
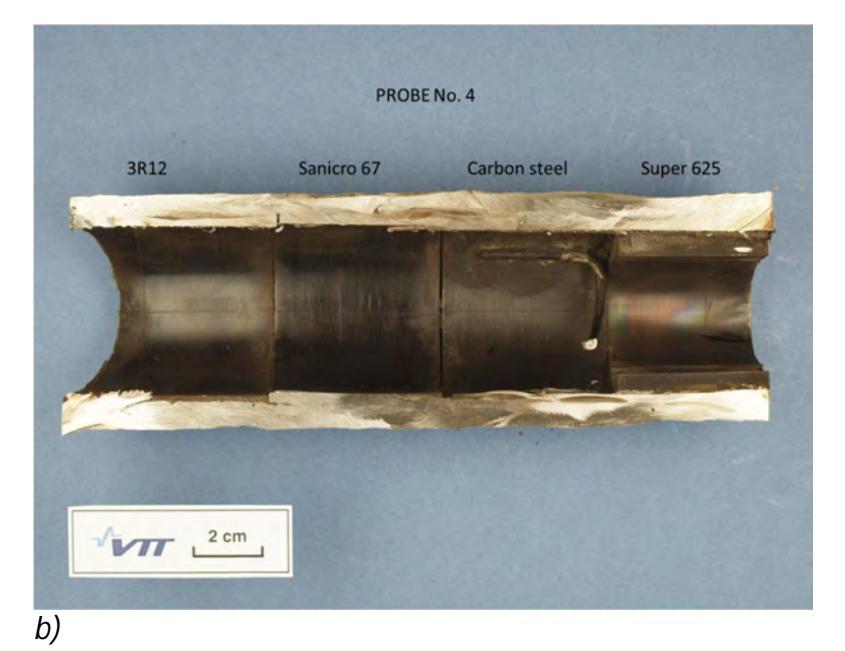
According to visual inspection the inner surfaces of the specimens were in good condition after testing. The outer surfaces of the 3R12, Sanicro 67 and Super 625 specimens were covered with thin dark deposits but appeared to be in good condition. The carbon steel specimen was heavily corroded.

Figure 39. Macrographs taken from the probe No. 4 head after exposure: a) outer surface exposed to the furnace side and b) inner surface exposed to the cooling liquid. A thermocouple soldered on the side surface of carbon steel specimen is clearly visible on inner surface.

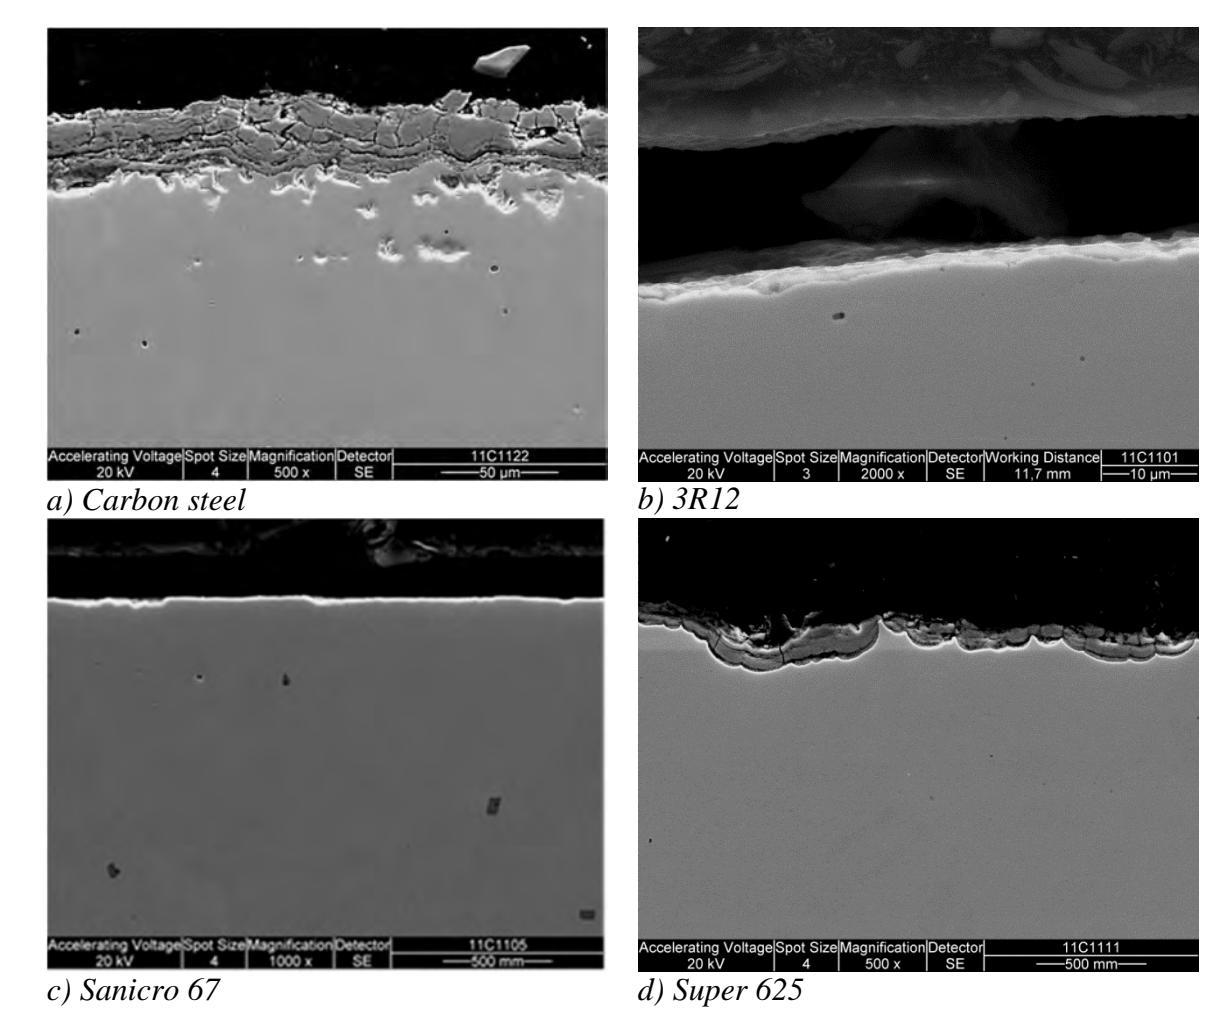
According to the EDS analysis (Figure 50) the layer on 3R12 was depleted in iron and nickel and enriched in chromium and contained also sulphur. The layer on Sanicro 67 contained sulphur and was depleted in iron and nickel, but the chromium content was at the same level than in the base material. The outermost layers on the Super 625 were depleted in iron, nickel, molybdenum and chromium and contained high amounts of sulphur.

Figure 49. Cross sections from a) carbon steel b) 3R12, c) Sanicro 67 and d) Super 625 after 2154 h exposure in lower furnace at 440 °C (Probe test No. 4).

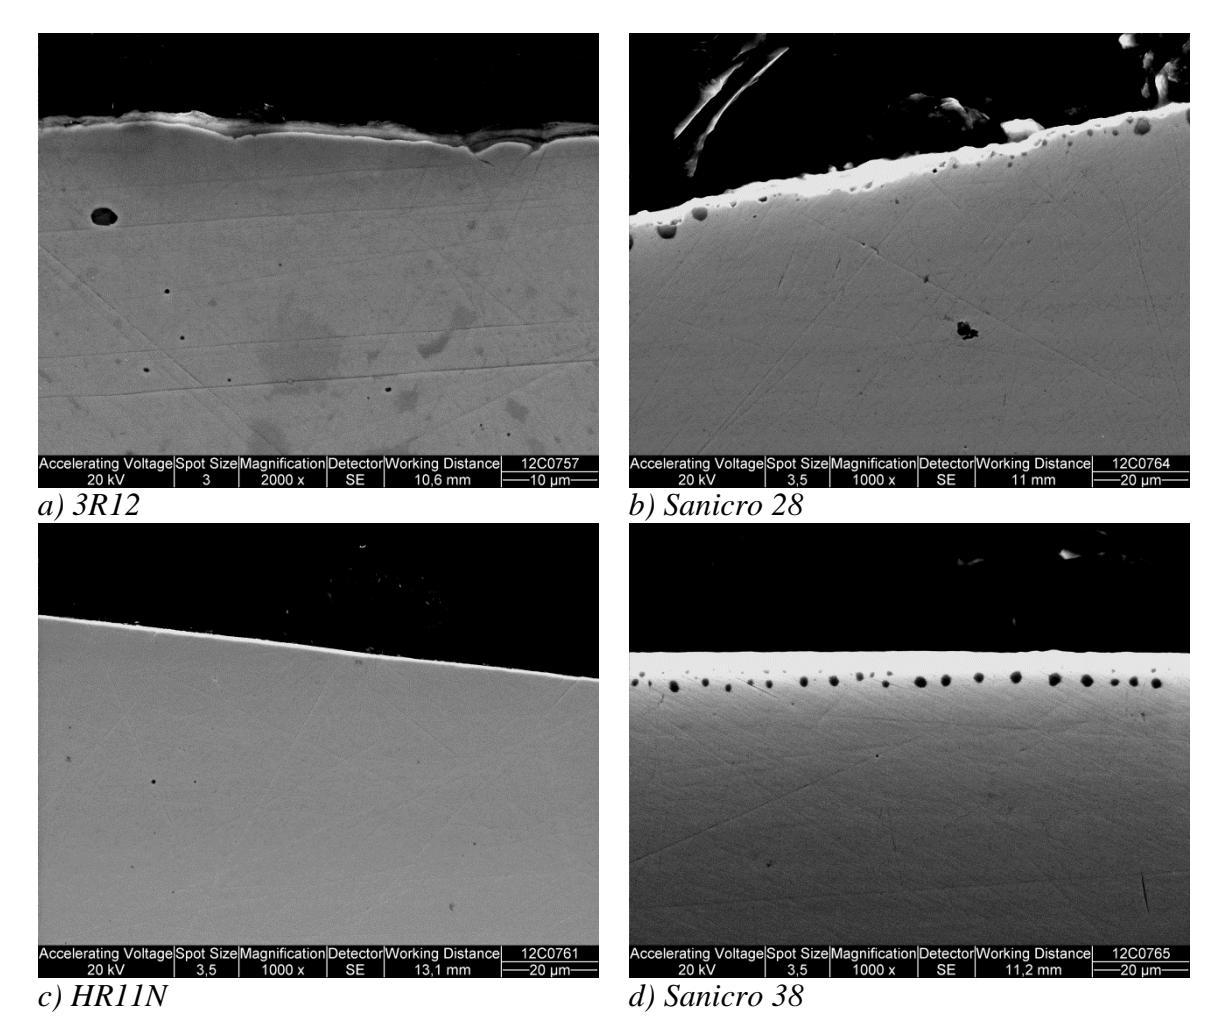
After the tests the samples were examined with optical microscope and/or SEM to determine the type of the corrosion attack. All samples had suffered from general thinning and no marked deposits or oxide/sulphide scales were observed on the surfaces, Figure 49. The layers found on 3R12, Sanicro 28, HR11N and Sanicro 38 were very thin ca. 2 μ m in thickness. EDS analysis showed that iron and nickel depletion and chromium enrichment had taken place in some locations in all materials and that in these locations sulphur was also detected (Figure 50).

Figure 59. Cross sections from a) 3R12, b) Sanicro 28, c) HR11N and d) Sanicro 38 after 2157 h exposure in lower furnace at 440 °C (Probe test No. 5).

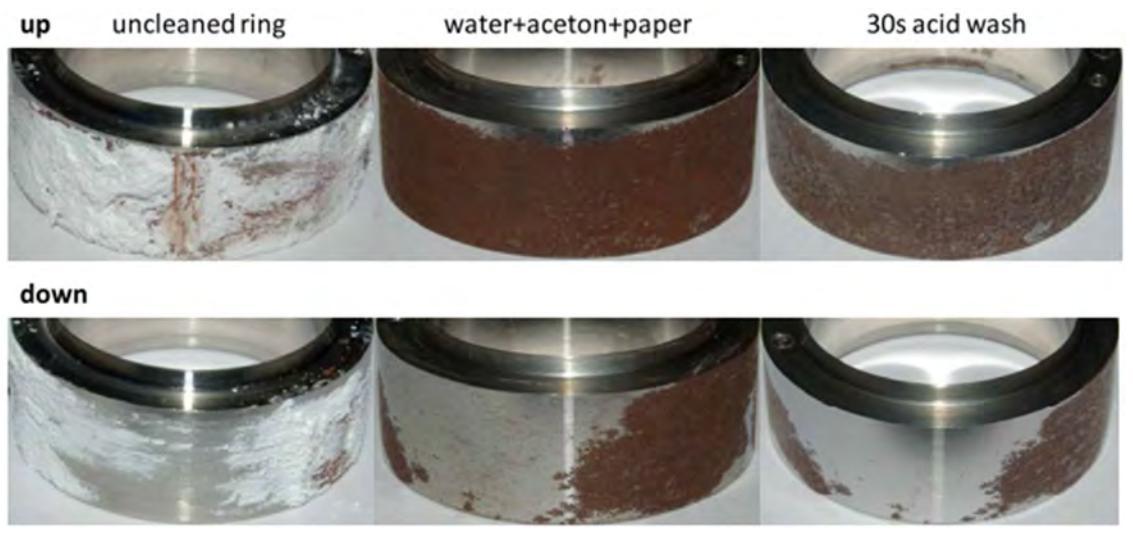
FIGURE 5-8 Ring after 811h normal operation. No iron oxide was found on the bottom edge of the probe.

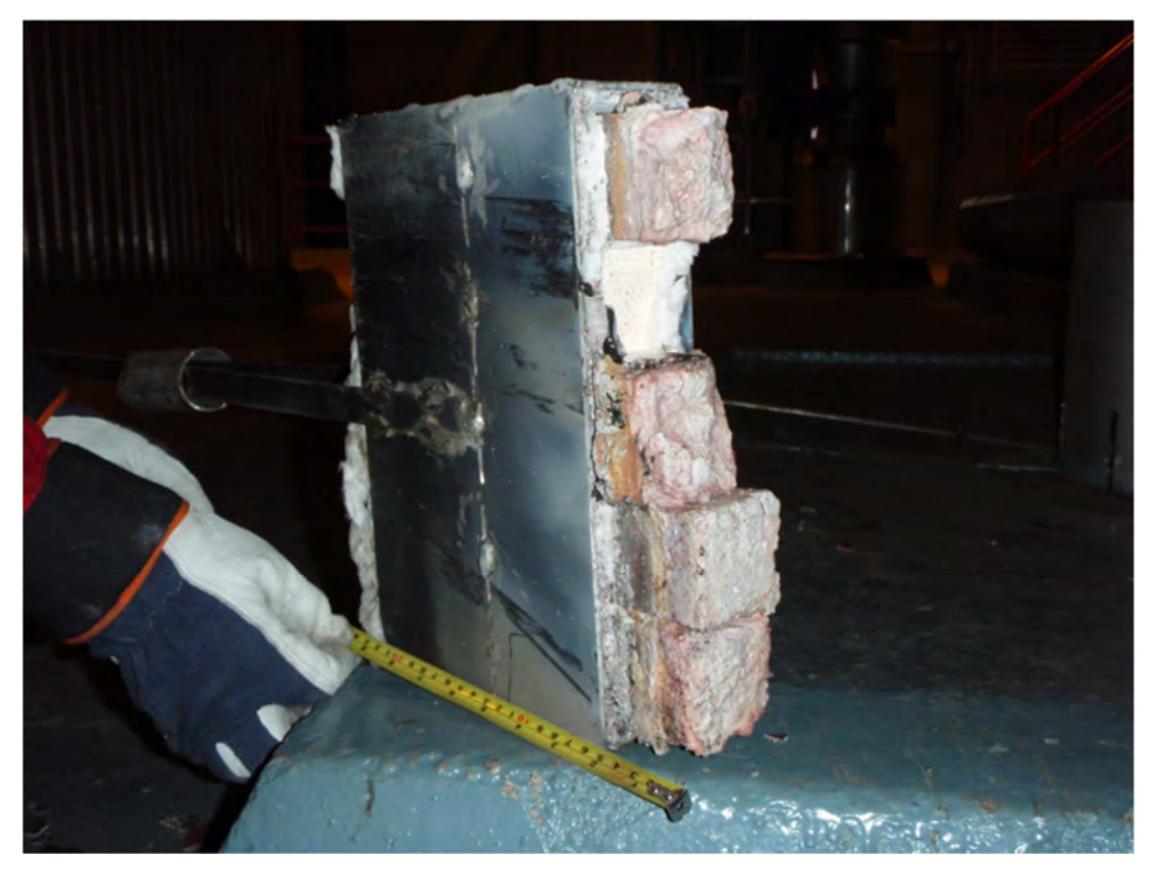
FIGURE 5-19. Refractory materials after test
