**Suomen Soodakattilayhdistys ry**

**SKYREC-seminar 2011**

**Raportti 8/2011**

## SKYREC SEMINAR 2011

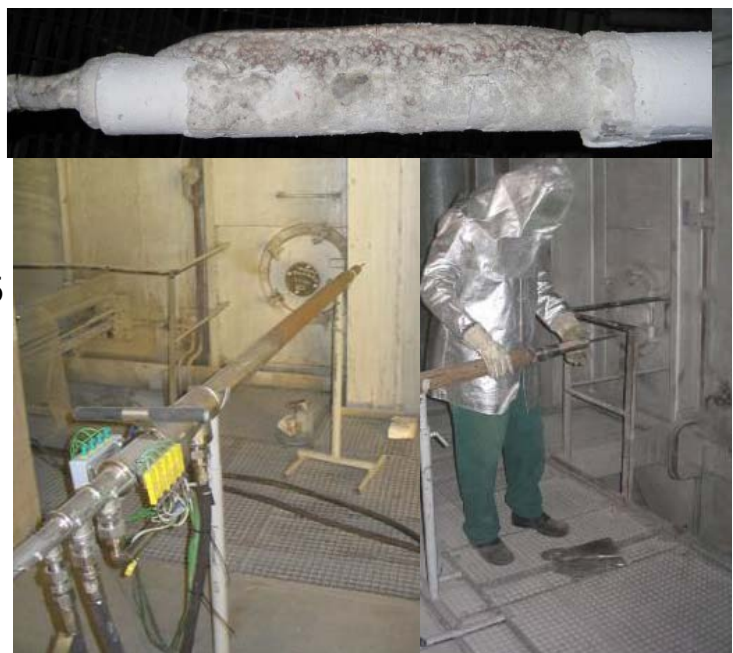
- VTT-Jyväskylä did corrosion testing with special probe
- fall 2010 – spring 2011
- Probe set to 530 °C & 570 °C
- SAN 28 < 347H < AISI 310 < HR11N < SAN 69 ~ Super 625
- Below 520 °C corrosion speed low
- Over 520 °C corrosion speed 0.5 – 1 mm/a

Problems in building a boiler to 540 °C

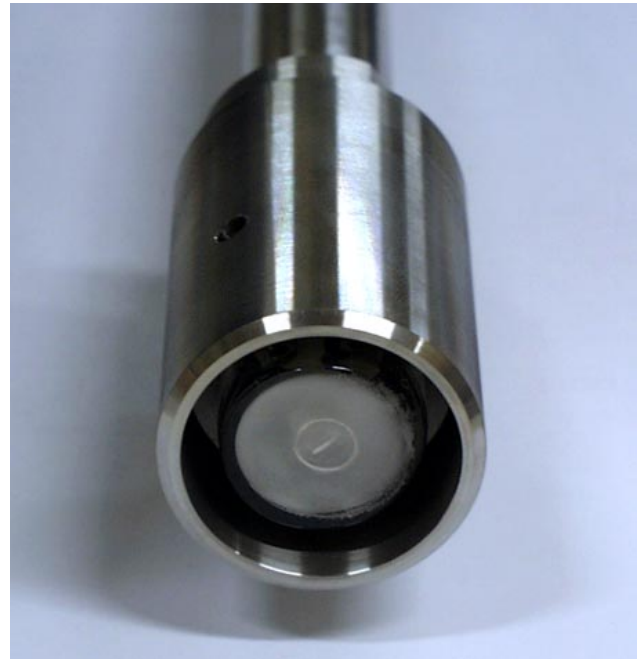
- Dew point probe made by Land
- Cooled probe has two electrodes at the end
- When an electrolyte (acid or water) condenses between electrodes, electricity is conducted resulting in a signal

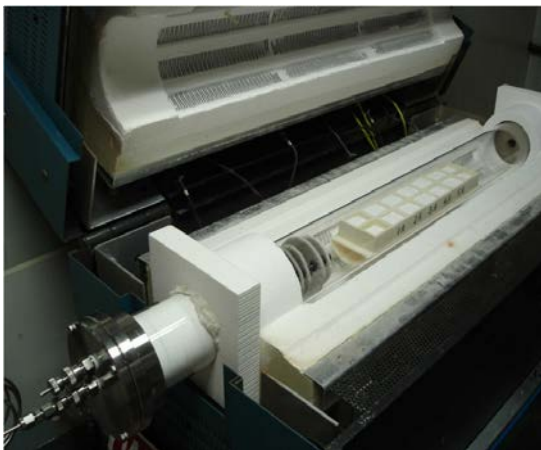
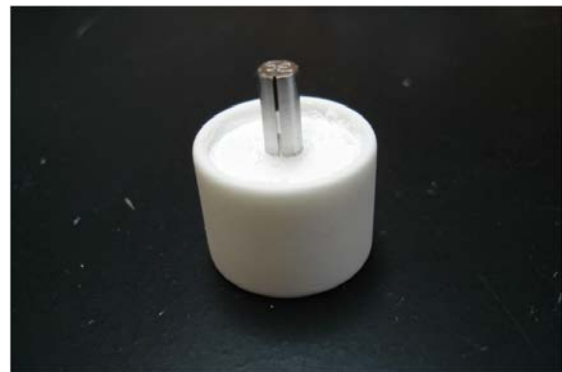
## Four furnaces are available for tests

- Horizontal tube furnaces with 7.6 cm OD tubes
- Gas flow rates of ~ 200 sccm (lineal velocity of 5 cm/sec)
- Simulated flue gases used: 5% O<sub>2</sub>, 10% CO<sub>2</sub>, 20% H<sub>2</sub>O
- Cylindrical specimens will be used; positioned vertically in pots
- Specimens 25 mm long; 5 mm dia; surface finish Ra 0.4-1.6 micron

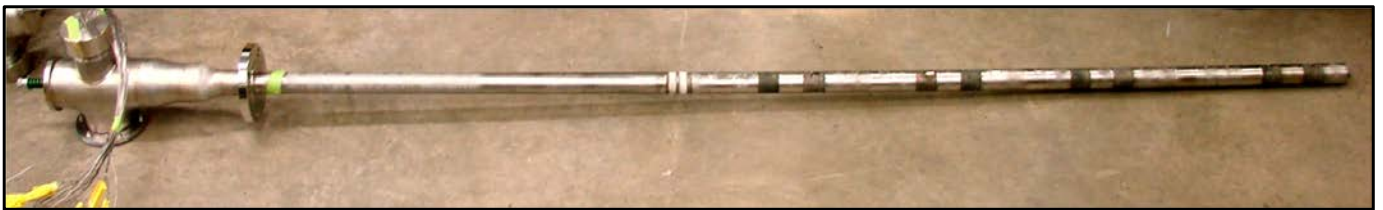
Probe for Crofton biomass  
boiler

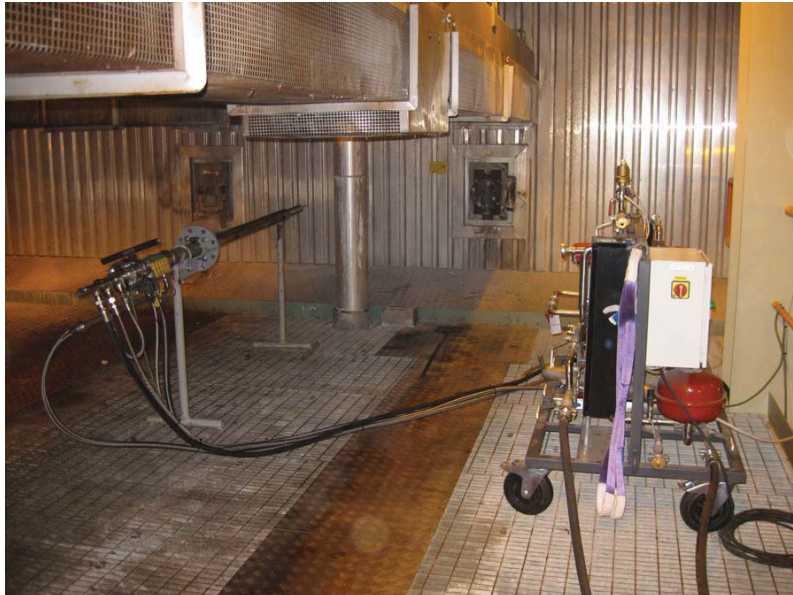
## **Probe 1 ready for insertion through an inlet located about one meter below the sootblower at level 10 ½ , between 2nd and 3rd Superheater**

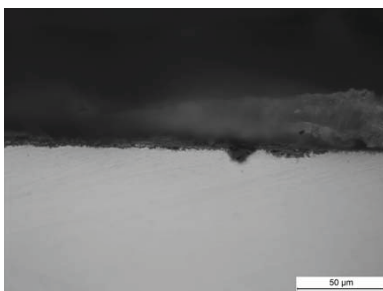
Windward:

527°C  
(reference  
position)

Leeward:

484°C  
(median)527°C  
(maximum)

Air- and water-cooled probes used imitate the behaviour of superheater tubes. The surface temperatures of the probes vary depending on the direction of the flue gas flow. The windward temperature is maintained constant by adjusting the cooling rate and the temperatures on other sides change when deposits are formed.

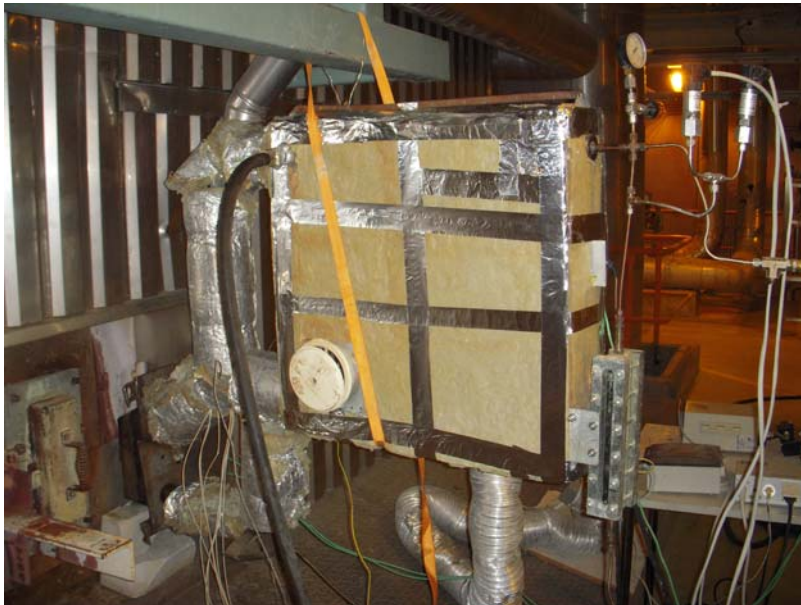
*Figure 2. Experimental setup before installation into liquor gun opening.*

The experimental setup consists of natural circulation circuit (Figure 2), which includes steam generator in which the test materials are placed (Figure 3). The steam generator is installed into liquor gun opening so that the front wall, consisting of the test materials, is at same level with furnace wall tubes.

The natural circulation circuit is cooled by air. Air flow is controlled so that the circuit pressure is kept constant. The set point for circuit pressure is selected so that the heat transfer liquid saturation temperature is 40°C higher than water saturation temperature at 169 bar pressure. This yields cladding temperatures 40°C higher than at 169 bar pressure, i.e. about 440°C. The heat transfer liquid used in the experiments is diphenyl oxide, which allows the circuit operation at moderate pressure.

- Diphenyl oxide heat transfer liquid → Moderate pressure
- Air flow control to keep circuit pressure constant
- Electrical heaters to keep the circuit pressurized to avoid heat transfer crisis and test material temperature surges
- Measurements for heat transfer liquid and test sample inner surface temperatures and system pressure

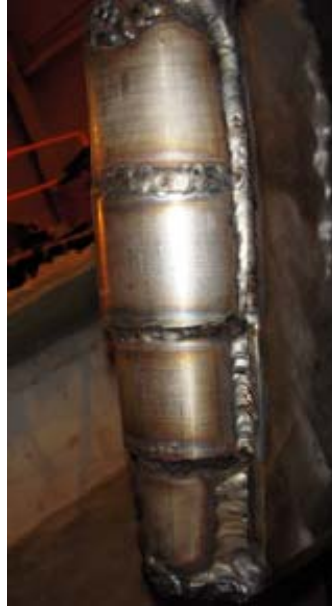
Figure 3. Steam generator front wall with tested materials

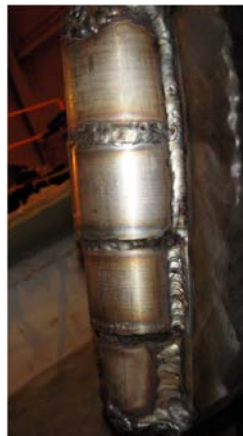
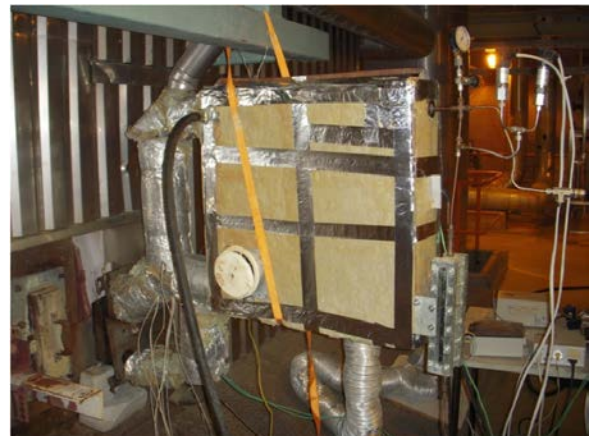
*Probe before installation into liquor gun opening (MB Joutseno)*

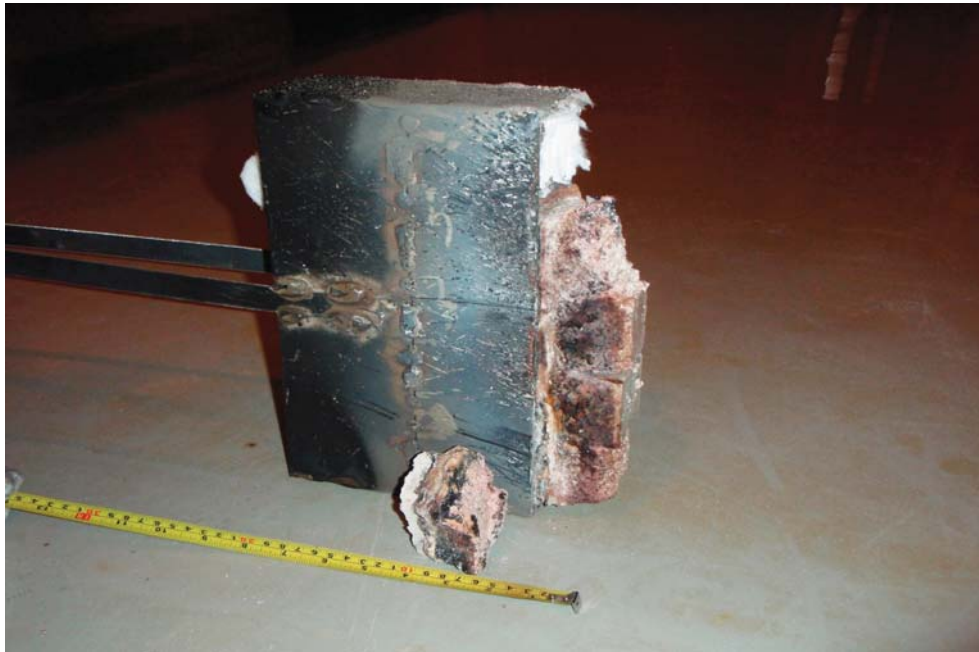
After 7 days, ZrO<sub>2</sub> castable broke off

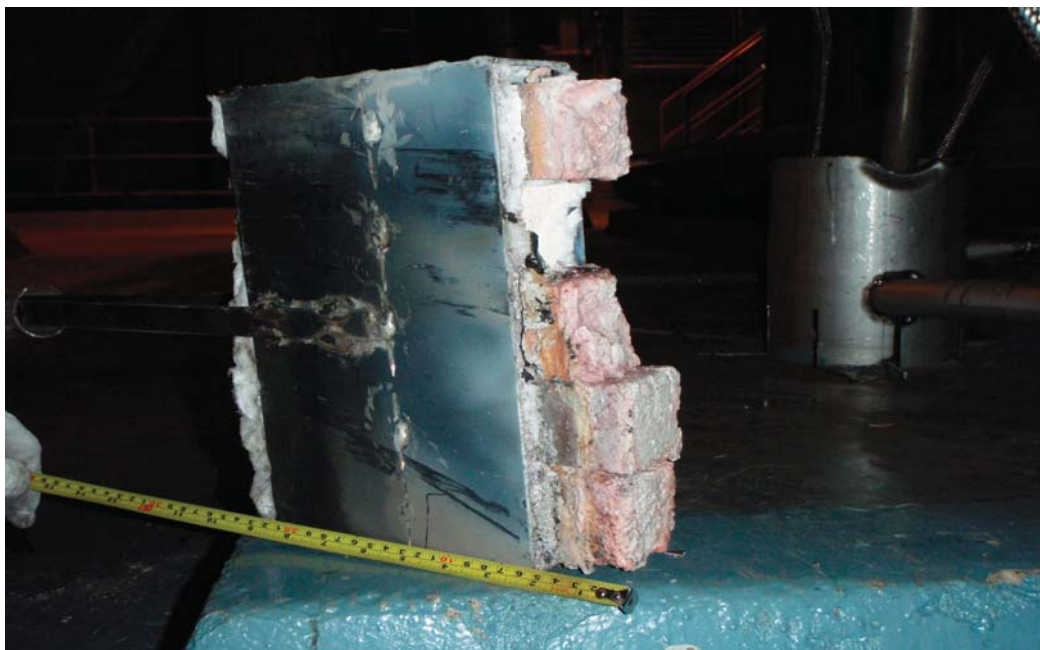
After 7 days, homemade castable spinel broke off

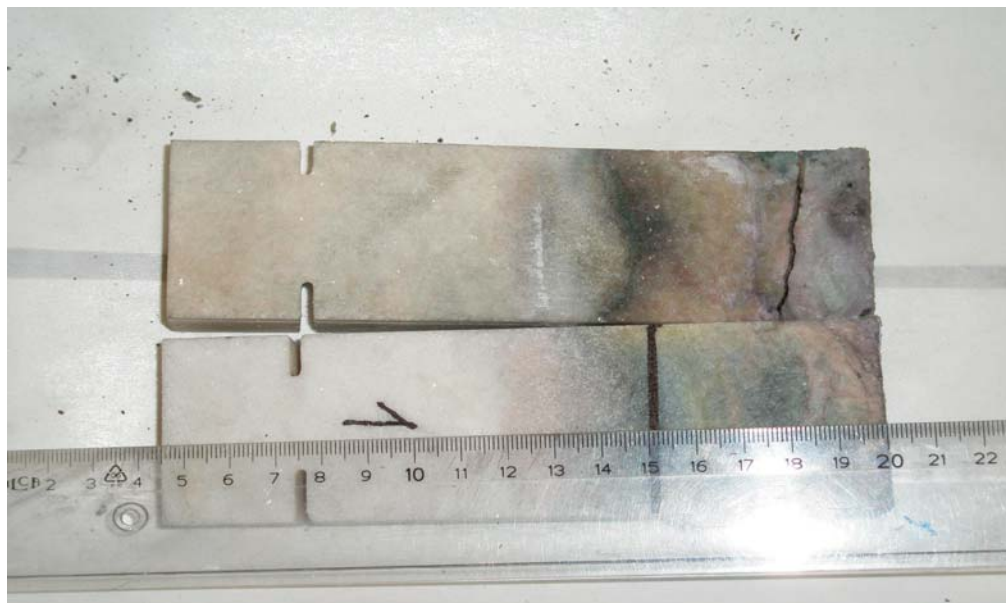
## Dense material wear off by thermal shock

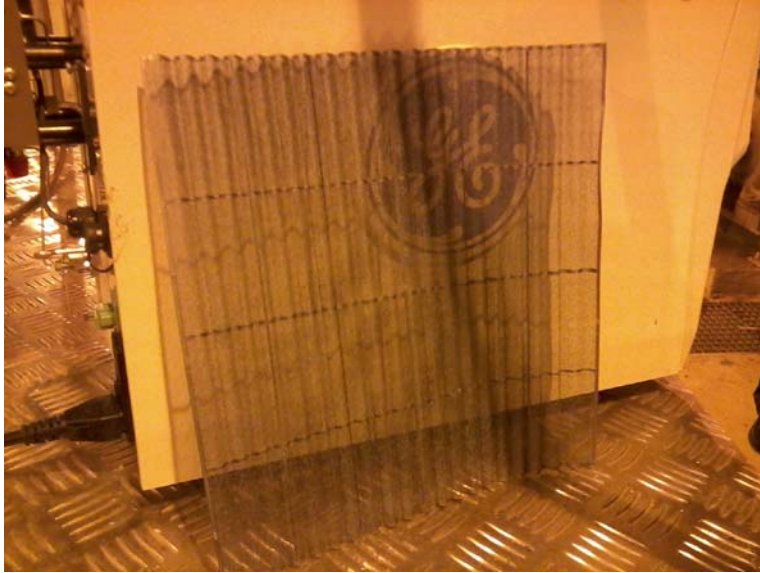
# TiO<sub>2</sub> catalyst

- \* TiO<sub>2</sub> should enhance hydroxyl radical formation
- \* This type of catalyst (porous net) had no effect

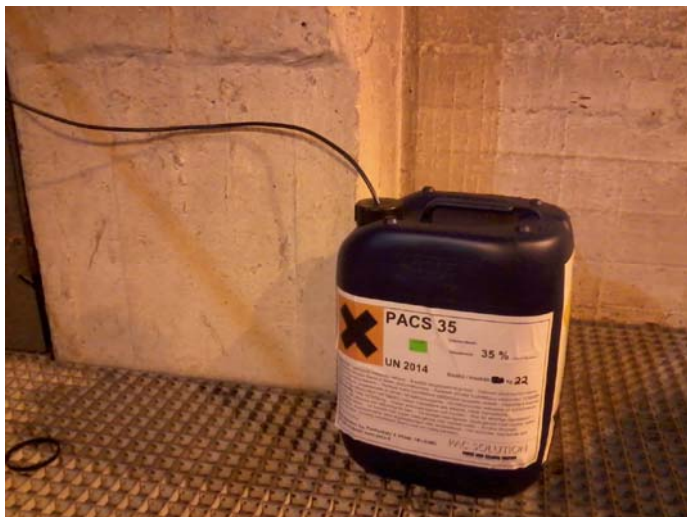
H<sub>2</sub>O<sub>2</sub> (35 %), elevated to ~ 40 m from dosing point
