SOOTBLOWER SAFETY AND UPGRADE GUIDELINE

Danny S. Tandra, Clyde Bergemann Power Group Americas, Inc

Sootblower Safety & Upgrade Guideline

55th Anniversary International Recovery Boiler Conference

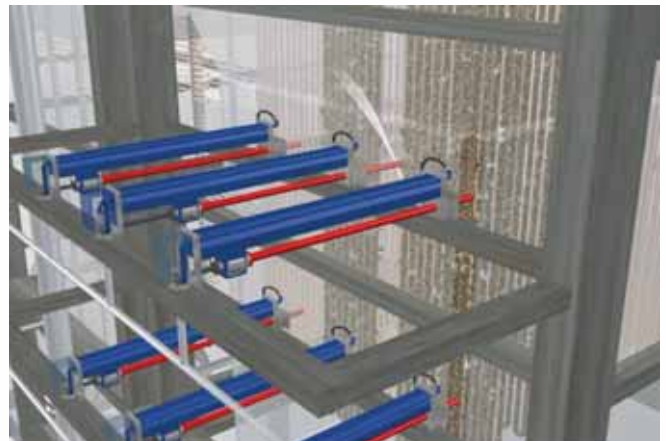
- Sootblowers play an important role to control fireside deposit accumulation in recovery boilers and to prevent unscheduled shutdown due to heavy fouling / plugging

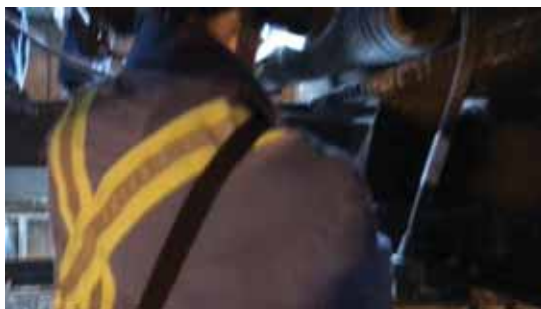
Indexing Mechanism

- If one of the indexing mechanism stuck (as seen in the video below) while the other functioned properly, the sootblower carriage can be misaligned causing abnormal stress to the lance tube and uneven wear on the gear rack

Progressive Helix Failure
Stuck on the left side

Gear Rack
Right side wear much more than Left side

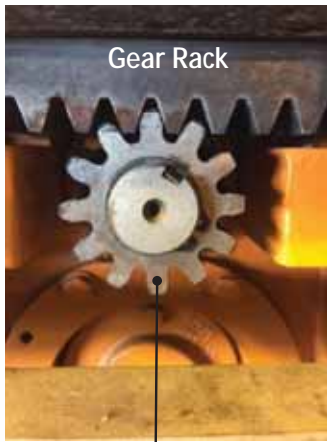
Sootblower Pinion

Sign of Sootblower Misalignment

Only half of the sootblower pinion engage the gear rack – This is a sign of sootblower misalignment
