Probe Study of Corrosion in the Economizers of a Kraft Recovery Boiler

Objectives

To better understand the cause of corrosion on the flue gas side of heat transfer tubes in the economizer section of a recovery boiler

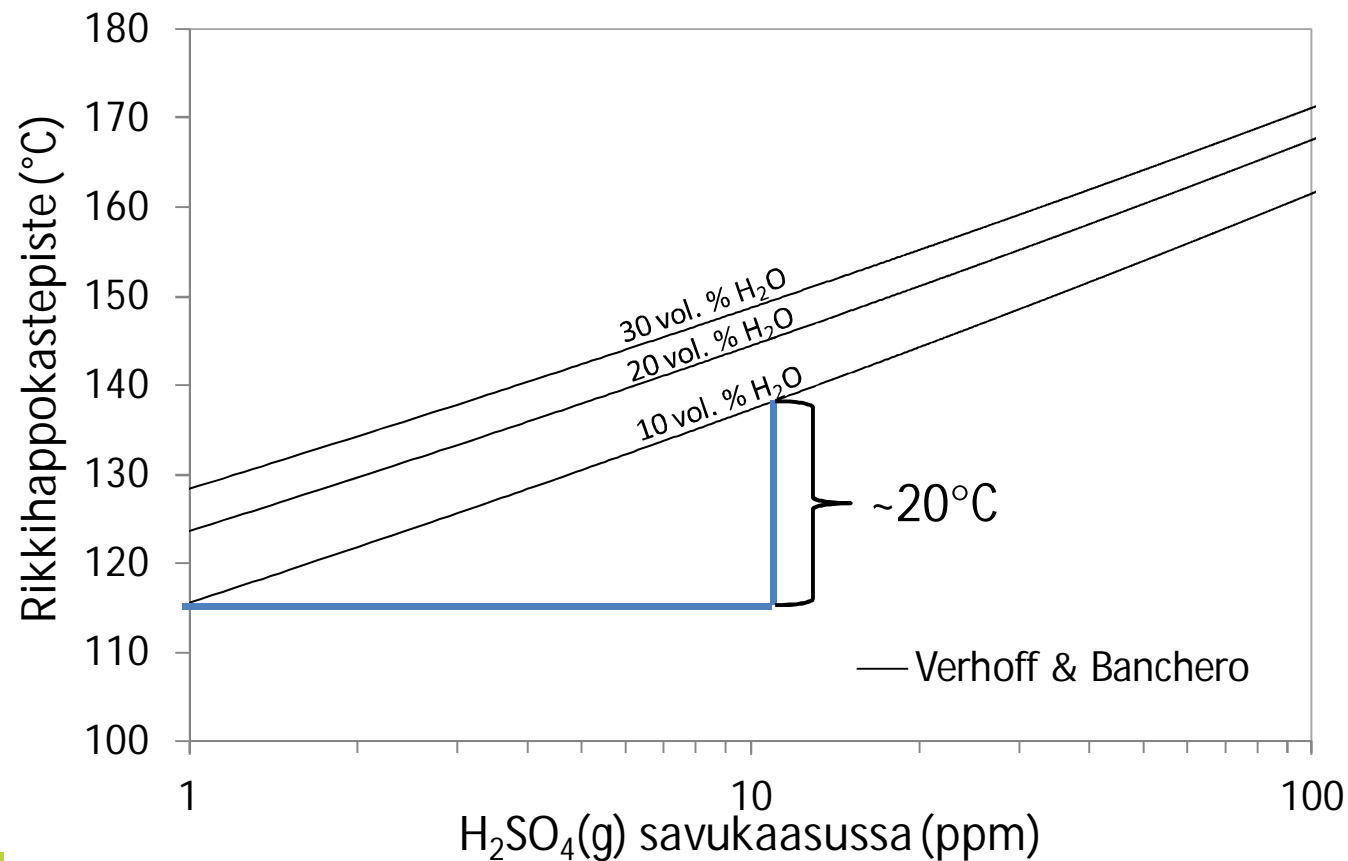
Sulfuric acid dew point

- When the $\text{H}_2\text{SO}_4(\text{g})$ concentration is known the dew point temperature can be estimated

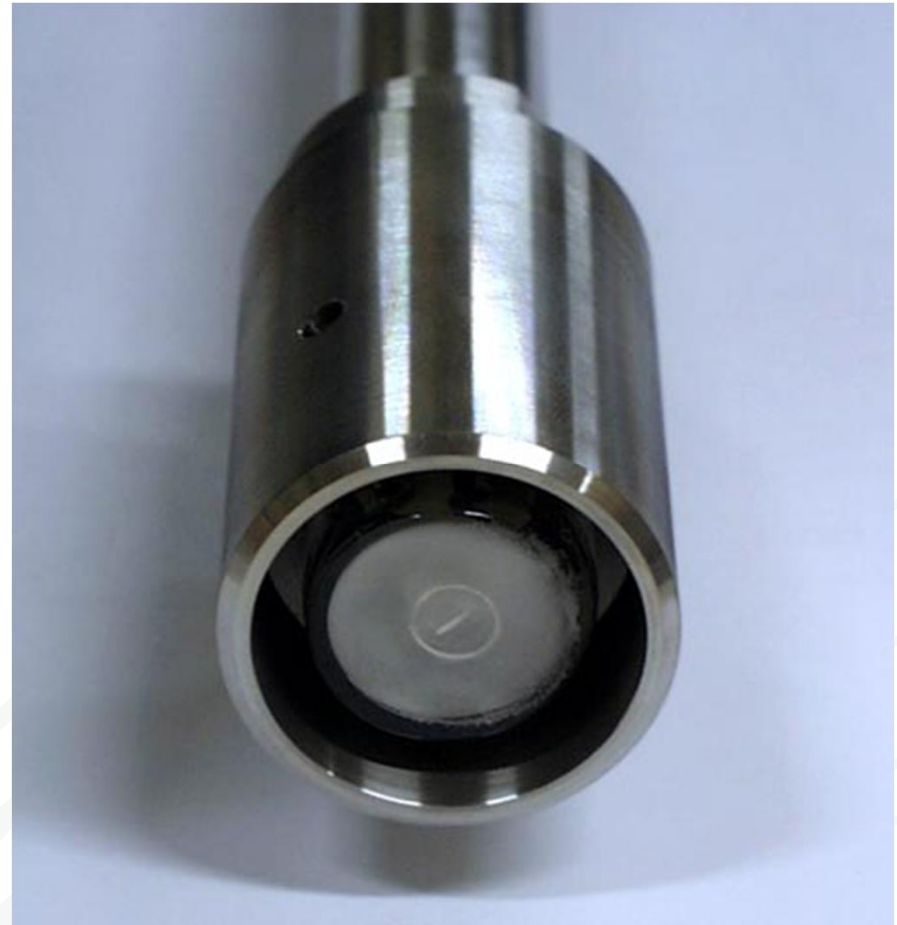
3. Dew point measurement

- Dew point probe (Land)
- Two electrodes in the probe tip
- Probe tip cooled with pressurized air
- When dew point reached, water or acid, a current is detected

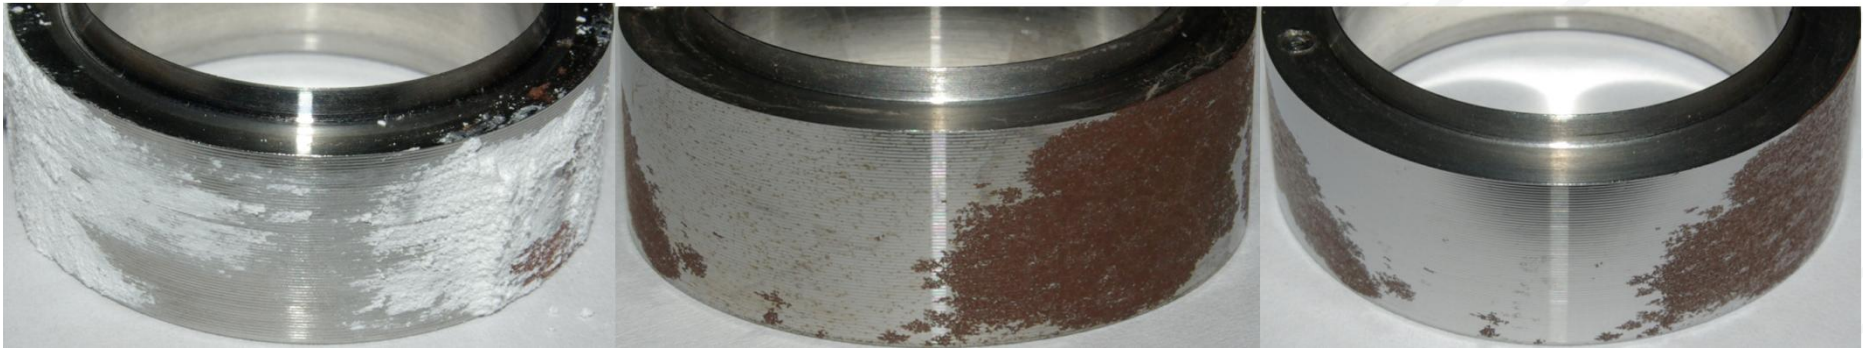
Ring after 811h normal operation

Note: Side pointing downwards (gravimetrically) -> No iron oxide

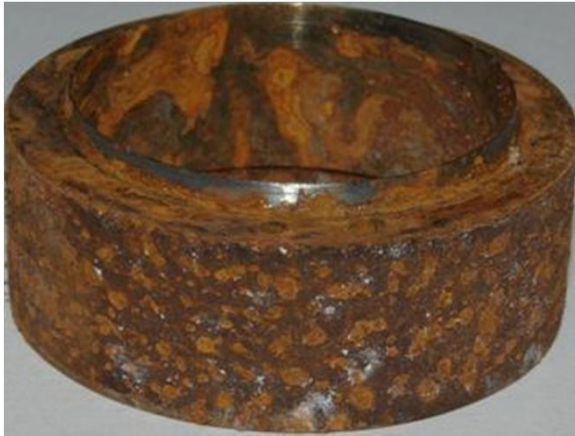
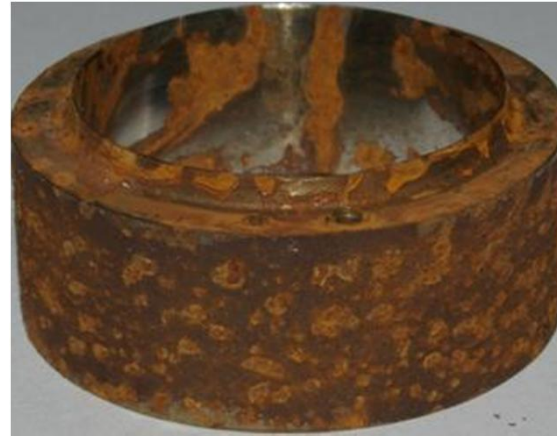
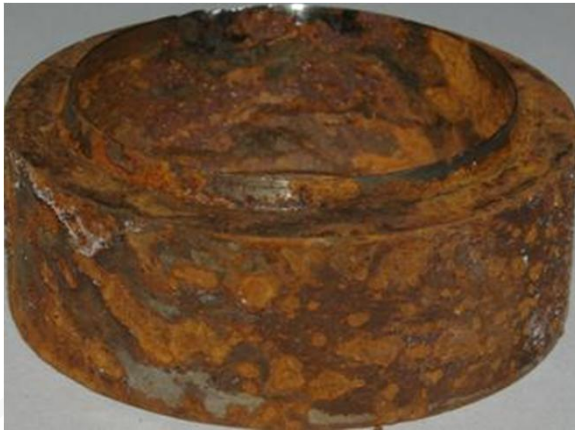
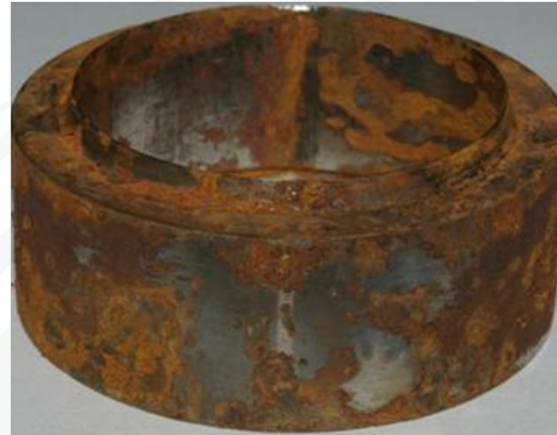
Ring after 1124h

Again areas
without
corrosion
downwards
