Final Report: Probe Study of Corrosion in the Economizers of a Kraft Recovery Boiler

Nikolai DeMartini, Tor Laurén, Emil Vainio, Mikko Hupa

Åbo Akademi University

4 January 2013

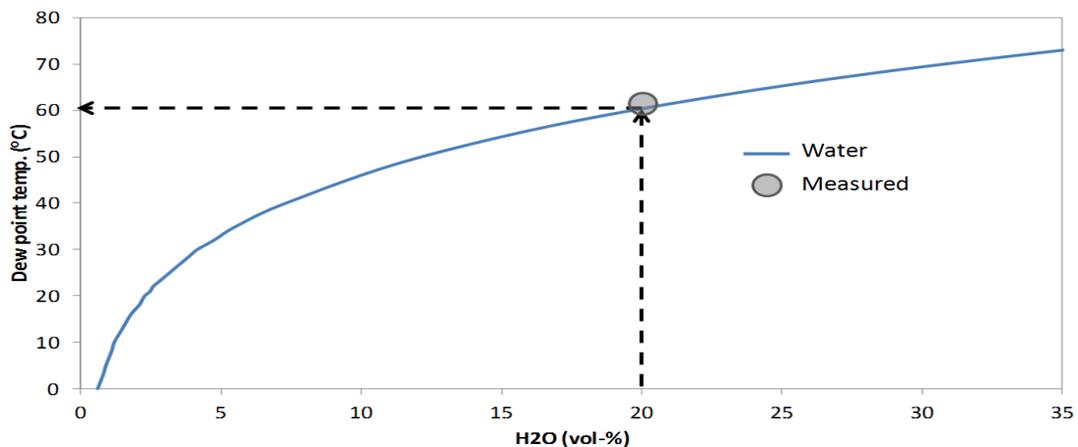
Figure 1. Water dew point temperature vs. flue gas water content. Measured dew point was for Rauma.

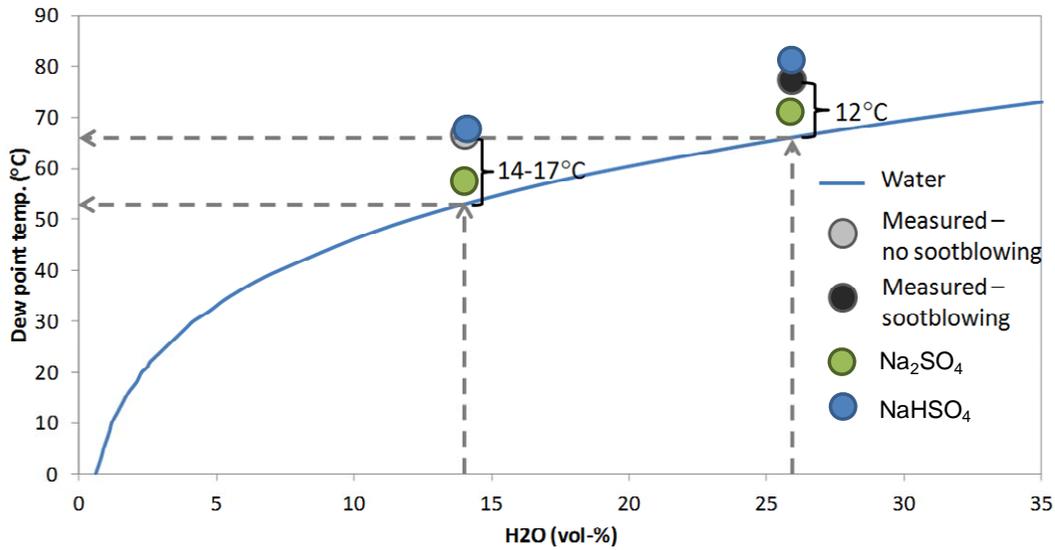
Figure 3. Effect of the salts NaHSO₄ and Na₂SO₄ on dew point. Dew points were measured at Heinola with and without sootblowing.

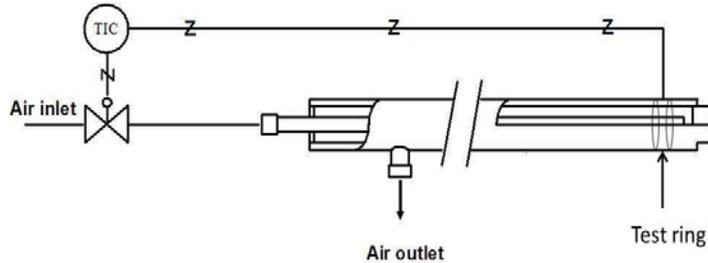
Figure 4. Air-cooled corrosion probe with temperature regulation.

The corrosion rate experiments were conducted using an air-cooled corrosion probe, Figure 4. The probe was kept at a temperature of 90 °C. This temperature was chosen because it is well below the acid dew point but well above the water dew point or the temperature at which salts would result in the absorption of water. A fresh test ring of carbon steel is placed in the probe tip. A thermocouple is located in the test ring and the temperature in the test ring is controlled by adjusting the air flow with a PID controller. After the test the corrosion products are washed with acetone and citric acid to wash off salts and corrosion products. The weight loss was determined by weighing the ring before and after exposure. This weight loss is used to calculate an average annual corrosion rate. The corrosion probe was located below the last pass of the economizers before the ESP, Figure 5 (MP 1). The H₂SO₄ measurements were taken at MP1, MP2 and at the bull nose. The schedule for the probe studies are given in Table I.

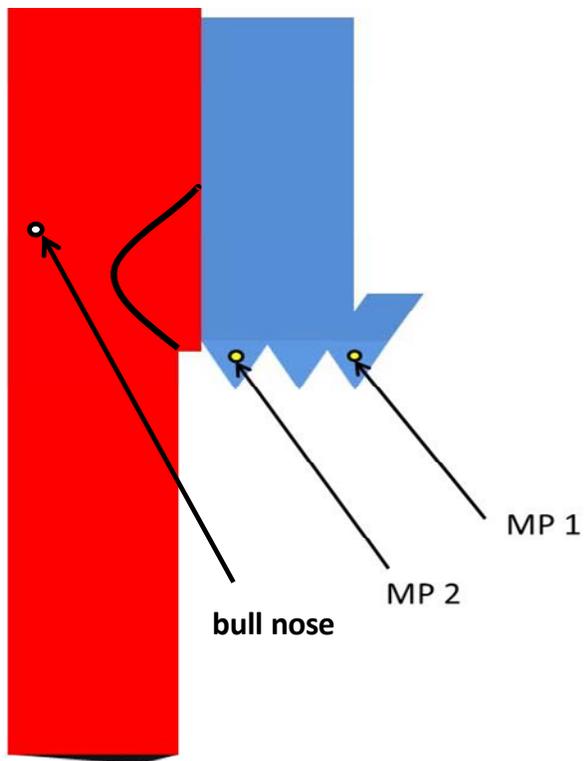
Figure 5. Measurement points for the SO₃ measurements. MP1 was the location for all corrosion probe studies.

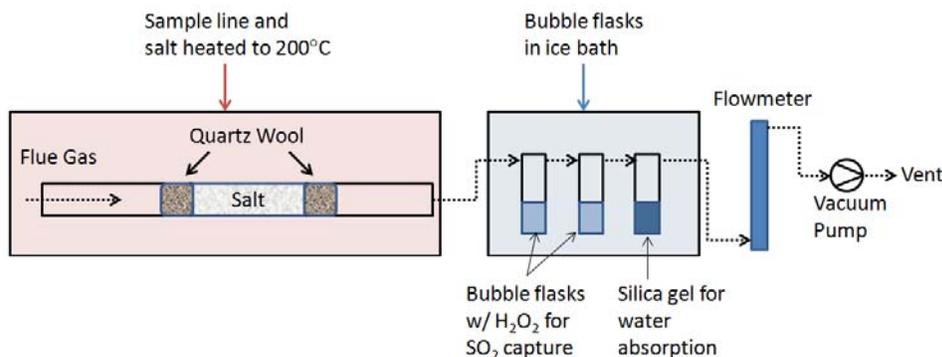
Figure 6. Schematic picture of the salt method.

The measurement setup used for the salt method is shown in Figure 5. The salt is heated to about 200°C, to avoid condensation in the salt. The salt is then dissolved in water and analyzed for sulfate ions by ion chromatography.

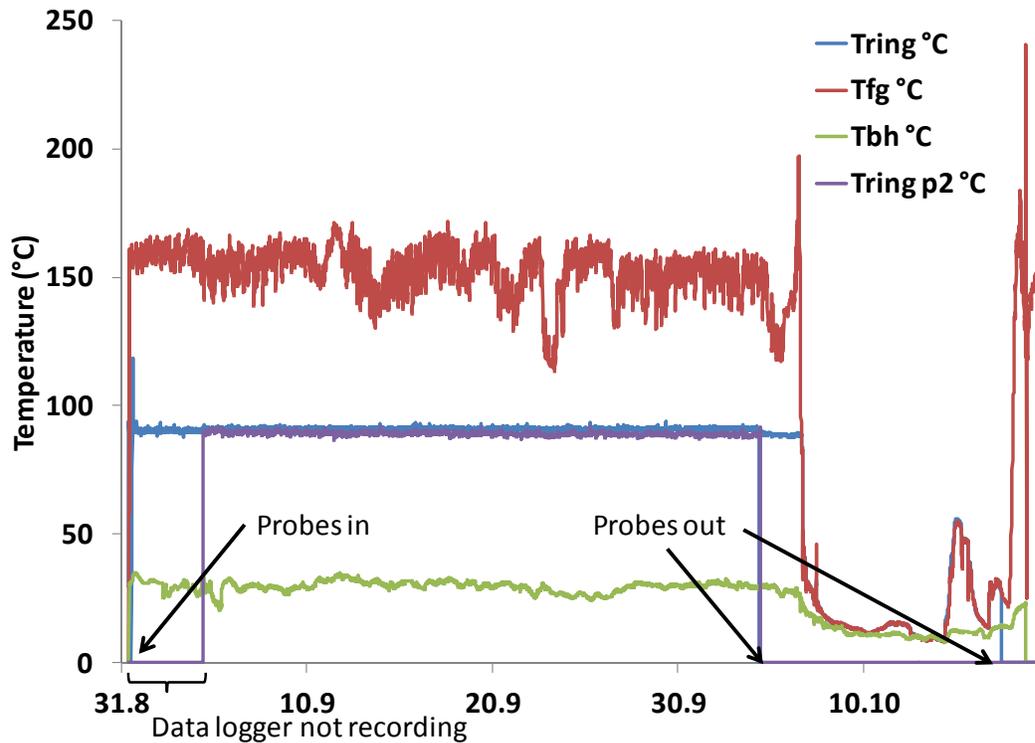
Figure 7. Temperatures of the probes (Tring and Tring p2), flue gas (Tfg) and boiler house (Tbh).

The flue gas temperature in the economizers was about 150 °C and did not drop below about 110 °C during normal operation, Figure 7. The probes were isothermal at 90 °C. The data logger did not record the temperature for one of the probes for the first few days, but the conditions were the same for both probes. The feed water temperature to the economizers was just over 110 °C, Figure 8. Corrosion at the feed water entrance to the economizers is nominal. This is another indication that acid dew point corrosion does not occur in the Rauma boiler. If it did, there should be corrosion here as 110 °C is below the calculated acid dew point temperature for 1 ppm H₂SO₄ and 20% relative humidity, Figure 2.

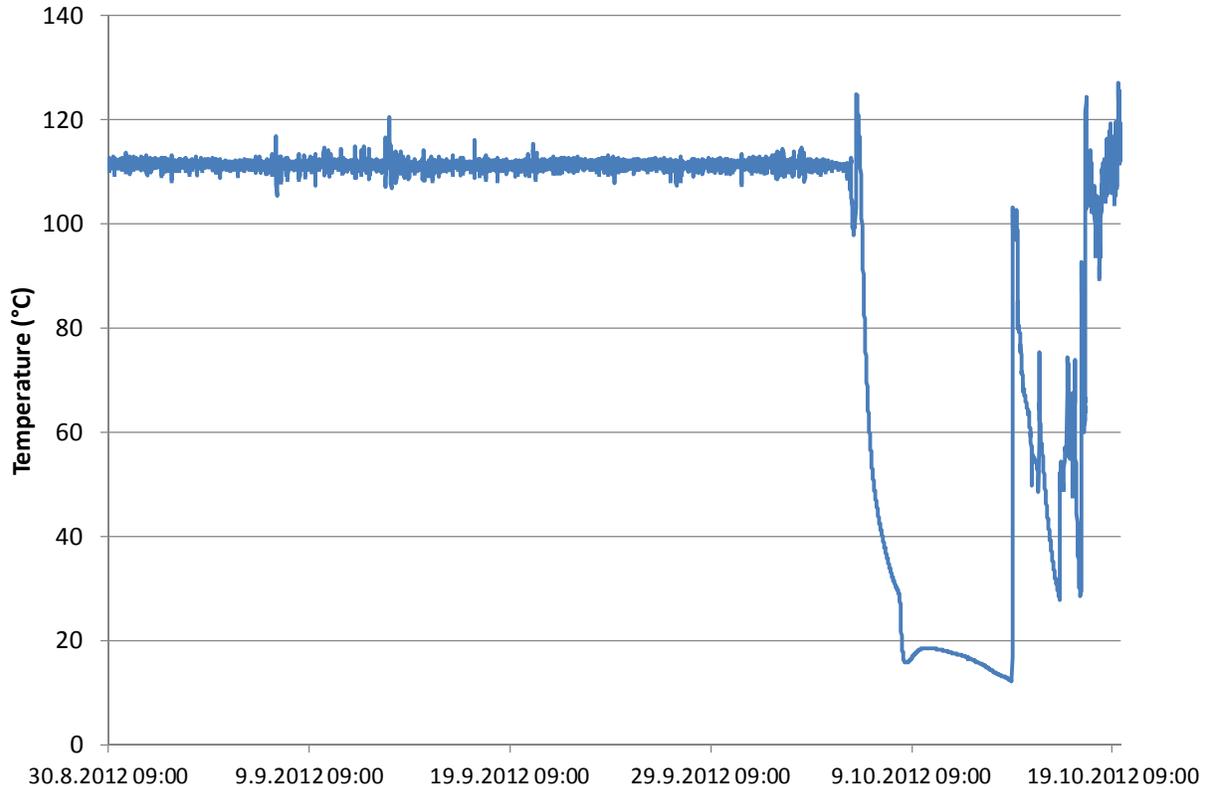
Figure 8. Feed water temperature to the economizers.

It was clear that there was no acid dew point corrosion during normal operation. This is also supported by the fact that there is not acid dewpoint corrosion seen where the feed water to the economizer comes into the boiler. The feed water temperature is between about 110 °C and 115 °C. This temperature is sufficiently low that if H_2SO_4 is present, acid dewpoint corrosion would be seen. From this study we can conclude mills can take more energy out of the flue gas without dew point corrosion under normal operational conditions.

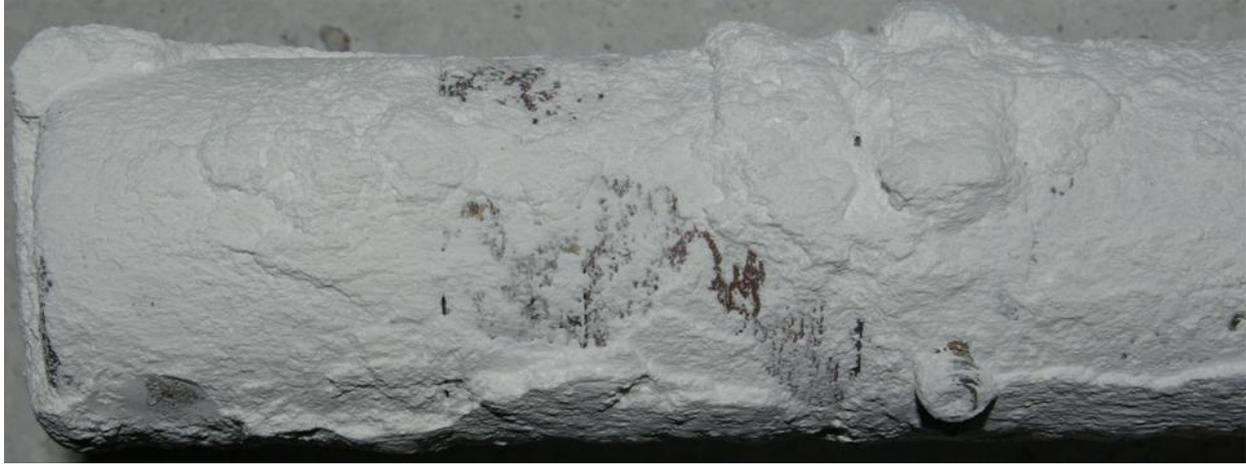
After 811h of normal operation the probe was covered in ash, Figure 9. There was virtually no corrosion on the probe, Figure 10. What little corrosion occurred was found on the top of the probe, but not on the bottom-most edge of the probe. The probe was placed in one of the lower turns in the economizers and it is not clear which were the windward and leeward sides of the probe. The corrosion layer was pitting up to approximately 10 μm , Figure 11. In some spots of the corrosion layer, the chloride was not balanced by alkali indicating iron chloride and chloride induced corrosion. One explanation for the combined observations of corrosion being present on the top but not bottom and the presence of chloride in the corrosion layer is that a small amount of water is dropping on the probe from the sootblowers. This would dissolve NaCl in the salt resulting in a chloride containing solution until the water evaporates.

Figure 9. Probe after 811h of Normal Operation

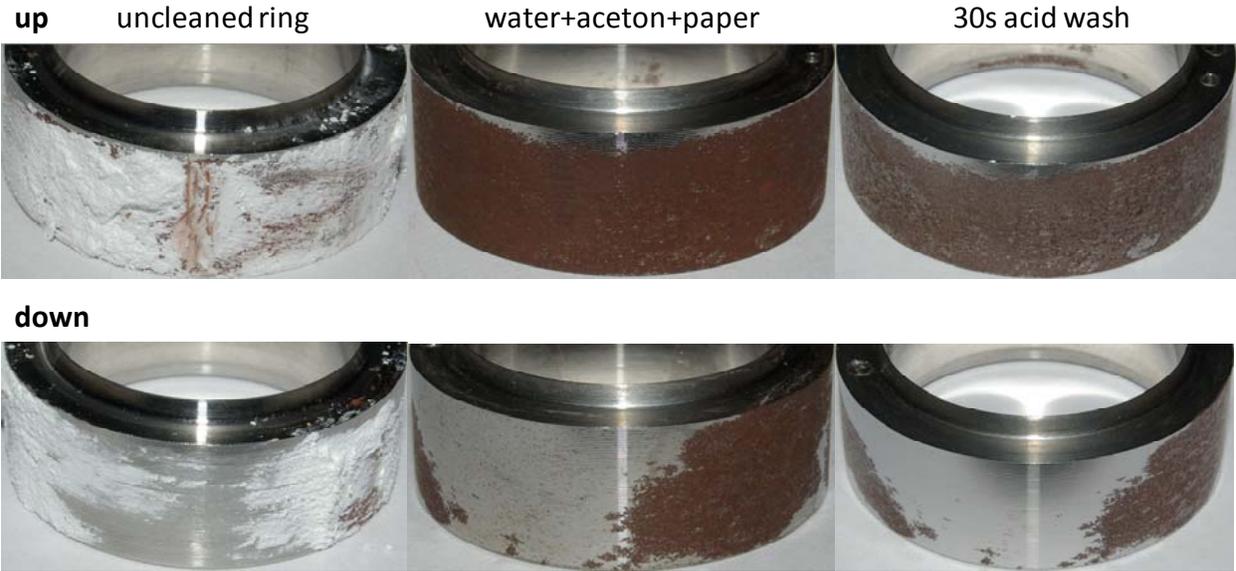
Figure 10. Ring after 811h normal operation. No iron oxide was found on the bottom edge of the probe.

Based on the corrosion results from the long term probe studies, annual corrosion rates were calculated to be 0.02 and 0.05 mm/yr for the probe pulled before the water wash and the probe pulled after the water wash respectively. Pitting was observed with pit depths of approximately 10 and 20 μm for the two probes. The presences of chloride in some of the pits that was not balanced by alkali indicated chloride induced pitting. On the rings from both of the probes, there was a patch at the gravimetric bottom of the ring where there was not corrosion. It seems probable that some water dripped down from the soot blowers that were about 2 m above the probe. This would have resulted in a chloride containing solution, even if for a short time before the water evaporates.

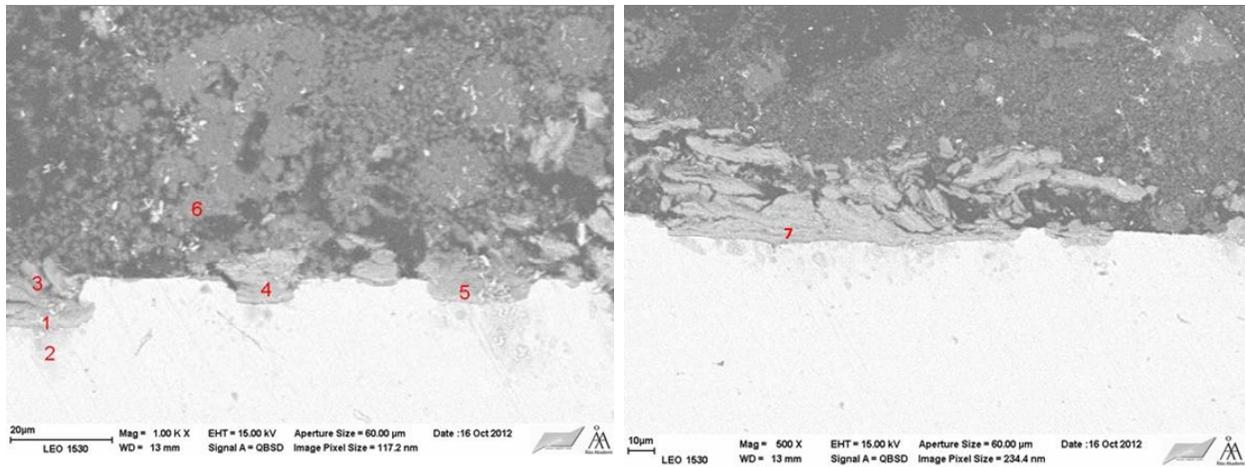
Spot	Na	Al	Si	S	Cl	K	Mn	Fe
1	1.3	0.3	0.2	0.1	0.5	0.1	0.4	38.2
2	0.0	0.3	0.2	0.0	0.6	0.0		39.3
3	3.1		0.3	1.4	0.4	1.5		34.9
4	3.7	0.3	0.2	0.6	0.7	0.3		36.4
5	1.7	0.5	0.2	0.2	1.2	0.4	0.4	37.2
6	20.5			13.5	2.3	7.3		1.1
7	0.4	0.5	0.3	0.1	2.5	0.1	0.3	37.5

Figure 11. Spot analysis of corrosion layer from probe pulled out after 811 hours of normal operation (before water wash). In spots 2 and 7, the Cl is not balanced by Na or K.

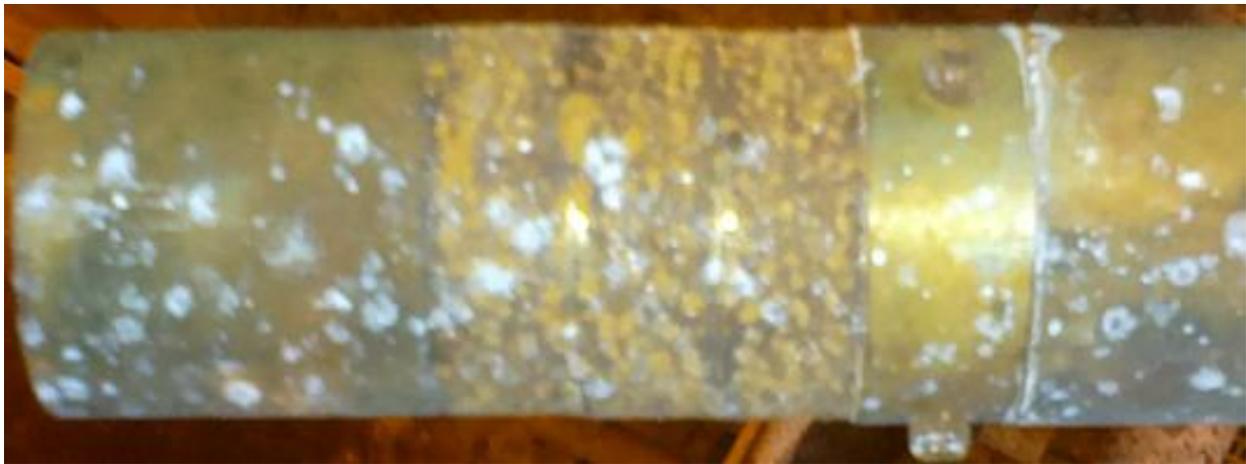
The probe that was pulled out after the water wash, Figure 12, had more corrosion than the probe pulled out before the water wash, but it was still a low level of corrosion, Figure 13. Again, the bottommost edge was not corroded. Based on the weight loss of the ring after the corrosion products were washed from the ring using acetone and acetic acid, the calculated average corrosion for the two probes on an annual basis was 0.02 and 0.05 mm/year for the probes pulled out before and after the water wash respectively, Table II.

Figure 12. Probe after water wash - 1124h total (811h "normal" operation + water wash)

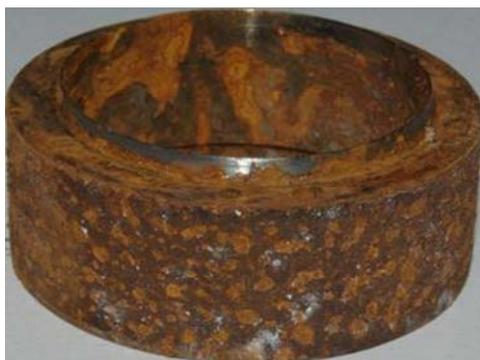
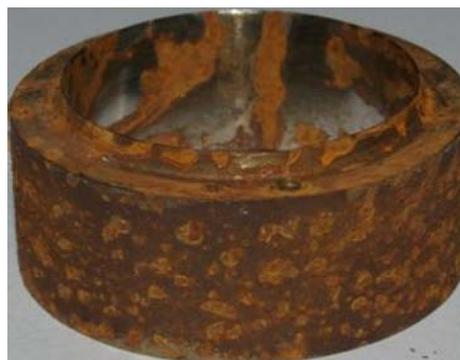
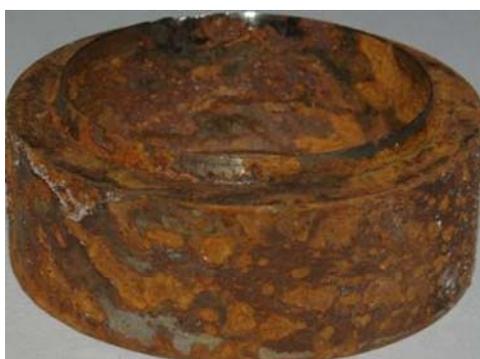
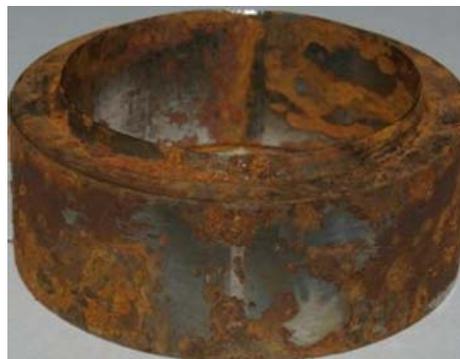
Figure 13. Ring after 1124h. Not that there are some areas without corrosion downwards on the bottom edge of the ring.

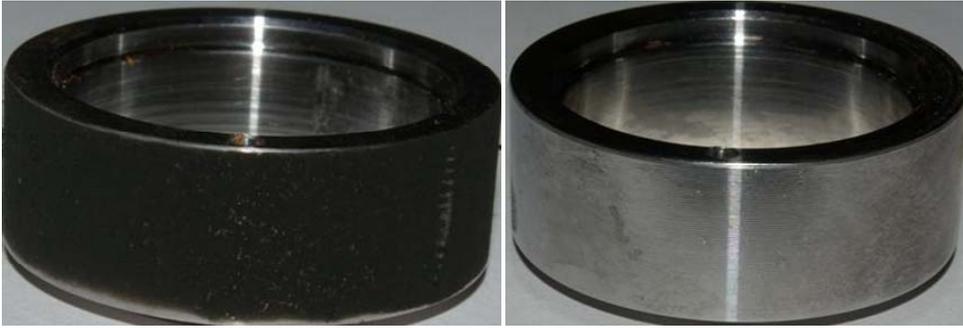
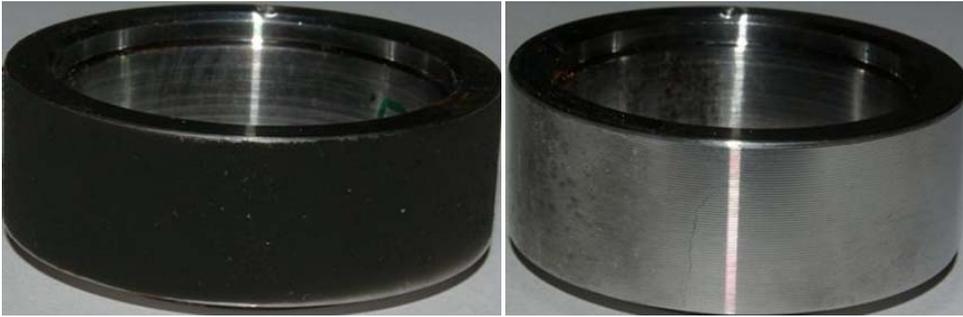
A 2h probe (90 °C) study was also made in the economizers. The probe study was carried out at the same time the measured SO₃ level was highest, but no corrosion was seen on the rings, Figure 14. Had there been an acid dew point above 90 °C, corrosion should have occurred during the two hour probe study.

Figure 14. Ring after 2h exposure during oil burning.

There was also no dew point corrosion seen during the oil firing. This may be due to the high air ratios used in this instance. A follow up study during start-up on oil could clarify if during start-up acid dew point corrosion can be seen if the probe temperature is 90 °C.
