**VTT, Characterisation of probe test samples exposed to BLRB lower  
furnace environments – draft report 26.11.2012**

# Characterisation of probe test samples exposed to BLRB lower furnace environments

Author: Pekka Pohjanne

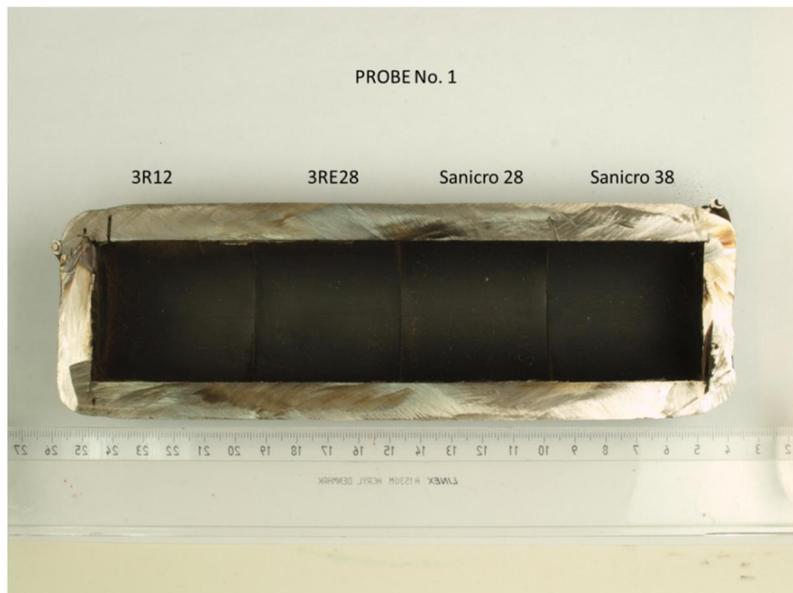
Total test duration of the test No. 1 was 1006 hours from which 906 hours at the target temperature of 440 °C. The test materials in this exposure were 3R12, 3RE28, Sanicro 28 and Sanicro 38, Figure 3. According to visual inspection all samples were in good condition after testing i.e. neither marked general or localised corrosion nor deposits or oxide scales were observed either on outer or inner surfaces.

Figure 3. Macrographs taken from the probe No. 1 head after exposure: a) outer surface exposed to the furnace side and b) inner surface exposed to the cooling liquid.

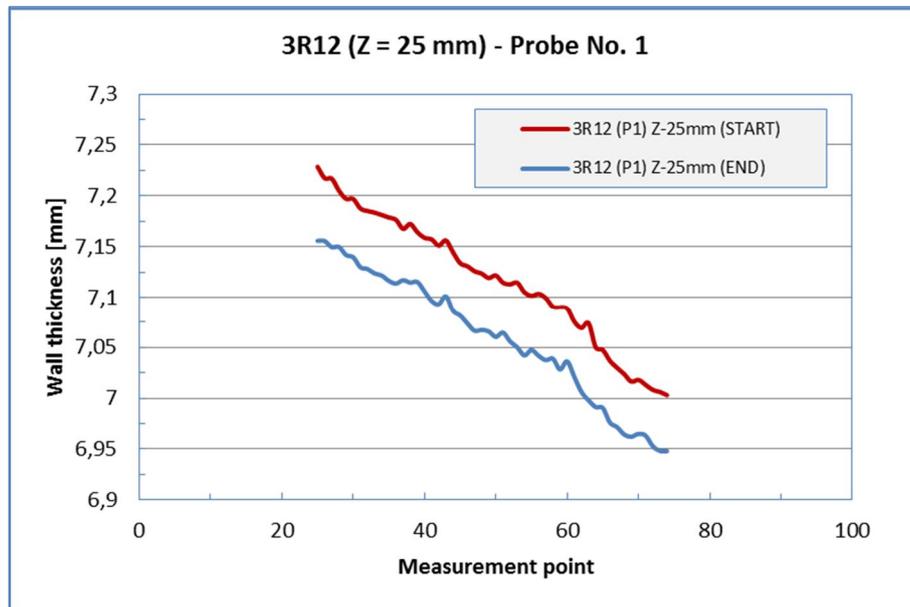
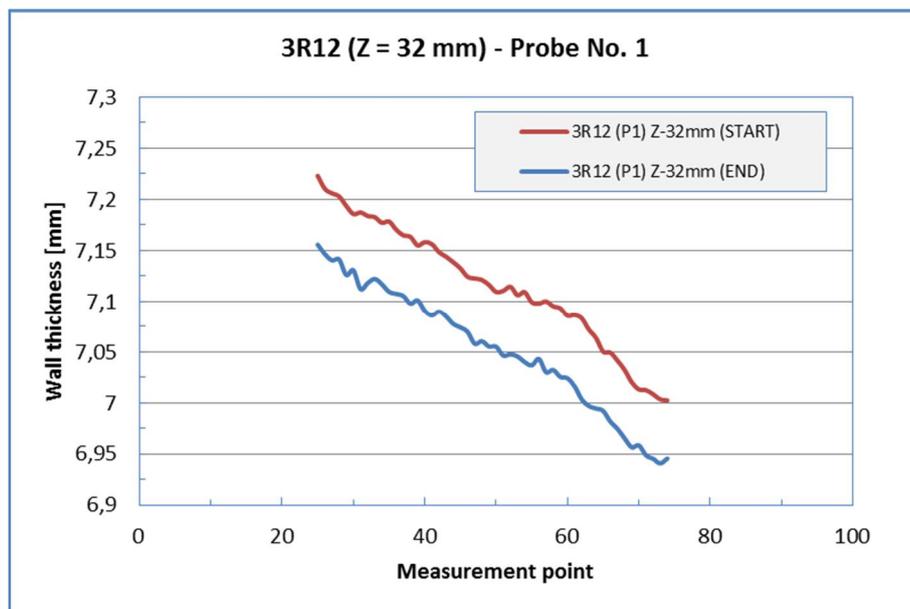
The results of the wall thickness profile measurements and the wall thinning curves derived from them are presented in Figures 4...11. The results showed that marked wall thinning had taken place on the 3R12 specimen. For the other materials the data was more scattered showing that wall thinning and deposit formation (increase in wall thickness) had taken place locally. Measurements showed also that tube wall thicknesses varied a lot as a function of circumference.

Figure 4. Circumferential wall thickness profiles from 3R12 specimen (Probe No. 1): a) axial location  $Z = 25$  mm and b) axial location  $Z = 32$  mm.

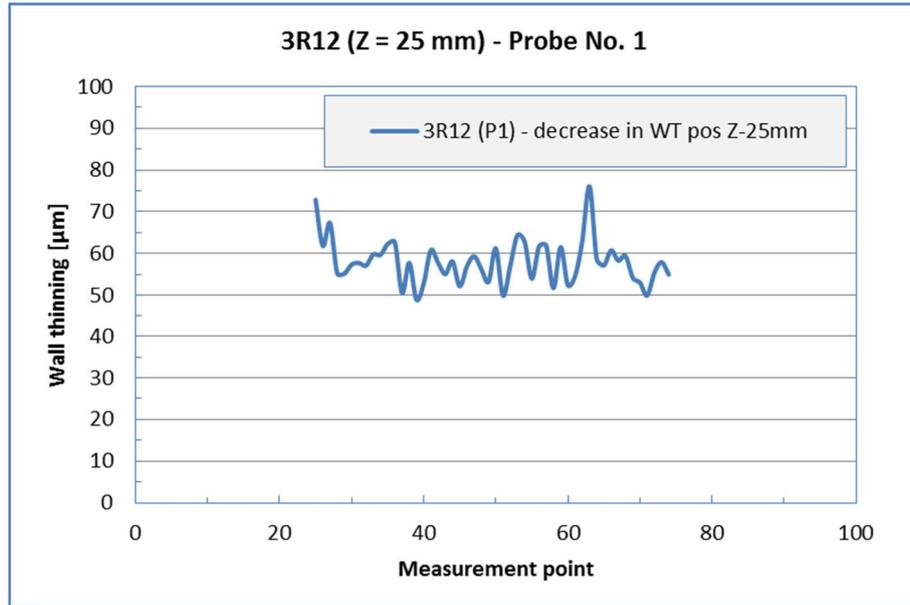
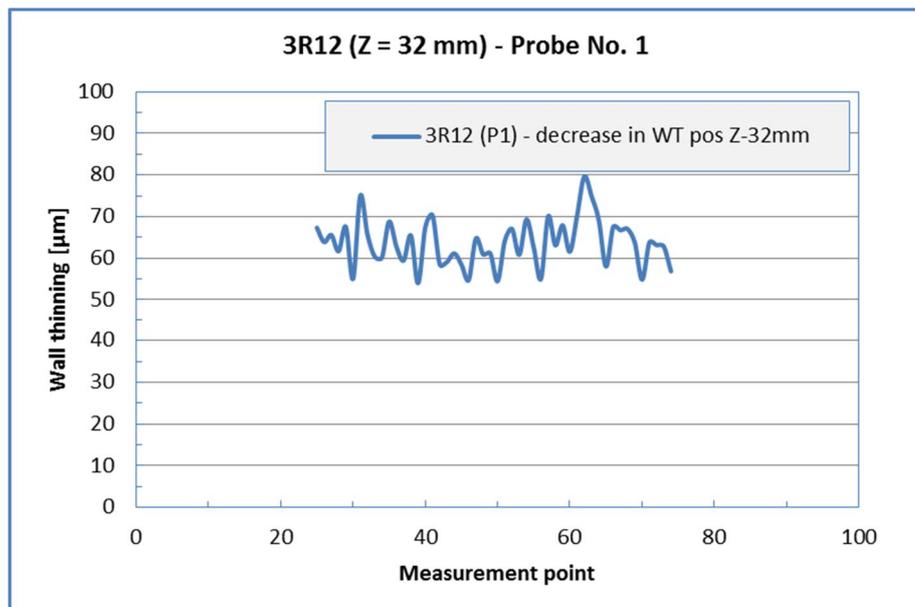
Figure 5. Circumferential wall thinning curves from 3R12 specimen (Probe No. 1):  
 a) axial location  $Z = 25$  mm and b) axial location  $Z = 32$  mm.

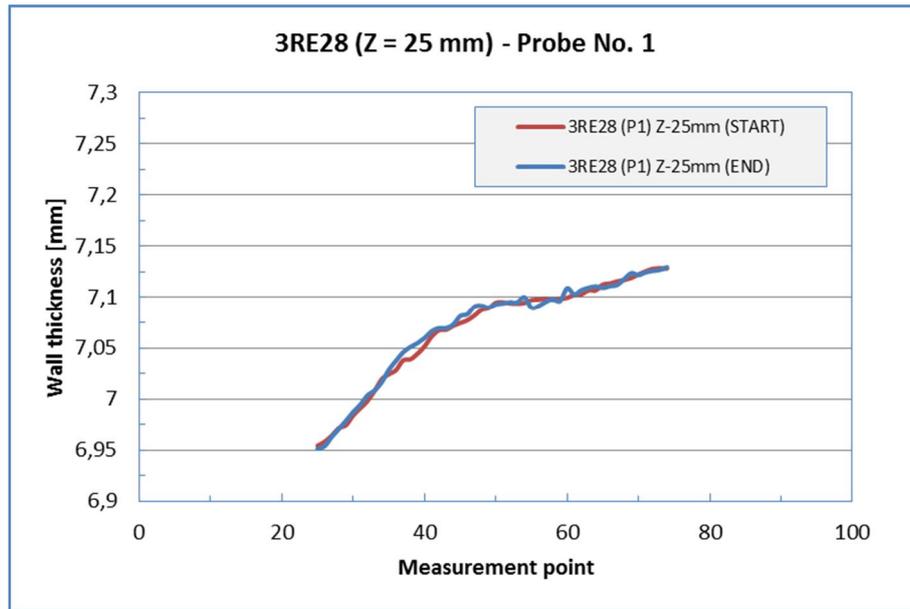
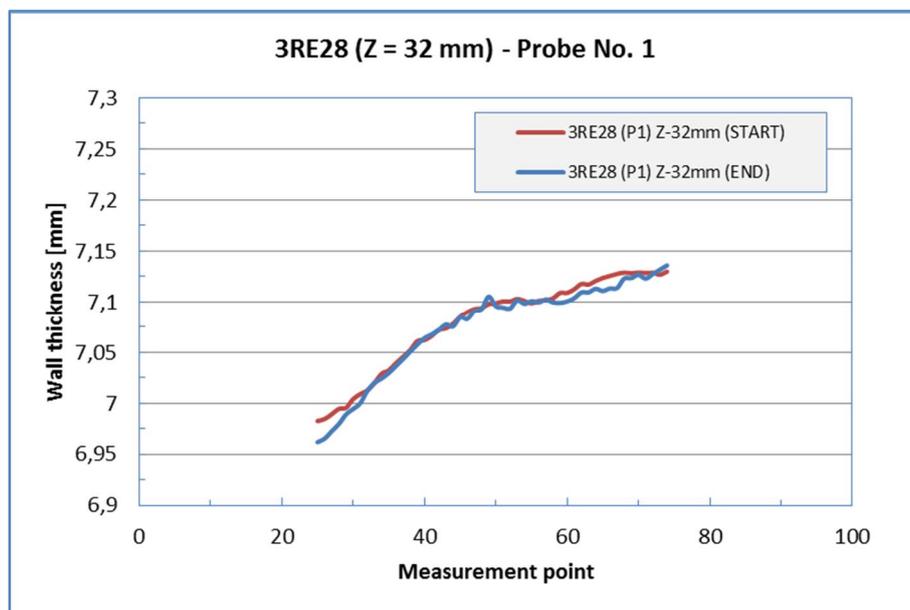
Figure 6. Circumferential wall thickness profiles from 3RE28 specimen (Probe No. 1): a) axial location  $Z = 25$  mm and b) axial location  $Z = 32$  mm.

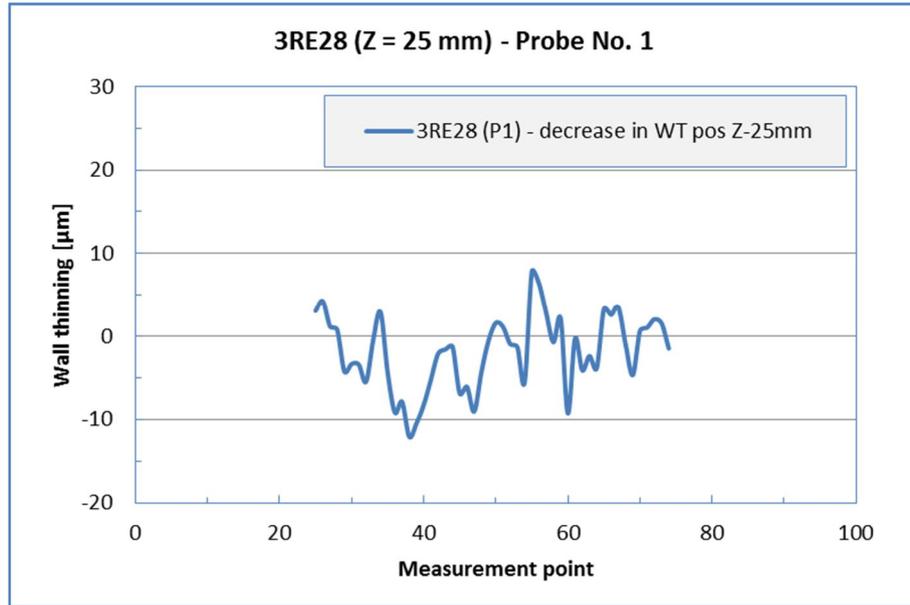
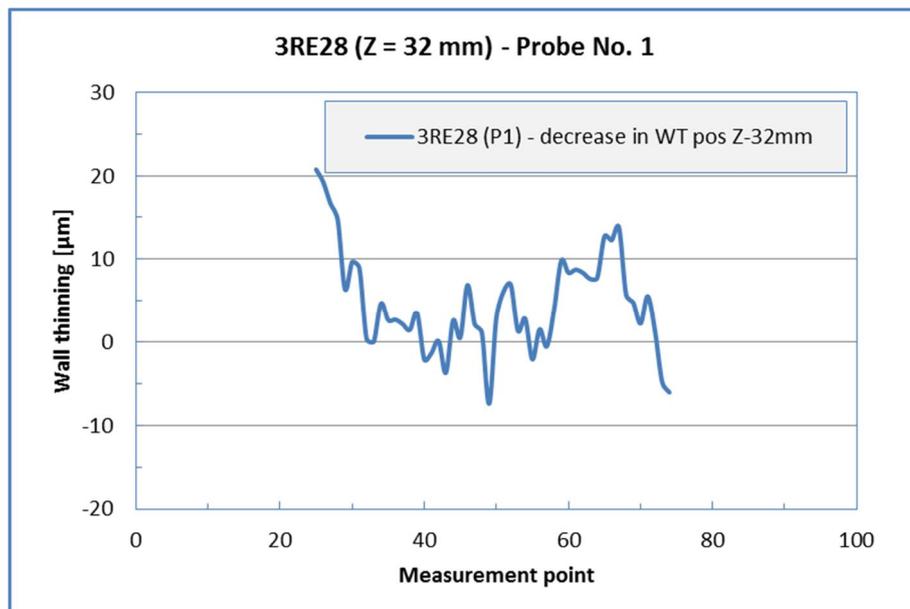
Figure 7. Circumferential wall thinning curves from 3RE28 specimen (Probe No. 1): a) axial location  $Z = 25$  mm and b) axial location  $Z = 32$  mm.

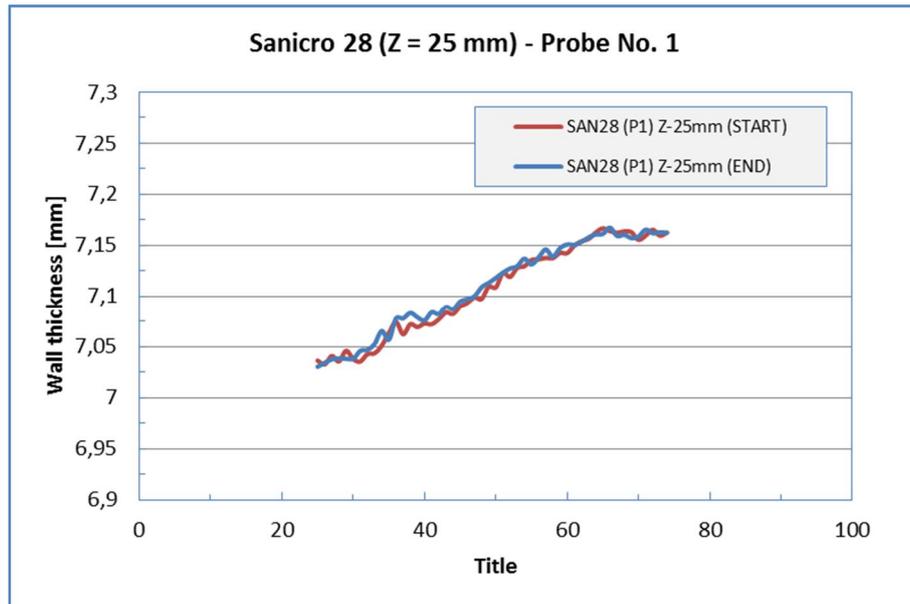
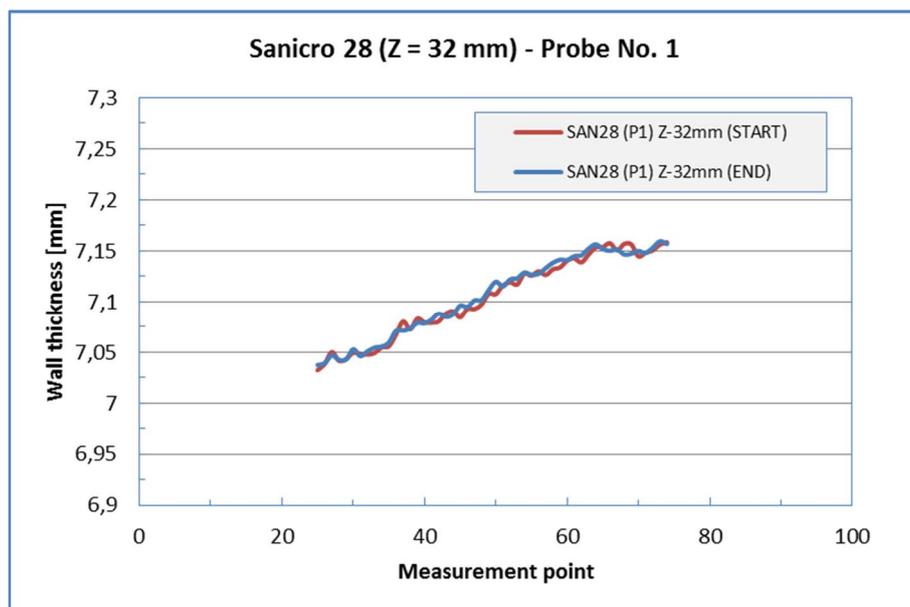
Figure 8. Circumferential wall thickness profiles from Sanicro 28 specimen (Probe No. 1): a) axial location  $Z = 25$  mm and b) axial location  $Z = 32$  mm.

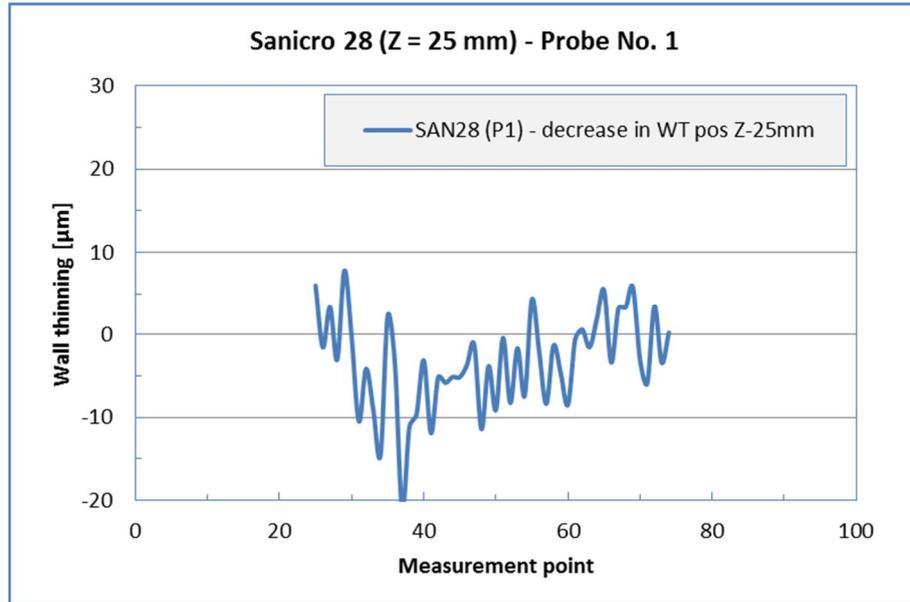
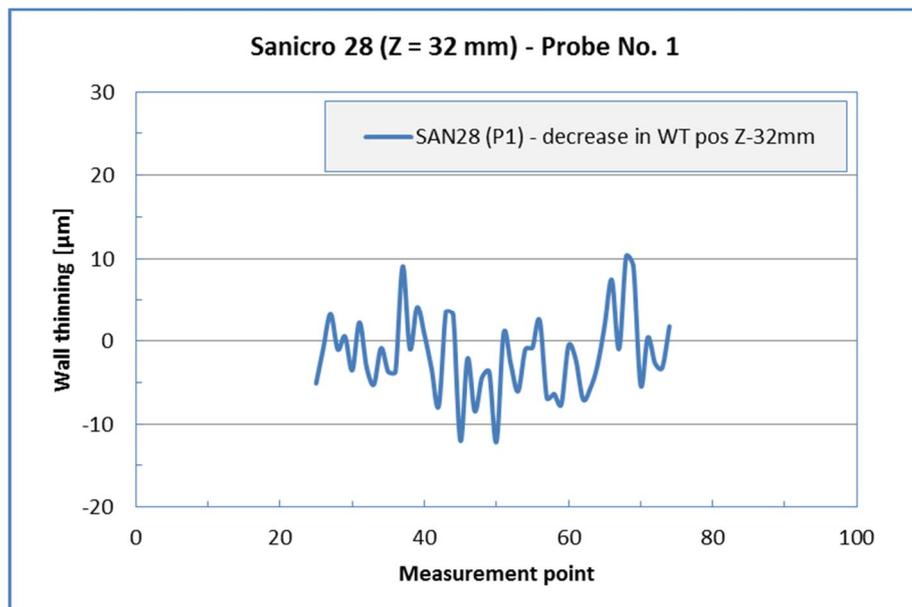
Figure 9. Circumferential wall thinning curves from Sanicro 28 specimen (Probe No. 1): a) axial location  $Z = 25$  mm and b) axial location  $Z = 32$  mm.

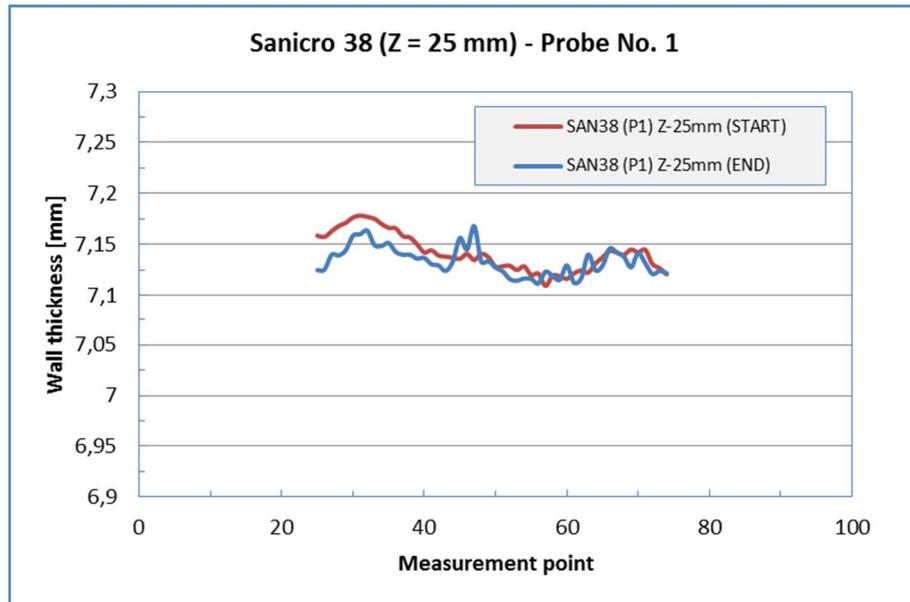
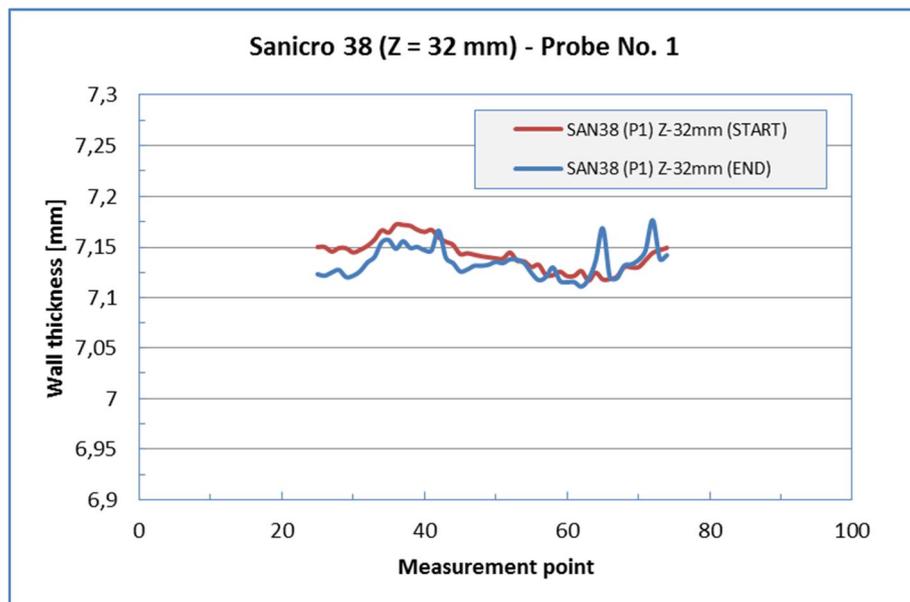
Figure 10. Circumferential wall thickness profiles from Sanicro 38 specimen (Probe No. 1): a) axial location  $Z = 25$  mm and b) axial location  $Z = 32$  mm.

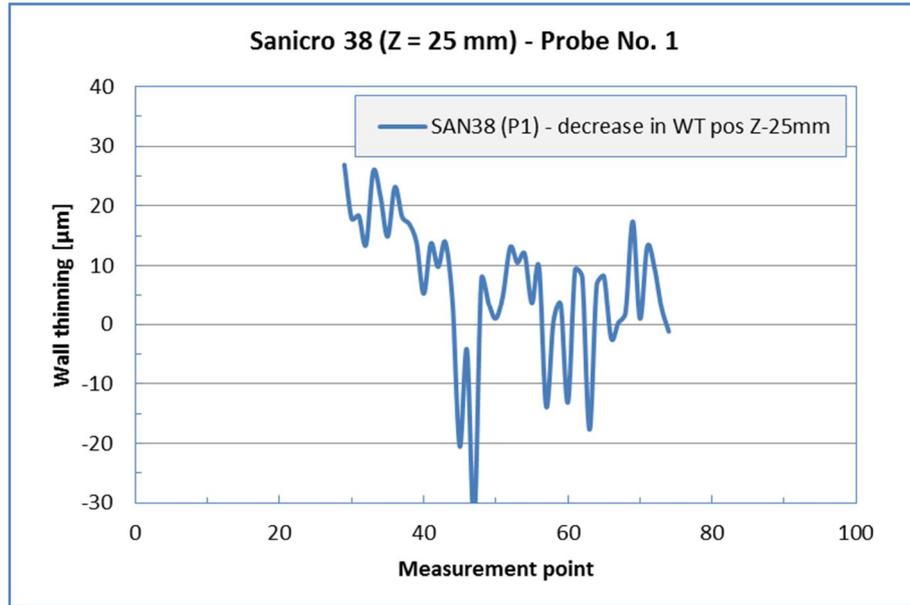
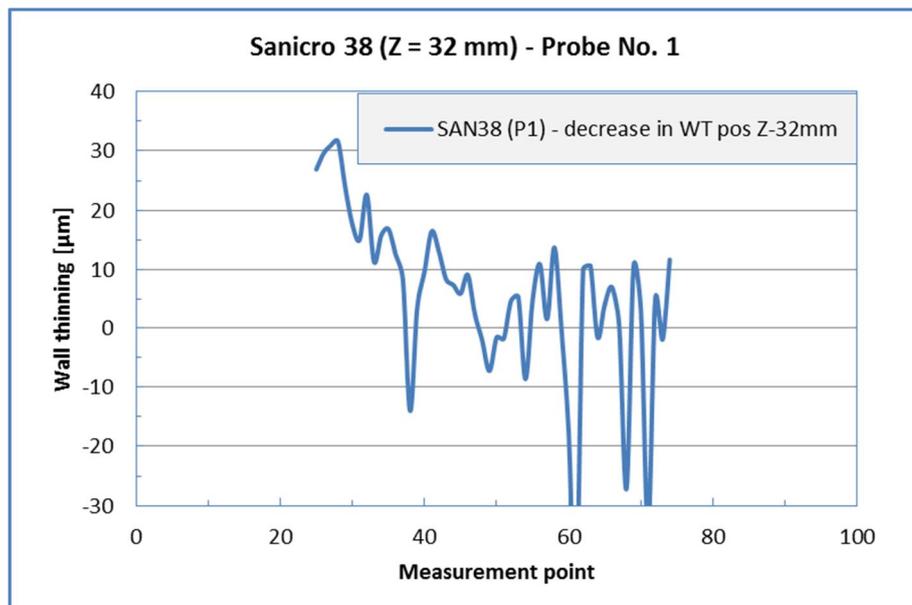
Figure 11. Circumferential wall thinning curves from Sanicro 38 specimen (Probe No. 1): a) axial location  $Z = 25$  mm and b) axial location  $Z = 32$  mm.

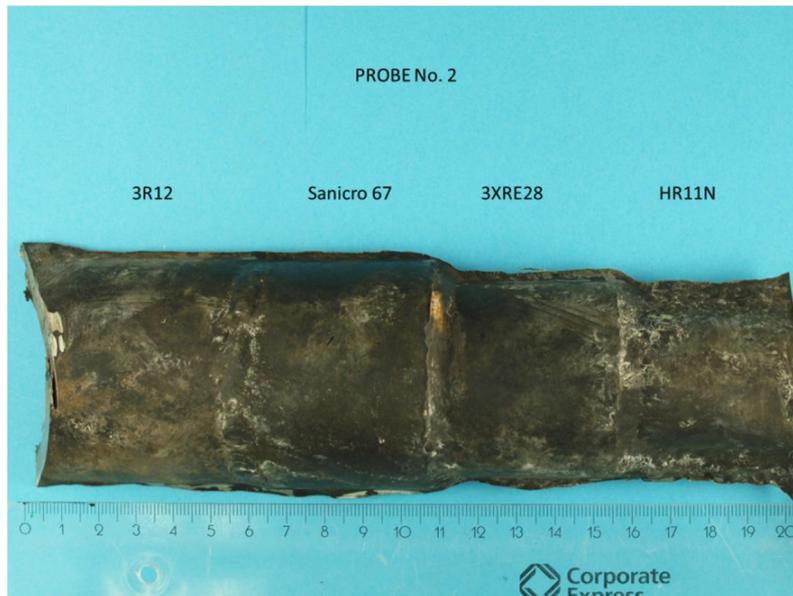
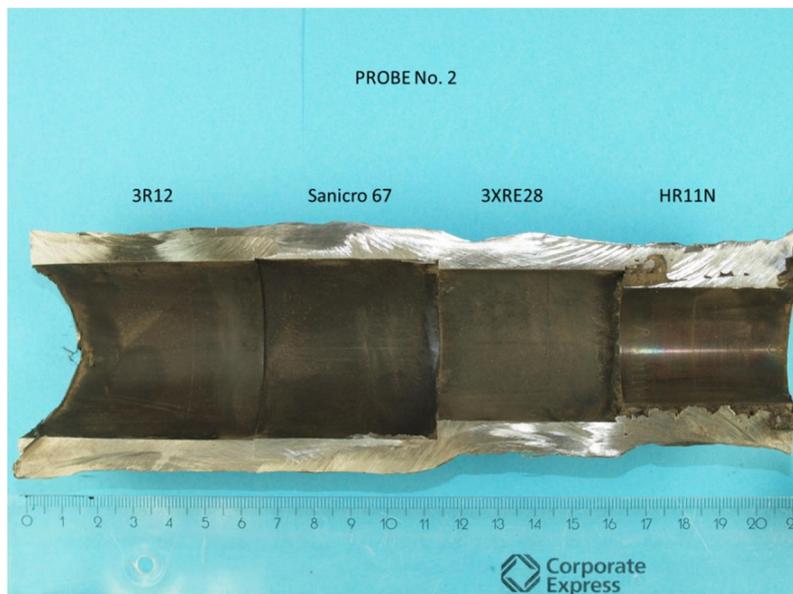
Total test duration of the test No. 2 was 1023 hours from which 744 hours at the target temperature of 440 °C. The test materials in this exposure were 3R12, 3XRE28, HR11N and Sanicro 67, Figure 15. According to visual inspection the inner surfaces of the specimens were in good condition after testing i.e. neither marked general or localised corrosion nor deposits or oxide scales were observed. The outer surfaces of the specimens appeared to be in good condition but the thin dark and white deposits on the surfaces hindered accurate examinations.

Figure 15. Macrographs taken from the probe No. 2 head after exposure: a) outer surface exposed to the furnace side and b) inner surface exposed to the cooling liquid.

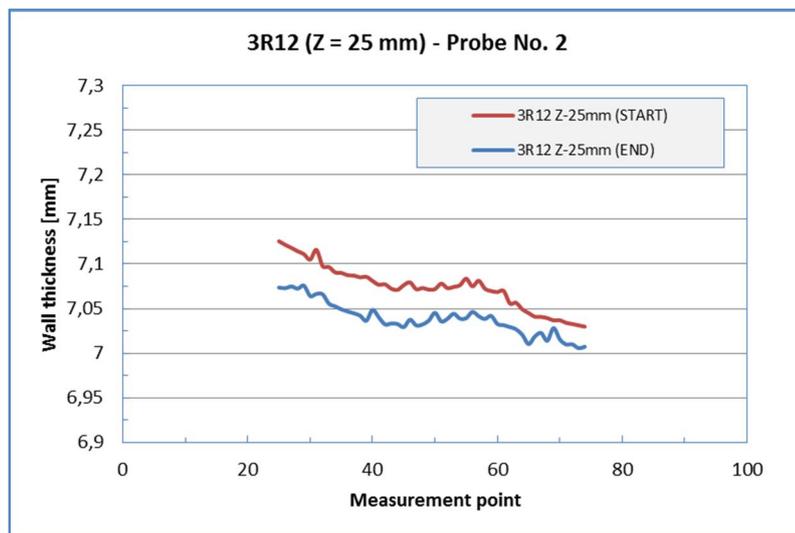
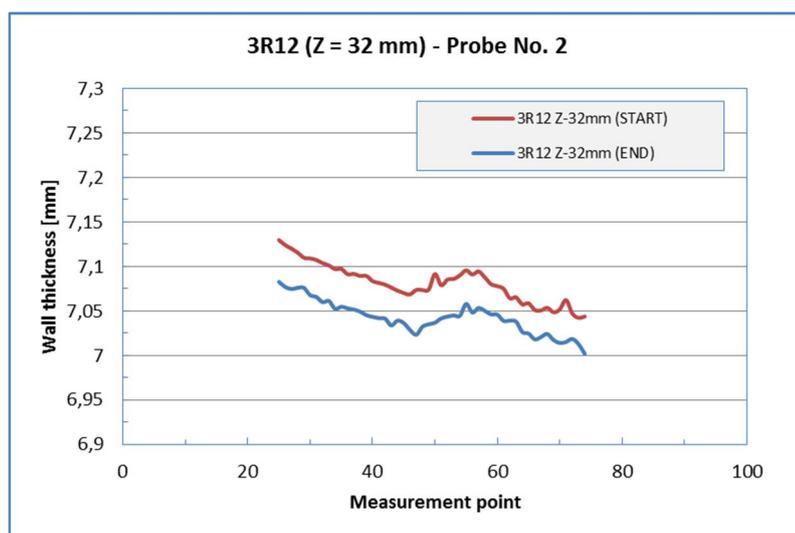
The results of the wall thickness profile measurements and the wall thinning curves derived from them are presented in Figures 16...23. The results showed that marked wall thinning had taken place on the 3R12 specimen and lesser degree also on the HR11N specimen. The data of the 3XRE28 and Sanicro 67 materials was more scattered showing that wall thinning and deposit formation (increase in wall thickness) had taken place locally. Measurements showed also that the wall thickness variations were smaller in the machined HR11N specimen than in the other specimens tested in as received condition. The average and maximum corrosion rates calculated on the basis of the wall thickness measurements are presented in Figure 12. In this test highest corrosion rate in the order of 0.6 mm/a was measured for the 3R12 material. The corrosion resistance of the 3XRE28, HR11N and Sanicro 67 was practically at the same level.

Figure 16. Circumferential wall thickness profiles from 3R12 specimen (Probe No. 2): a) axial location  $Z = 25$  mm and b) axial location  $Z = 32$  mm.

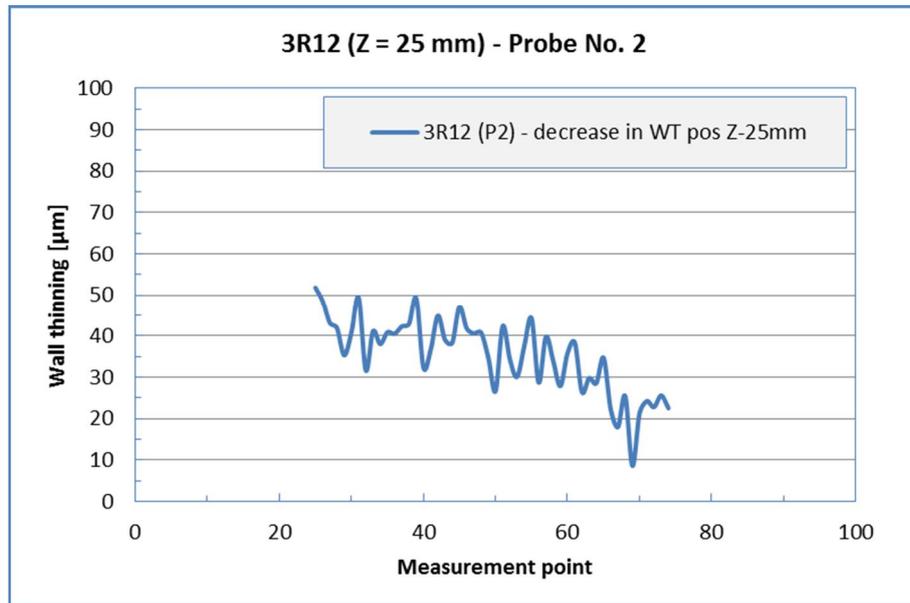
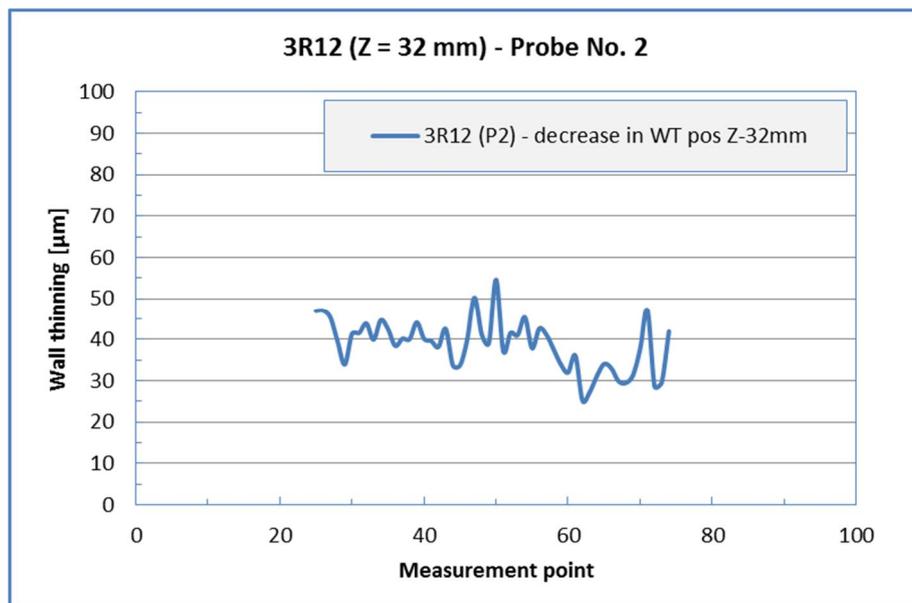
Figure 17. Circumferential wall thinning curves from 3R12 specimen (Probe No. 2): a) axial location  $Z = 25$  mm and b) axial location  $Z = 32$  mm.

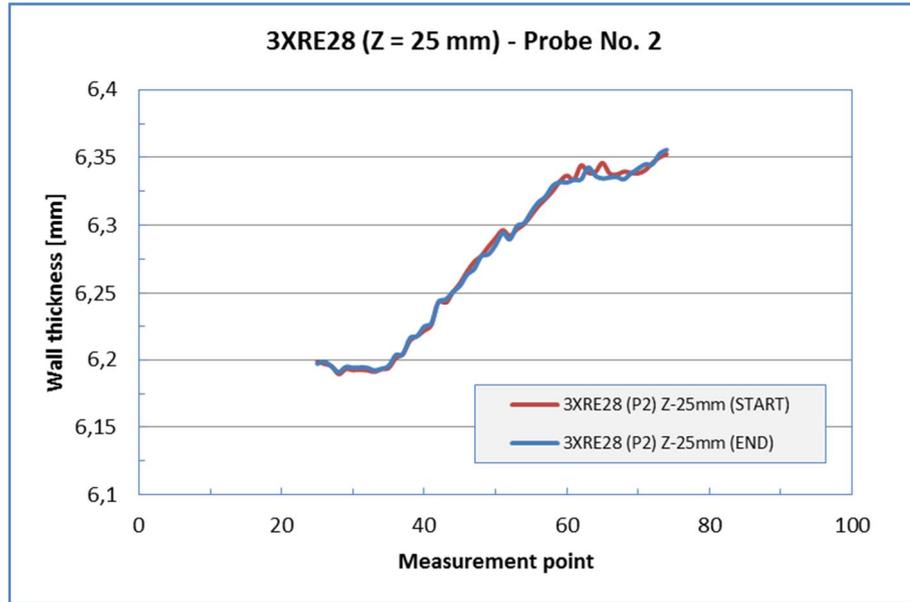
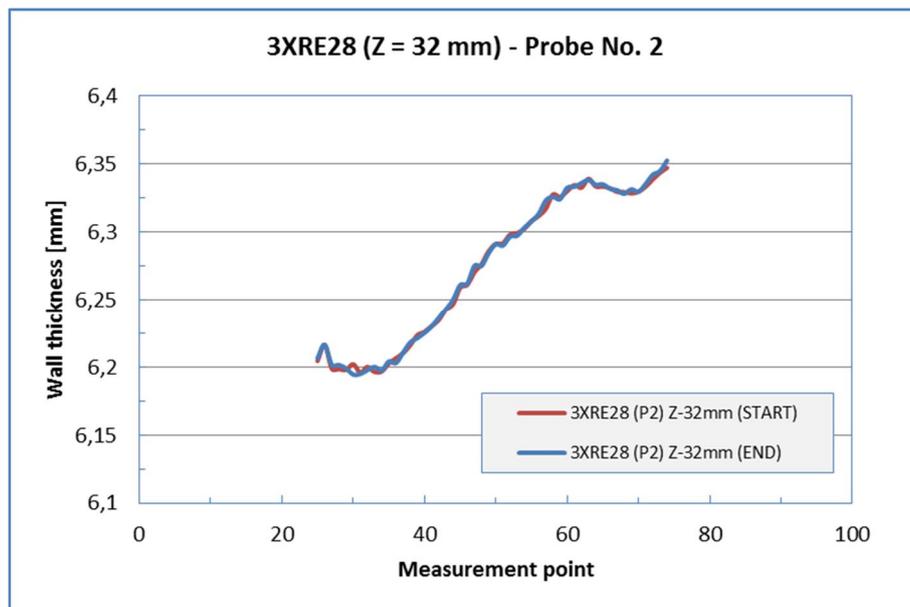
Figure 18. Circumferential wall thickness profiles from 3XRE28 specimen (Probe No. 2): a) axial location  $Z = 25$  mm and b) axial location  $Z = 32$  mm.

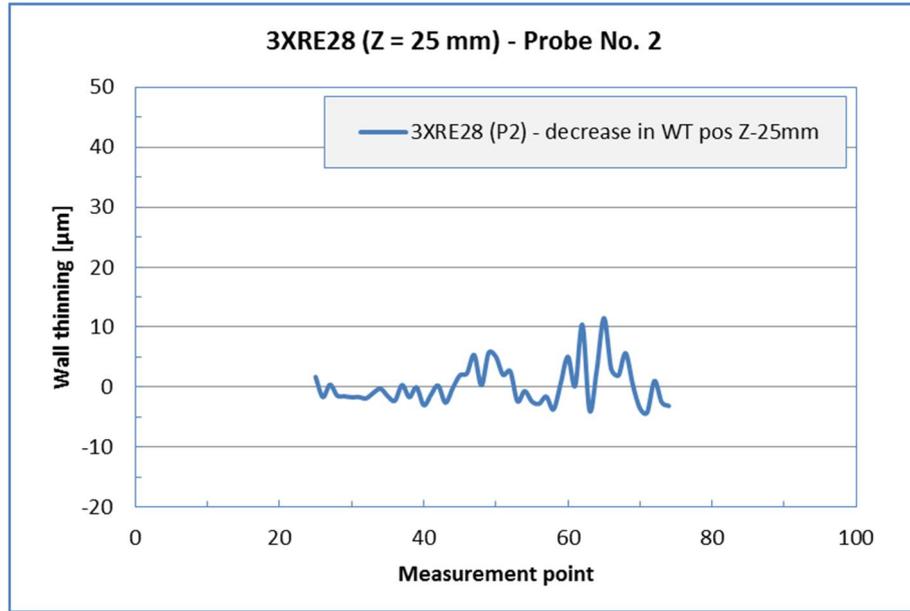
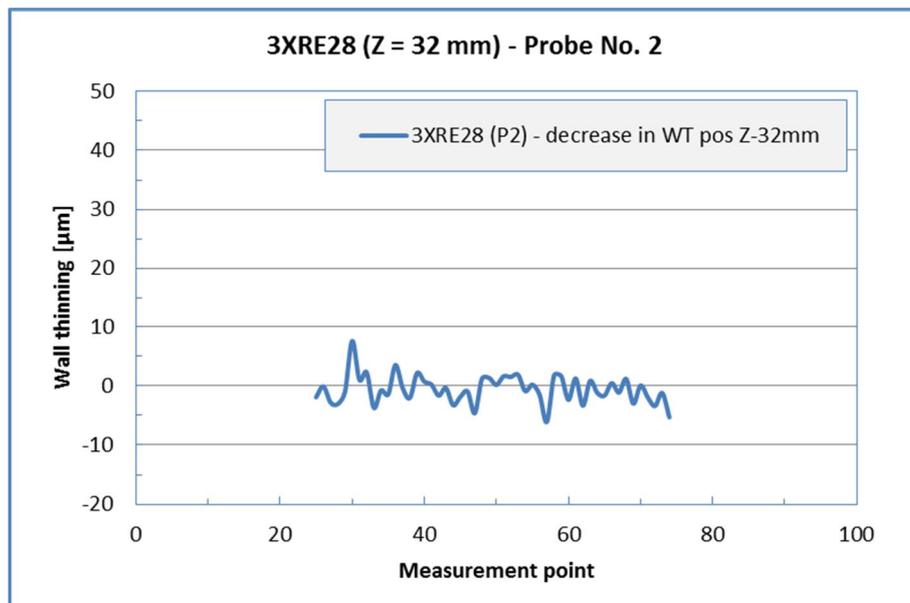
Figure 19. Circumferential wall thinning curves from 3XRE28 specimen (Probe No. 2): a) axial location  $Z = 25$  mm and b) axial location  $Z = 32$  mm.

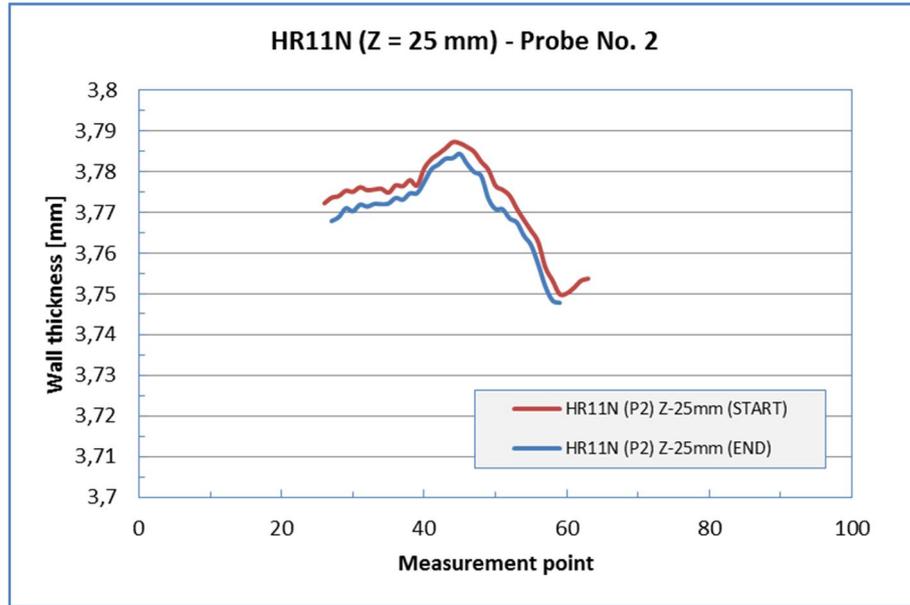
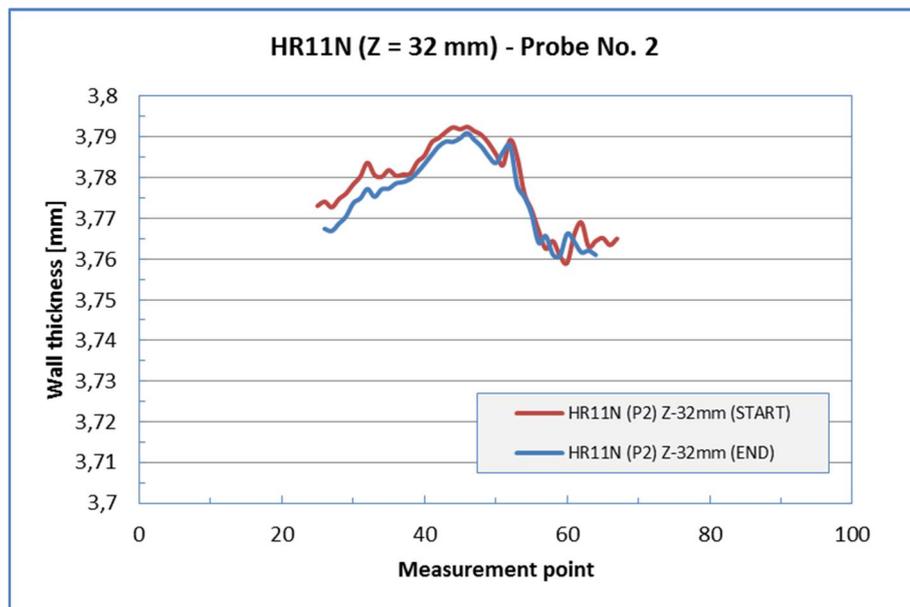
Figure 20. Circumferential wall thickness profiles from HR11N specimen (Probe No. 2): a) axial location  $Z = 25$  mm and b) axial location  $Z = 32$  mm.

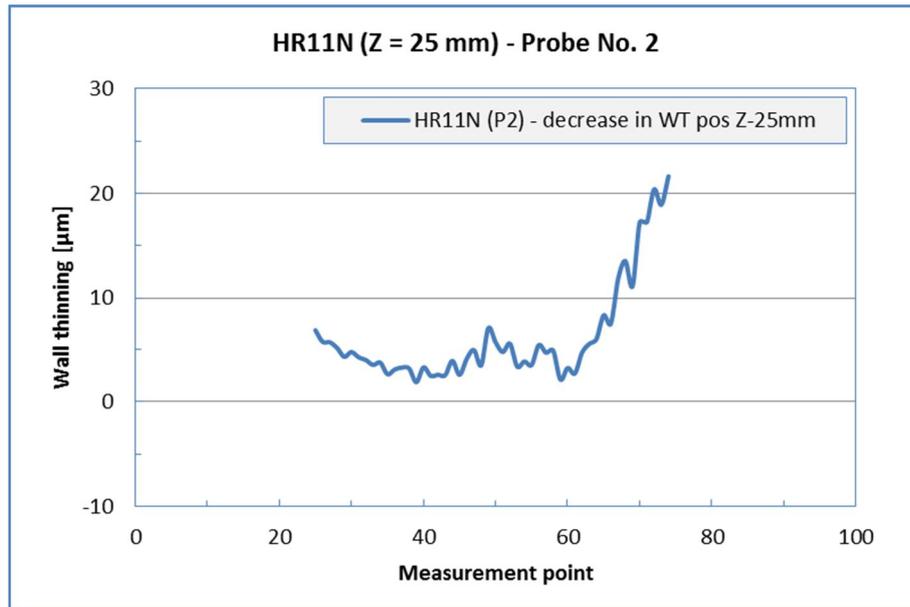
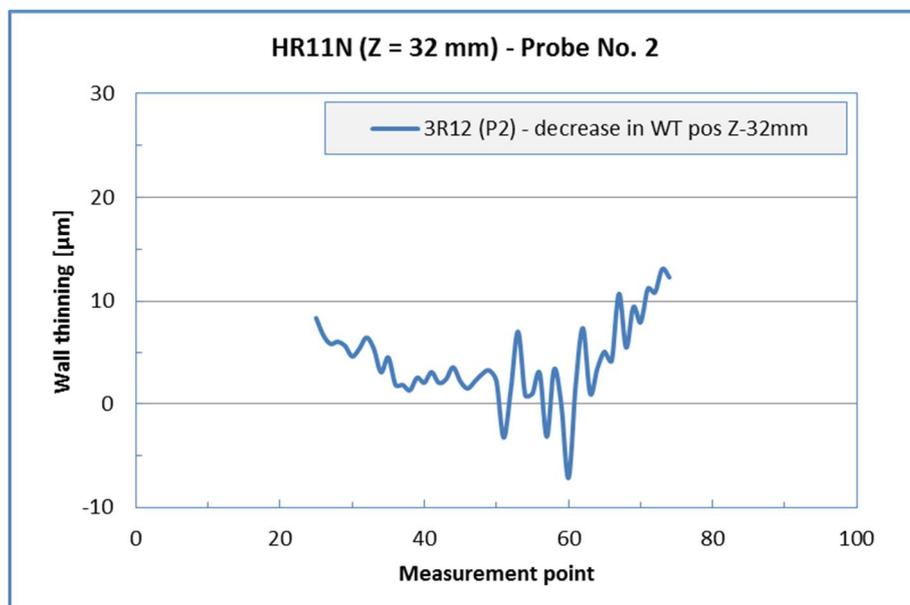
Figure 21. Circumferential wall thinning curves from HR11N specimen (Probe No. 2): a) axial location  $Z = 25$  mm and b) axial location  $Z = 32$  mm.

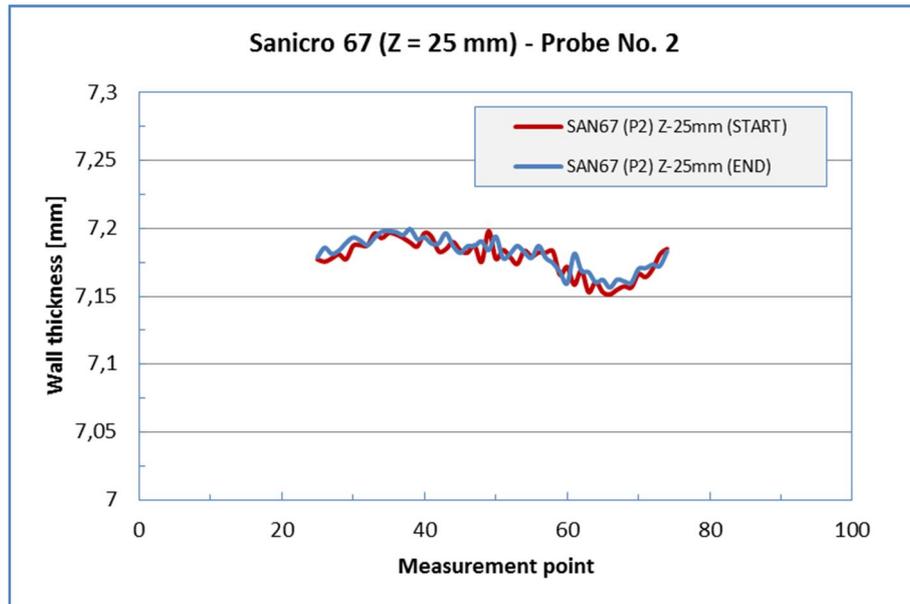
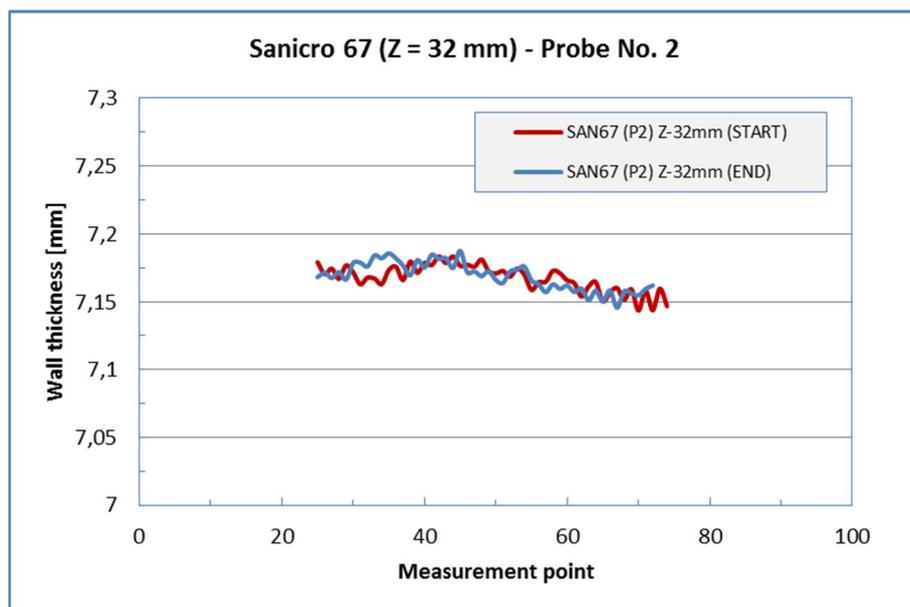
Figure 22. Circumferential wall thickness profiles from Sanicro 67 specimen (Probe No. 2): a) axial location  $Z = 25$  mm and b) axial location  $Z = 32$  mm.

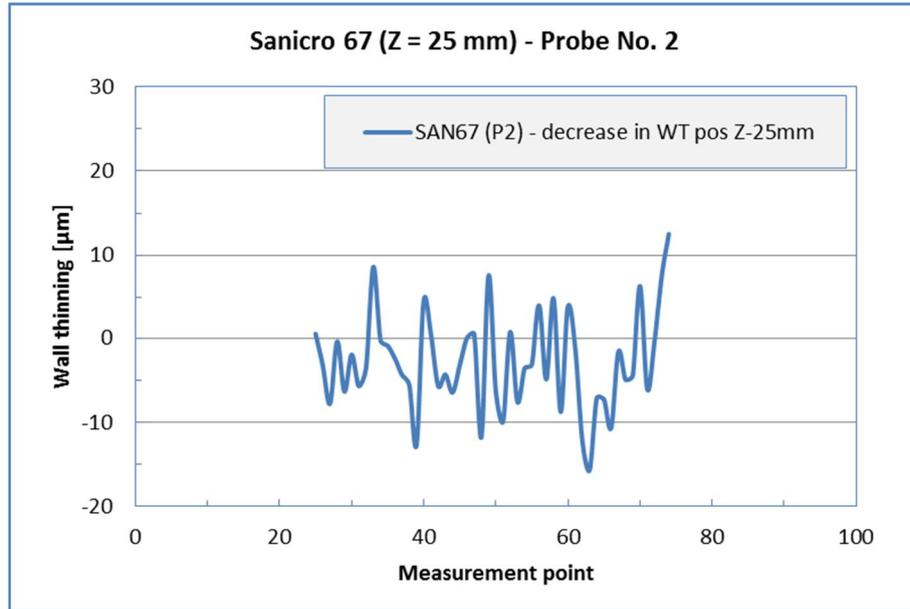
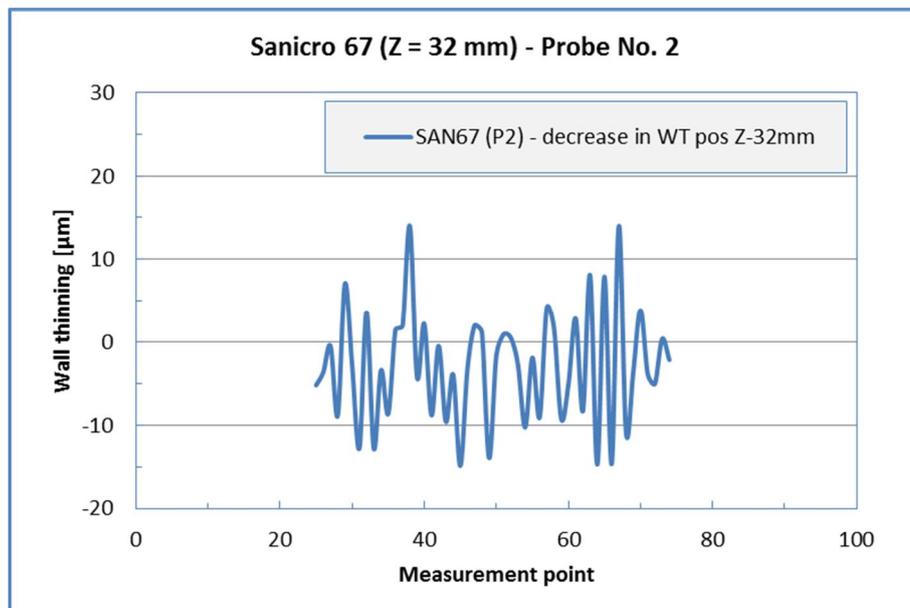
Figure 23. Circumferential wall thinning curves from Sanicro 67 specimen (Probe No. 2): a) axial location  $Z = 25$  mm and b) axial location  $Z = 32$  mm.

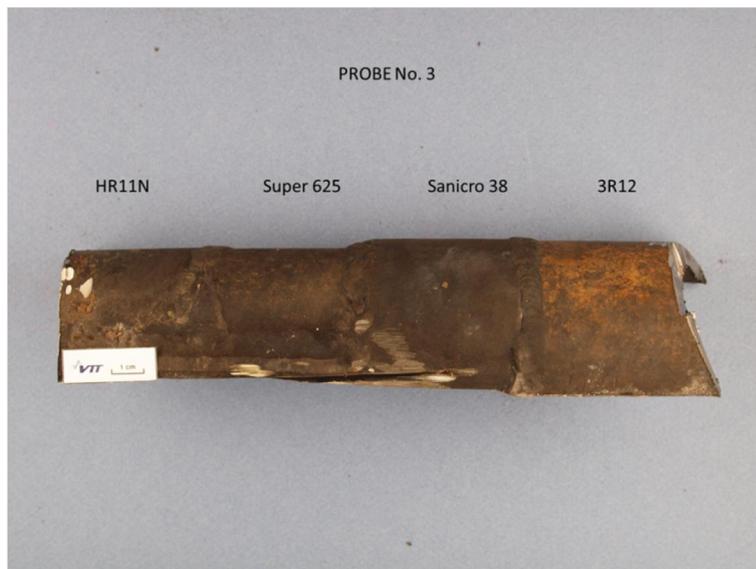
According to visual inspection the inner surfaces of the specimens were in good condition after testing. Some deposits were observed on the inner surfaces but based on their appearance they originate from the probe cutting conducted after the probe has been removed from the boiler. The outer surfaces of the specimens were covered with dark and brown deposits but appeared to be in good condition.

*Figure 27. Macrographs taken from the probe No. 3 head after exposure: a) outer surface exposed to the furnace side and b) inner surface exposed to the cooling liquid.*

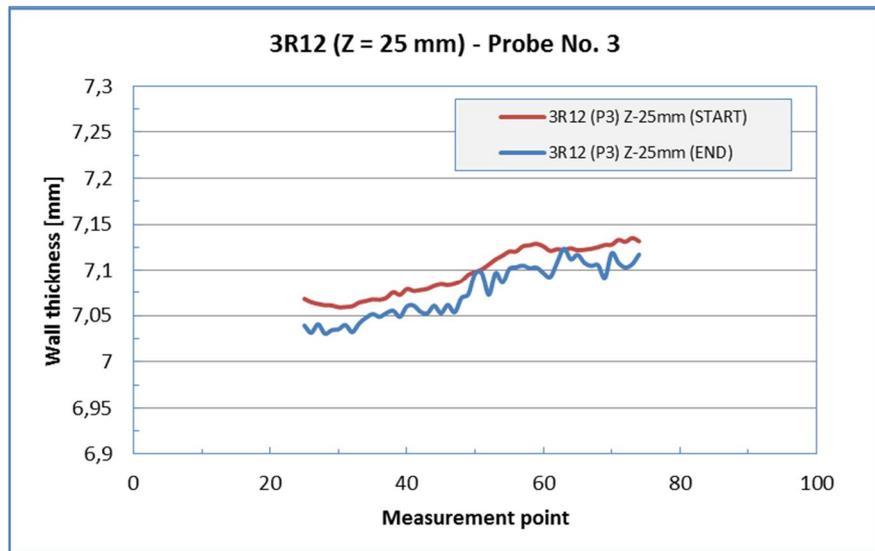
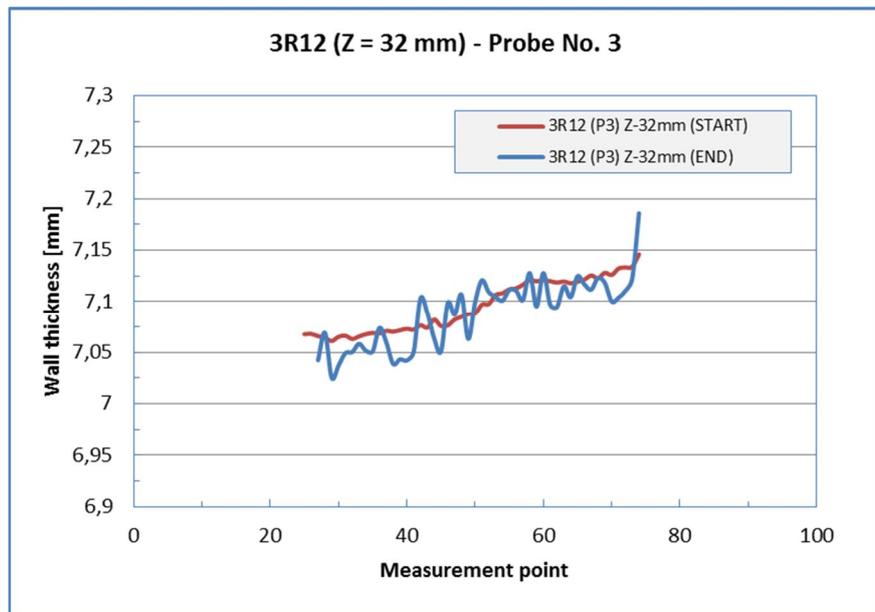
The results of the wall thickness profile measurements and the wall thinning curves derived from them are presented in Figures 28...35. The results showed that marked wall thinning had taken place only on the 3R12 specimen. Some wall thinning was observed also on the Super 625 specimen. The data of the HR11N and Sanicro 38 was more scattered showing that wall thinning and deposit formation (increase in wall thickness) had taken place locally. In addition the data in this test was more scattered than in the previous test indicating that all deposits were not removed from the surfaces in washing performed for the specimens' prior measurements.

Figure 28. Circumferential wall thickness profiles from 3R12 specimen (Probe No. 3): a) axial location  $Z = 25$  mm and b) axial location  $Z = 32$  mm.
