**VTT, Characterisation of probe test samples exposed to BLRB lower  
furnace environments – draft report 26.11.2012**

# Characterisation of probe test samples exposed to BLRB lower furnace environments

Author: Pekka Pohjanne

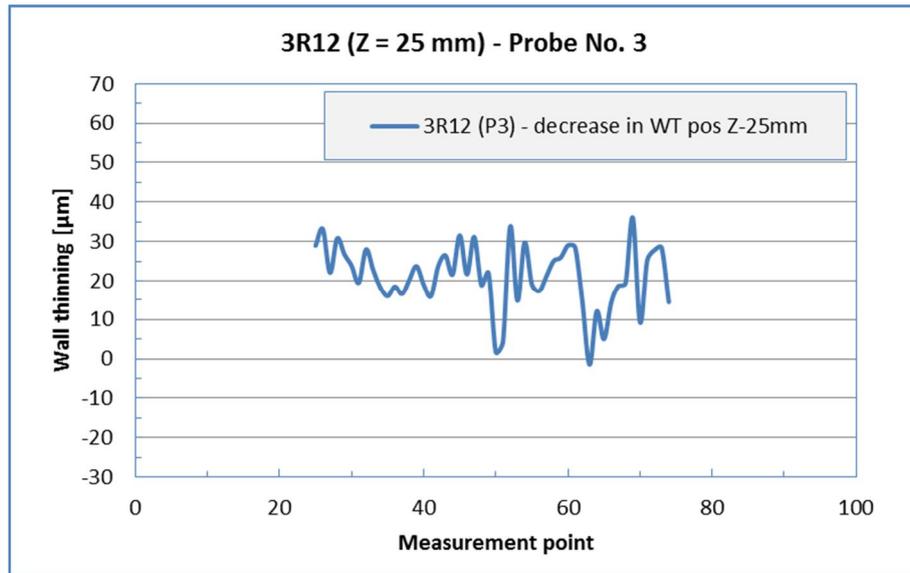
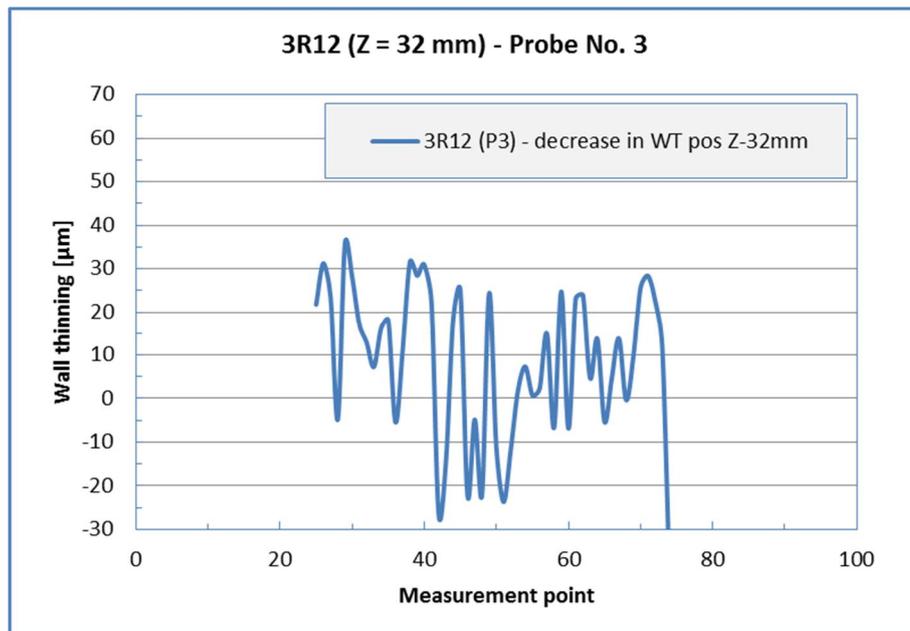
The results of the wall thickness profile measurements and the wall thinning curves derived from them are presented in Figures 28...35. The results showed that marked wall thinning had taken place only on the 3R12 specimen. Some wall thinning was observed also on the Super 625 specimen. The data of the HR11N and Sanicro 38 was more scattered showing that wall thinning and deposit formation (increase in wall thickness) had taken place locally. In addition the data in this test was more scattered than in the previous test indicating that all deposits were not removed from the surfaces in washing performed for the specimens' prior measurements.

Figure 29. Circumferential wall thinning curves from 3R12 specimen (Probe No. 3): a) axial location  $Z = 25$  mm and b) axial location  $Z = 32$  mm.

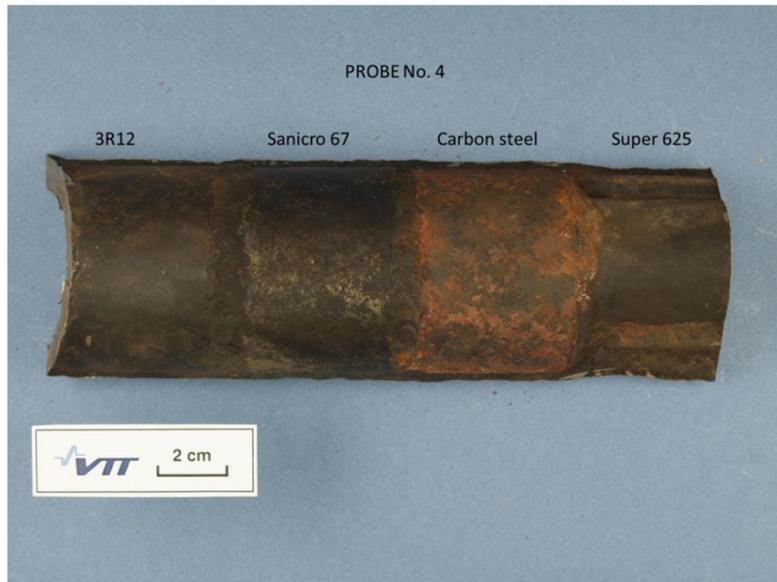
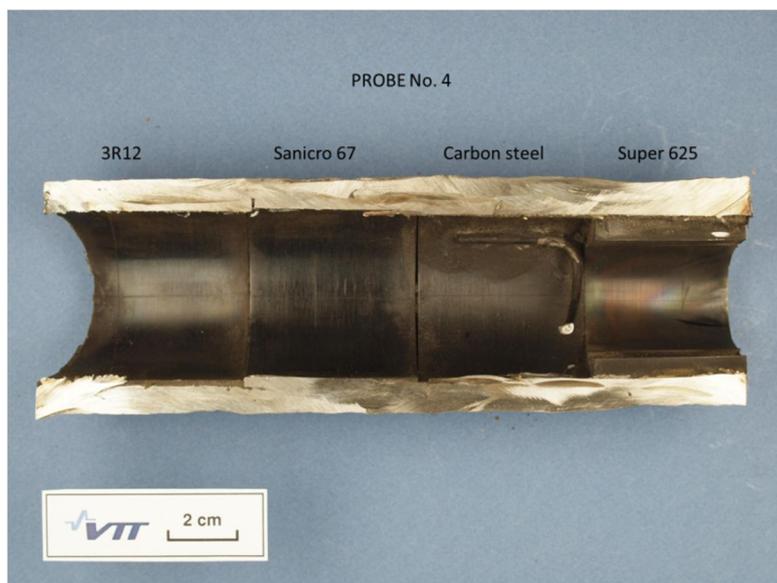
According to visual inspection the inner surfaces of the specimens were in good condition after testing. The outer surfaces of the 3R12, Sanicro 67 and Super 625 specimens were covered with thin dark deposits but appeared to be in good condition. The carbon steel specimen was heavily corroded.

Figure 39. Macrographs taken from the probe No. 4 head after exposure: a) outer surface exposed to the furnace side and b) inner surface exposed to the cooling liquid. A thermocouple soldered on the side surface of carbon steel specimen is clearly visible on inner surface.

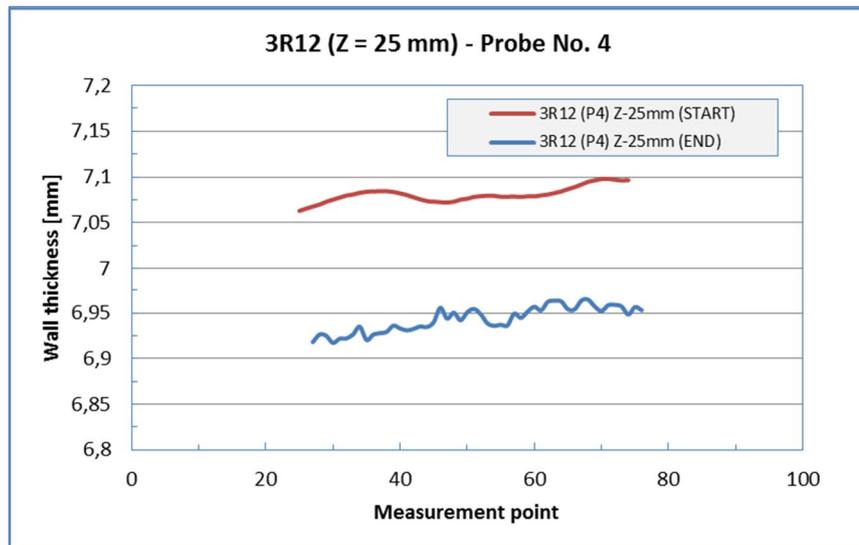
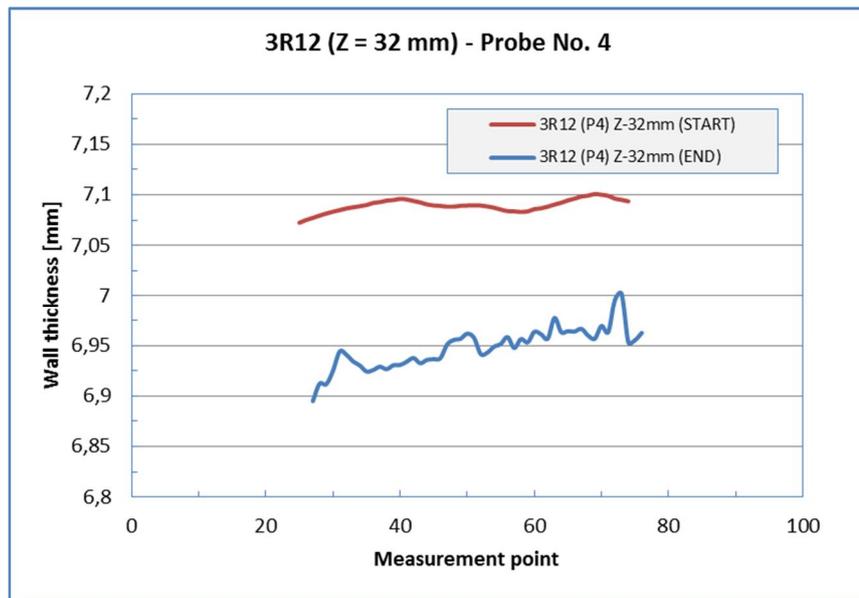
The results of the wall thickness profile measurements and the wall thinning curves derived from them are presented in Figures 40...47. The results showed that intense wall thinning had taken place on carbon steel specimen. Marked wall thinning was also observed on the 3R12 specimen and lesser degree also on the Super 625 specimen. The data of the Sanicro 67 specimen was more scattered showing that wall thinning and deposit formation (increase in wall thickness) had taken place locally. The results showed also that surface polishing prior testing together with longer exposure time reduced data scatter and thus improved accuracy.

Figure 40. Circumferential wall thickness profiles from 3R12 specimen (Probe No. 4): a) axial location  $Z = 25$  mm and b) axial location  $Z = 32$  mm.

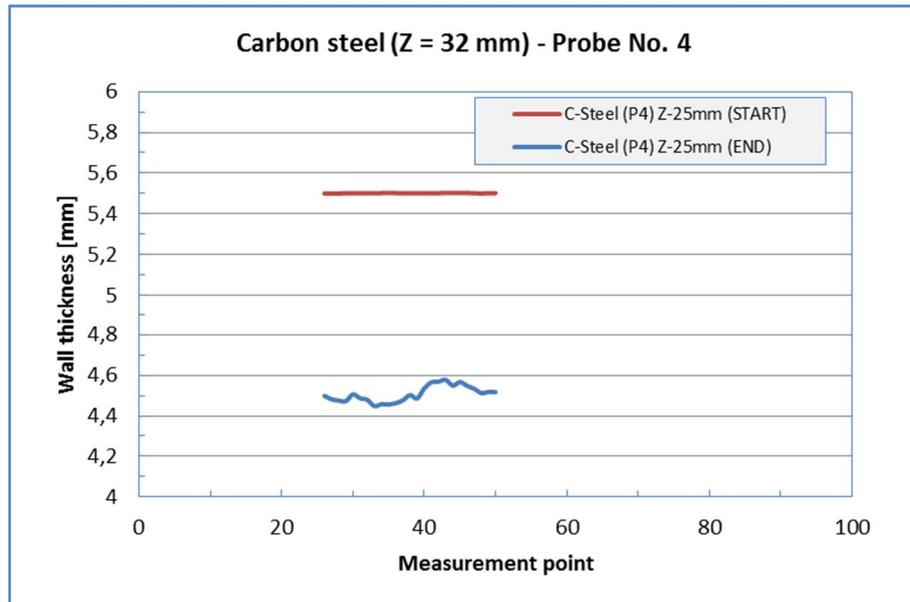
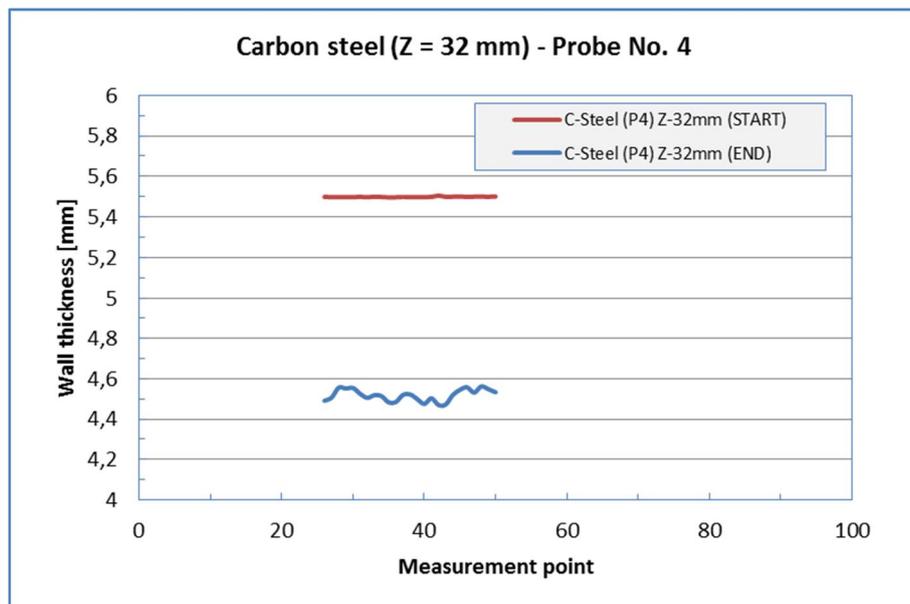
Figure 42. Circumferential wall thickness profiles from carbon steel specimen (Probe No. 4): a) axial location  $Z = 25$  mm and b) axial location  $Z = 32$  mm.

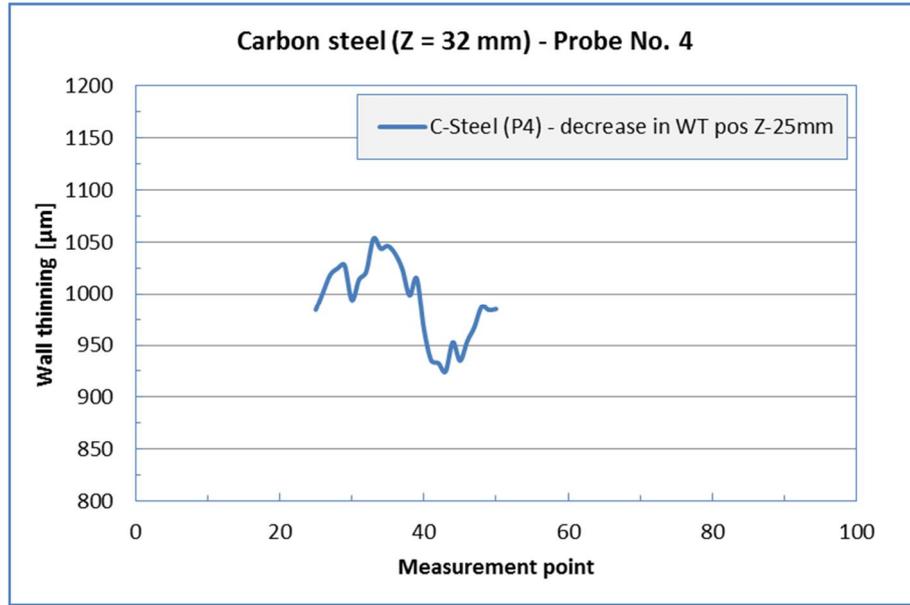
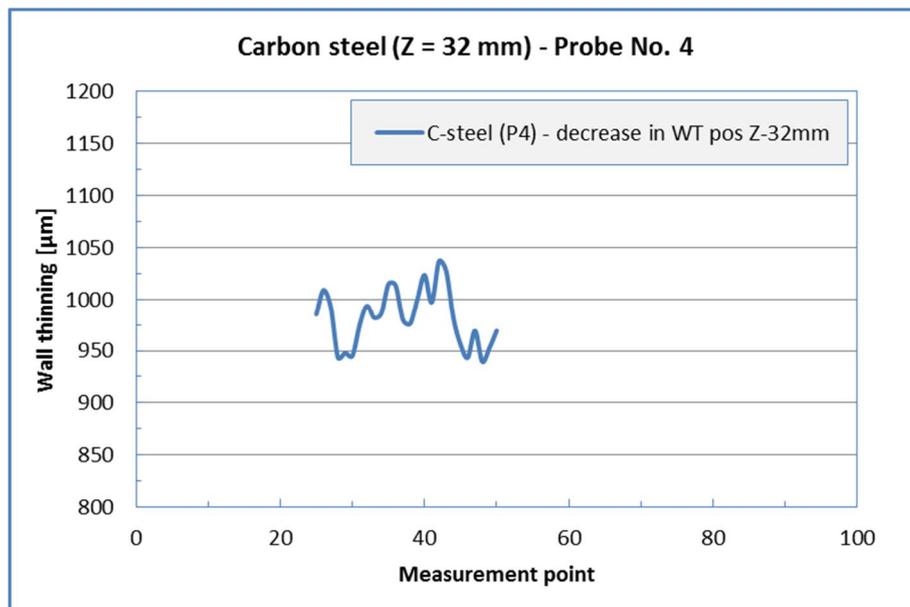
The average and maximum corrosion rates calculated on the basis of the wall thickness measurements are presented in Figure 48. Highest corrosion rates, ca. 4 mm/a, were measured for the carbon steel as expected. The 3R12 had the second highest corrosion rates, order of 0.6 mm/a. Maximum corrosion rate of the Super 625 was in the order 0.1 mm/a in this test, i.e. significantly lower than in the test No.3, where a maximum corrosion rate of 0.2...0.3 mm/a was observed. The best material in this test was Sanicro 67, its maximum corrosion rate was only about 0.02 mm/a.

Figure 43. Circumferential wall thinning curves from carbon steel specimen (Probe No. 4): a) axial location  $Z = 25$  mm and b) axial location  $Z = 32$  mm.

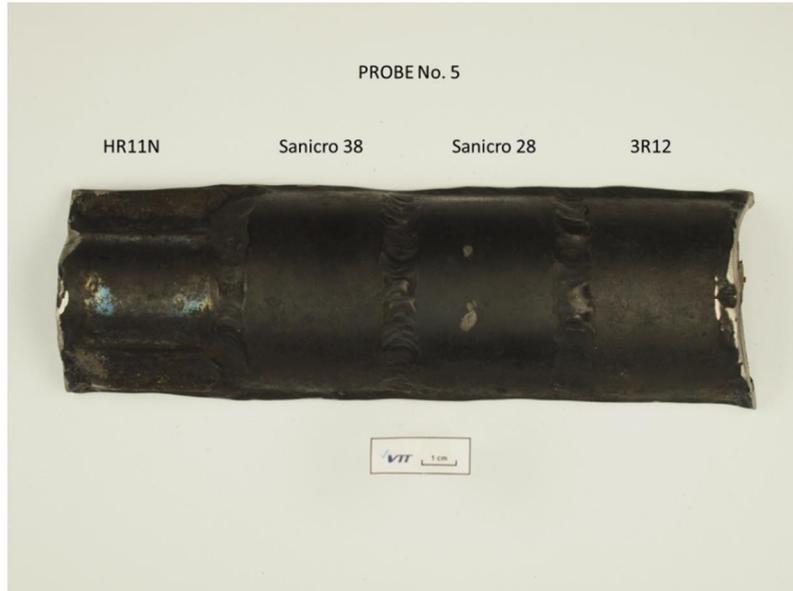
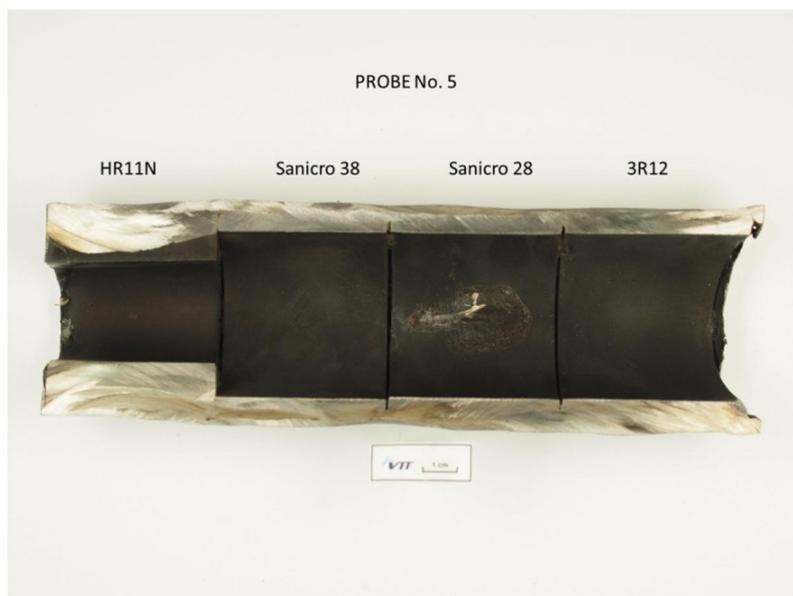
Total test duration of the test No. 5 was 2630 hours from which 2157 hours at the target temperature of 440 °C. The test materials in this exposure were 3R12, Sanicro 28, HR11N and Sanicro 38, Figure 51. According to visual inspection all samples were in good condition after testing i.e. neither marked general or localised corrosion nor deposits or oxide scales were observed either on outer or inner surfaces.

*Figure 51. Macrographs taken from the probe No. 5 head after exposure: a) outer surface exposed to the furnace side and b) inner surface exposed to the cooling liquid. A thermocouple soldered on the middle of Sanicro28 specimen, that hindered WT measurements after exposure, is clearly visible on inner surface.*

The results of the wall thickness profile measurements and the wall thinning curves derived from them for 3R12, HR11N and Sanicro 38 are presented in Figures 52...57. The results showed that marked wall thinning had taken on the 3R12 specimen. Some wall thinning was observed also on the Sanicro 38 specimen and locally also on the HR11N specimen. The WT profile measurements for the Sanicro 28 sample after the test failed due to the thermocouple that was soldered on the inner surface of the specimen (Figure 51b).

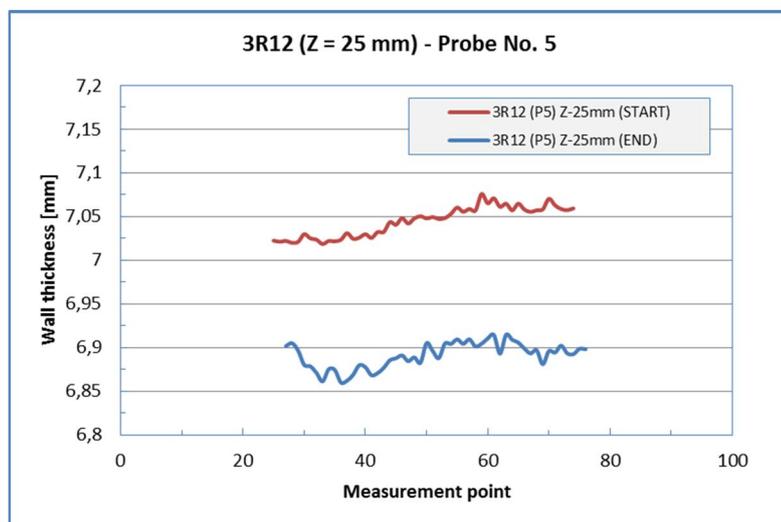
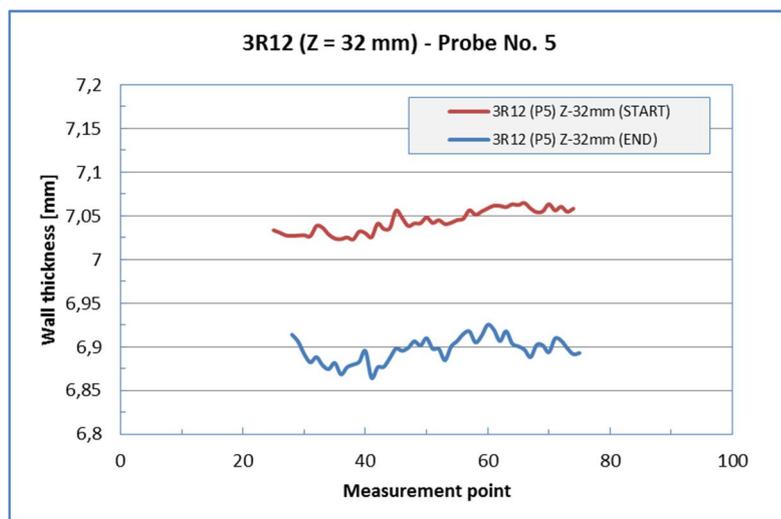
Figure 52. Circumferential wall thickness profiles from 3R12 specimen (Probe No. 5): a) axial location  $Z = 25$  mm and b) axial location  $Z = 32$  mm.

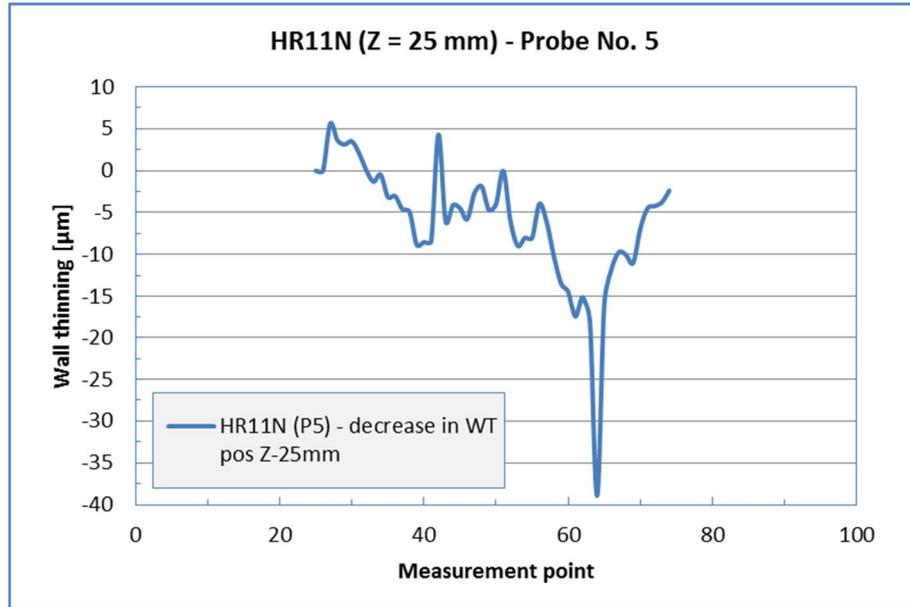
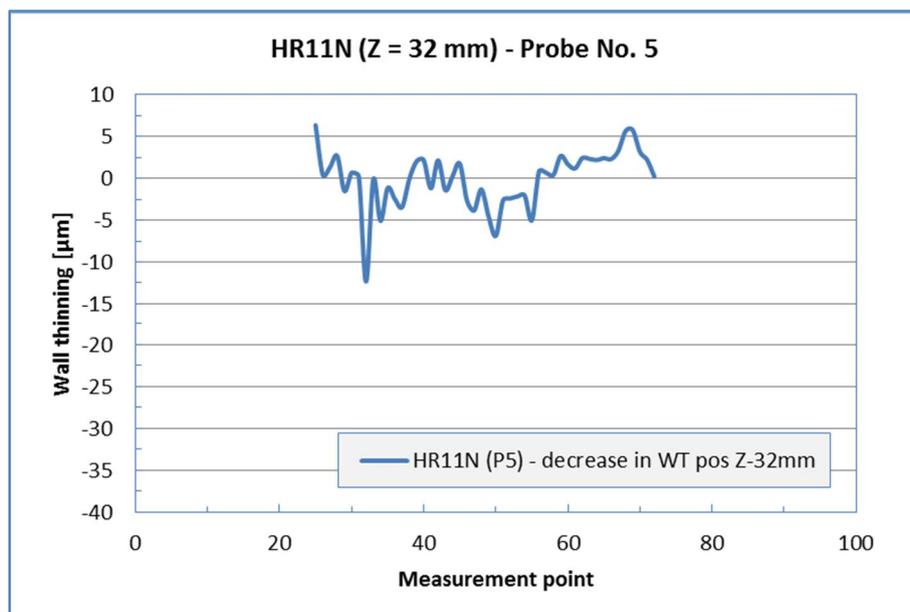
Figure 54. Circumferential wall thickness profiles from HR11N specimen (Probe No. 5): a) axial location  $Z = 25$  mm and b) axial location  $Z = 32$  mm.

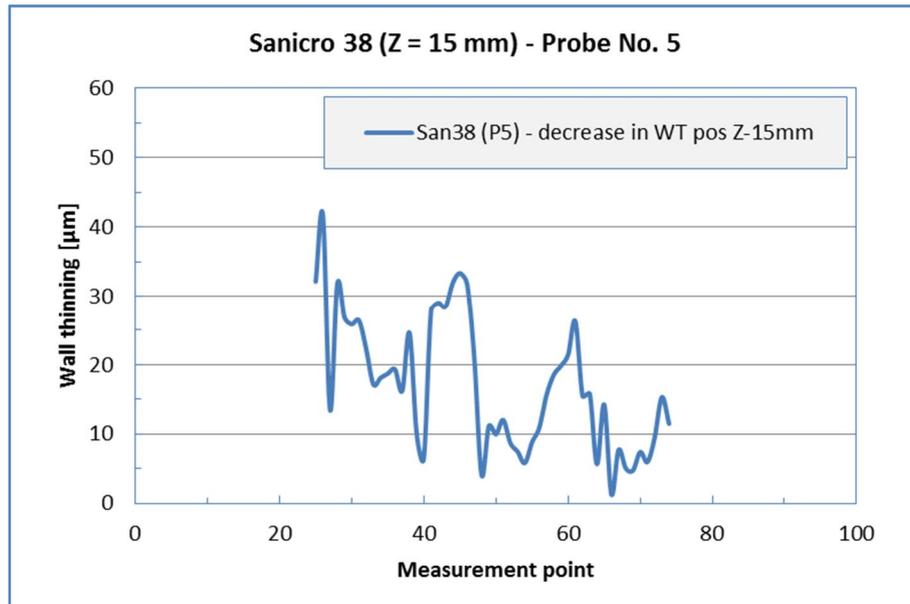
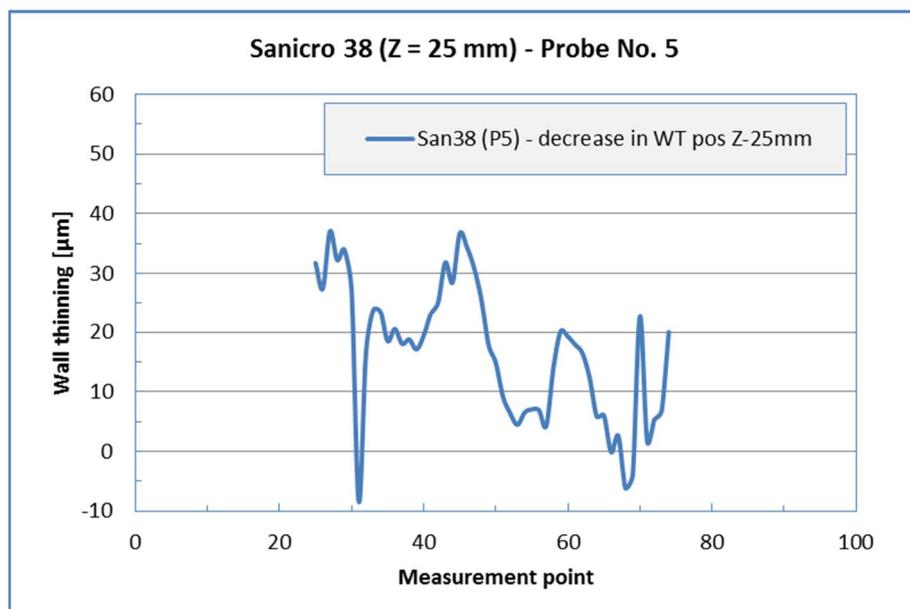
Figure 56. Circumferential wall thickness profiles from Sanicro 38 specimen (Probe No. 5): a) axial location  $Z = 15$  mm and b) axial location  $Z = 25$  mm.

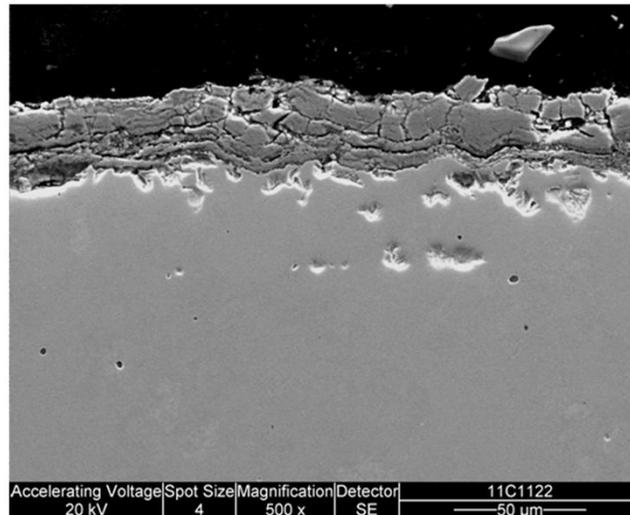
a) *Carbon steel*

The carbon steel corroded at extremely high rate ( $>4$  mm/a) at the temperature of 440 °C. Also the 3R12 (AISI 304L) corrodes in such high rate ( $>0.6$  mm/a) at 440 °C that it can't be safely used in the lower furnace in the future high pressure recovery boilers, where material temperatures are expected to rise to level of 400...440 °C. The performance of the Sanicro 38 and HR11N was satisfactory in long term test at 440 °C ( $CR_{max} \sim 0.1...0.2$  mm/a), but it is recommended to verify their performance also at lower temperature (400 °C). The new material group which looks promising is the high chromium alloys 3RE28/3XRE28 and Sanicro 28, but their long term performance should be verified in the future. If the corrosion resistance is the determining factor, the Sanicro 67 seems to be a good material for future boilers, since its corrosion rate was lowest from the studied alloys. Based on the long term test the Super 625 in the second best choice for the future high pressure boiler, but because of its relatively high corrosion rate in short term test more and longer tests are needed to verify its performance.
