**Sulakourujen materiaalitutkimus, VTT – KMP esitys 23.1.2020**

# Sulakourujen materiaalitutkimus

Konemestaripäivät 23.01.2020  
Sanni Yli-Olli  
Satu Tuurna

# SOODAKATTILAN AJO-OLOSUHTEET JA TULIPESÄN ALAOSAN KORROOSIO

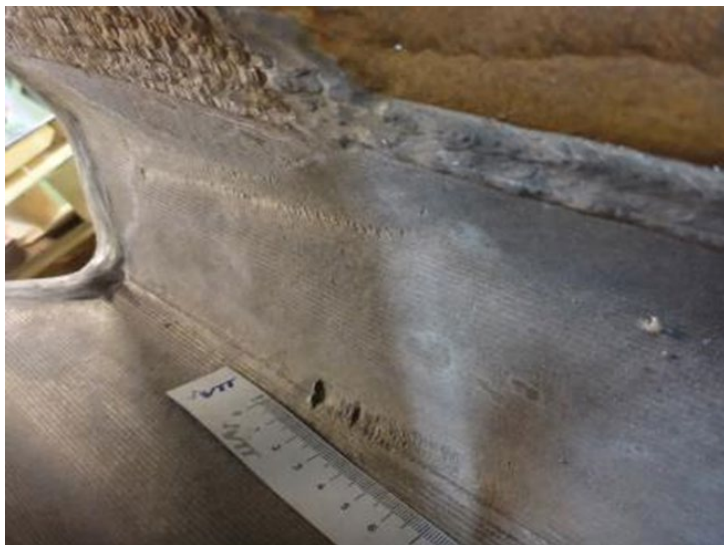
Rassauksen jättämiä jälkiä

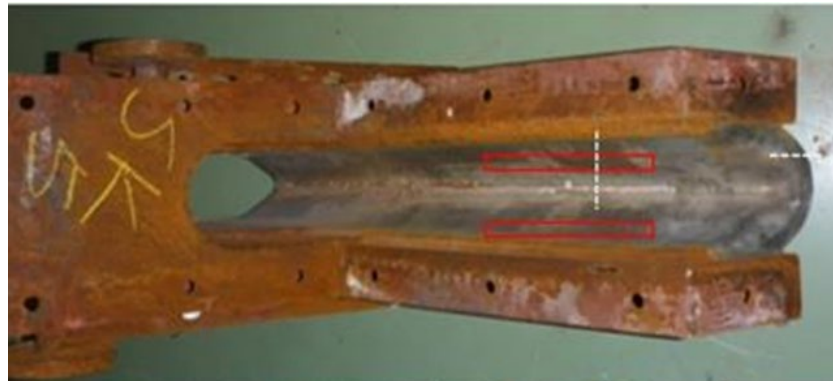
Säröilyä kourun seinämällä

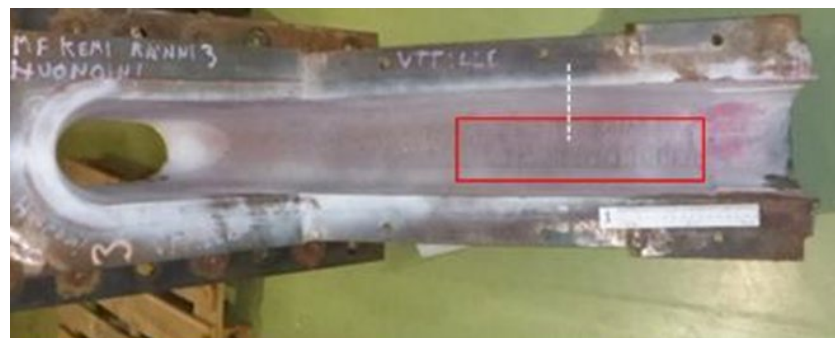
Säröilyä kourun pohjalla

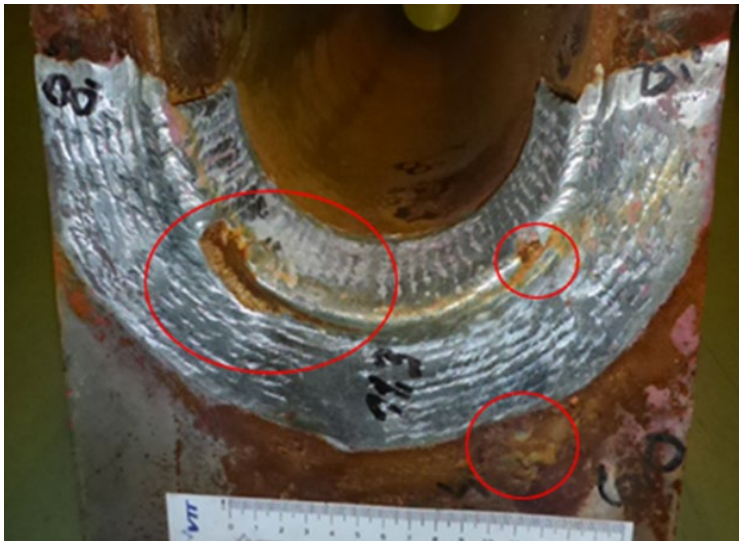
Päädyn syöpymiä

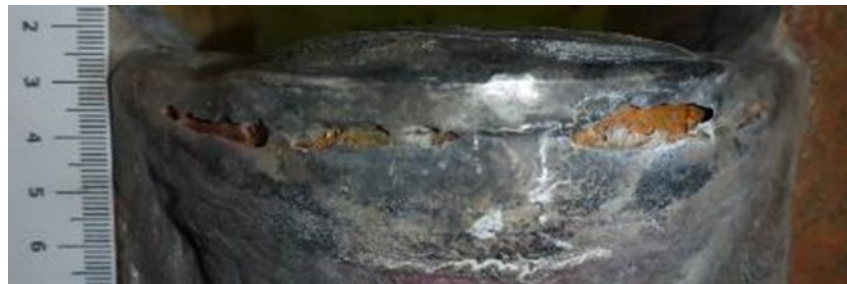
Päädyn syöpymiä

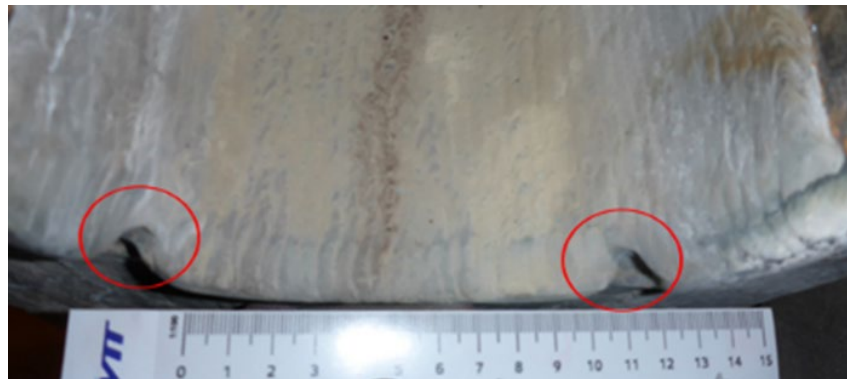
Päädyn syöpymiä

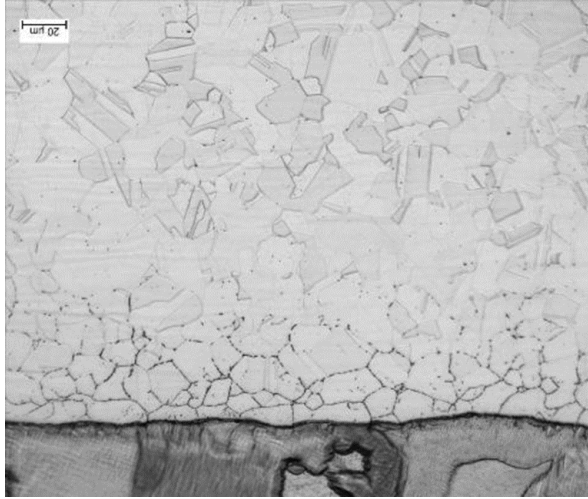
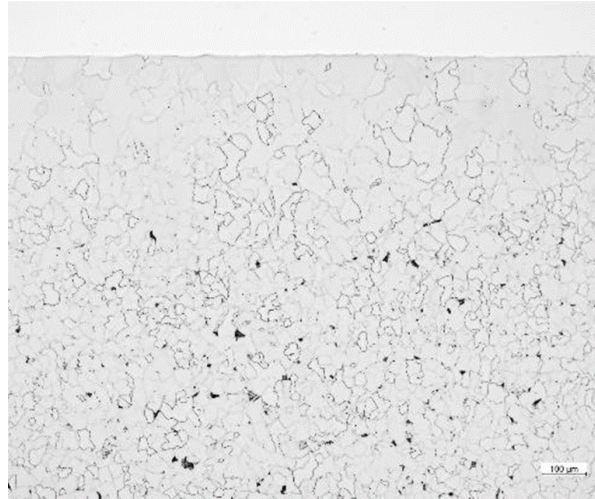
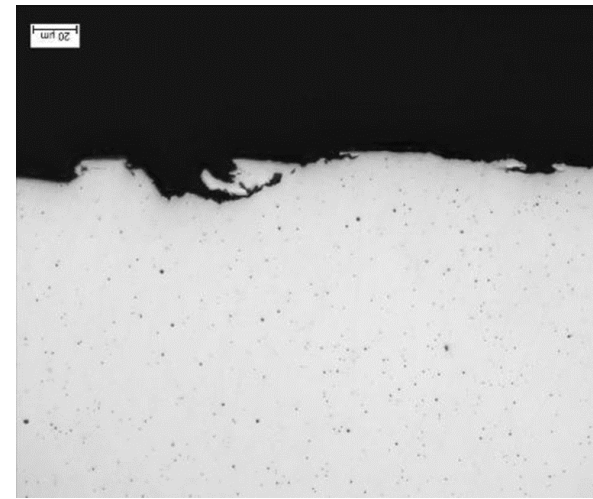
# Laitos 1 – V:n mallinen compound -kouru

- pinnoitteen puolella n. 55  $\mu\text{m}$  matkalla karbideja raerajoilla sekä perusaineen puolella n. 200  $\mu\text{m}$  hiilenkatovyöhyke
- pinnoitteen pinnalla kourun seinämällä pieniä säröjä
- ajojakso 12 kk

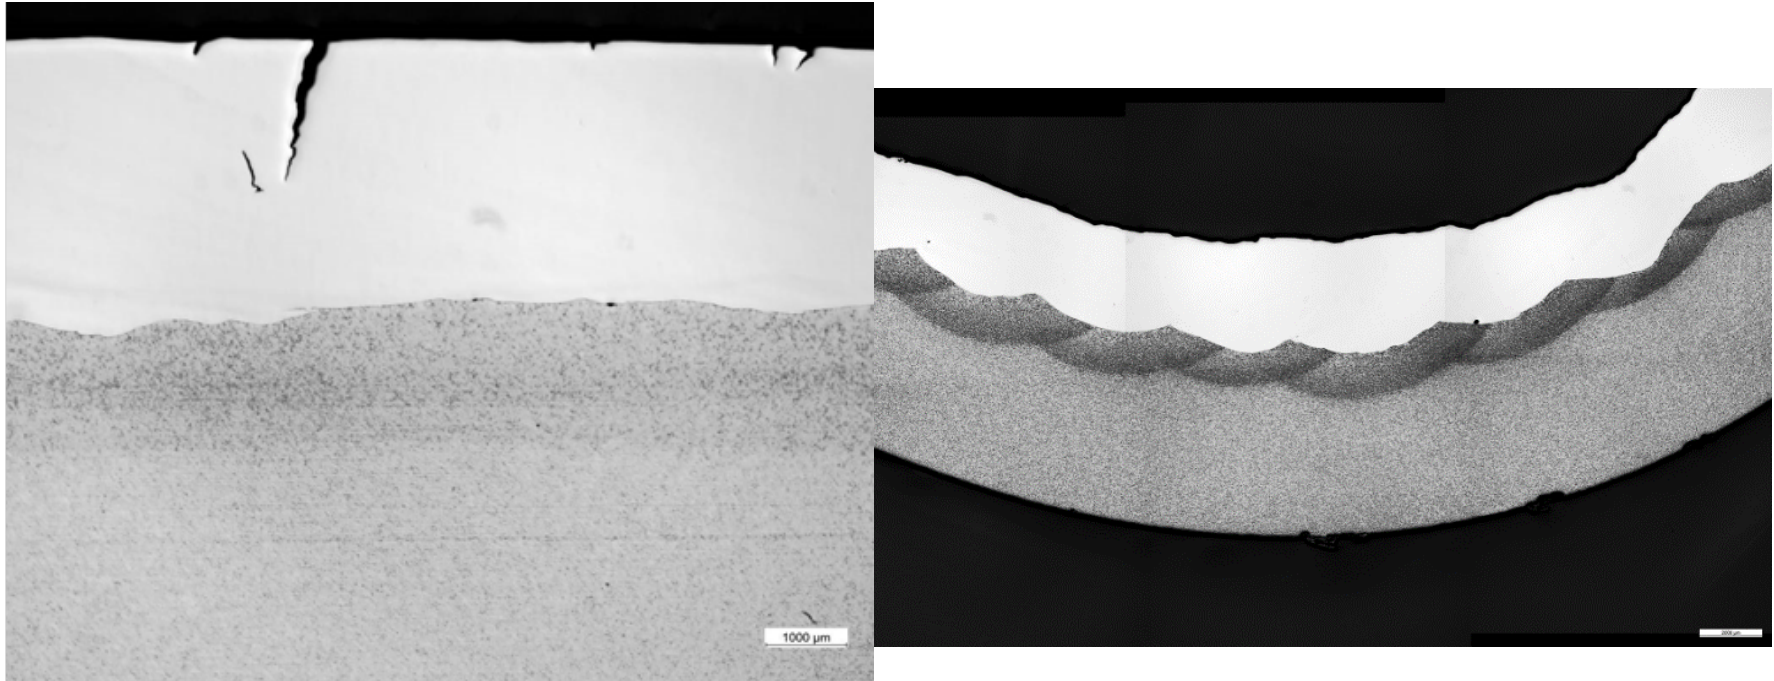
## Laitos 2 – V:n mallinen laserpinnoitettu kouru

- seinämällä satunnaisia säröjä, jotka eivät ulottuneet perusaineeseen, syvin 1800 µm
- ajojakso 18kk

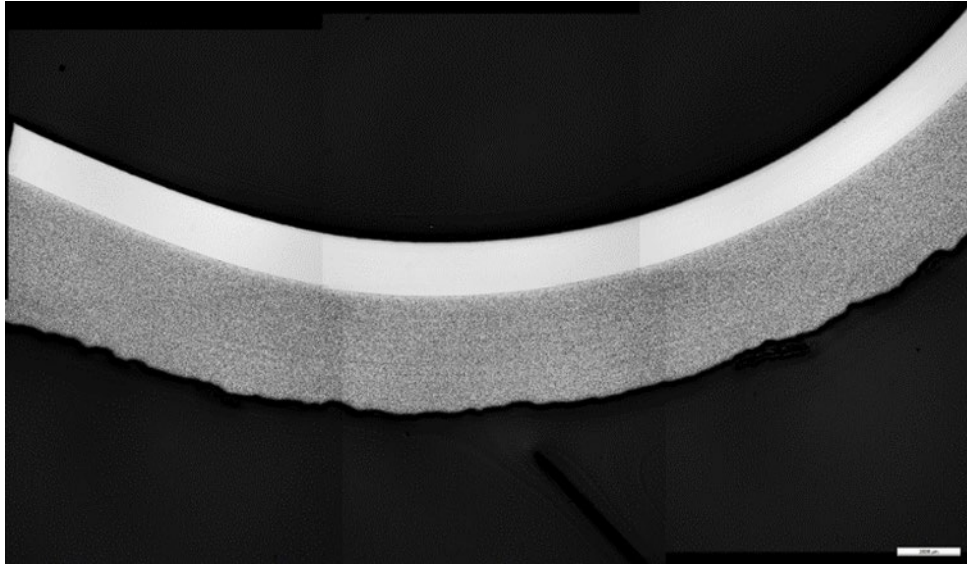
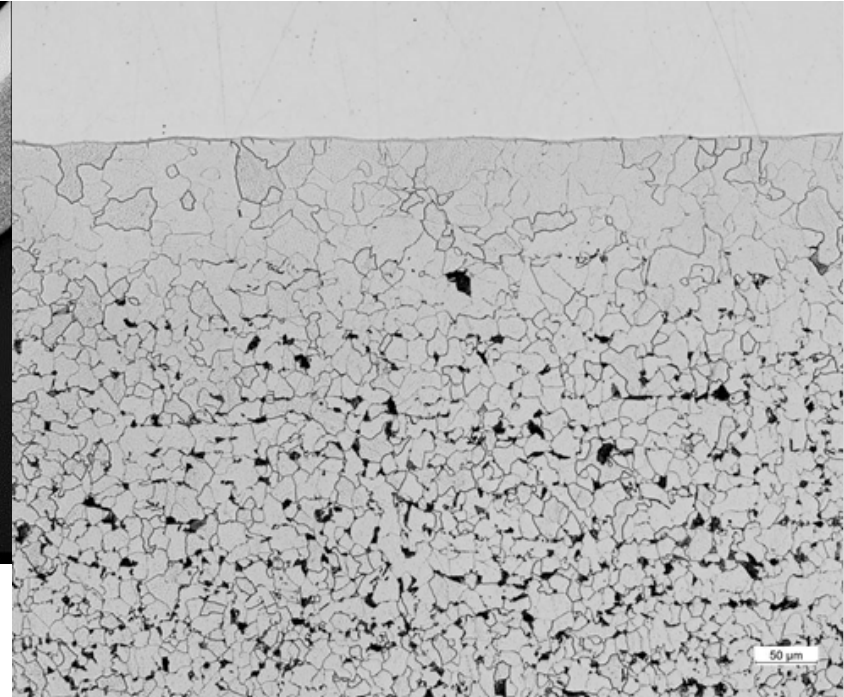
# Laitos 3 – syöpymää compound -kourun jättöpäädyssä

- ferriittis-perliittinen, ei lämpökuorman aiheuttamaa rakenteen hajaantumista
- pinnoite-perusainerajapinnalla noin 140 μm paksuinen hiilenkatovyöhyke
- ajojakso 24 kk

Jättöpään syöpymää

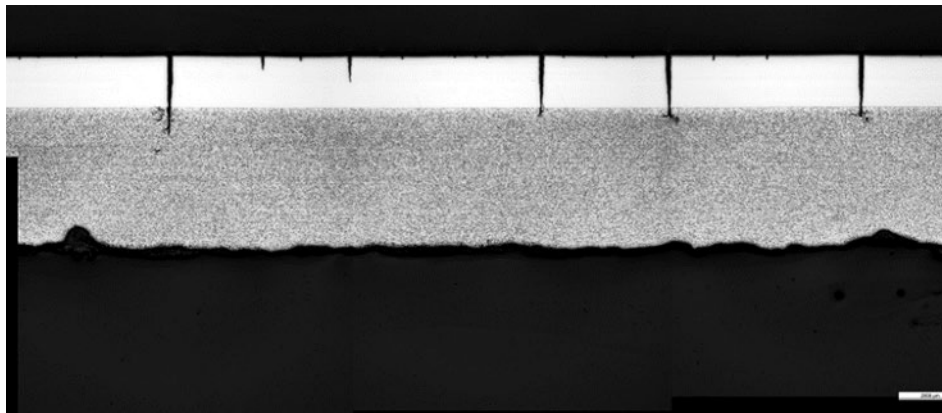
# Laitos 3 – säröjä compound -kourun seinämällä

- seinämällä perusaineeseen ulottuvia säröjä ( $> 2100 \mu\text{m}$ )
- ajojakso 24 kk

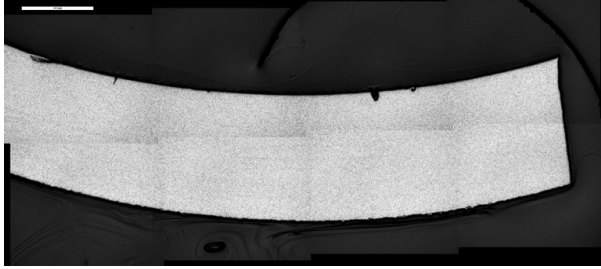
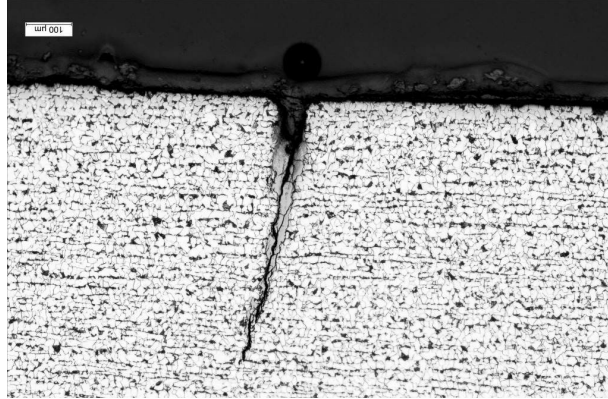
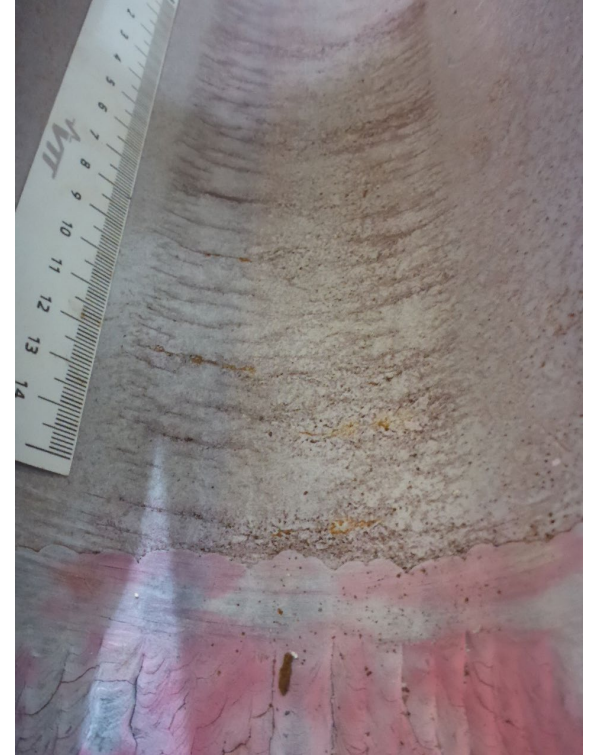
# Laitos 4 – musta kouru, säröjä kourun pohjalla

- pinnoitetta jättöpäässä n. 110 mm matkalla
- pinnoittamattomalla alueella kourun pohjalla säröjä, syvyys noin 750  $\mu\text{m}$
- ajojakso 12 kk

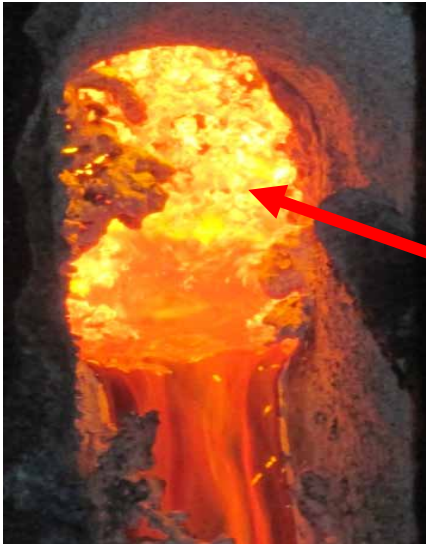
## Spout opening

High bed and a pile of char at top of the spouts.  
No air flow to spout opening to keep it clean.

*Burning char and smelt is in contact with spout opening tubes  
➔ risk of spout opening tube corrosion (cracks or general corrosion)*

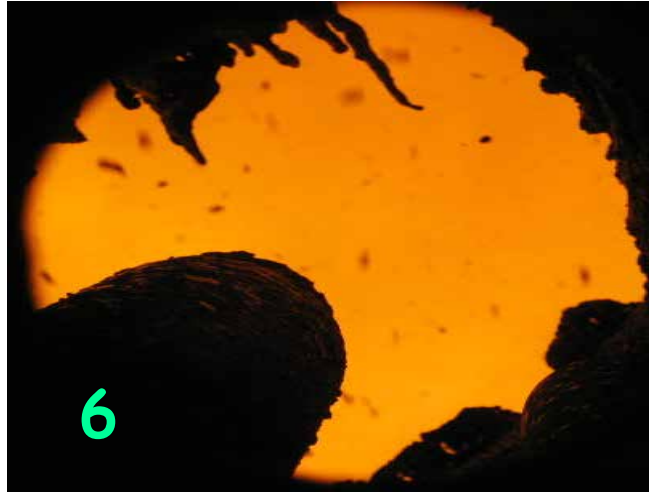
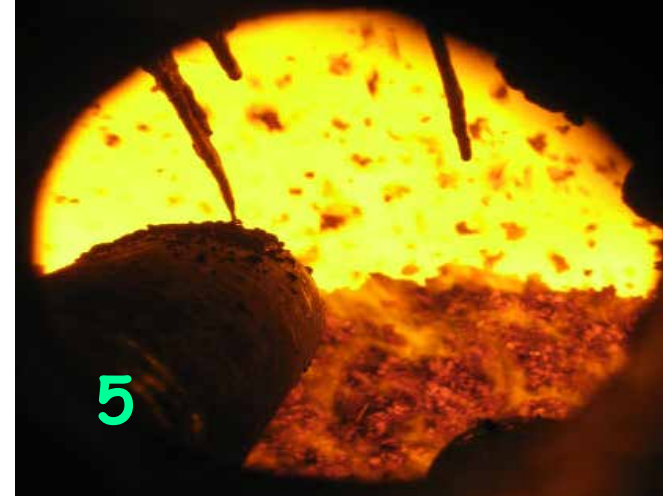
High local bed in front of burner 3

**Case A** Lot of char particles flying and piling up in front of Burner 3, close to wall  
→ high and hot local bed → Temperature spikes in the floor tubes  
Caused by “overheated” smelt attack to the floor tubes below.

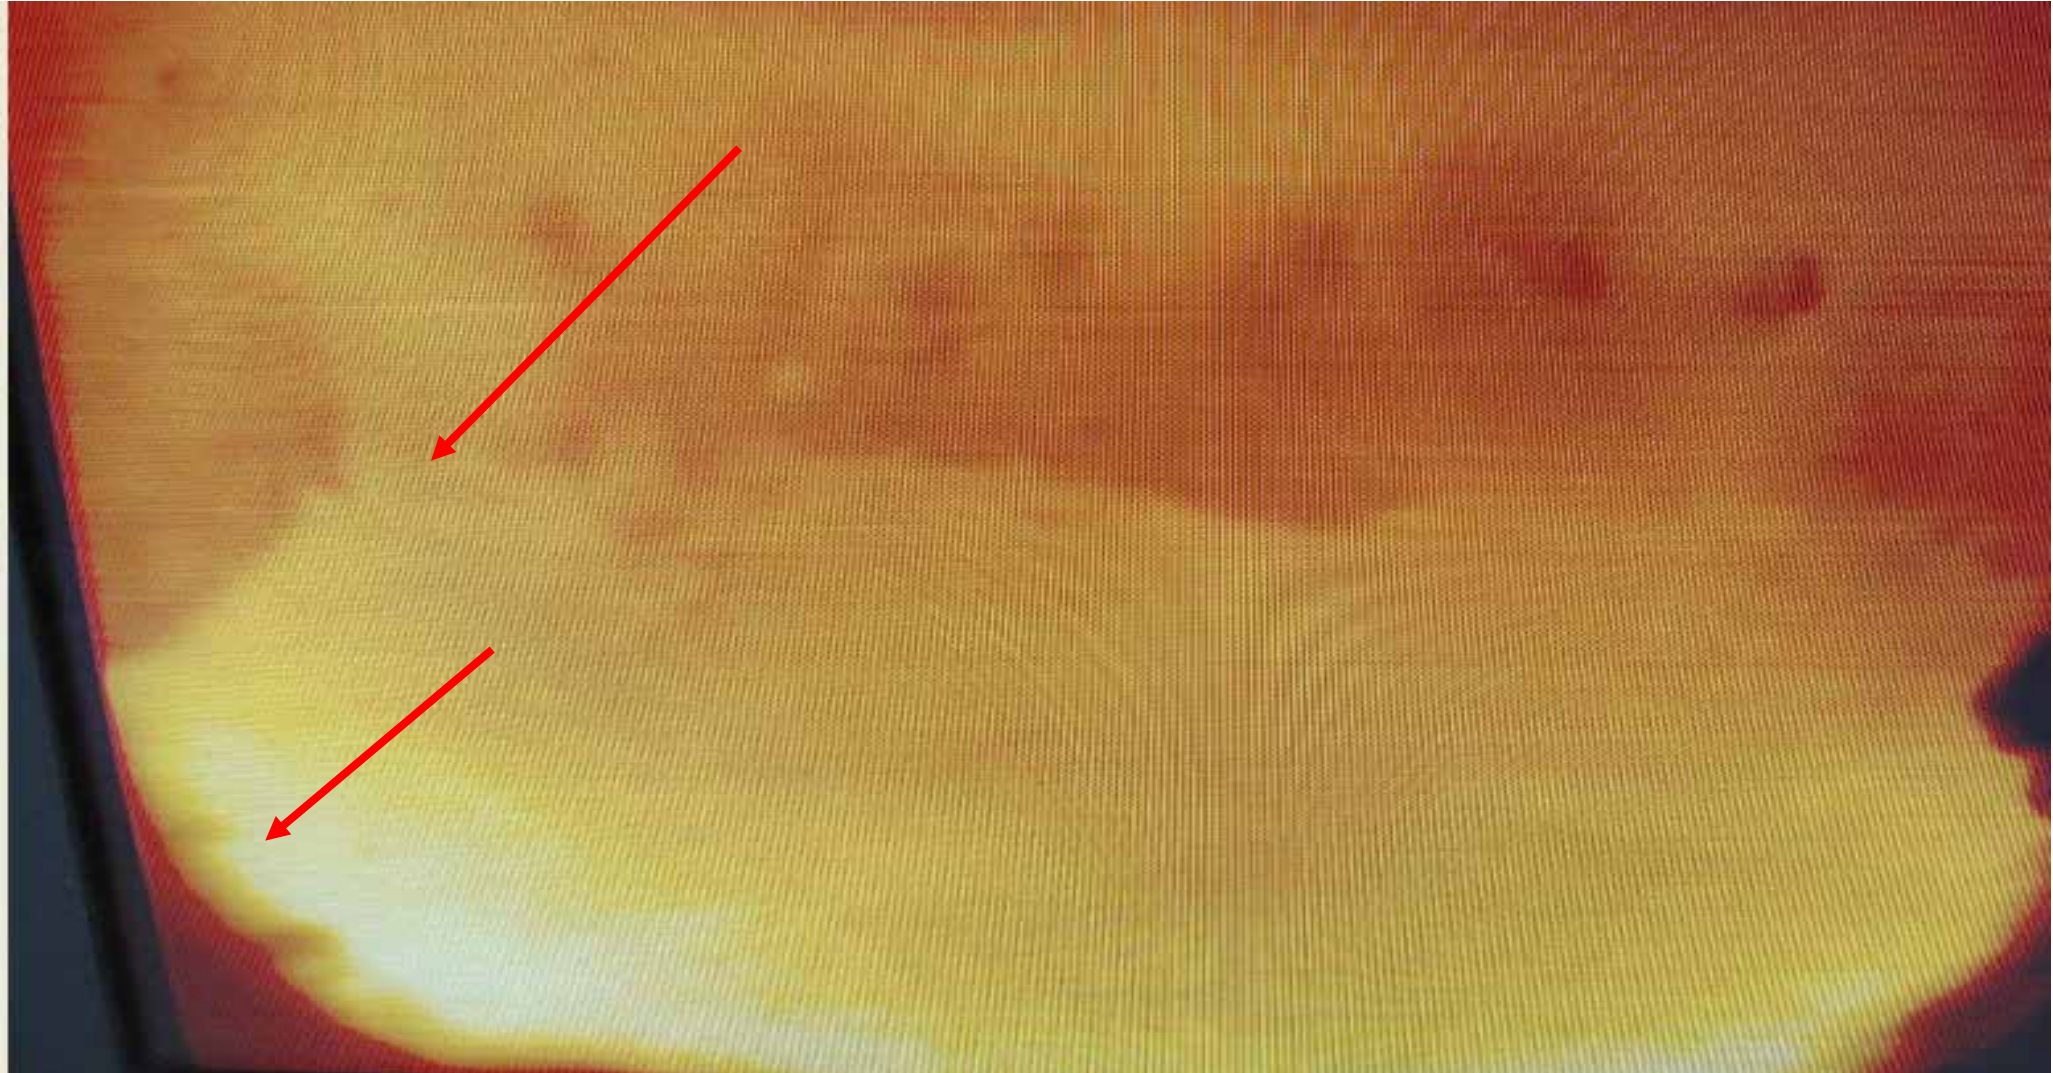
Lower furnace cracks caused by local overheating, "hot spots"  
Recovery Boiler 650 tds/d, DS 75%, splash plates

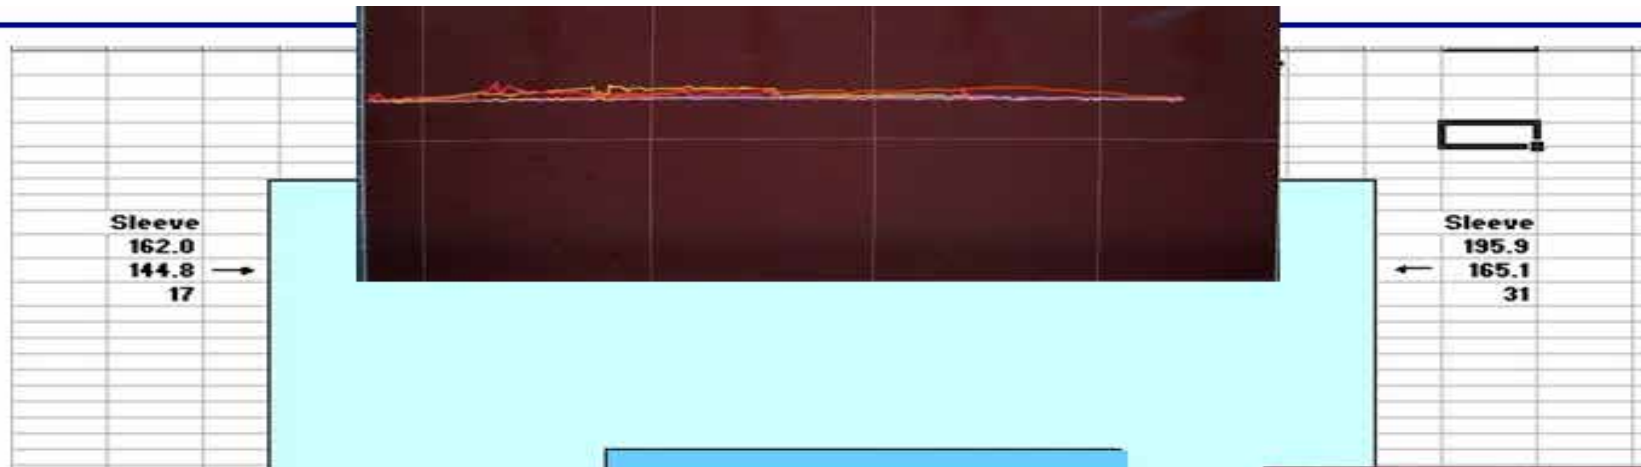
A lot temperature spikes at front wall, small spikes other walls

Bed very close to front wall

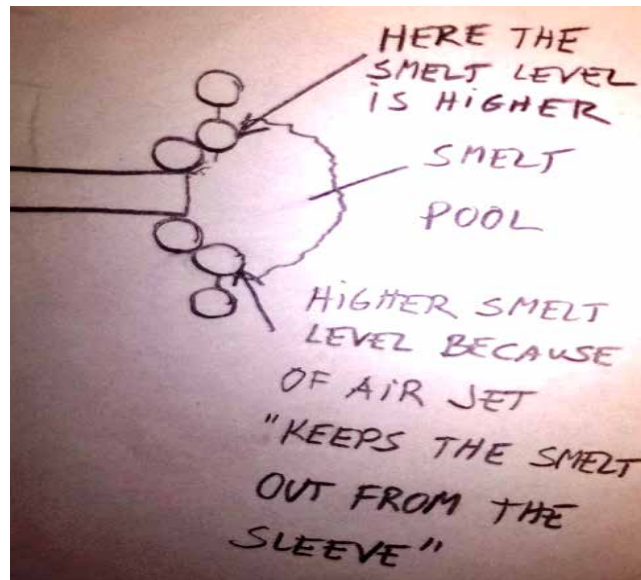
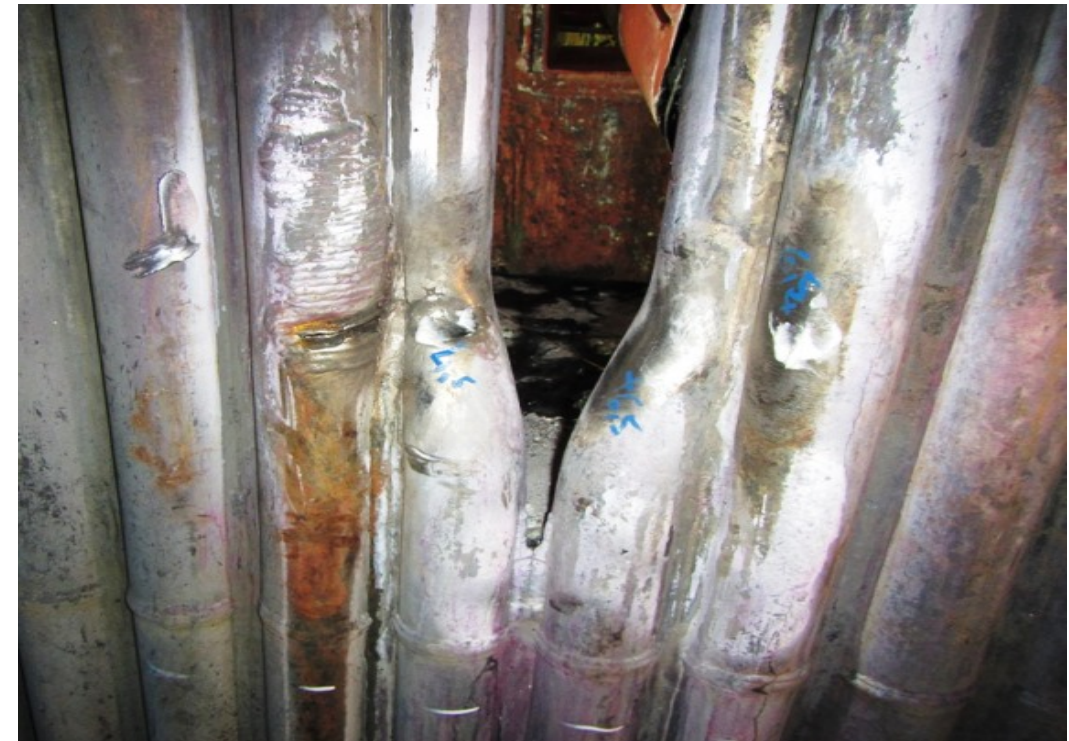
No cracks in the opening tubes but in the second tubes

San38 tubes = no cracks  
304L tubes = cracks

304L   304L   San38   San38   304L

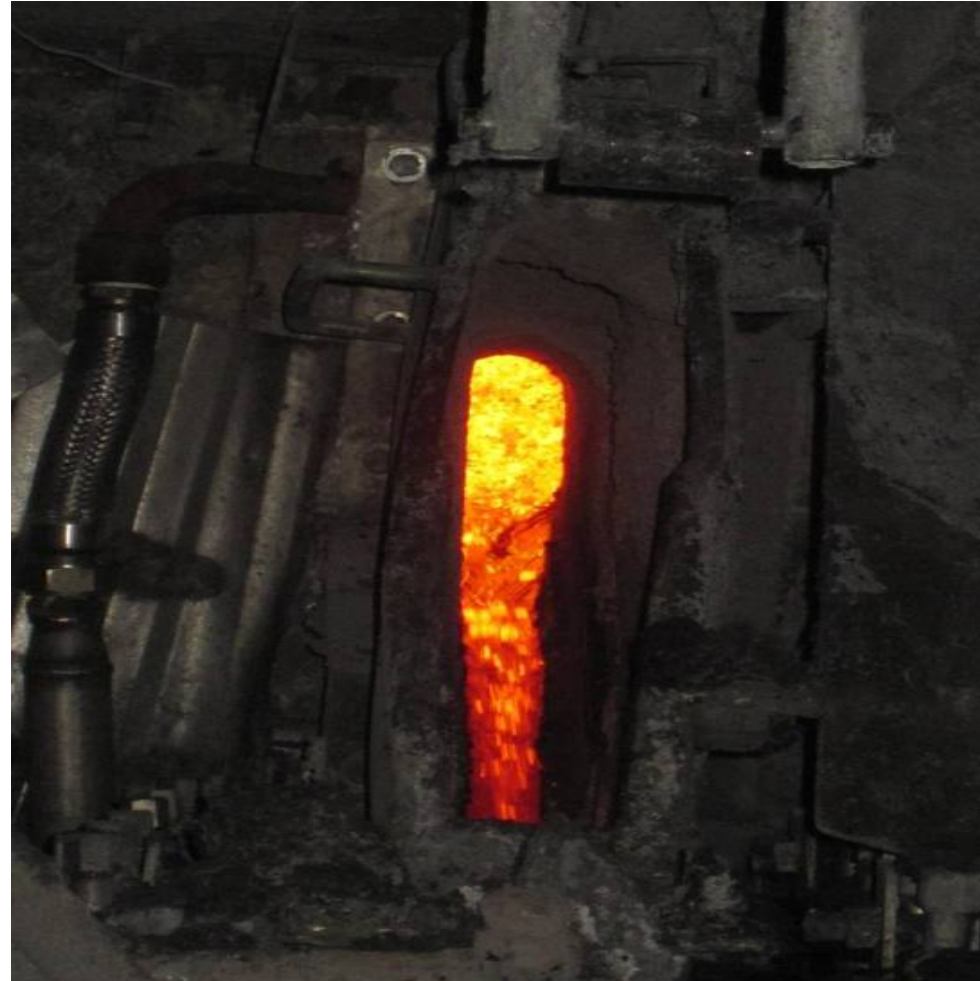
Primary airport tubes and Spout opening tube cracks  
Recovery Boiler 1000 tds/d, DS 71%, splash plates

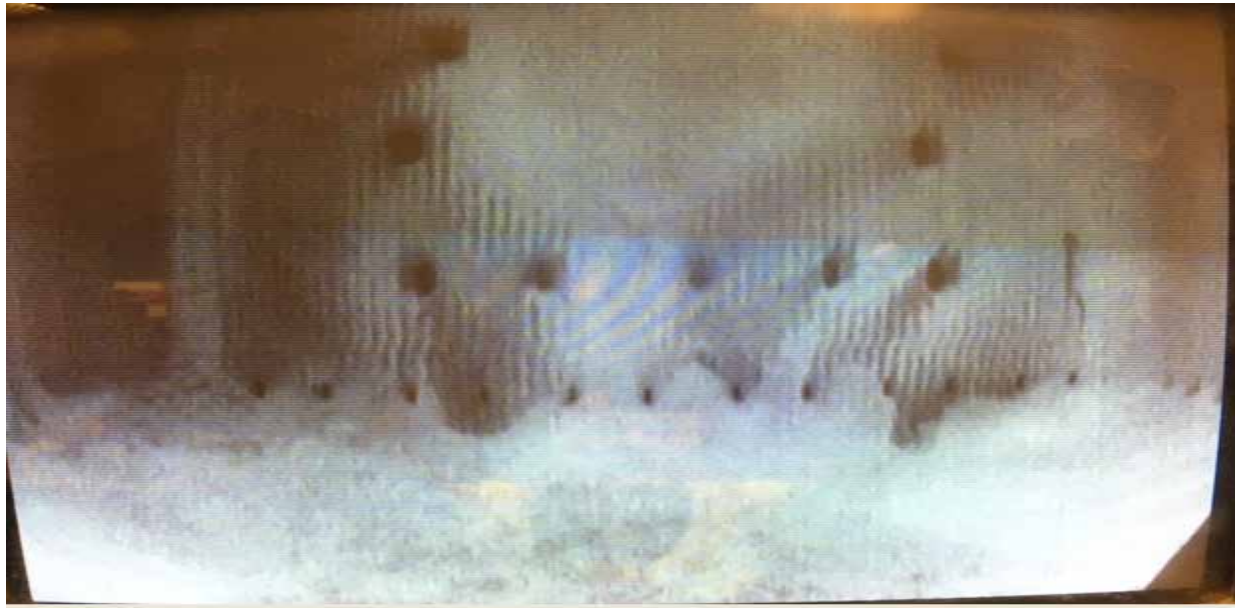
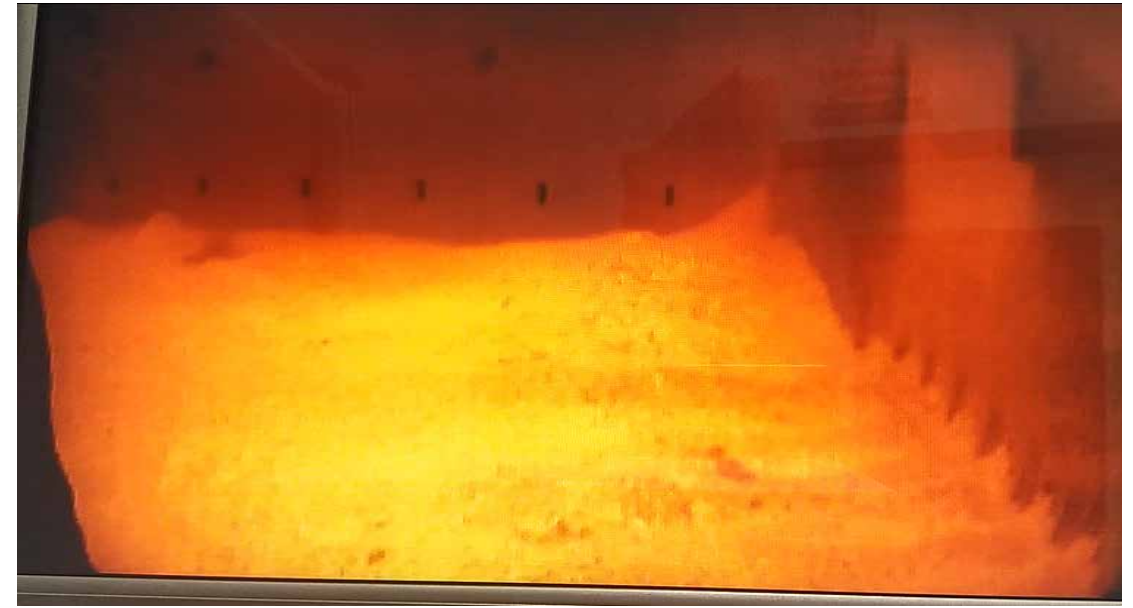
Char bed tuning is not easy with a camera view like this.

Below is the view what we'd like to see. Good camera shows details about the char bed → easier to tune up and avoid cracking problems.

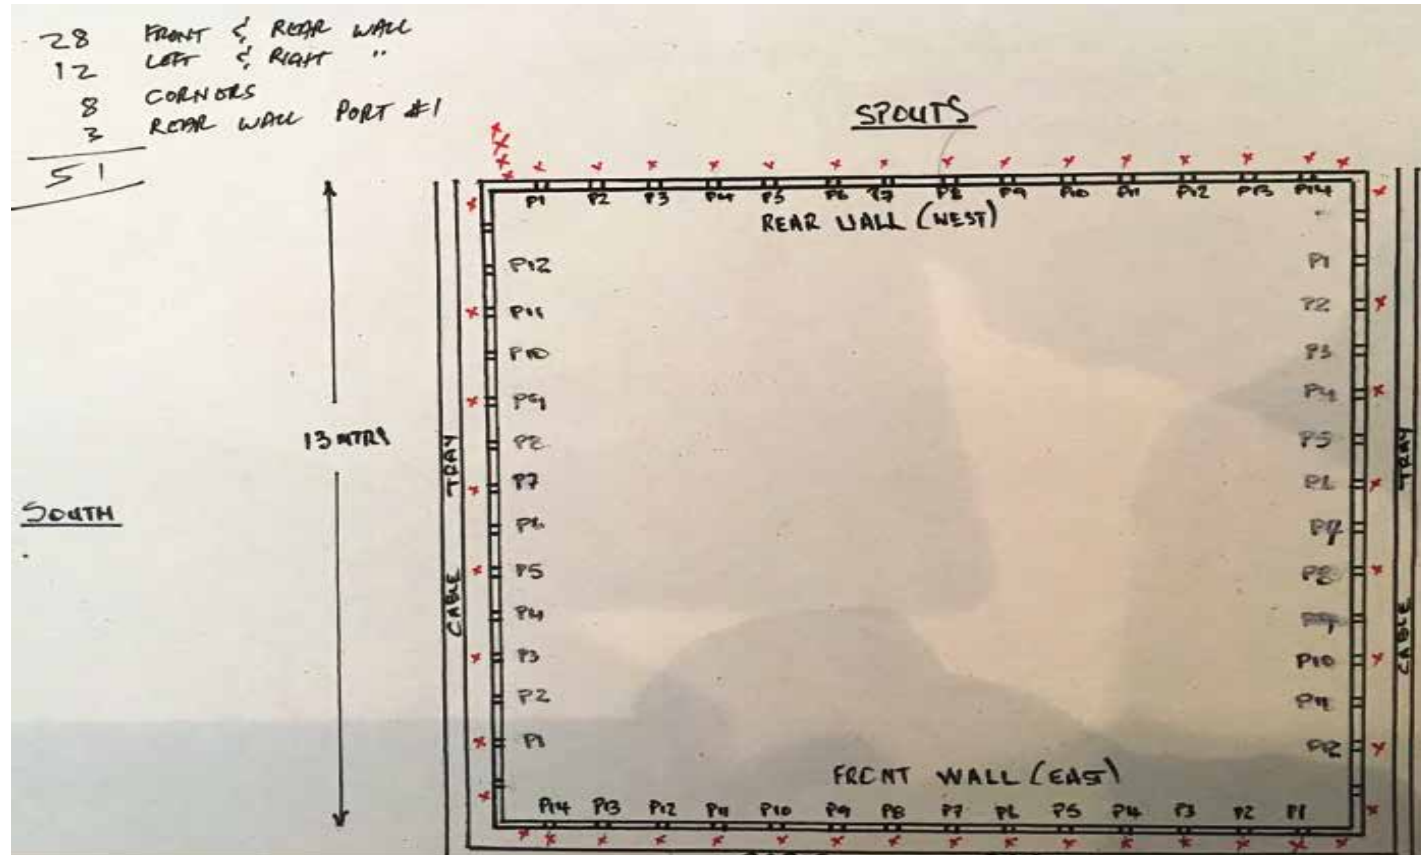
Mill E maintenance experts prepared a detailed map of corroded (cracked) primary air ports with history information. Based on this map and visual observation, the exact location and number of thermocouples to be installed in the shutdown were selected
