# Characterisation of probe test samples exposed to BLRB lower furnace environments

Author: Pekka Pohjanne

Report's title Characterisation of probe test samples exposed to BLRB lower furnace environments	
Customer, contact person, address Soodakattilayhdistys ry.	Order reference
Project name SKYREC Sondi	Project number/Short name 33189
Author(s) Pekka Pohjanne	Pages 70/
Keywords	Report identification code VTT-R-02472-13
<p><b>Abstract</b></p> <p>Current trend to increase electricity generation of recovery boilers possess new demands for the tube materials, when the material temperatures are increased due to higher steam values. Operational experiences from current boilers have shown that the AISI 304 L compound tubes suffer from accelerated corrosion in furnace wall, when the material temperatures are increased from normal values due to the internal surfaces scales. This indicates that the AISI 304L might be unsuitable cladding material for the future high pressure boilers.</p> <p>The goal of this study was to test different potential cladding materials in actual recovery boiler lower furnace conditions, but at higher than current temperatures, in order to determine what material

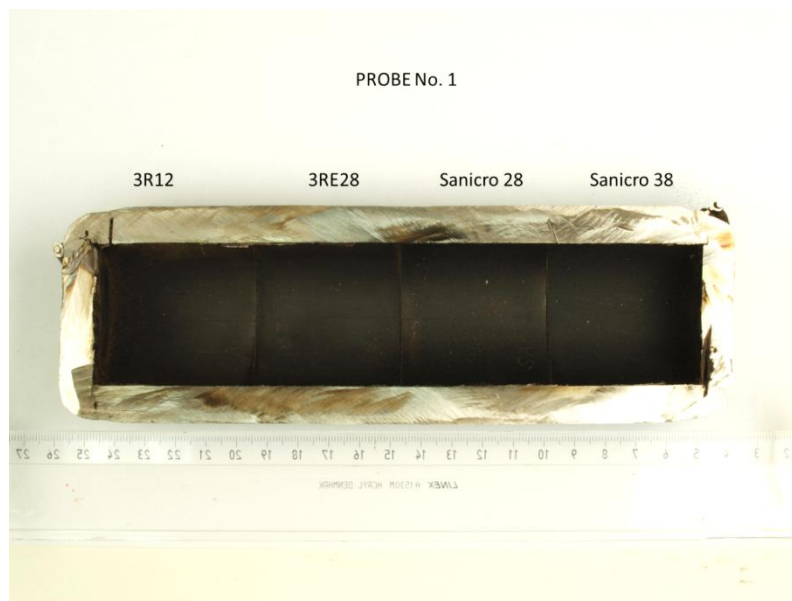
Total test duration of the test No. 1 was 1006 hours, from which 906 hours at the target temperature of 440 °C. The test materials in this exposure were 3R12, 3RE28, Sanicro 28 and Sanicro 38, Figure 3. According to visual inspection all samples were in good condition after testing i.e. neither marked general or localised corrosion nor deposits or oxide scales were observed either on outer or inner surfaces.

Figure 3. Macrographs taken from the probe No. 1 head after exposure: a) outer surface exposed to the furnace side and b) inner surface exposed to the cooling liquid.

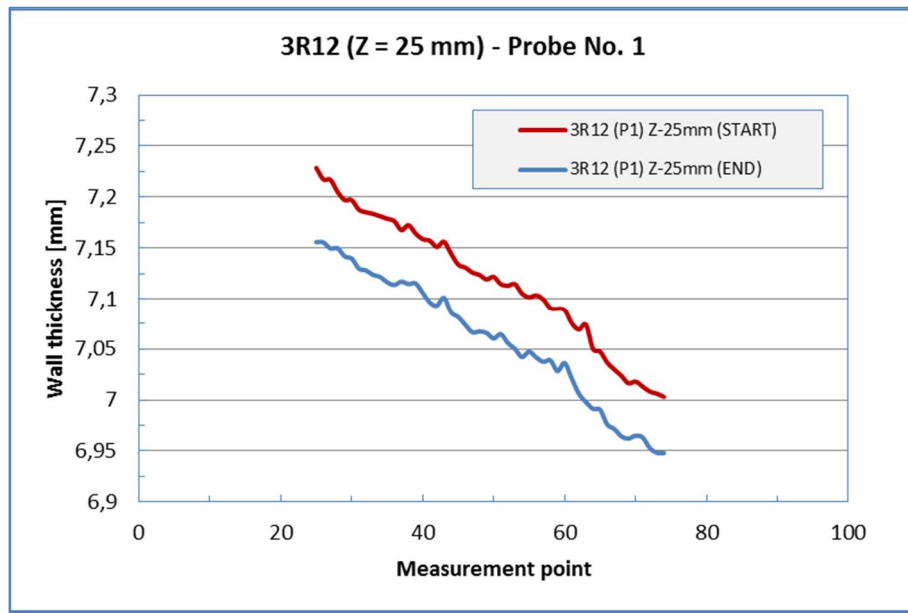
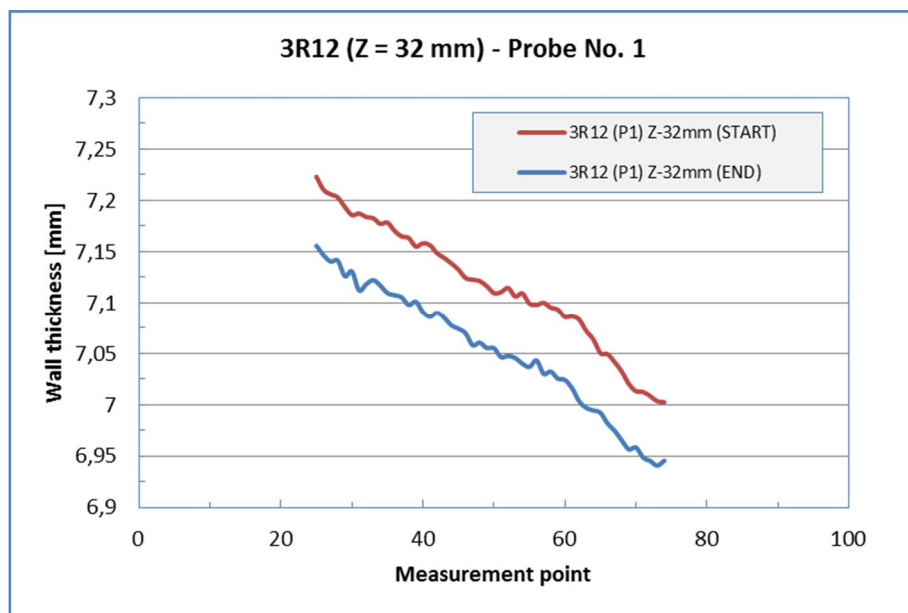
The results of the wall thickness profile measurements and the wall thinning curves derived from them are presented in Figures 4...11. The results showed that marked wall thinning had taken place on the 3R12 specimen. For the other materials the data was more scattered, showing that wall thinning and deposit formation (increase in wall thickness) had taken place locally. Measurements showed also that tube wall thicknesses varied markedly as a function of circumference.

Figure 4. Circumferential wall thickness profiles from 3R12 specimen (Probe No. 1): a) axial location  $Z = 25$  mm and b) axial location  $Z = 32$  mm.

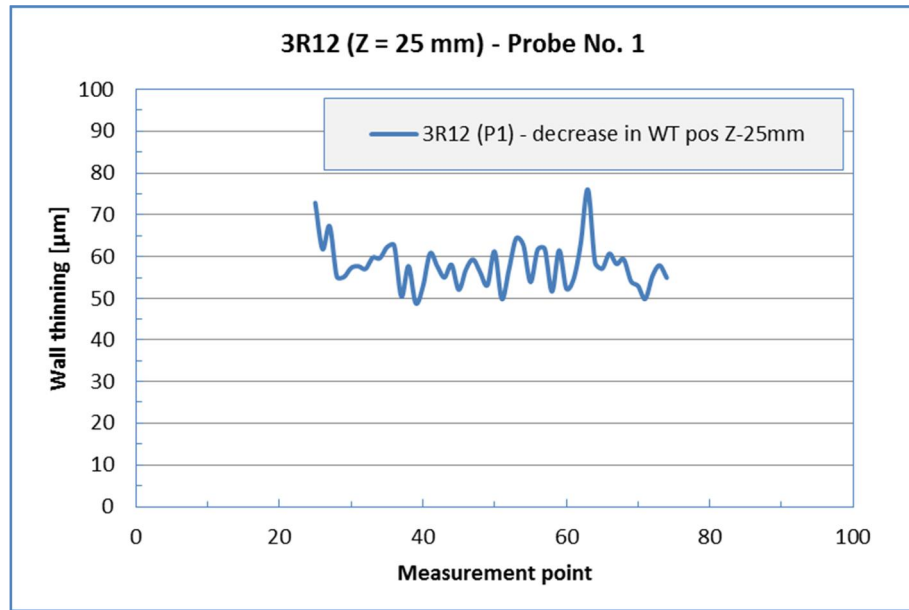
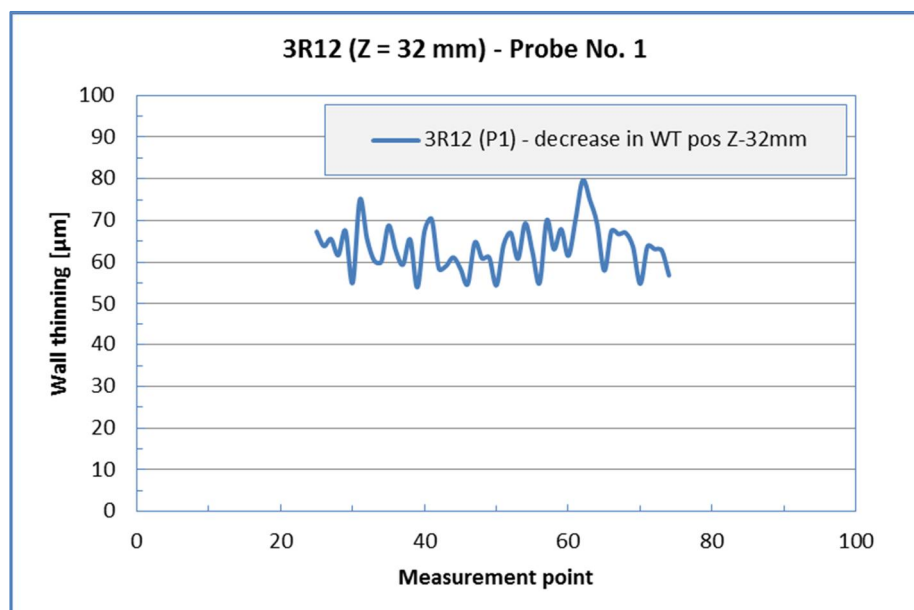
Figure 5. Circumferential wall thinning curves from 3R12 specimen (Probe No. 1): a) axial location  $Z = 25$  mm and b) axial location  $Z = 32$  mm.

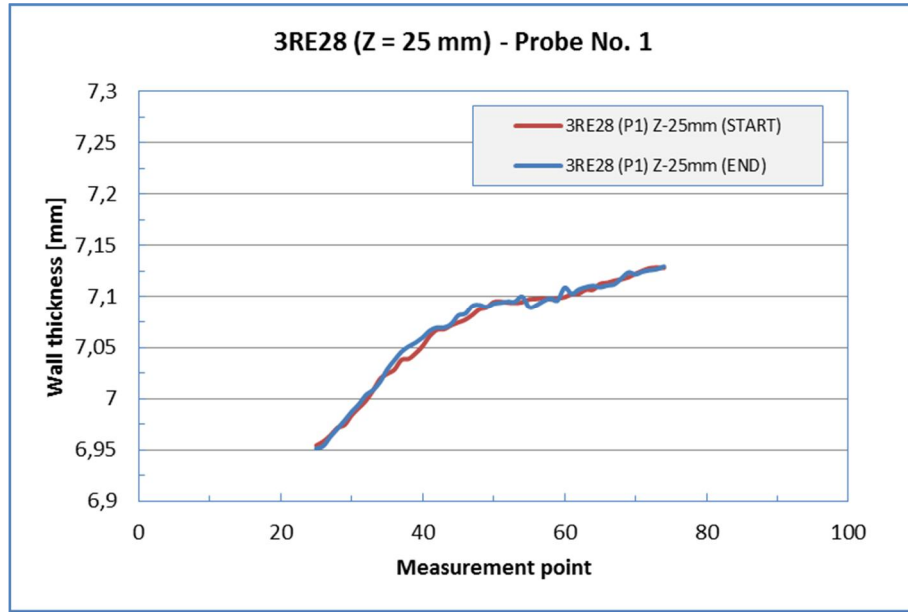
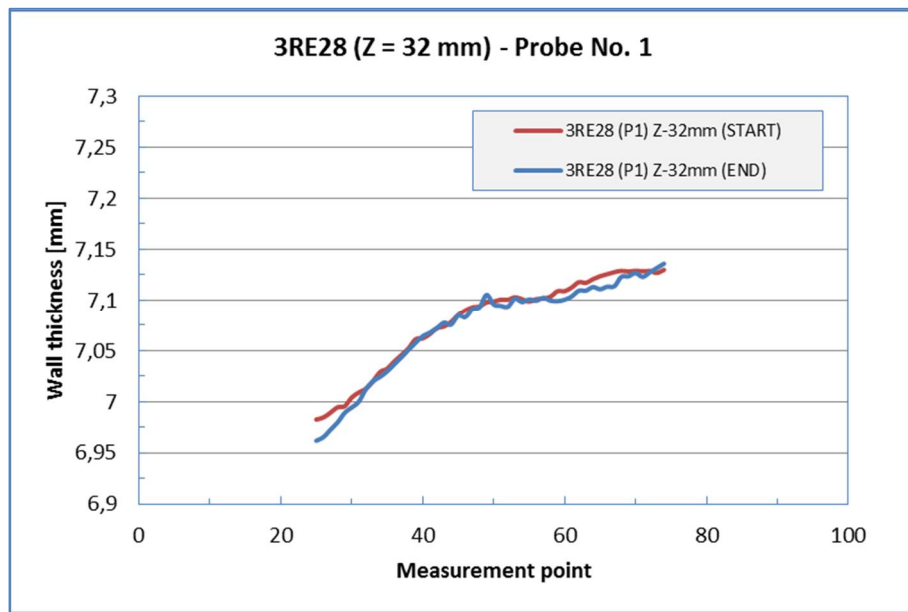
Figure 6. Circumferential wall thickness profiles from 3RE28 specimen (Probe No. 1): a) axial location  $Z = 25$  mm and b) axial location  $Z = 32$  mm.

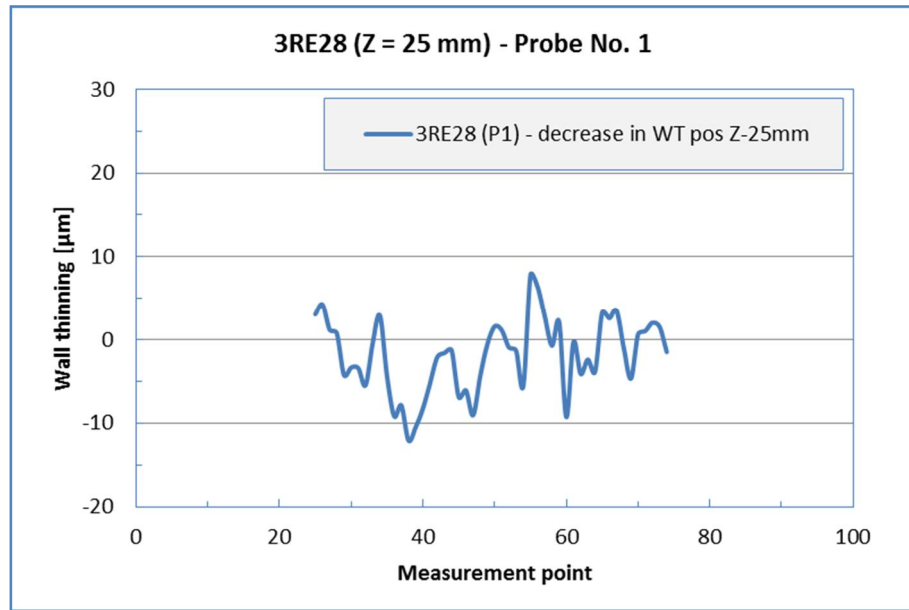
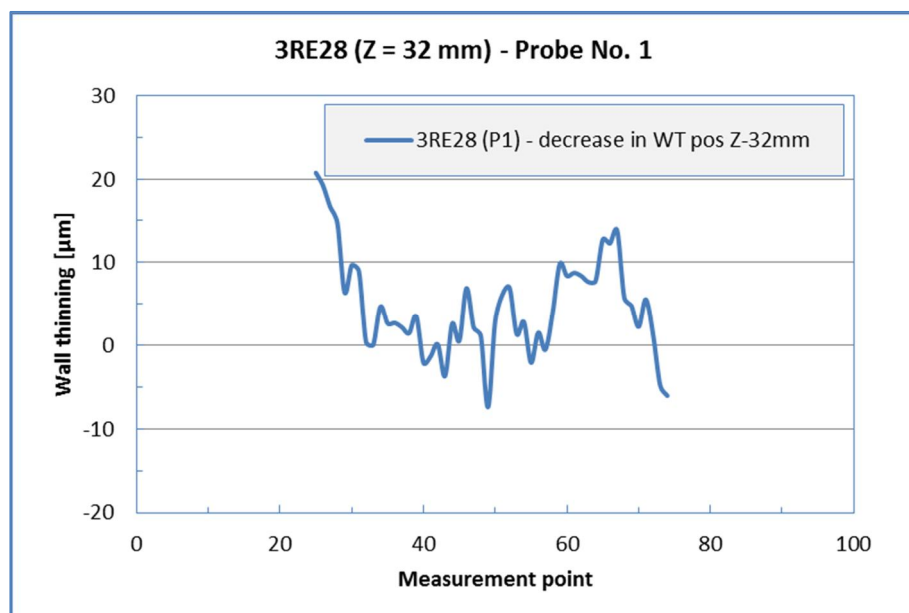
Figure 7. Circumferential wall thinning curves from 3RE28 specimen (Probe No. 1): a) axial location  $Z = 25$  mm and b) axial location  $Z = 32$  mm.

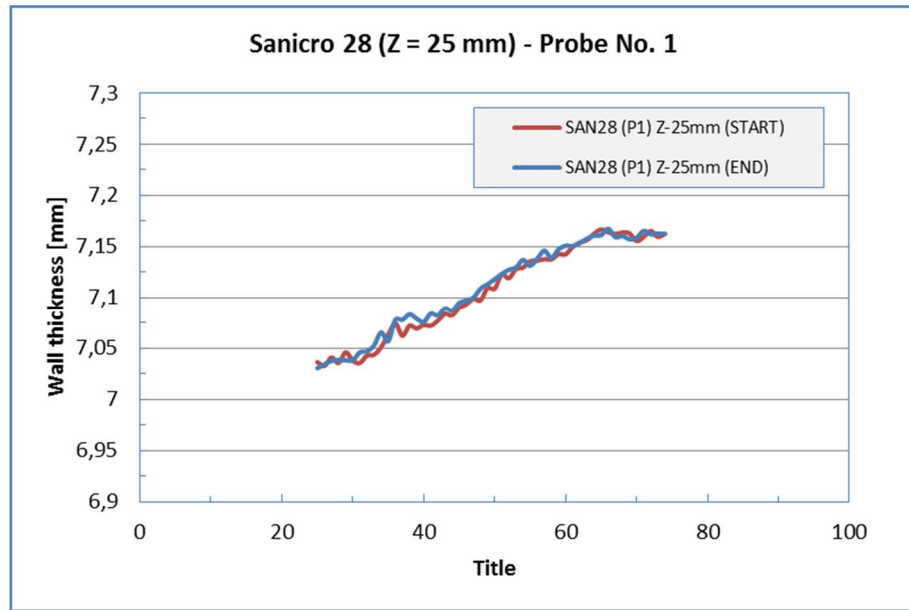
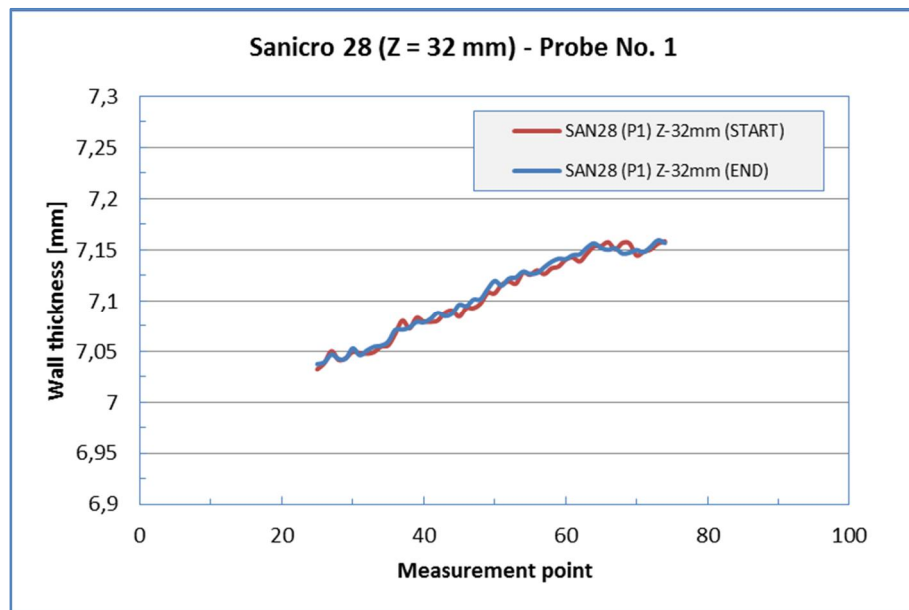
Figure 8. Circumferential wall thickness profiles from Sanicro 28 specimen (Probe No. 1): a) axial location  $Z = 25$  mm and b) axial location  $Z = 32$  mm.

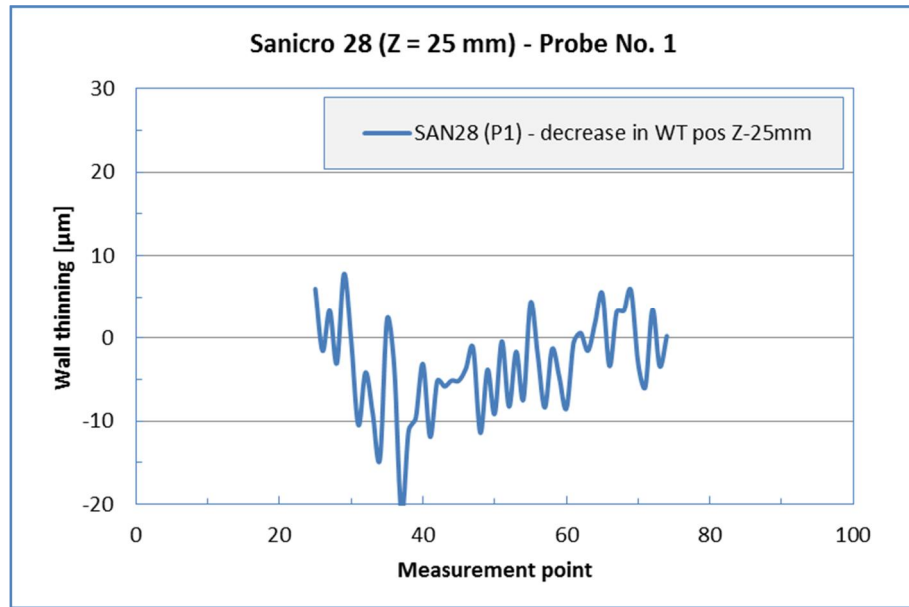
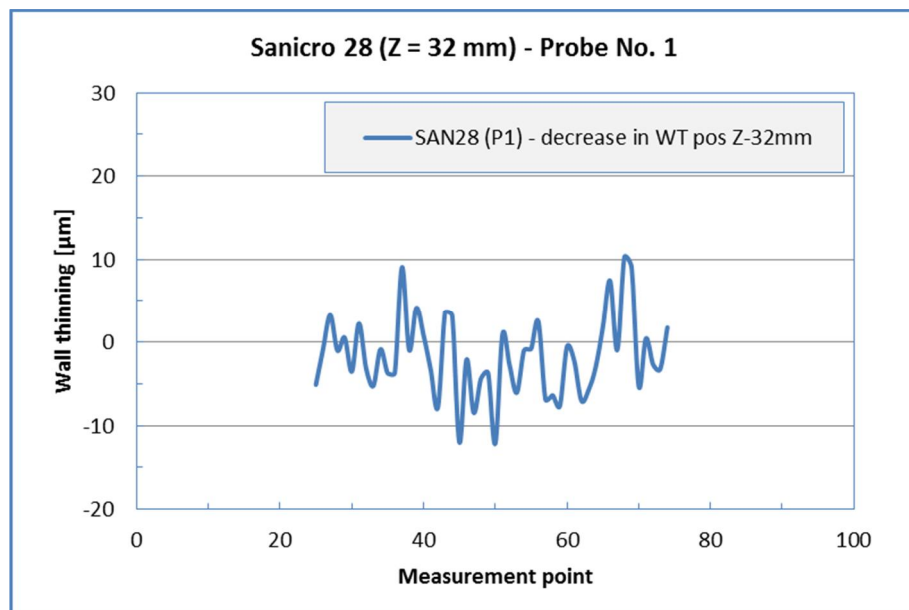
Figure 9. Circumferential wall thinning curves from Sanicro 28 specimen (Probe No. 1): a) axial location  $Z = 25$  mm and b) axial location  $Z = 32$  mm.

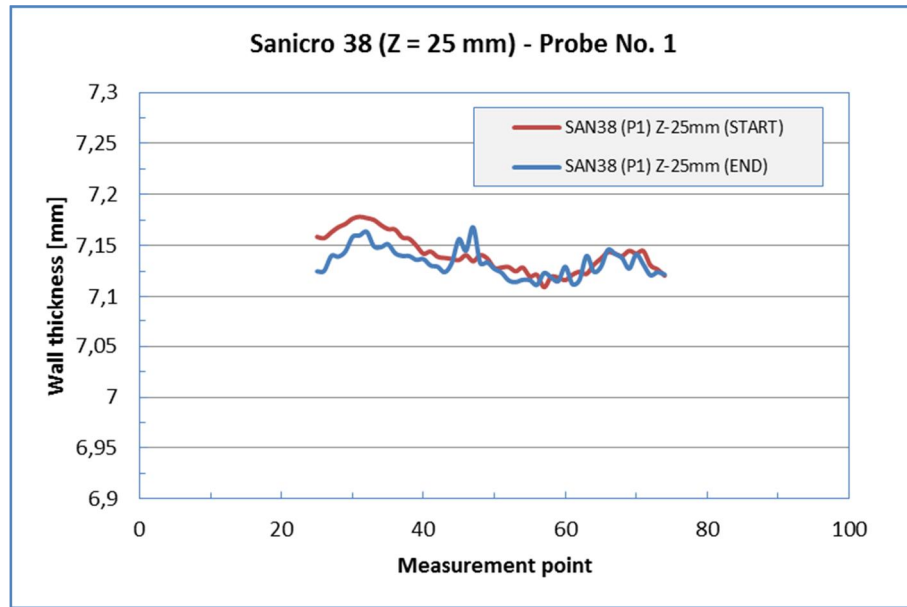
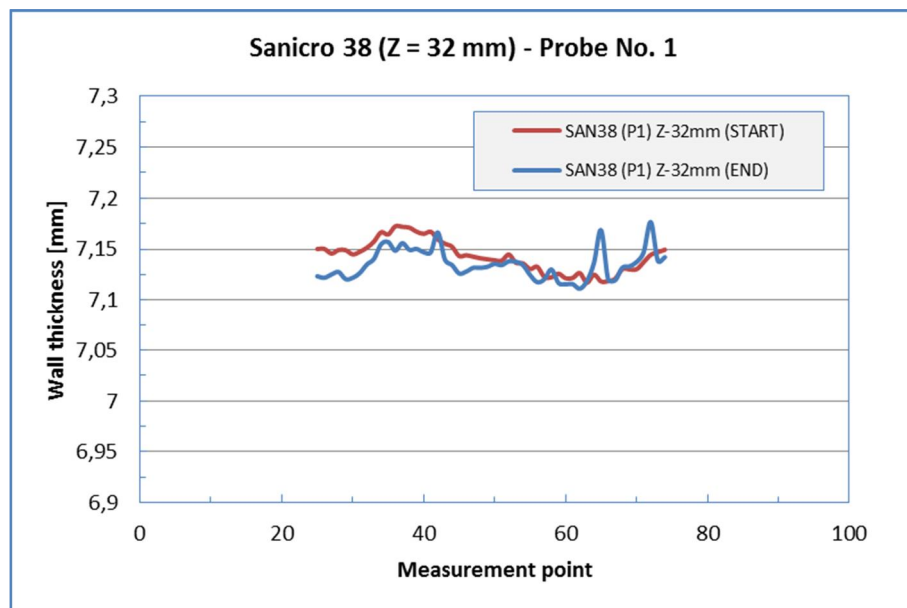
Figure 10. Circumferential wall thickness profiles from Sanicro 38 specimen (Probe No. 1): a) axial location  $Z = 25$  mm and b) axial location  $Z = 32$  mm.

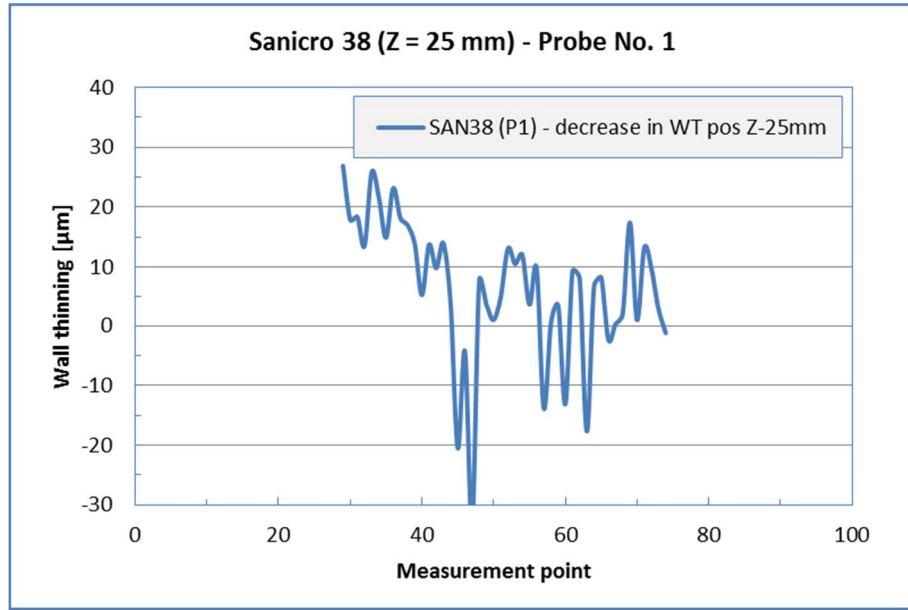
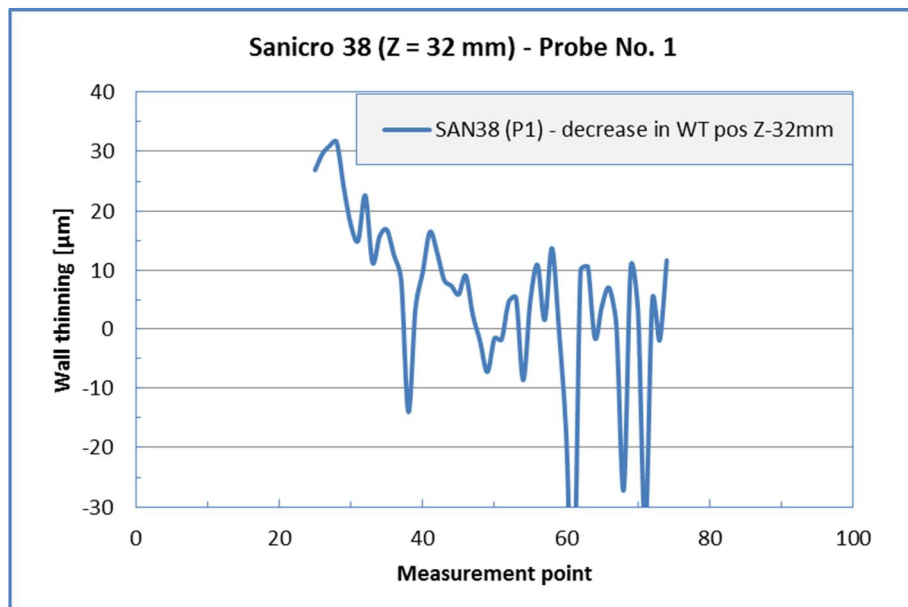
Figure 11. Circumferential wall thinning curves from Sanicro 38 specimen (Probe No. 1): a) axial location  $Z = 25$  mm and b) axial location  $Z = 32$  mm.

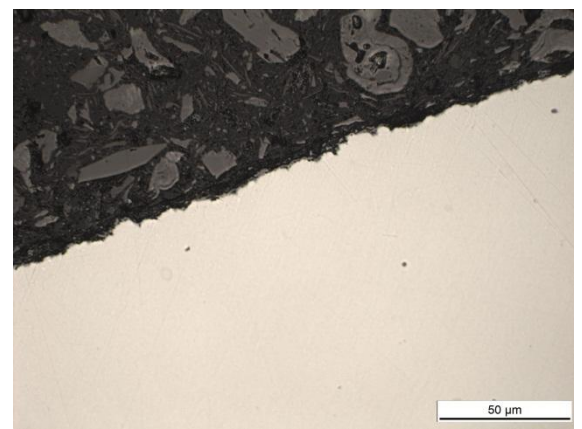
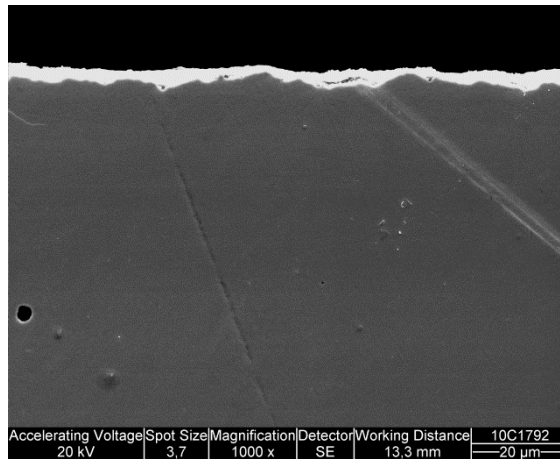
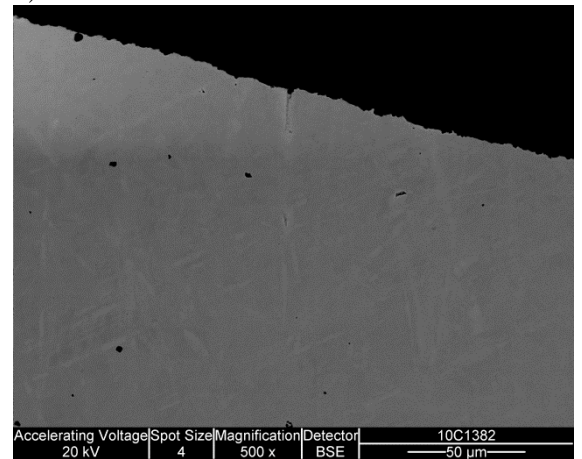
After the tests the samples were examined with optical microscope and/or SEM to determine the type of the corrosion attack. All samples had suffered from general thinning and no marked deposits or oxide/sulphide scales were observed, Figure 13. According to the EDS analysis (Figure 14) the thin layers (thickness ca. 5  $\mu\text{m}$ ) on 3RE28 and Sanicro 28 were depleted in iron and nickel and enriched in chromium and contained also high amounts of sulphur. Whereas the composition of thin layer on 3R12 was similar to the base material and no sulphur was detected.

Figure 13. Cross sections from a) 3R12, b) 3RE28, c) Sanicro 28 and d) Sanicro 38 after 906 h exposure in lower furnace at 440 °C (Probe test No. 1).

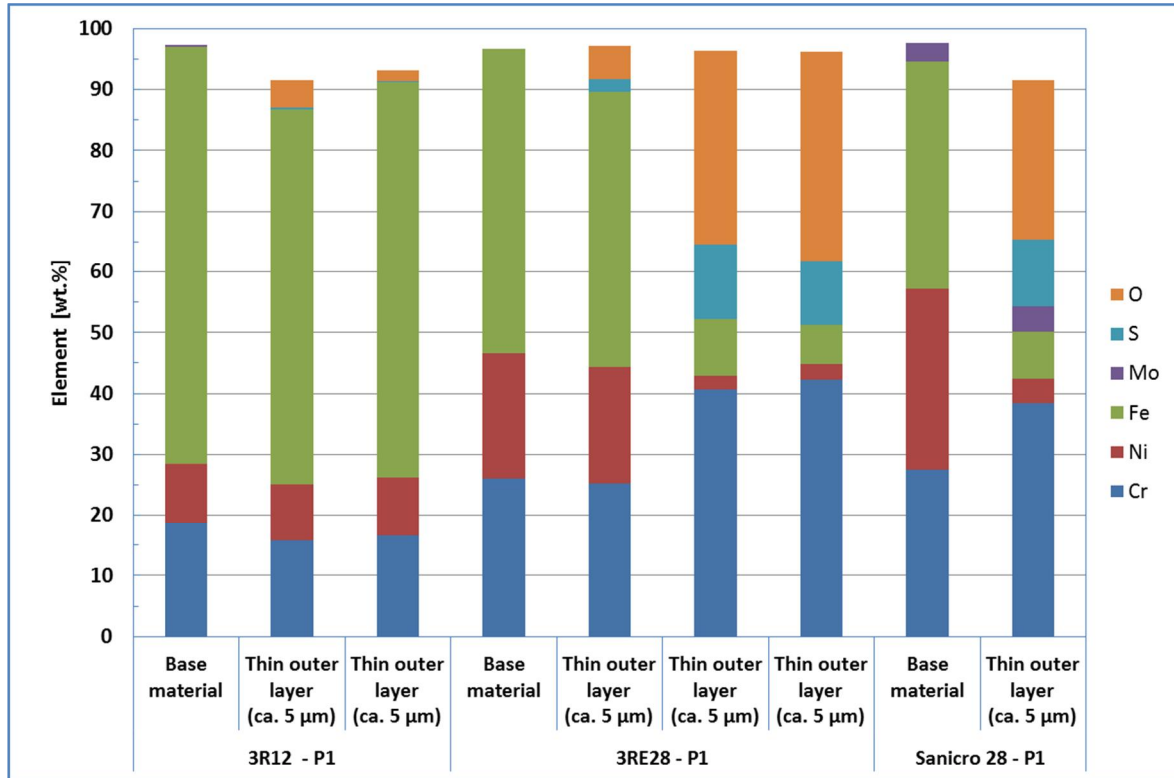
Figure 14. Results from the EDS analysis performed for the 3R12, 3RE28 and Sanicro 28 specimens after 906 h exposure in lower furnace at 440 °C (Probe test No. 1). Note: Quantitative results from cross sections, carbon excluded. Data from layers are from point analysis, whereas area analysis was used for base materials.

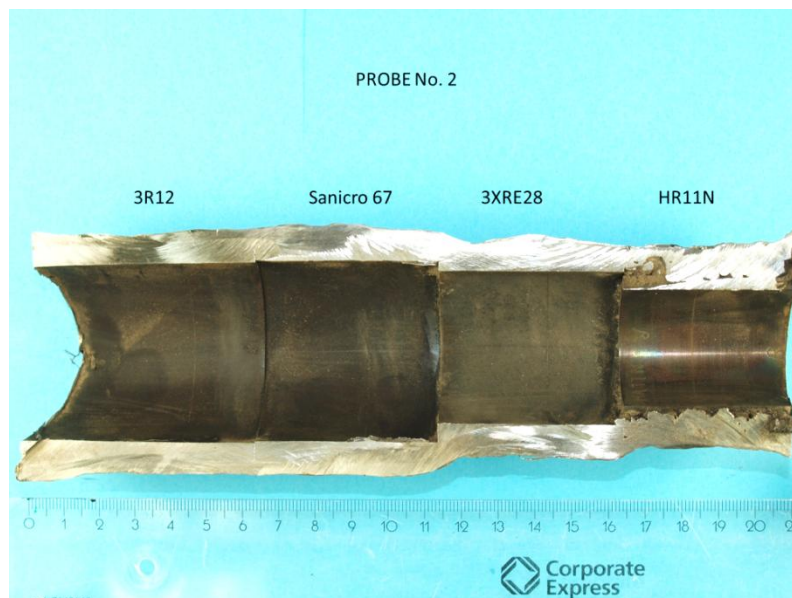
Total test duration of the test No. 2 was 1023 hours from which 744 hours at the target temperature of 440 °C. The test materials in this exposure were 3R12, 3XRE28, HR11N and Sanicro 67, Figure 15. According to visual inspection the inner surfaces of the specimens were in good condition after testing i.e. neither marked general or localised corrosion nor deposits or oxide scales were observed. The outer surfaces of the specimens appeared to be in good condition, but the thin dark and white deposits on the surfaces hindered accurate examinations.

Figure 15. Macrographs taken from the probe No. 2 head after exposure: a) outer surface exposed to the furnace side and b) inner surface exposed to the cooling liquid.

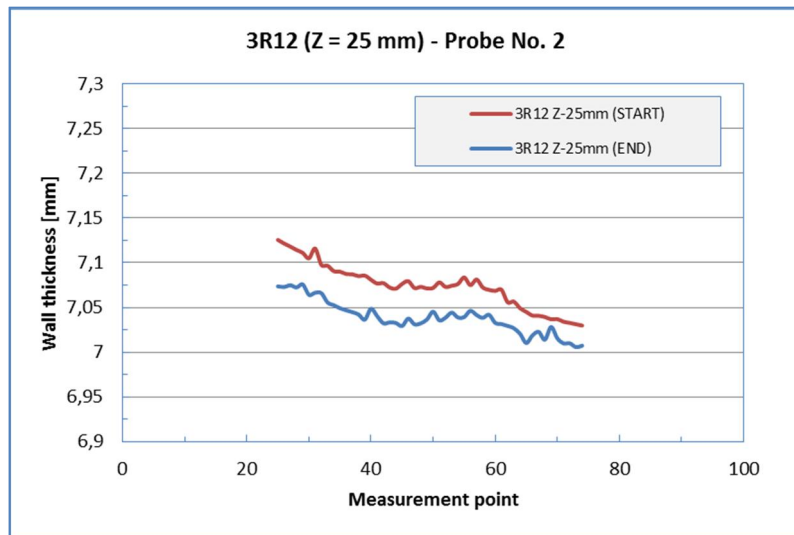
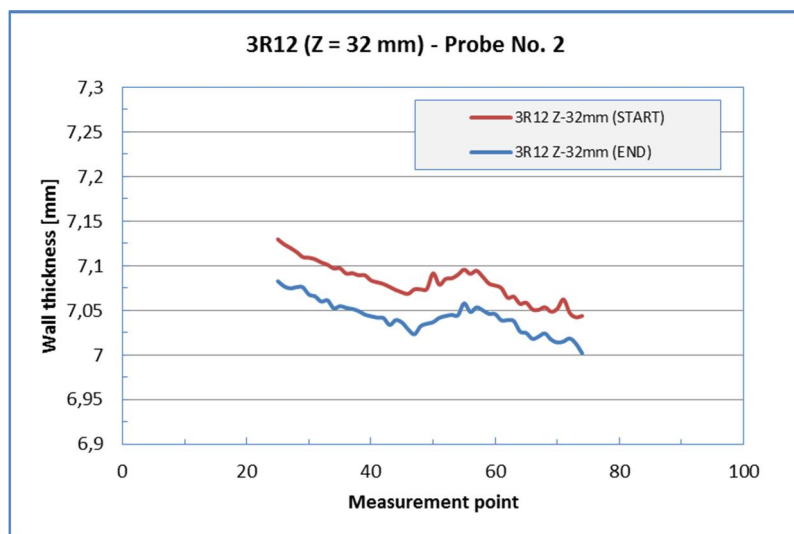
The results of the wall thickness profile measurements and the wall thinning curves derived from them are presented in Figures 16...23. The results showed that marked wall thinning had taken place on the 3R12 specimen and to some extent also on the HR11N specimen. The data of the 3XRE28 and Sanicro 67 materials was more scattered showing that wall thinning and deposit formation (increase in wall thickness) had taken place locally. Measurements showed also that the wall thickness variations were smaller in the machined HR11N specimen, than in the other specimens tested in as received condition. The average and maximum corrosion rates calculated on the basis of the wall thickness measurements are presented in Figure 12. In this test highest corrosion rate in the order of 0.6 mm/a was measured for the 3R12 material. The corrosion resistance of the 3XRE28, HR11N and Sanicro 67 was practically at the same level.

Figure 16. Circumferential wall thickness profiles from 3R12 specimen (Probe No. 2): a) axial location  $Z = 25$  mm and b) axial location  $Z = 32$  mm.

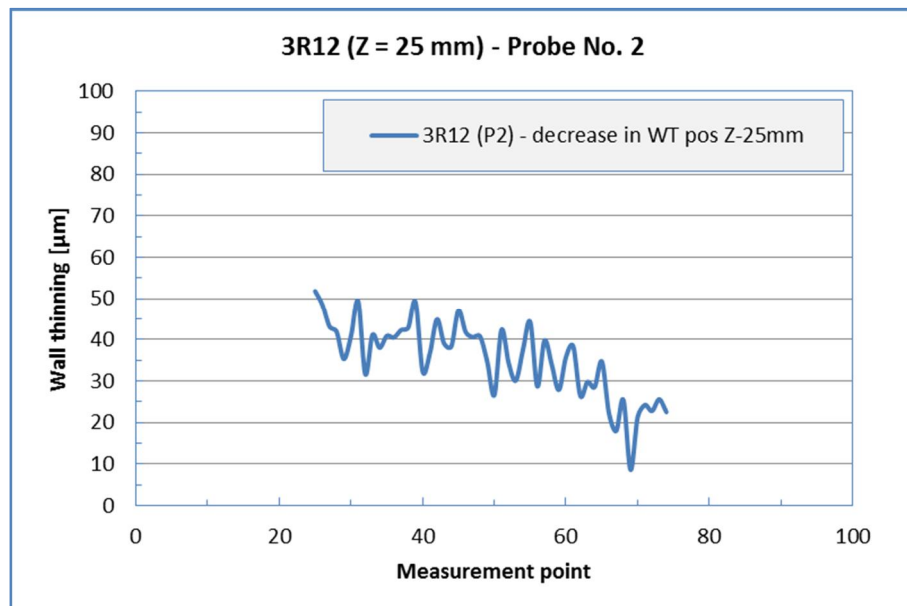
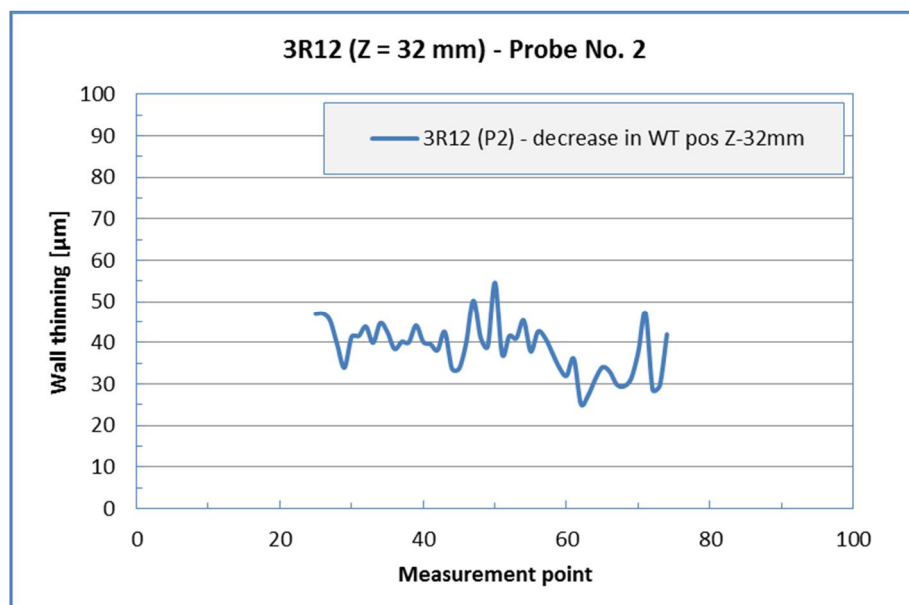
Figure 17. Circumferential wall thinning curves from 3R12 specimen (Probe No. 2): a) axial location  $Z = 25$  mm and b) axial location  $Z = 32$  mm.

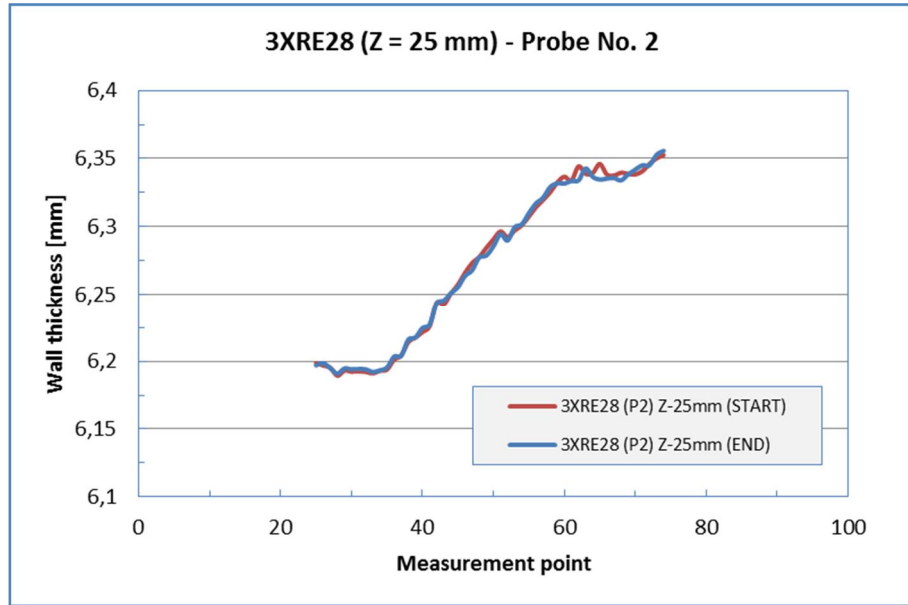
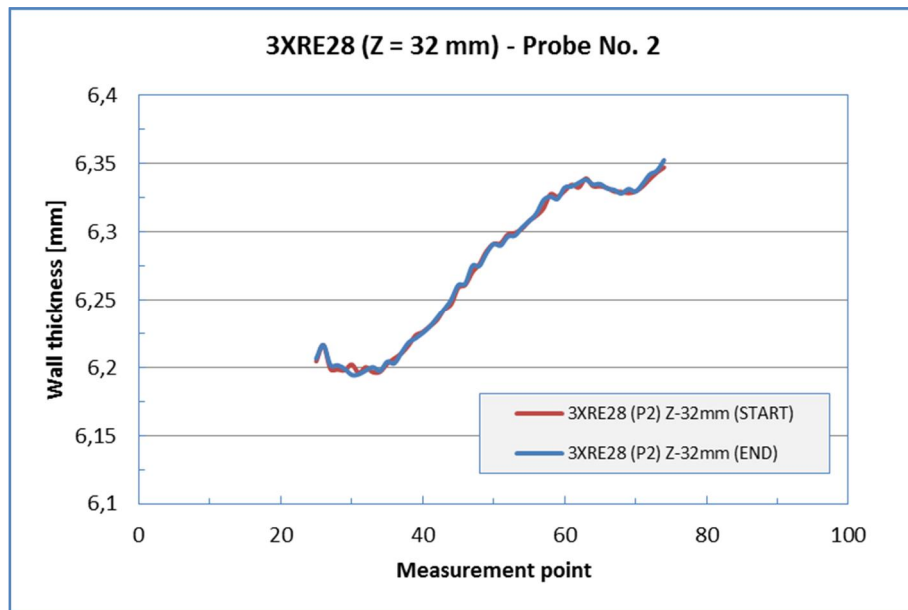
Figure 18. Circumferential wall thickness profiles from 3XRE28 specimen (Probe No. 2): a) axial location  $Z = 25$  mm and b) axial location  $Z = 32$  mm.

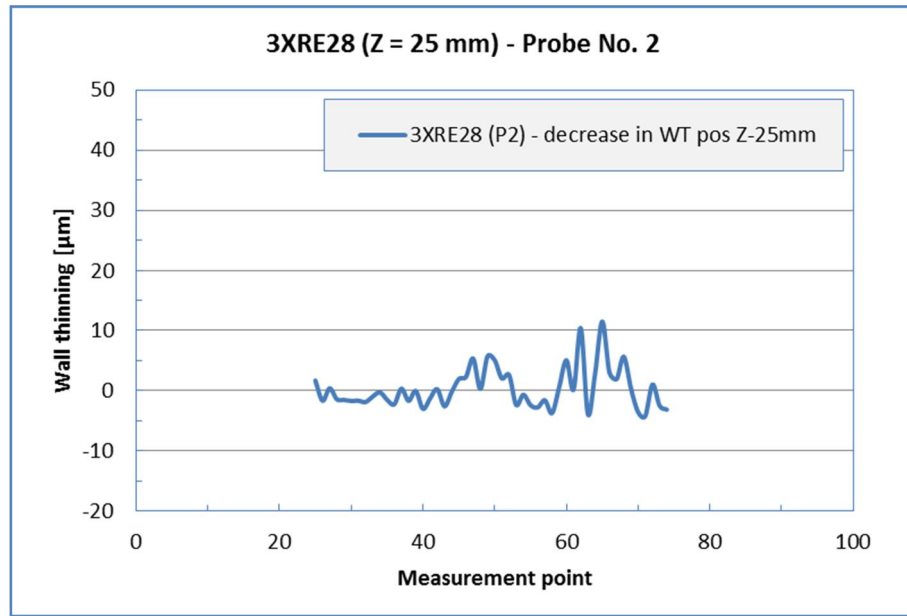
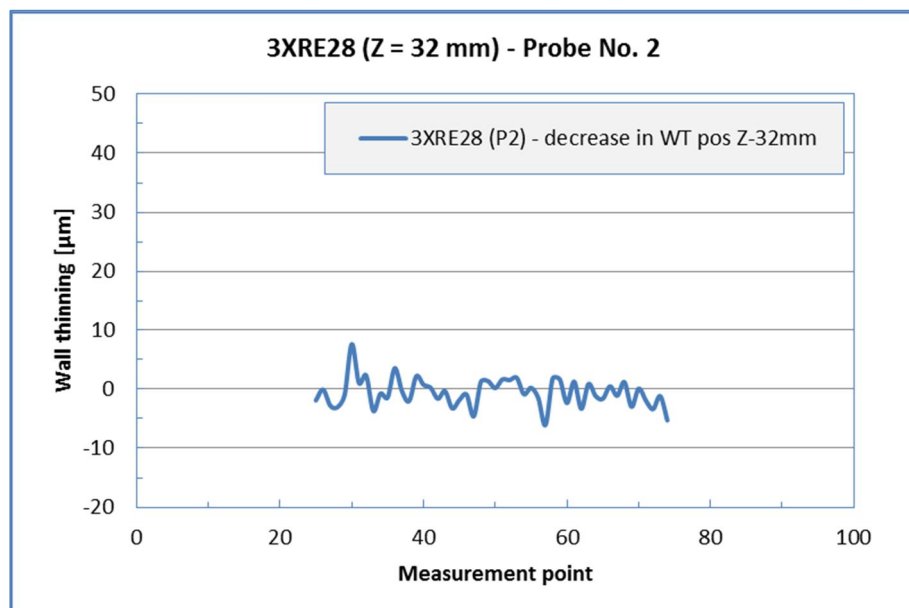
Figure 19. Circumferential wall thinning curves from 3XRE28 specimen (Probe No. 2): a) axial location  $Z = 25$  mm and b) axial location  $Z = 32$  mm.

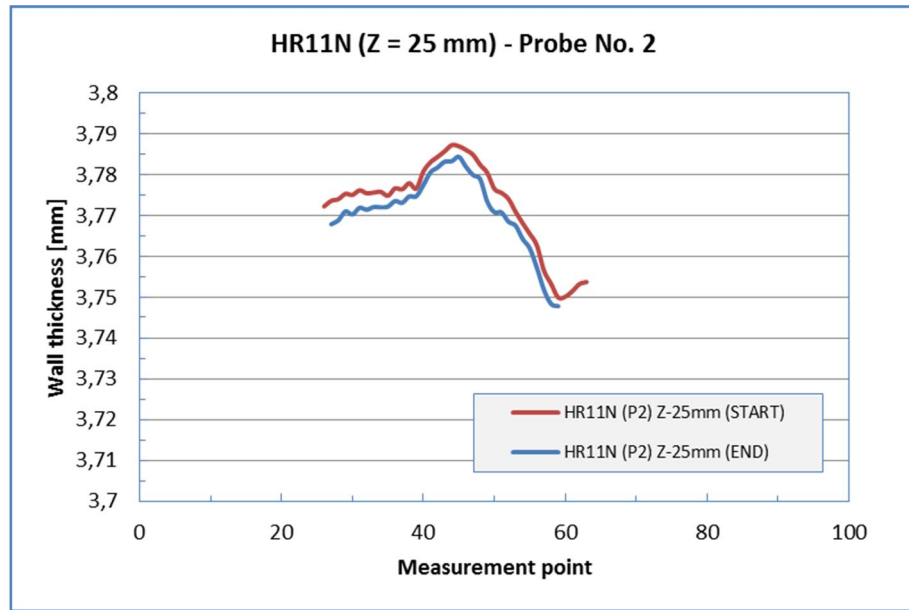
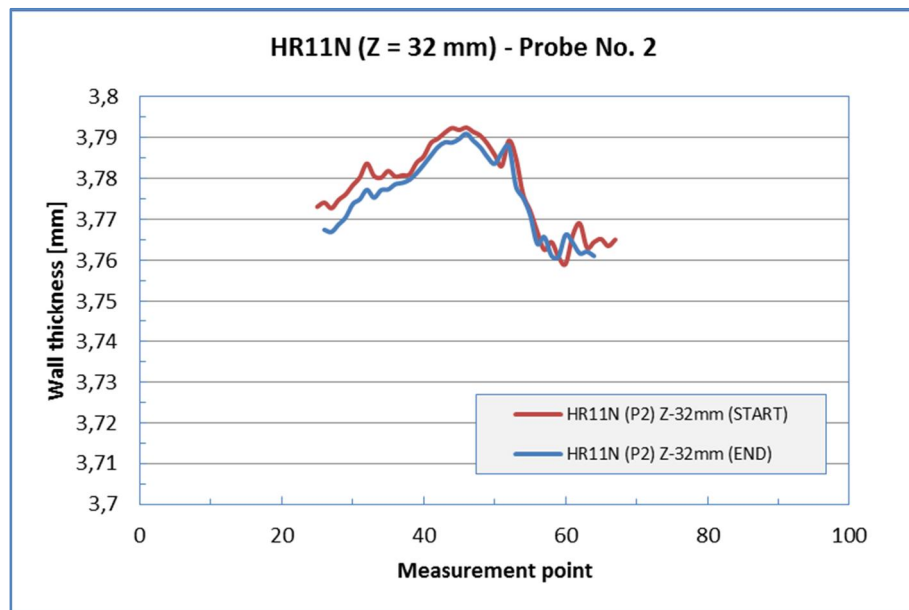
Figure 20. Circumferential wall thickness profiles from HR11N specimen (Probe No. 2): a) axial location  $Z = 25$  mm and b) axial location  $Z = 32$  mm.

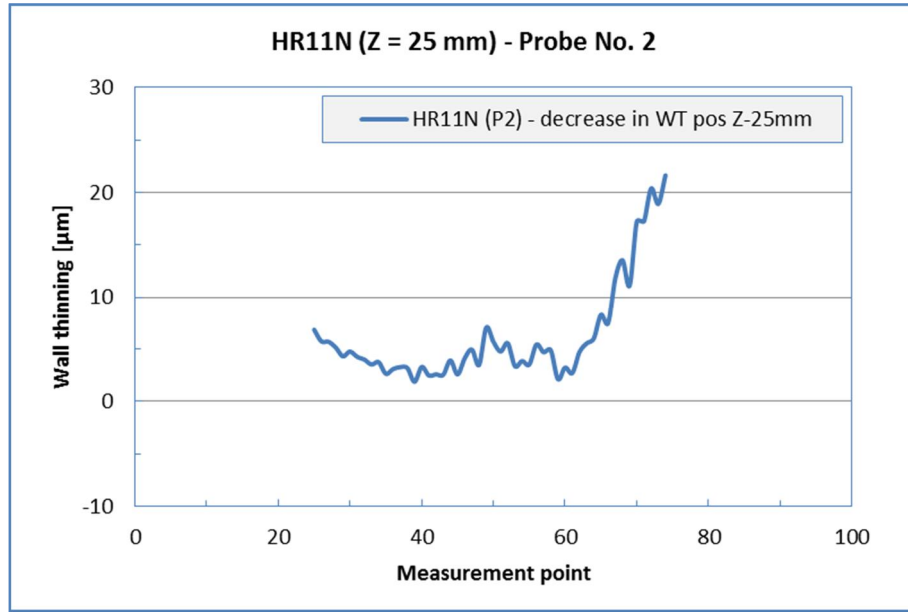
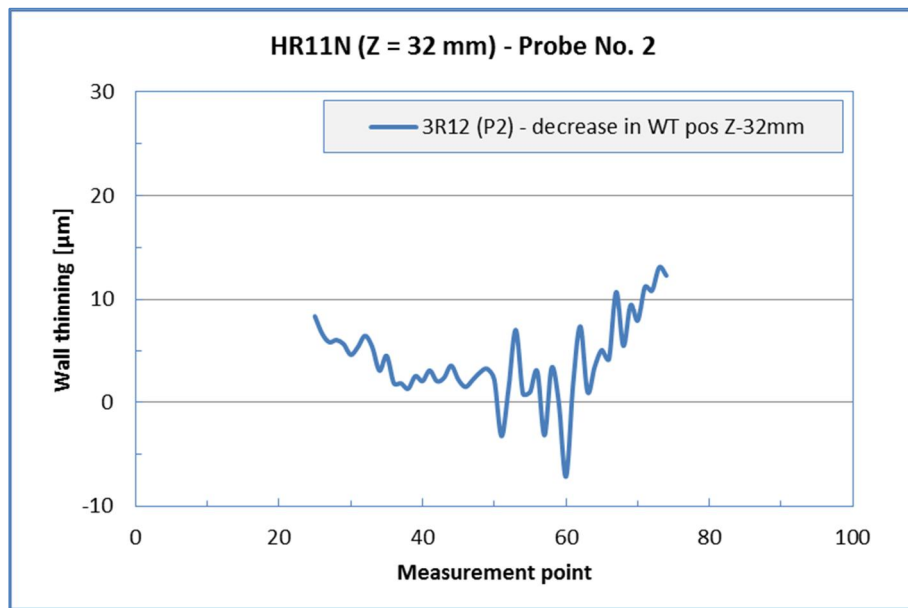
Figure 21. Circumferential wall thinning curves from HR11N specimen (Probe No. 2): a) axial location  $Z = 25$  mm and b) axial location  $Z = 32$  mm.

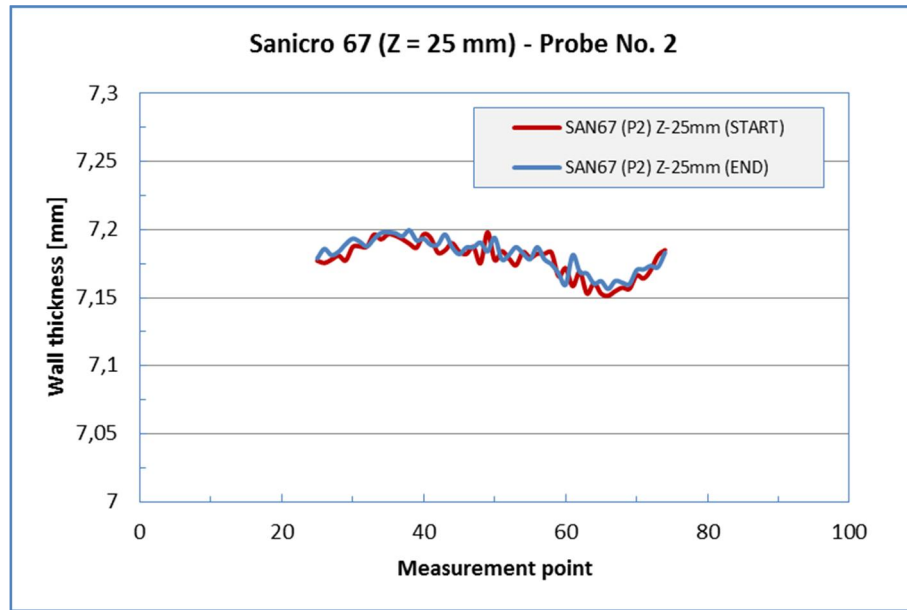
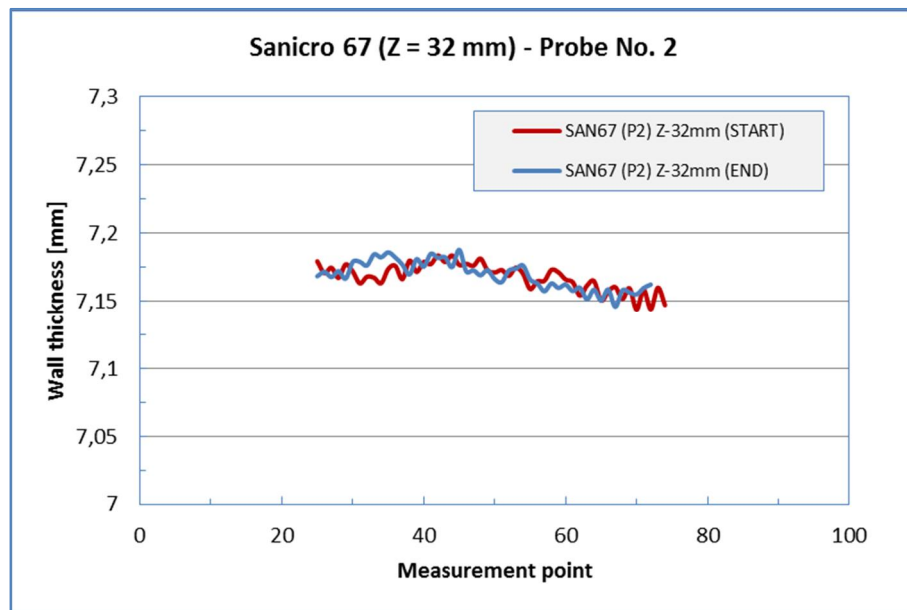
Figure 22. Circumferential wall thickness profiles from Sanicro 67 specimen (Probe No. 2): a) axial location  $Z = 25$  mm and b) axial location  $Z = 32$  mm.

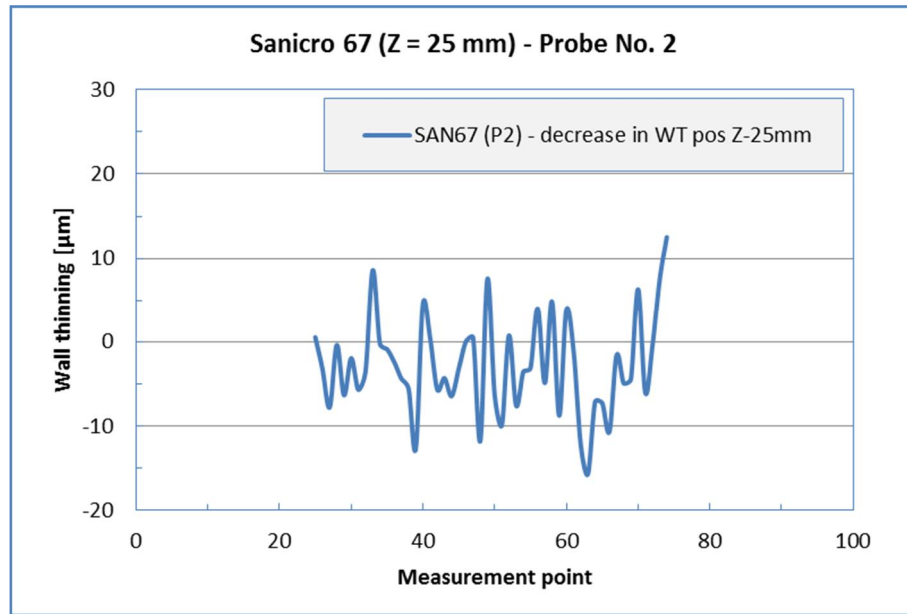
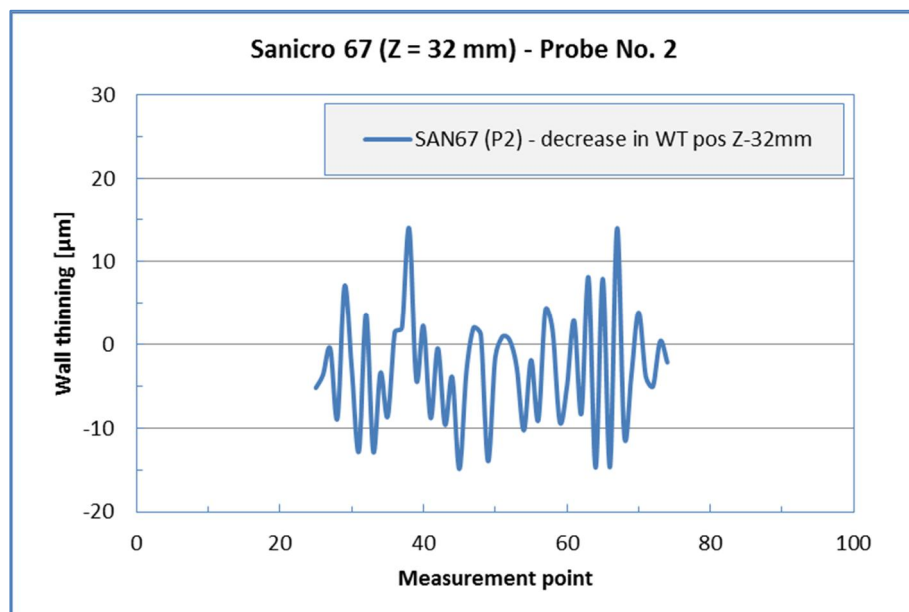
Figure 23. Circumferential wall thinning curves from Sanicro 67 specimen (Probe No. 2): a) axial location  $Z = 25$  mm and b) axial location  $Z = 32$  mm.
