# Characterisation of probe test samples exposed to BLRB lower furnace environments

Author: Pekka Pohjanne

Report's title Characterisation of probe test samples exposed to BLRB lower furnace environments	
Customer, contact person, address Soodakattilayhdistys ry.	Order reference
Project name SKYREC Sondi	Project number/Short name 33189
Author(s) Pekka Pohjanne	Pages 70/
Keywords	Report identification code VTT-R-02472-13
<p><b>Abstract</b></p> <p>Current trend to increase electricity generation of recovery boilers possess new demands for the tube materials, when the material temperatures are increased due to higher steam values. Operational experiences from current boilers have shown that the AISI 304 L compound tubes suffer from accelerated corrosion in furnace wall, when the material temperatures are increased from normal values due to the internal surfaces scales. This indicates that the AISI 304L might be unsuitable cladding material for the future high pressure boilers.</p> <p>The goal of this study was to test different potential cladding materials in actual recovery boiler lower furnace conditions, but at higher than current temperatures, in order to determine what material

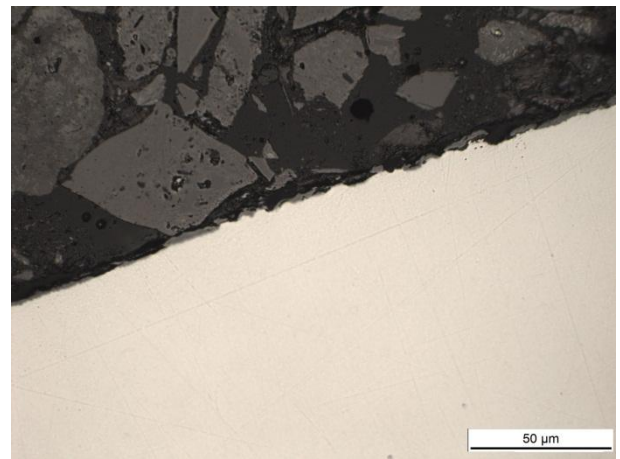
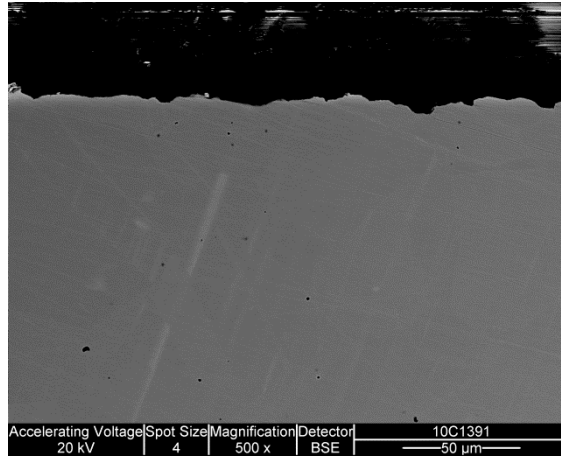
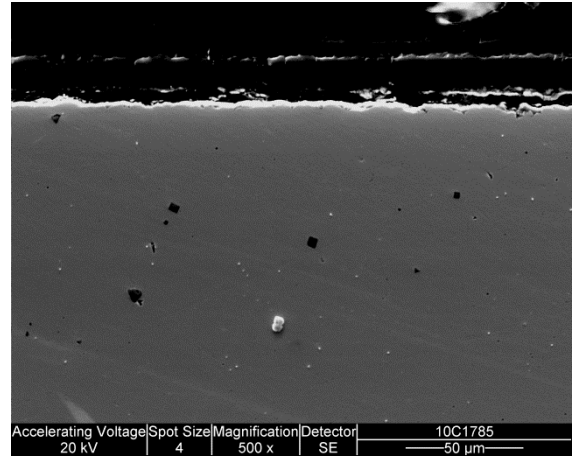
After the tests the samples were examined with optical microscope and/or SEM to determine the type of the corrosion attack. All samples had suffered from general thinning and no marked deposits or oxide/sulphide scales were observed on the surfaces, Figure 25. According to the EDS analysis (Figure 26) the thin, a few  $\mu\text{m}$  thick layer, observed on 3XRE28 was depleted in iron and nickel and enriched in chromium and contained also high amounts of sulphur. Similar thin layer (thickness ca. 3  $\mu\text{m}$ ) on Sanicro 67 contained high amounts of sulphur and was depleted in nickel and iron whereas chromium content was at the same level than in the base material.

Figure 25. Cross sections from a) 3R12, b) 3XRE28, c) HR11N and d) Sanicro 67 after 744 h exposure in lower furnace at 440 °C (Probe test No. 2).

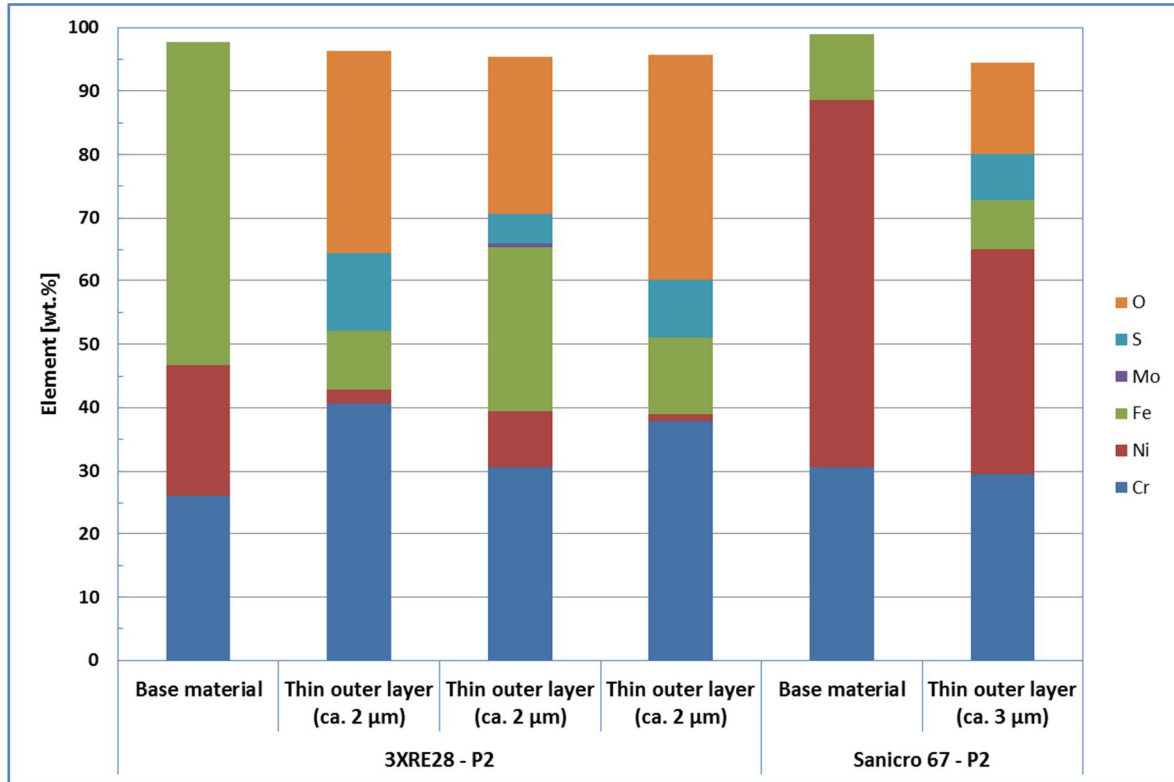
Figure 26. Results from the EDS analysis performed for the 3XRE28 and Sanicro 67 specimens after 744 h exposure in lower furnace at 440 °C (Probe test No. 2). Note: Quantitative results from cross sections, carbon excluded. Data from layers are from point analysis, whereas area analysis was used for base materials.

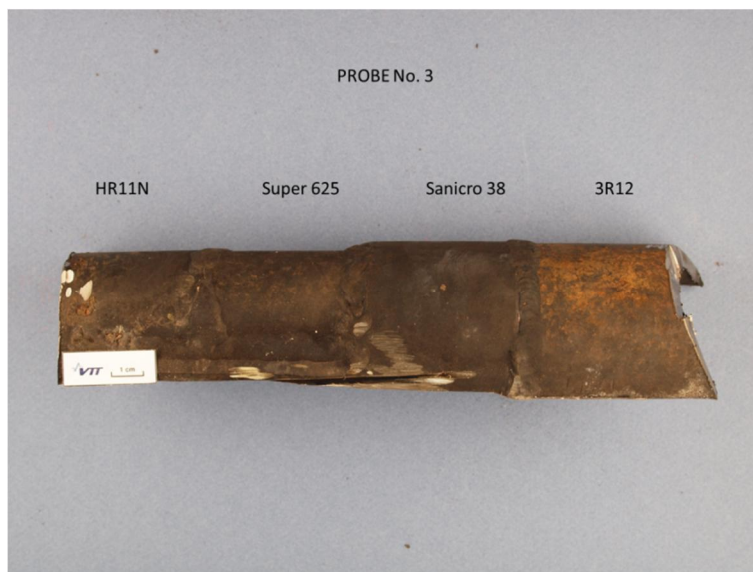
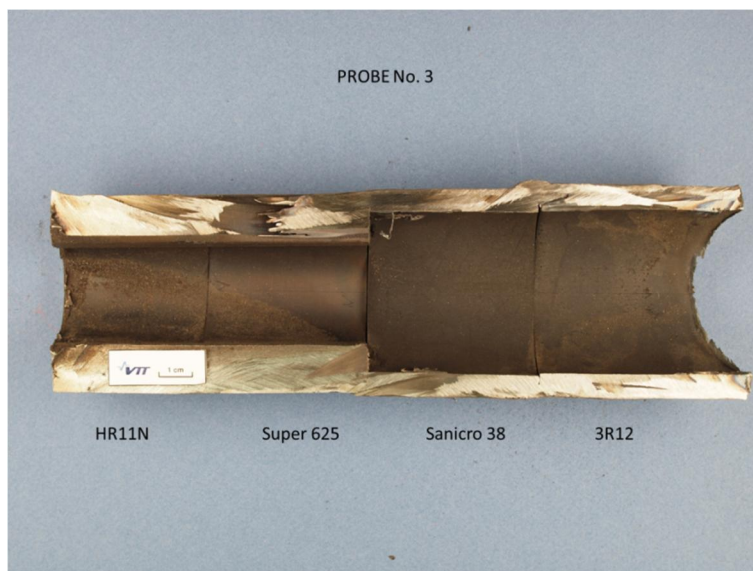
According to visual inspection the inner surfaces of the specimens were in good condition after testing. Some deposits were observed on the inner surfaces but based on their appearance they originate from the probe cutting conducted after the probe has been removed from the boiler. The outer surfaces of the specimens were covered with dark and brown deposits but appeared to be in good condition.

Figure 27. Macrographs taken from the probe No. 3 head after exposure: a) outer surface exposed to the furnace side and b) inner surface exposed to the cooling liquid.

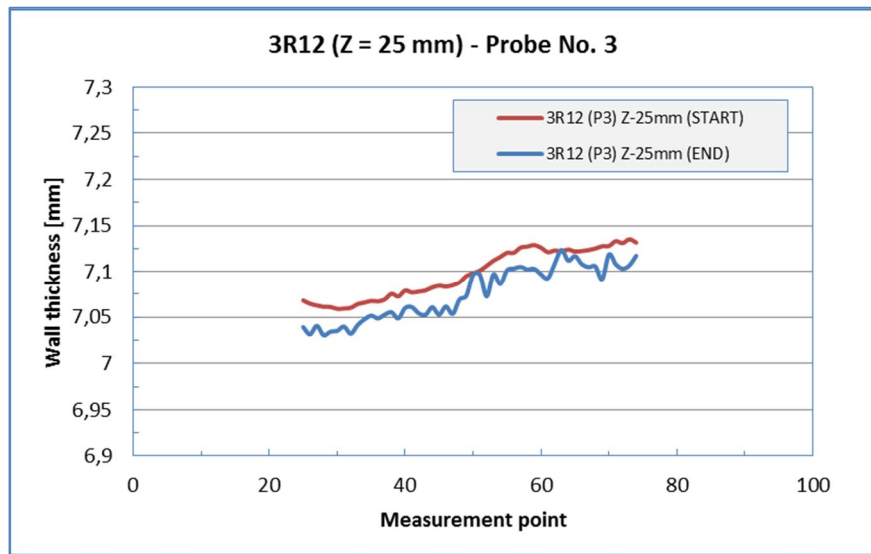
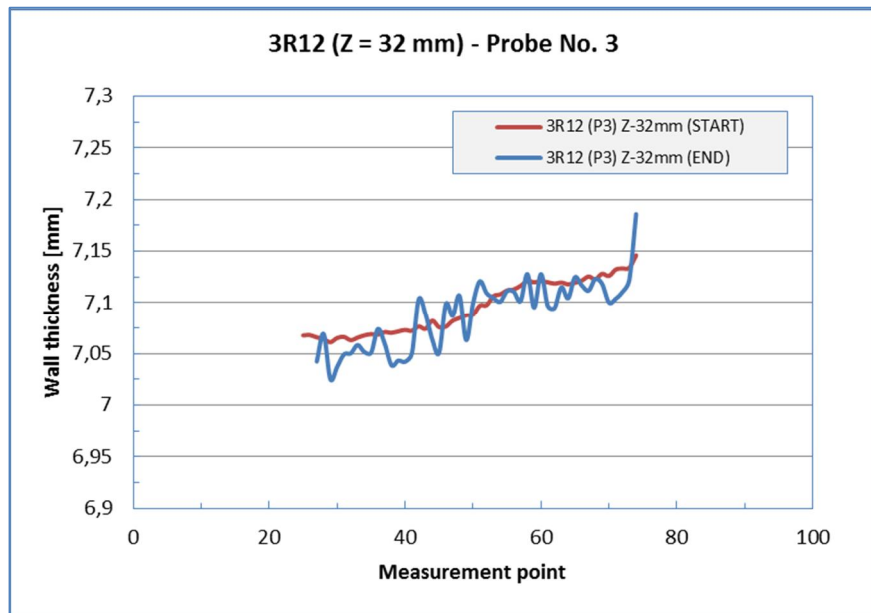
The results of the wall thickness profile measurements and the wall thinning curves derived from them are presented in Figures 28...35. The results showed that marked wall thinning had taken place only on the 3R12 specimen. Some wall thinning was observed also on the Super 625 specimen. The data of the HR11N and Sanicro 38 was more scattered showing that wall thinning and deposit formation (increase in wall thickness) had taken place locally. In addition the data in this test was more scattered than in the previous test indicating that all deposits were not removed from the surfaces in washing performed for the specimens' prior measurements.

Figure 28. Circumferential wall thickness profiles from 3R12 specimen (Probe No. 3): a) axial location  $Z = 25$  mm and b) axial location  $Z = 32$  mm.

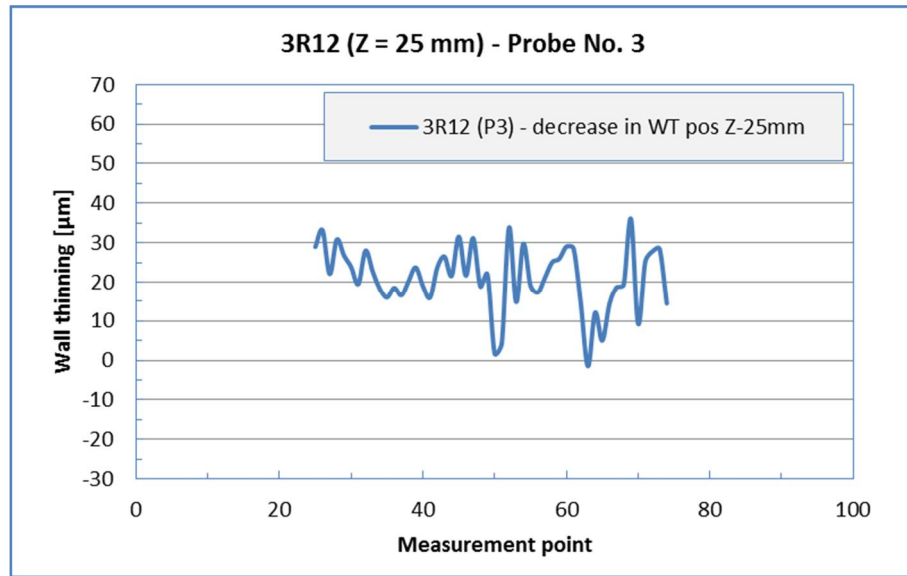
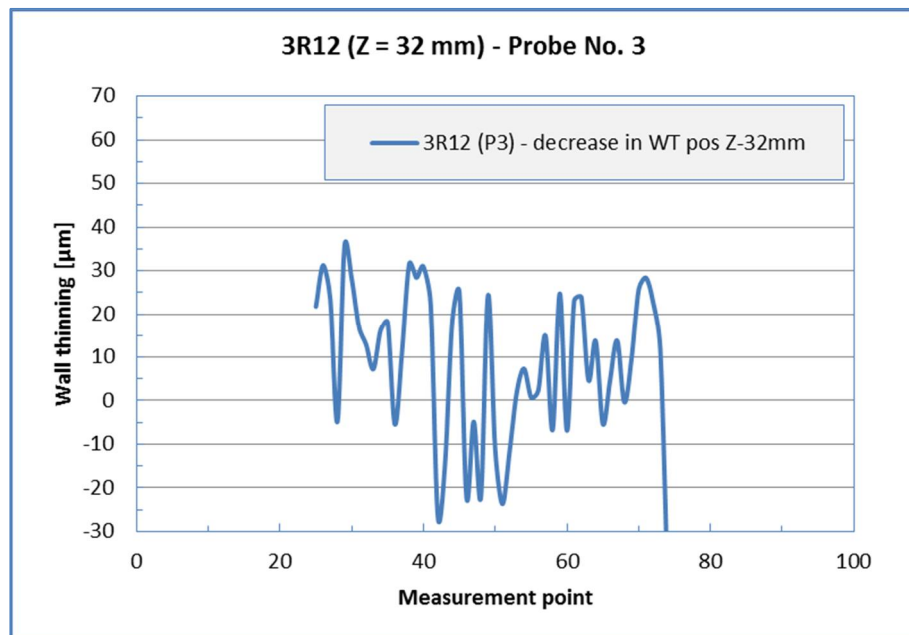
Figure 29. Circumferential wall thinning curves from 3R12 specimen (Probe No. 3): a) axial location  $Z = 25$  mm and b) axial location  $Z = 32$  mm.

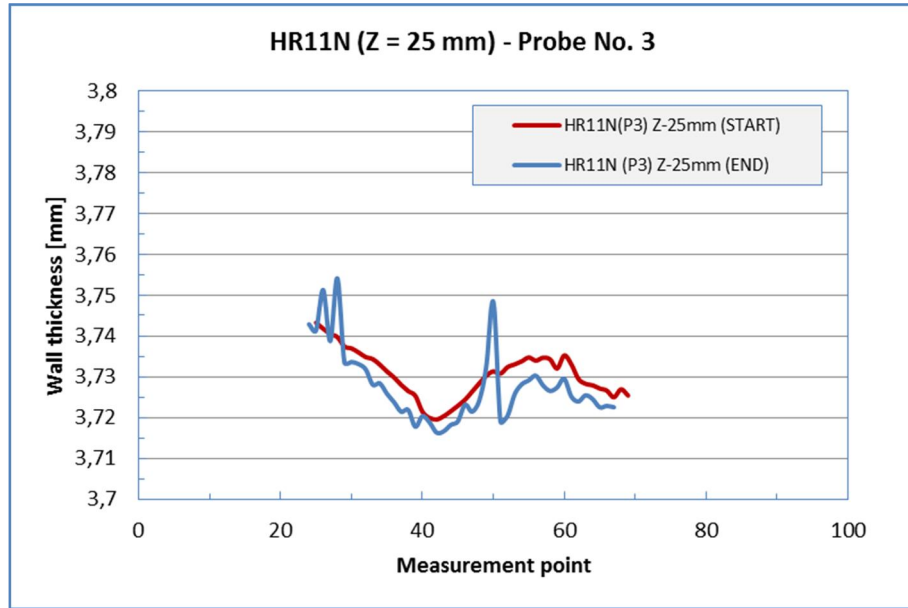
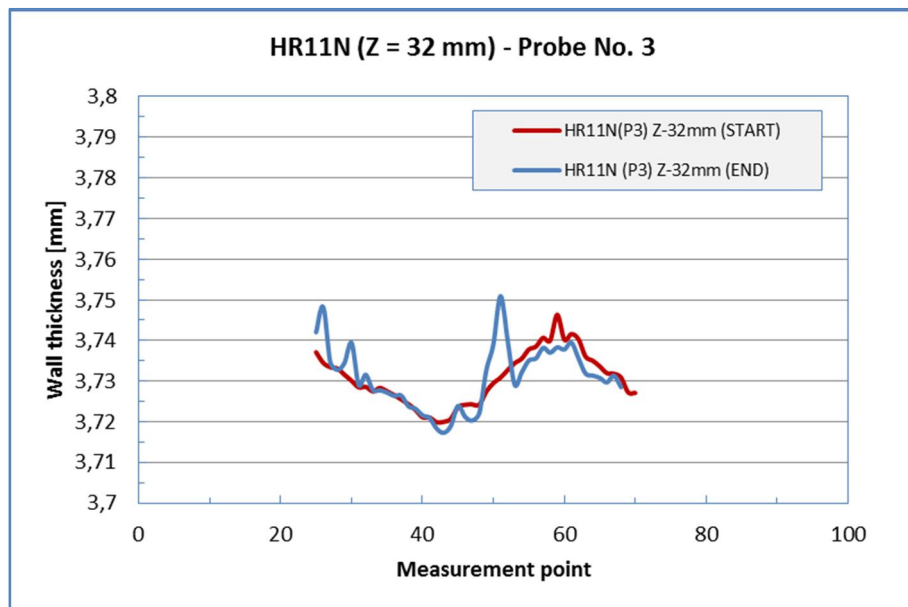
Figure 30. Circumferential wall thickness profiles from HR11N specimen (Probe No. 3): a) axial location  $Z = 25$  mm and b) axial location  $Z = 32$  mm.

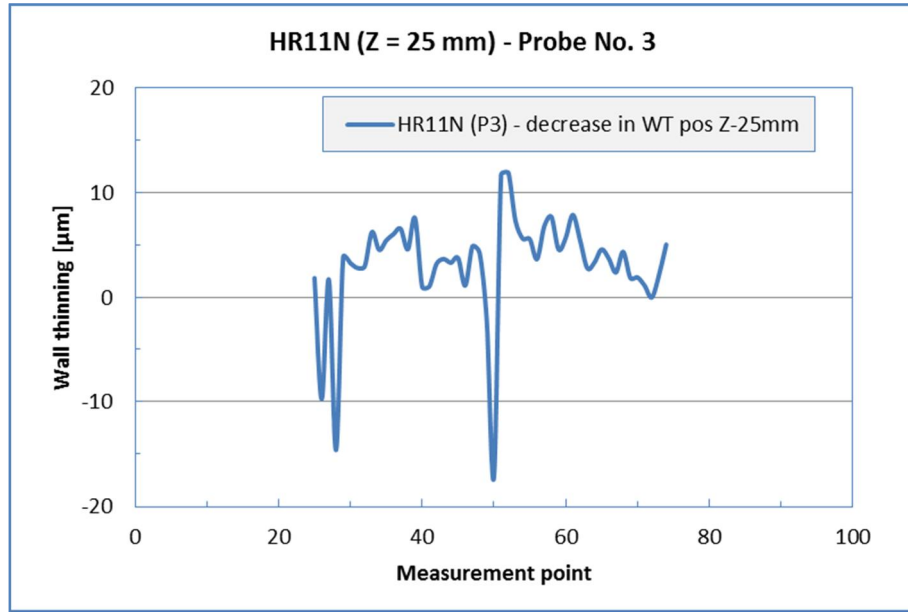
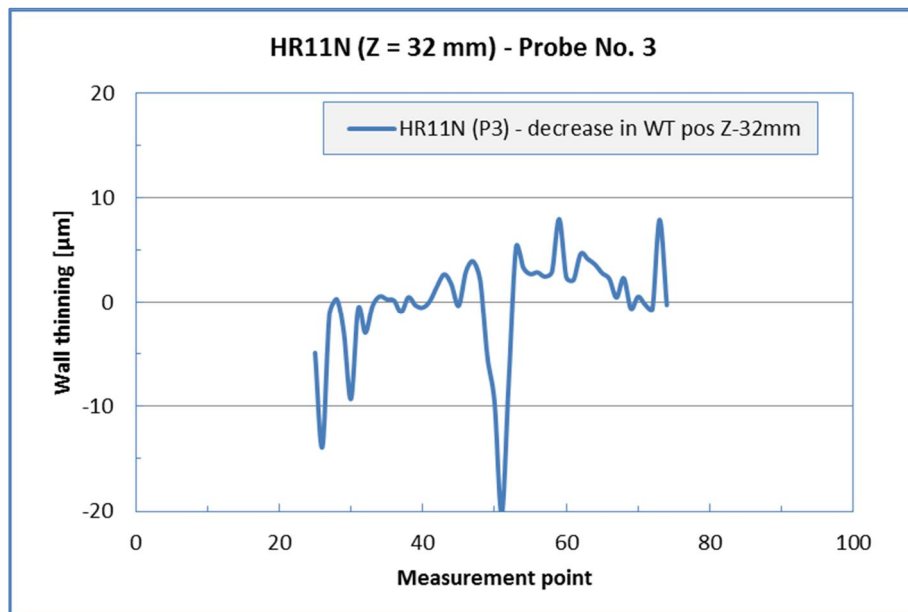
Figure 31. Circumferential wall thinning curves from HR11N specimen (Probe No. 3): a) axial location  $Z = 25$  mm and b) axial location  $Z = 32$  mm.

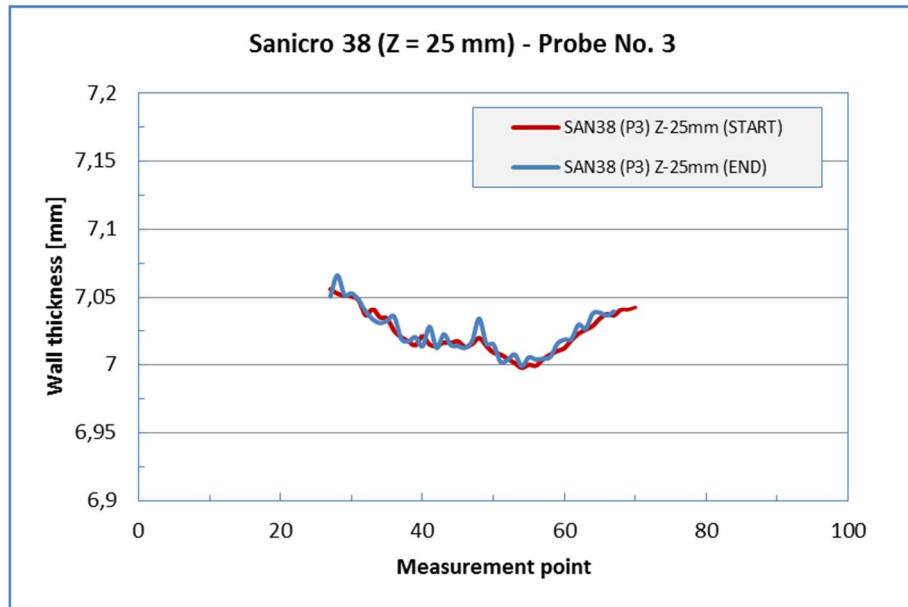
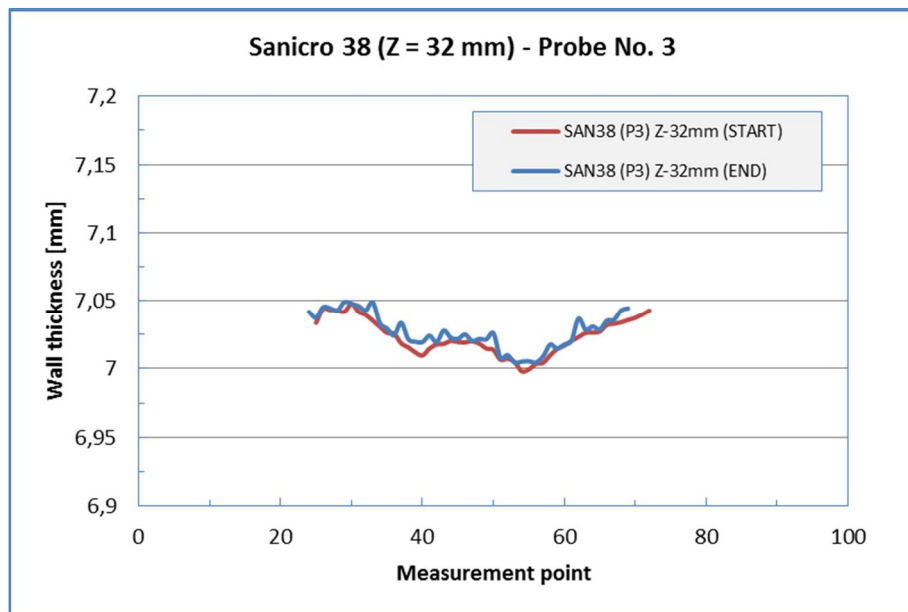
Figure 32. Circumferential wall thickness profiles from Sanicro 38 specimen (Probe No. 3): a) axial location  $Z = 25$  mm and b) axial location  $Z = 32$  mm.

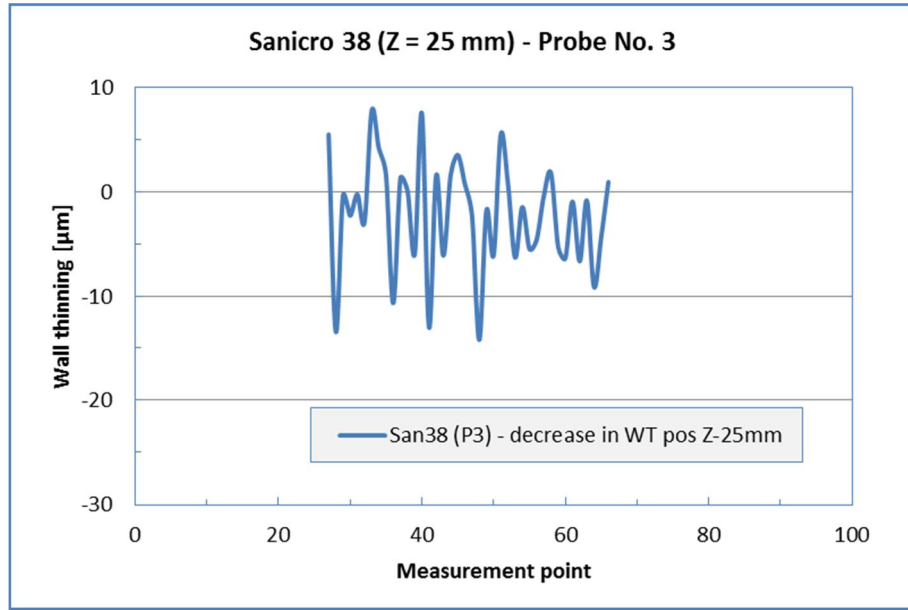
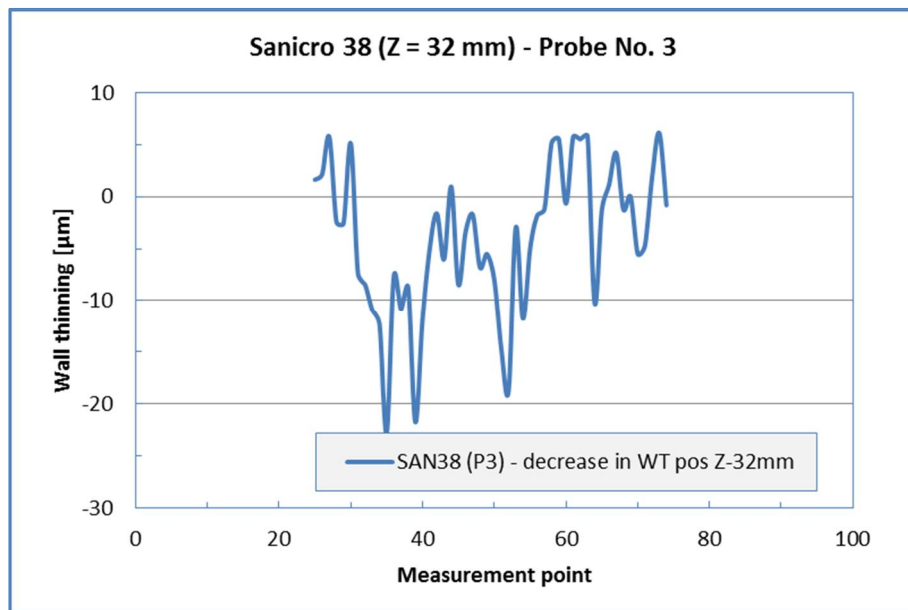
Figure 33. Circumferential wall thinning curves from Sanicro 38 specimen (Probe No. 3): a) axial location  $Z = 25$  mm and b) axial location  $Z = 32$  mm.

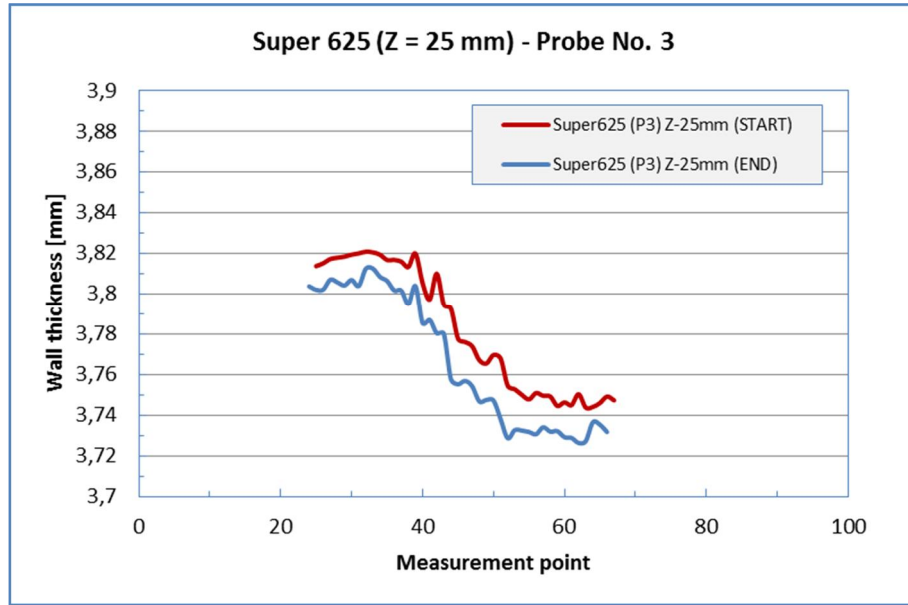
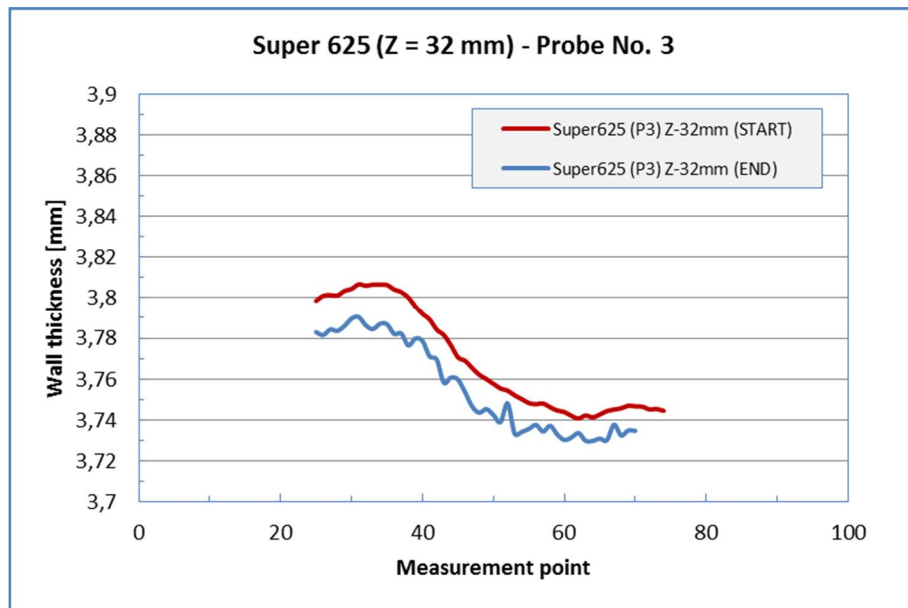
Figure 34. Circumferential wall thickness profiles from Super 625 specimen (Probe No. 3): a) axial location  $Z = 25$  mm and b) axial location  $Z = 32$  mm.

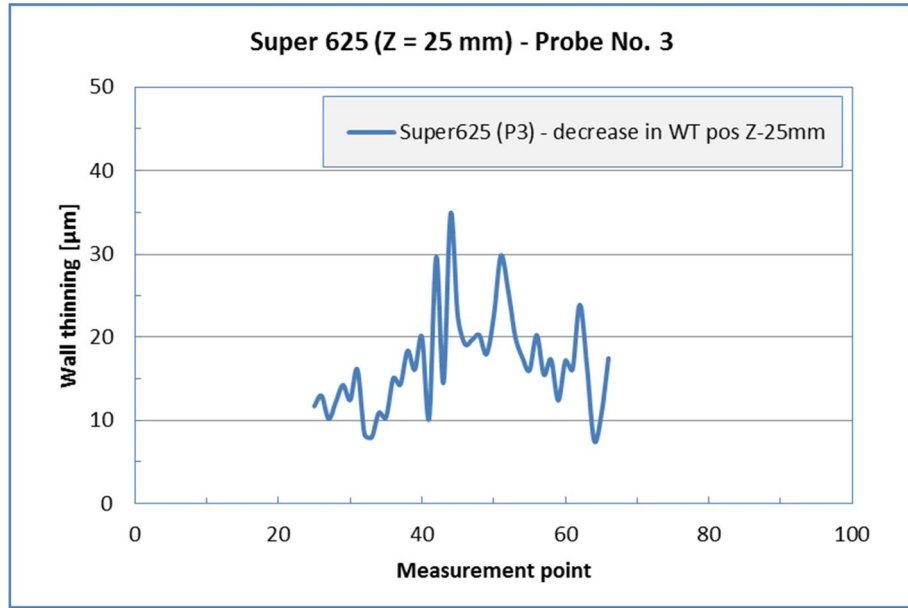
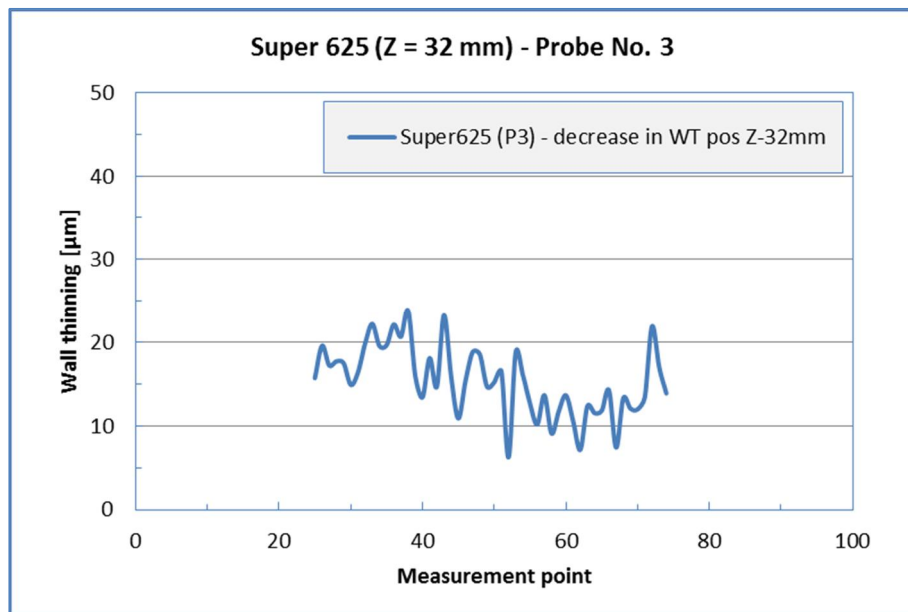
Figure 35. Circumferential wall thinning curves from Super 625 specimen (Probe No. 3): a) axial location  $Z = 25$  mm and b) axial location  $Z = 32$  mm.

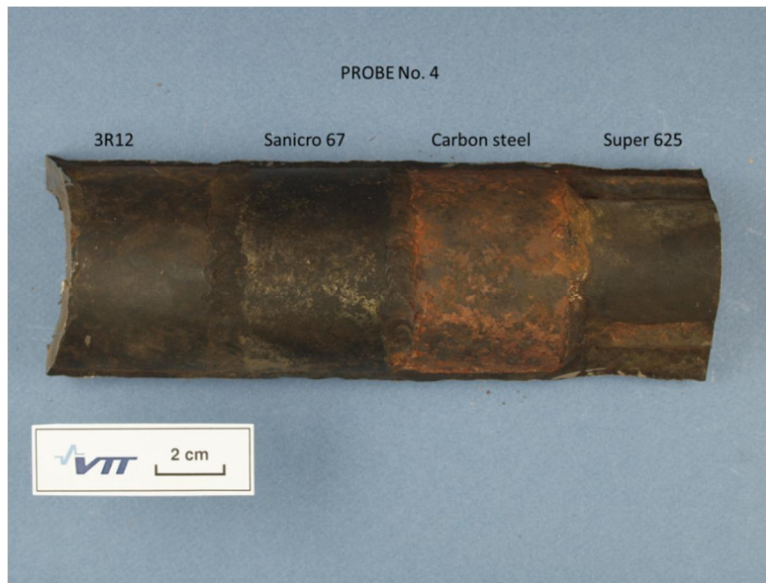
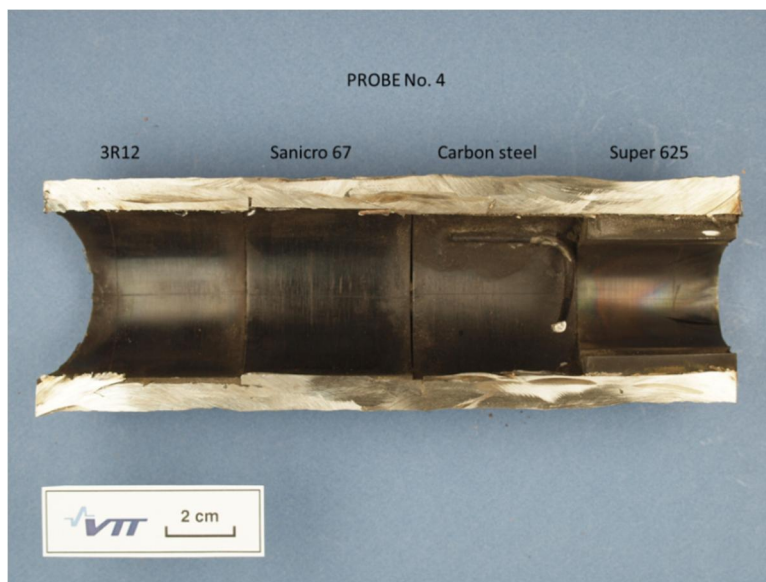
According to visual inspection the inner surfaces of the specimens were in good condition after testing. The outer surfaces of the 3R12, Sanicro 67 and Super 625 specimens were covered with thin dark deposits but appeared to be in good condition. The carbon steel specimen was heavily corroded.

*Figure 39. Macrographs taken from the probe No. 4 head after exposure: a) outer surface exposed to the furnace side and b) inner surface exposed to the cooling liquid. A thermocouple soldered on the side surface of carbon steel specimen is clearly visible on inner surface.*

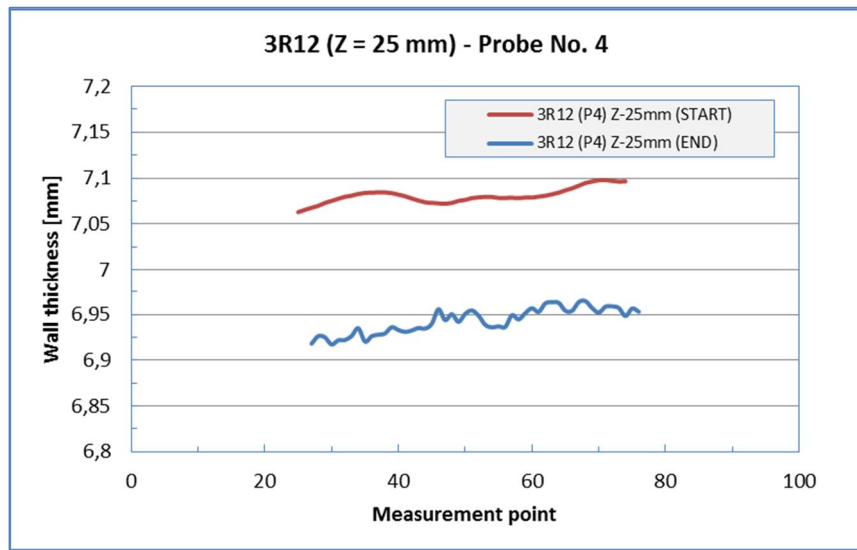
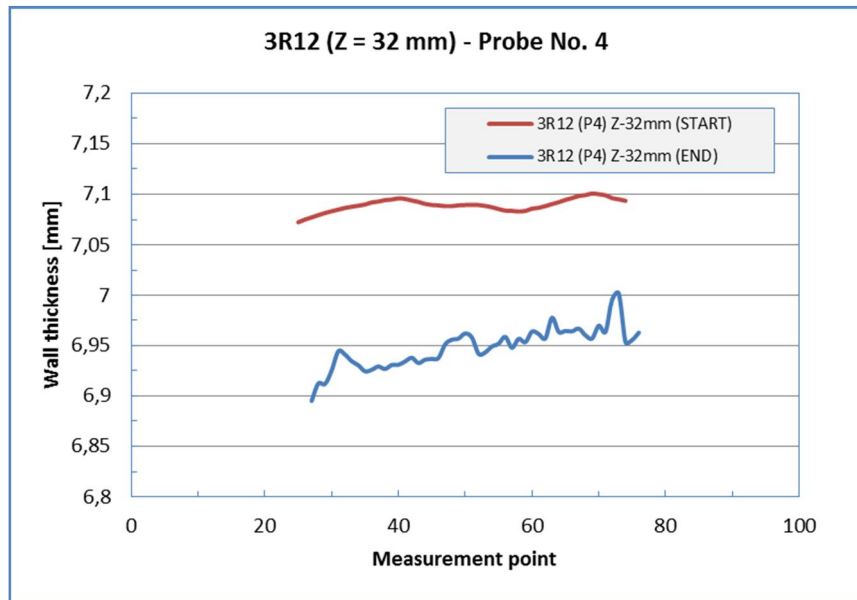
The results of the wall thickness profile measurements and the wall thinning curves derived from them are presented in Figures 40...47. The results showed that intense wall thinning had taken place on carbon steel specimen. Marked wall thinning was also observed on the 3R12 specimen and lesser degree also on the Super 625 specimen. The data of the Sanicro 67 specimen was more scattered showing that wall thinning and deposit formation (increase in wall thickness) had taken place locally. The results showed also that surface polishing prior testing together with longer exposure time reduced data scatter and thus improved accuracy.

Figure 40. Circumferential wall thickness profiles from 3R12 specimen (Probe No. 4): a) axial location  $Z = 25$  mm and b) axial location  $Z = 32$  mm.

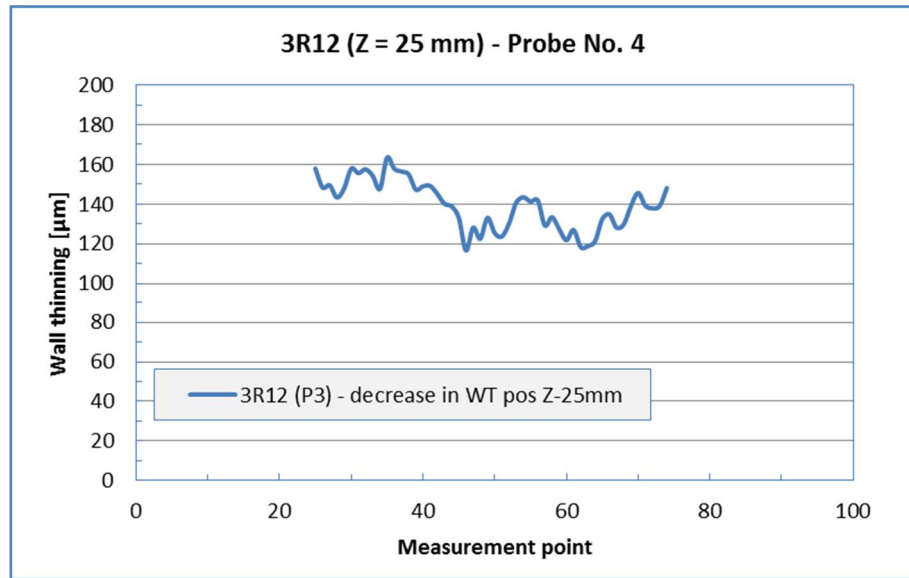
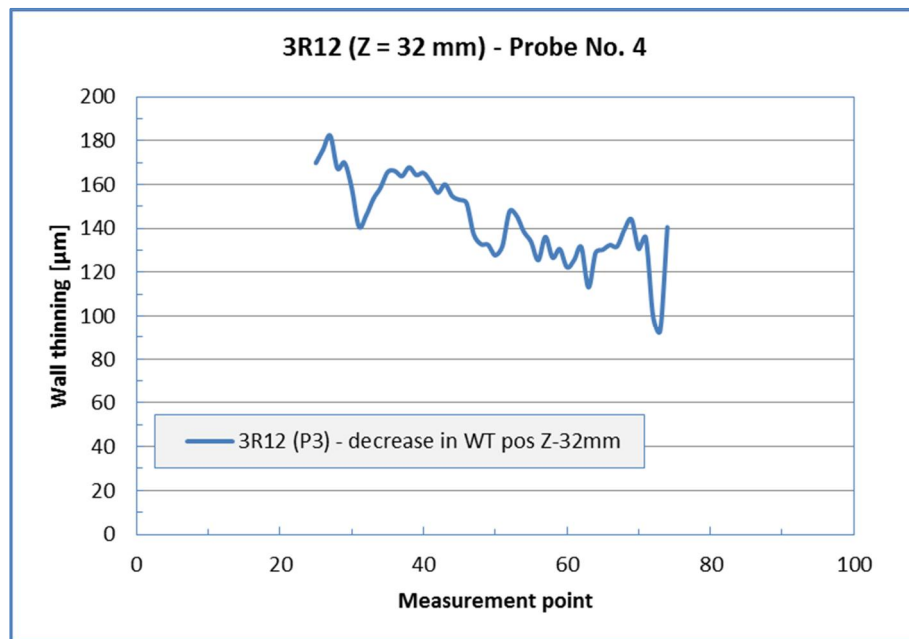
Figure 41. Circumferential wall thinning curves from 3R12 specimen (Probe No. 4): a) axial location  $Z = 25$  mm and b) axial location  $Z = 32$  mm.

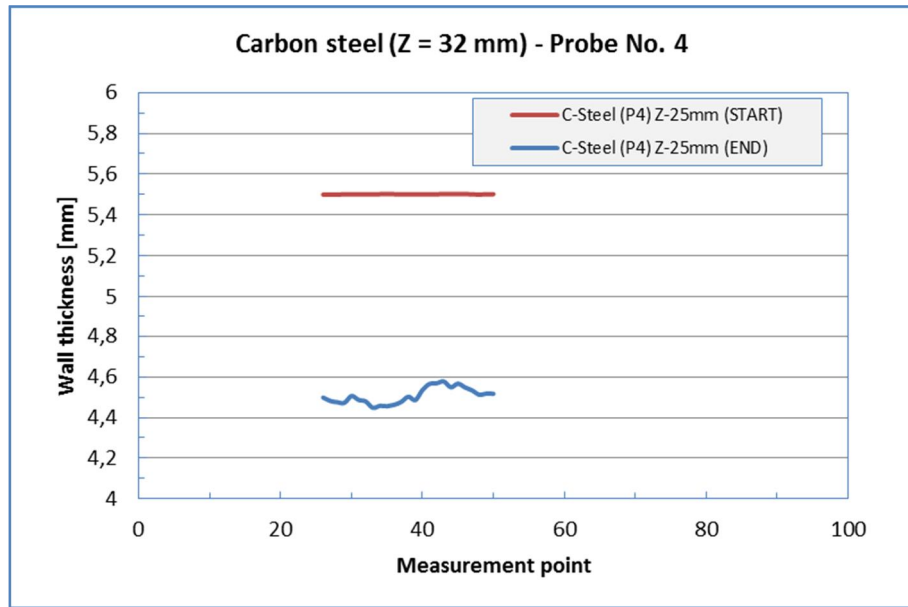
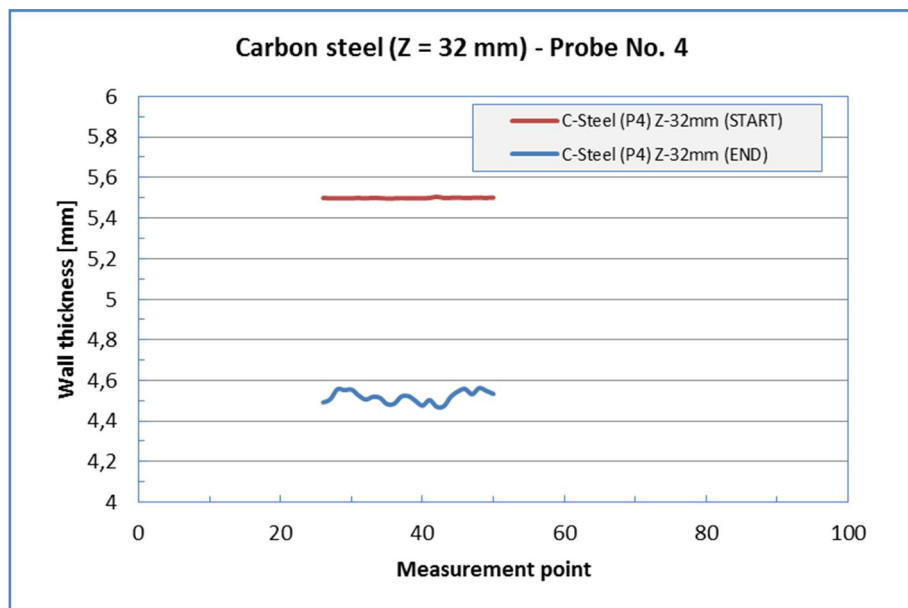
Figure 42. Circumferential wall thickness profiles from carbon steel specimen (Probe No. 4): a) axial location  $Z = 25$  mm and b) axial location  $Z = 32$  mm.

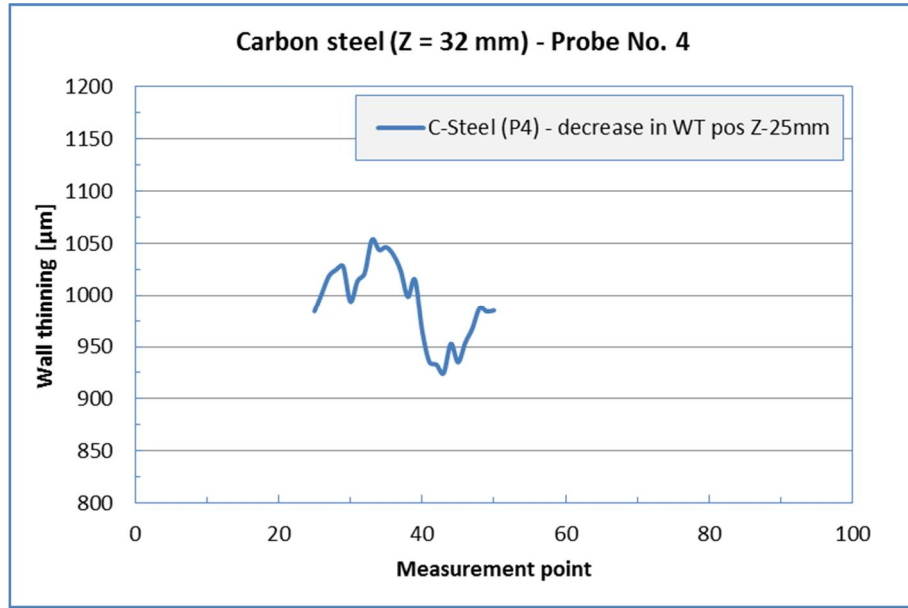
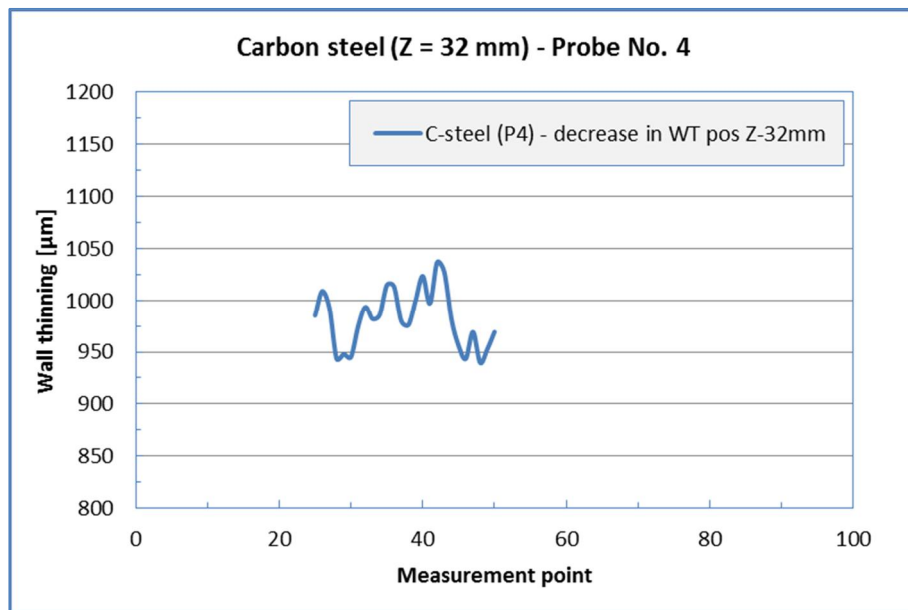
Figure 43. Circumferential wall thinning curves from carbon steel specimen (Probe No. 4): a) axial location  $Z = 25$  mm and b) axial location  $Z = 32$  mm.

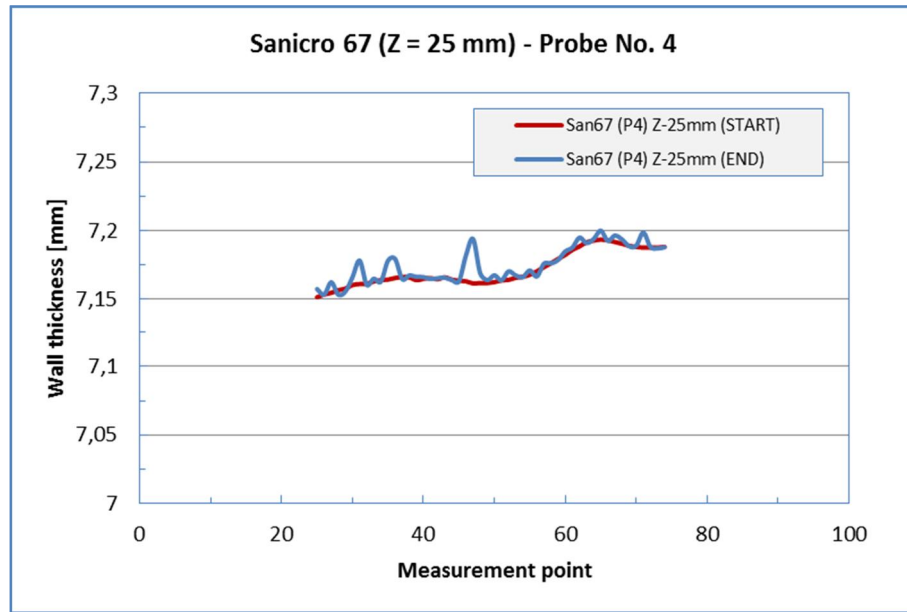
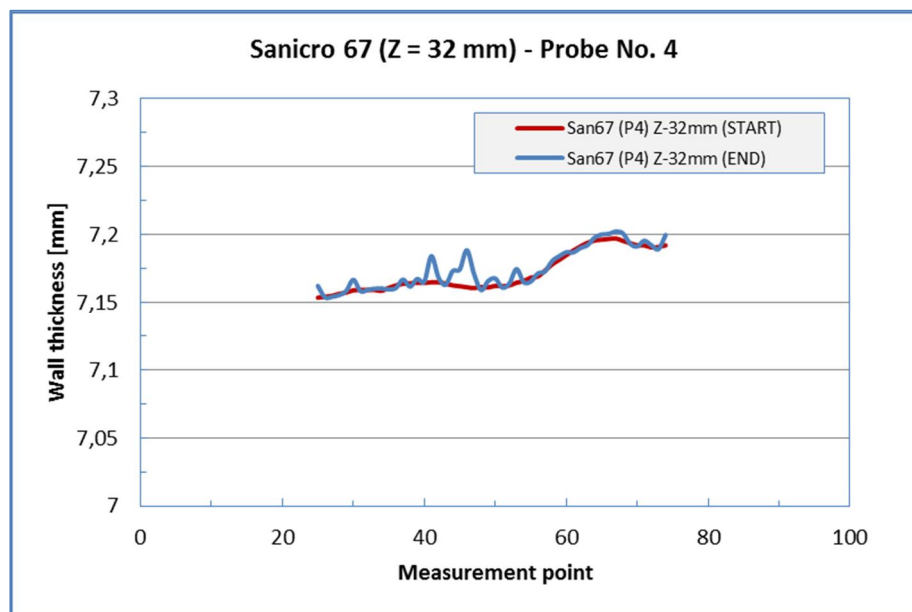
Figure 44. Circumferential wall thickness profiles from Sanicro 67 specimen (Probe No. 4): a) axial location  $Z = 25$  mm and b) axial location  $Z = 32$  mm.

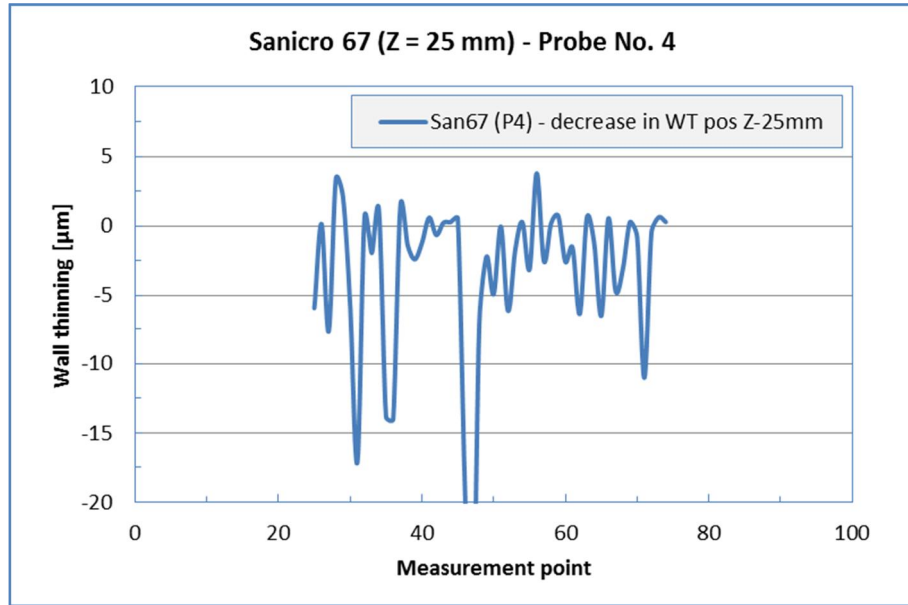
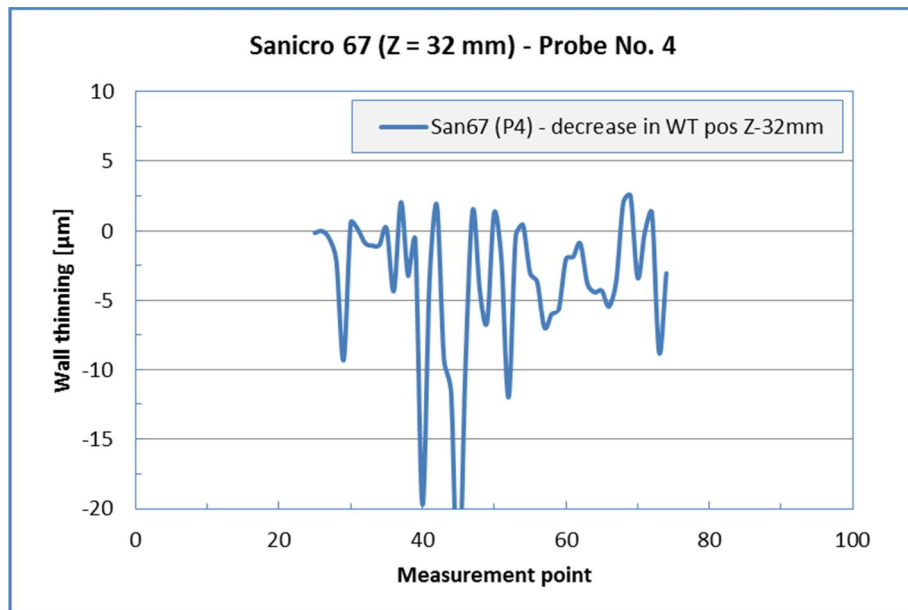
Figure 45. Circumferential wall thinning curves from Sanicro 67 specimen (Probe No. 4): a) axial location  $Z = 25$  mm and b) axial location  $Z = 32$  mm.

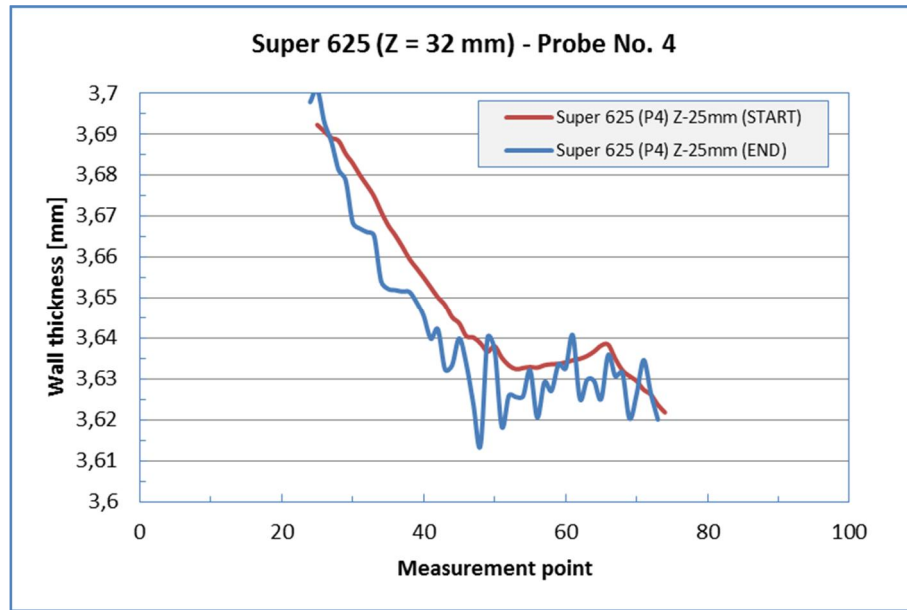
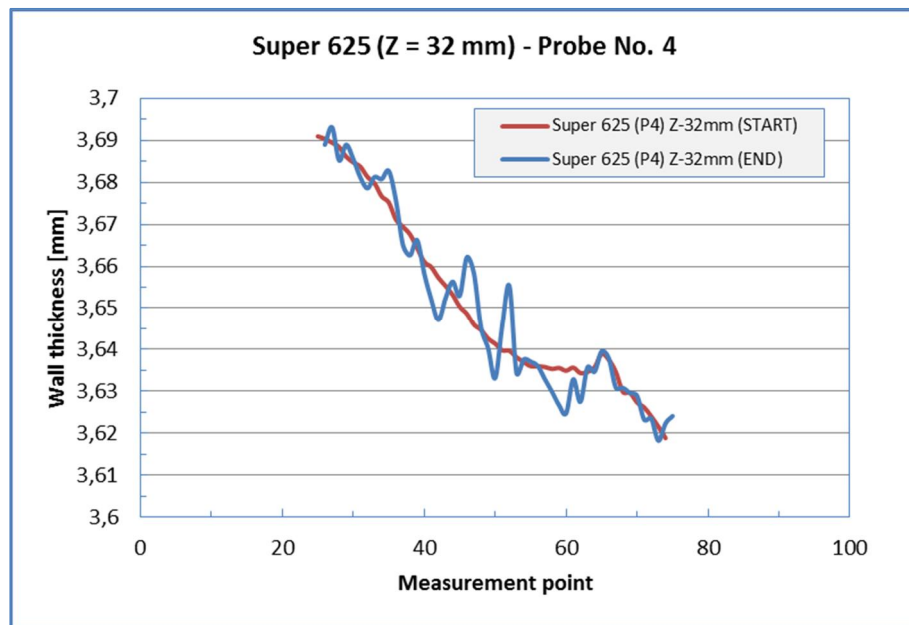
Figure 46. Circumferential wall thickness profiles from Super 625 specimen (Probe No. 4): a) axial location  $Z = 25$  mm and b) axial location  $Z = 32$  mm.

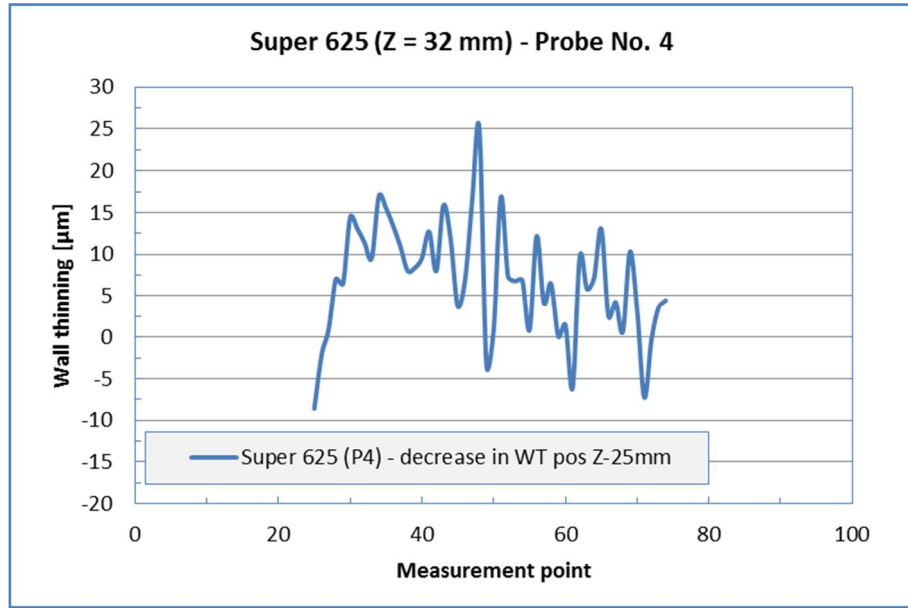
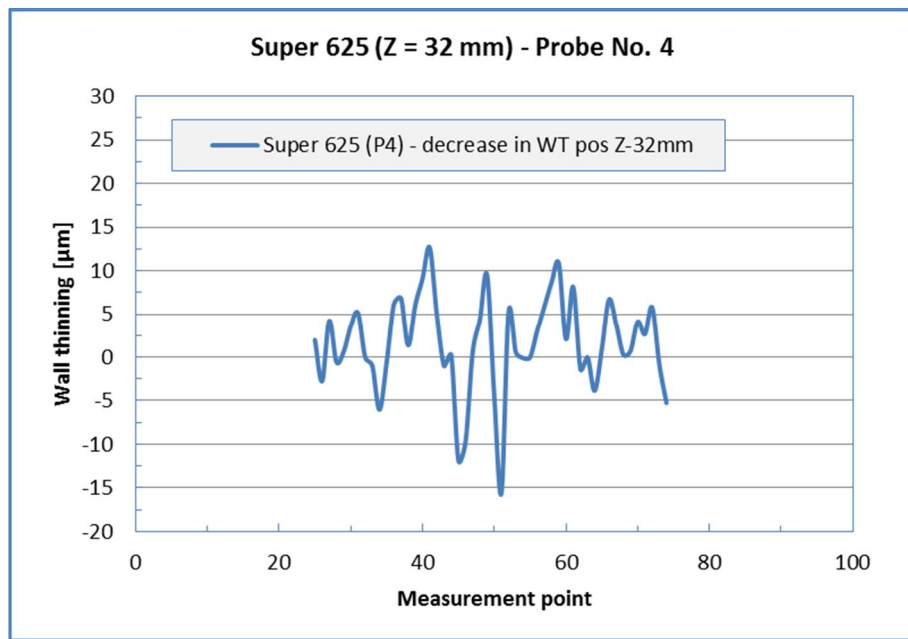
Figure 47. Circumferential wall thinning curves from Super 625 specimen (Probe No. 4): a) axial location  $Z = 25$  mm and b) axial location  $Z = 32$  mm.
