# Characterisation of probe test samples exposed to BLRB lower furnace environments

Author: Pekka Pohjanne

Report's title Characterisation of probe test samples exposed to BLRB lower furnace environments	
Customer, contact person, address Soodakattilayhdistys ry.	Order reference
Project name SKYREC Sondi	Project number/Short name 33189
Author(s) Pekka Pohjanne	Pages 70/
Keywords	Report identification code VTT-R-02472-13
<p><b>Abstract</b></p> <p>Current trend to increase electricity generation of recovery boilers possess new demands for the tube materials, when the material temperatures are increased due to higher steam values. Operational experiences from current boilers have shown that the AISI 304 L compound tubes suffer from accelerated corrosion in furnace wall, when the material temperatures are increased from normal values due to the internal surfaces scales. This indicates that the AISI 304L might be unsuitable cladding material for the future high pressure boilers.</p> <p>The goal of this study was to test different potential cladding materials in actual recovery boiler lower furnace conditions, but at higher than current temperatures, in order to determine what material

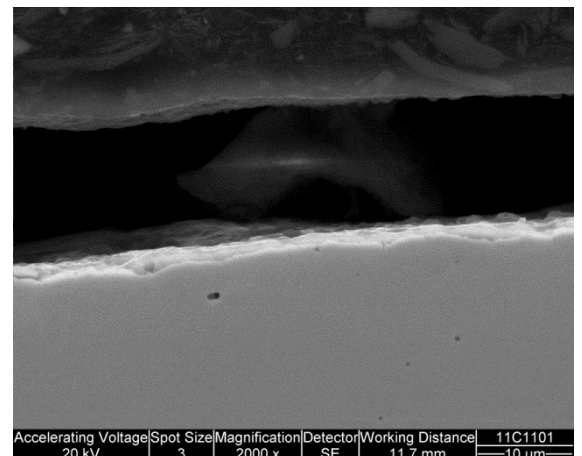
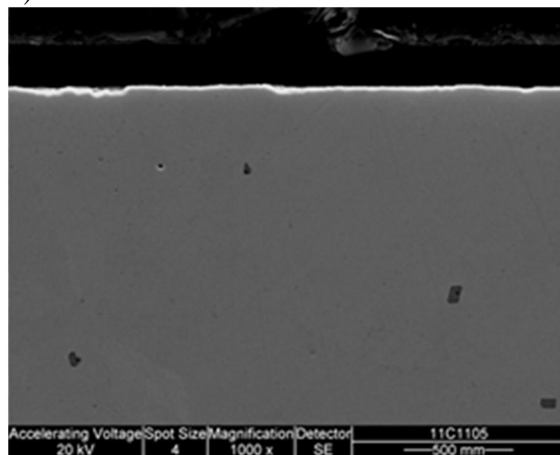
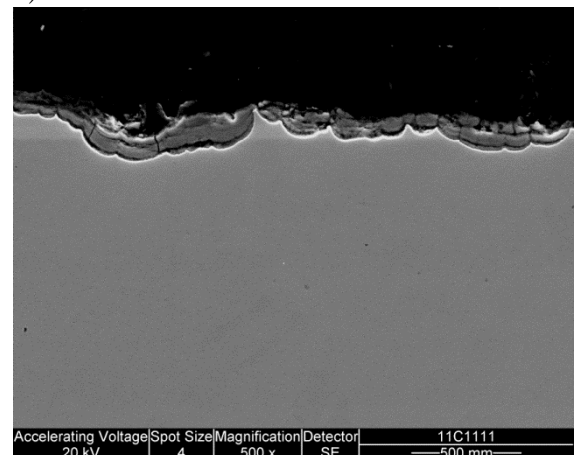
After the tests the samples were examined with optical microscope and/or SEM to determine the type of the corrosion attack. All samples had suffered from general thinning, Figure 49. The carbon steel showed scale thickness of about 25  $\mu\text{m}$  after 2700 h exposure. The layers formed on 3R12 and Sanicro 67 were thin ca.5  $\mu\text{m}$  in thickness. Whereas on the Super 625 ca. 10...20  $\mu\text{m}$  thick peeling like scale was observed.

Figure 49. Cross sections from a) carbon steel b) 3R12, c) Sanicro 67 and d) Super 625 after 2154 h exposure in lower furnace at 440 °C (Probe test No. 4). Note: scale is incorrect in Fig. 49b.

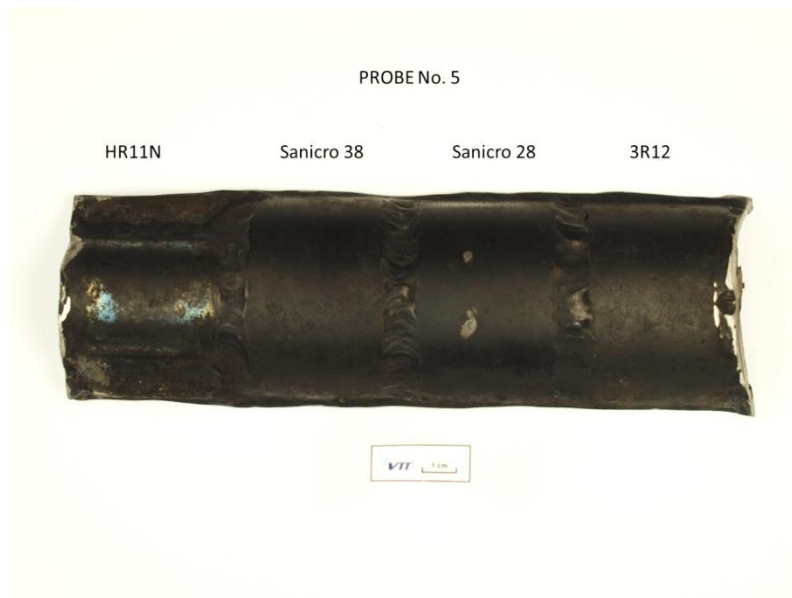
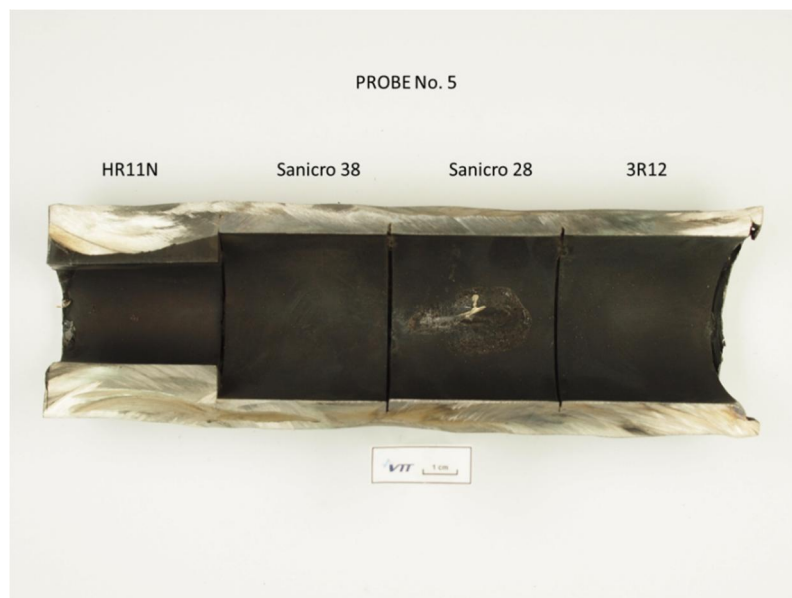
Total test duration of the test No. 5 was 2630 hours from which 2157 hours at the target temperature of 440 °C. The test materials in this exposure were 3R12, Sanicro 28, HR11N and Sanicro 38, Figure 51. According to visual inspection all samples were in good condition after testing i.e. neither marked general or localised corrosion nor deposits or oxide scales were observed either on outer or inner surfaces.

*Figure 51. Macrographs taken from the probe No. 5 head after exposure: a) outer surface exposed to the furnace side and b) inner surface exposed to the cooling liquid. A thermocouple soldered on the middle of Sanicro28 specimen, that hindered WT measurements after exposure, is clearly visible on inner surface.*

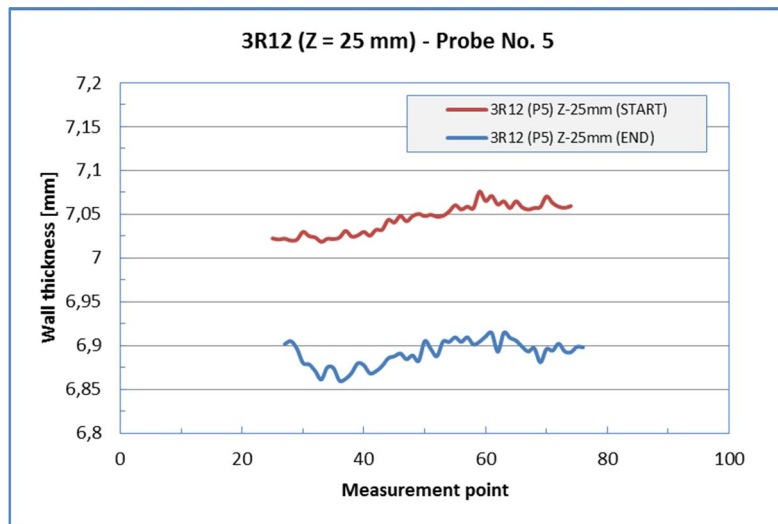
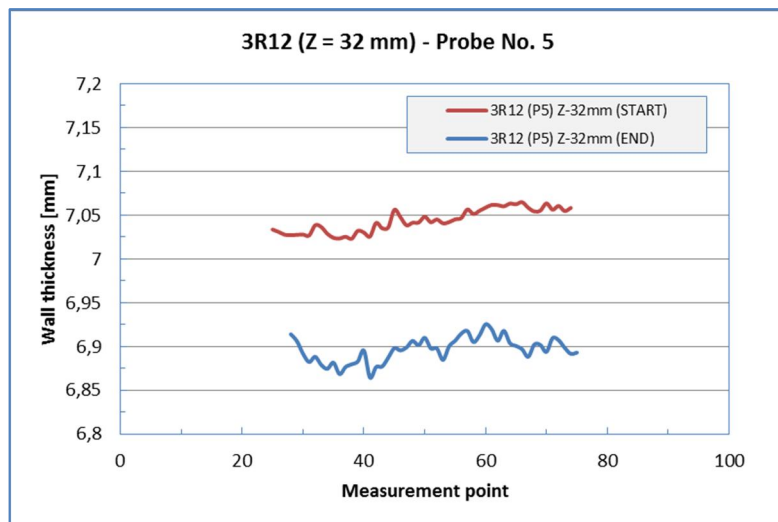
The results of the wall thickness profile measurements and the wall thinning curves derived from them for 3R12, HR11N and Sanicro 38 are presented in Figures 52...57. The results showed that marked wall thinning had taken on the 3R12 specimen. Some wall thinning was observed also on the Sanicro 38 specimen and locally also on the HR11N specimen. The WT profile measurements for the Sanicro 28 sample after the test failed due to the thermocouple that was soldered on the inner surface of the specimen (Figure 51b).

Figure 52. Circumferential wall thickness profiles from 3R12 specimen (Probe No. 5): a) axial location  $Z = 25$  mm and b) axial location  $Z = 32$  mm.

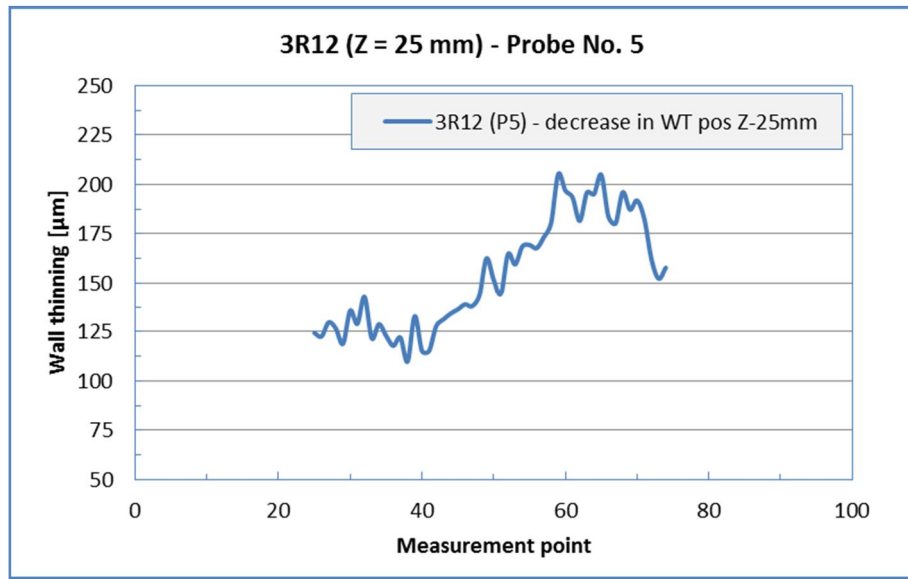
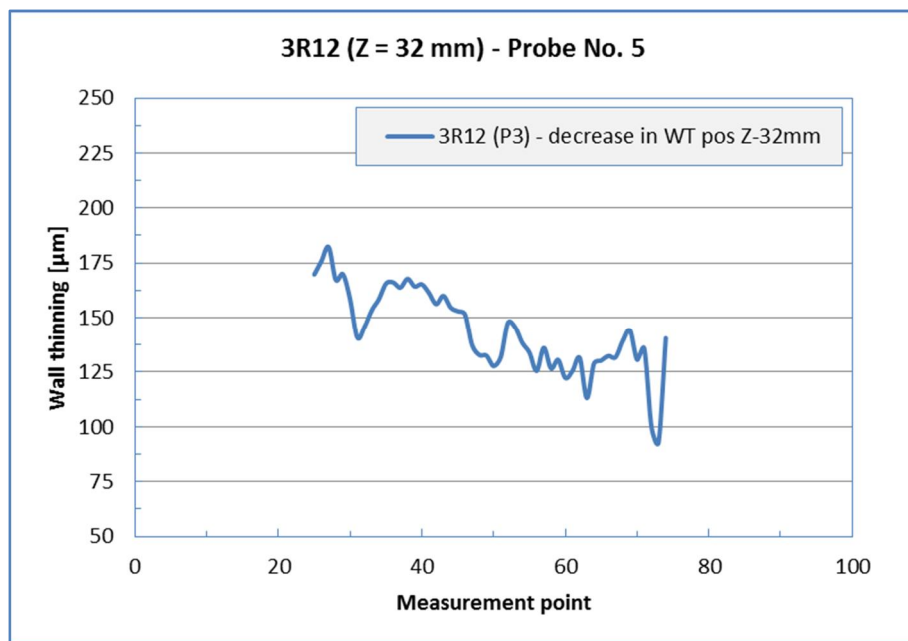
Figure 53. Circumferential wall thinning curves from 3R12 specimen (Probe No. 5): a) axial location  $Z = 25$  mm and b) axial location  $Z = 32$  mm.

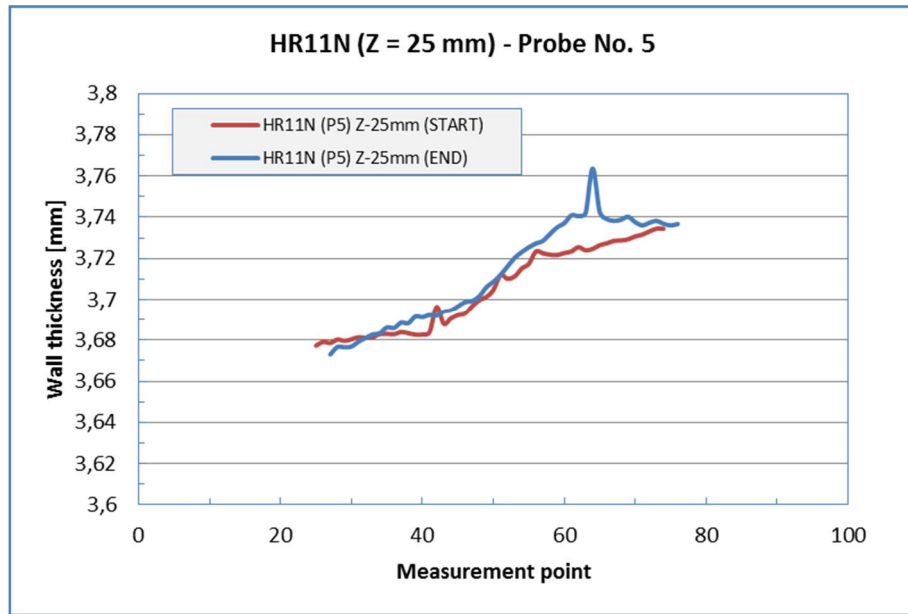
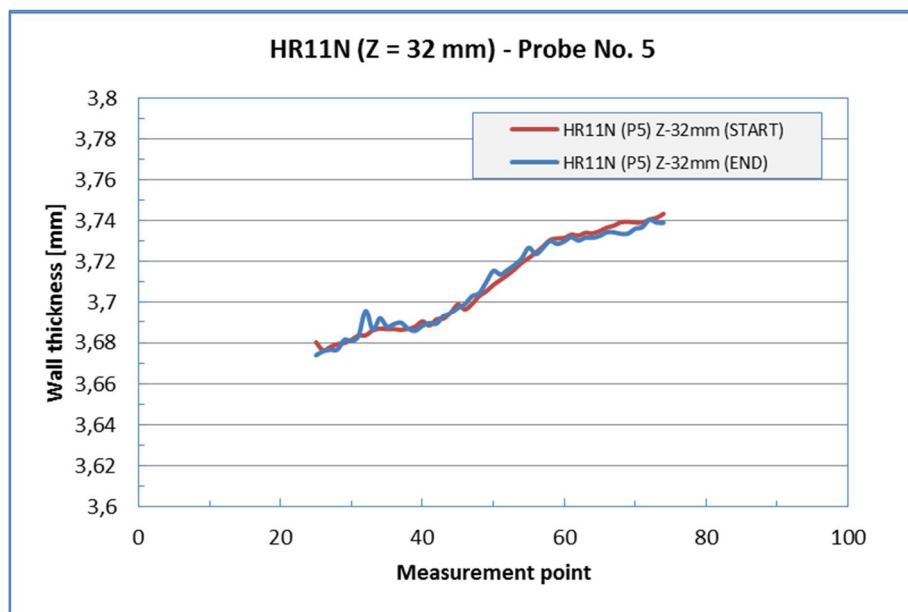
Figure 54. Circumferential wall thickness profiles from HR11N specimen (Probe No. 5): a) axial location  $Z = 25$  mm and b) axial location  $Z = 32$  mm.

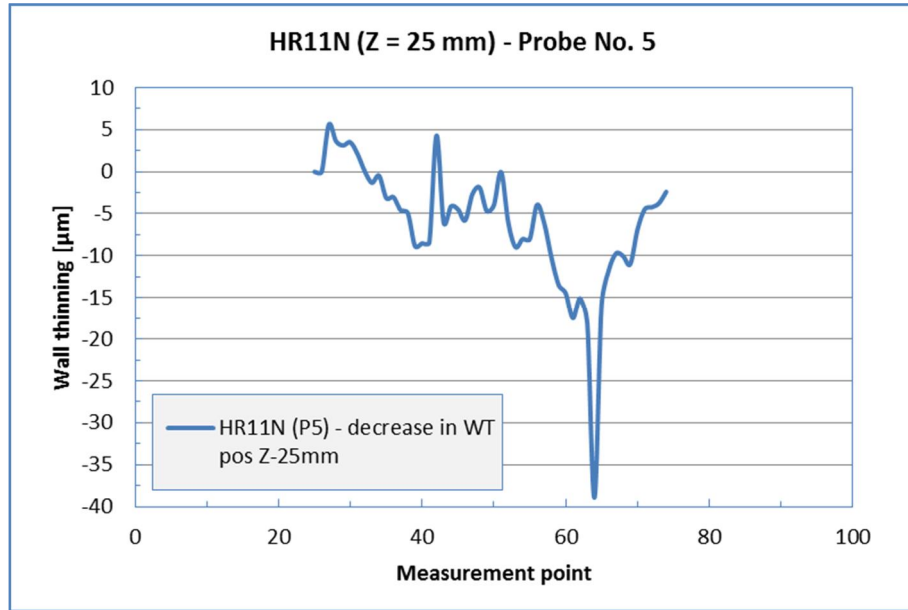
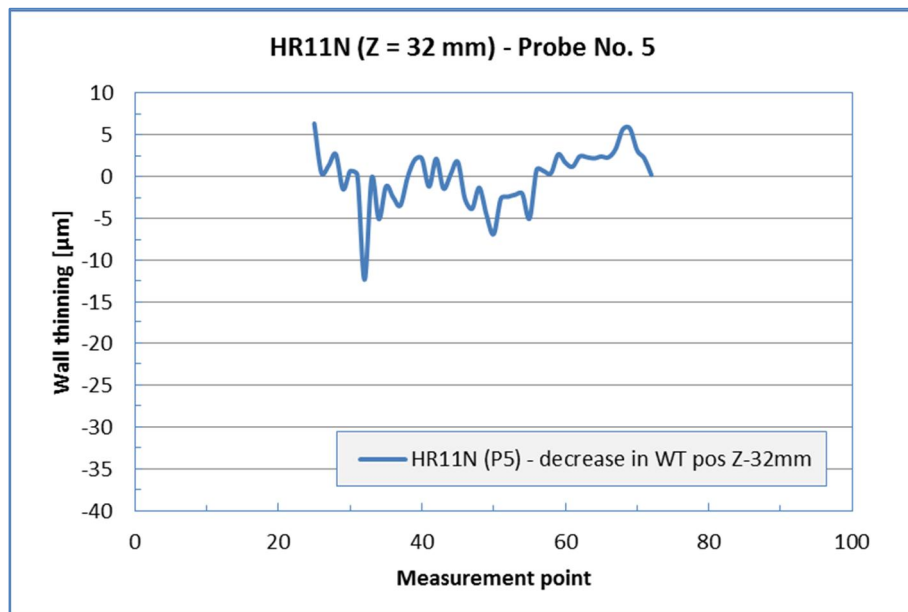
Figure 55. Circumferential wall thinning curves from HR11N specimen (Probe No. 5): a) axial location  $Z = 25 \text{ mm}$  and b) axial location  $Z = 32 \text{ mm}$ .

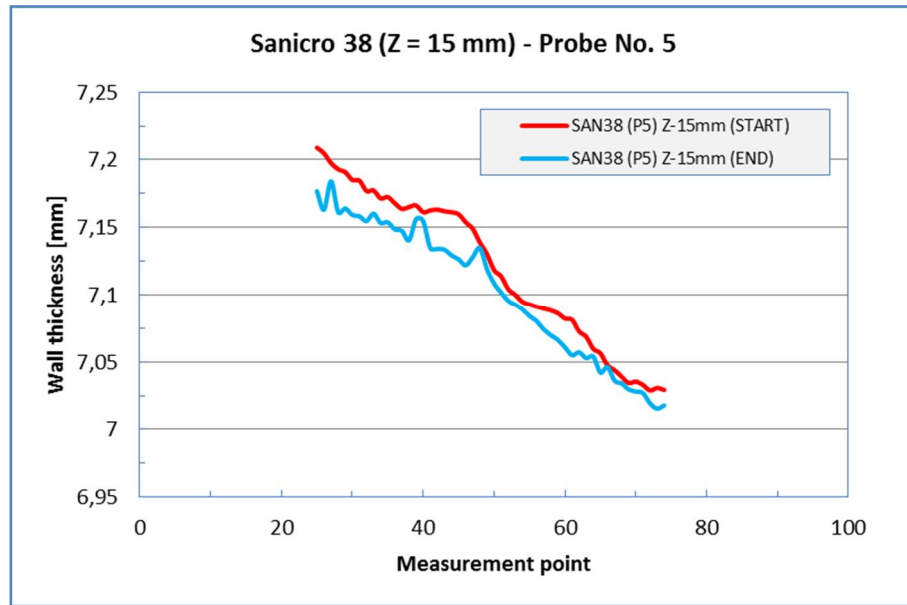
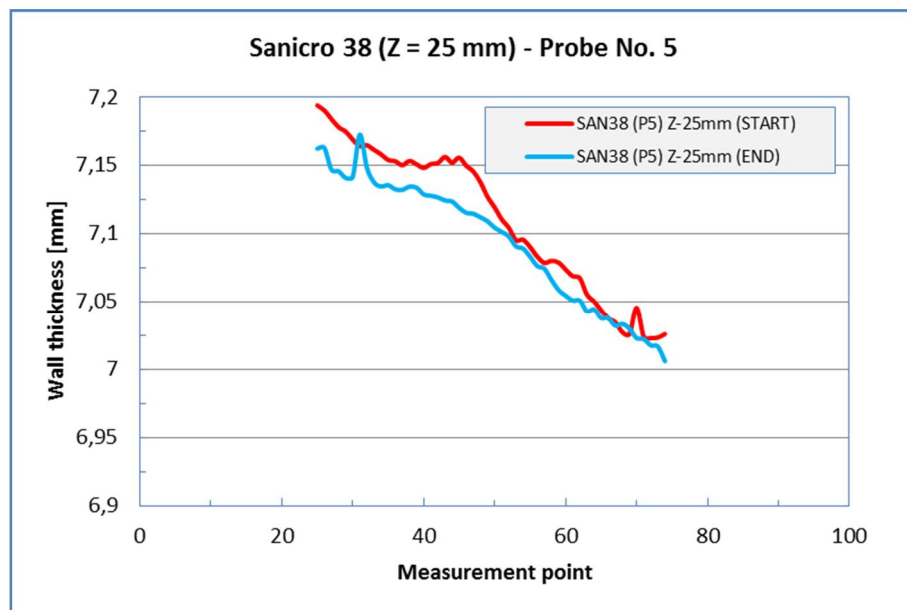
Figure 56. Circumferential wall thickness profiles from Sanicro 38 specimen (Probe No. 5): a) axial location  $Z = 15$  mm and b) axial location  $Z = 25$  mm.

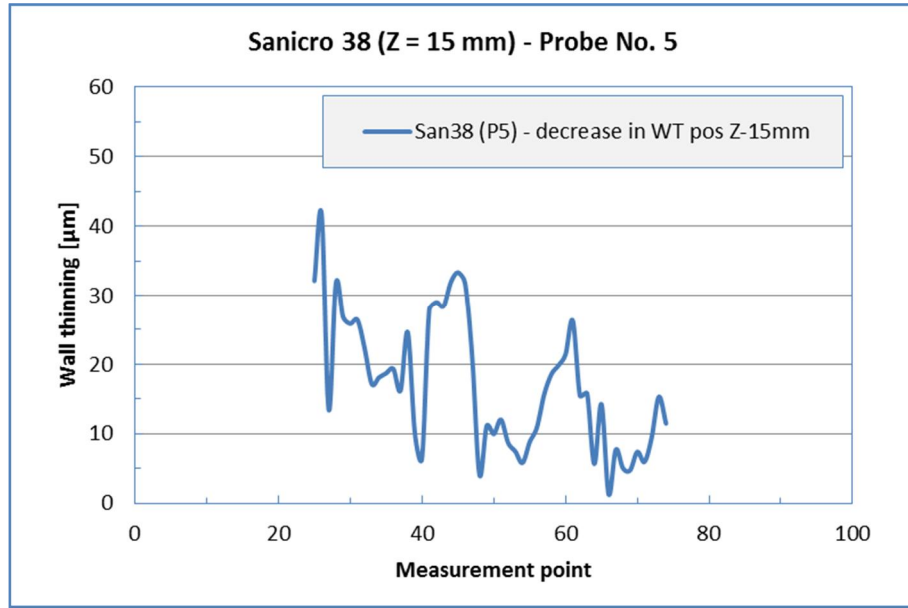
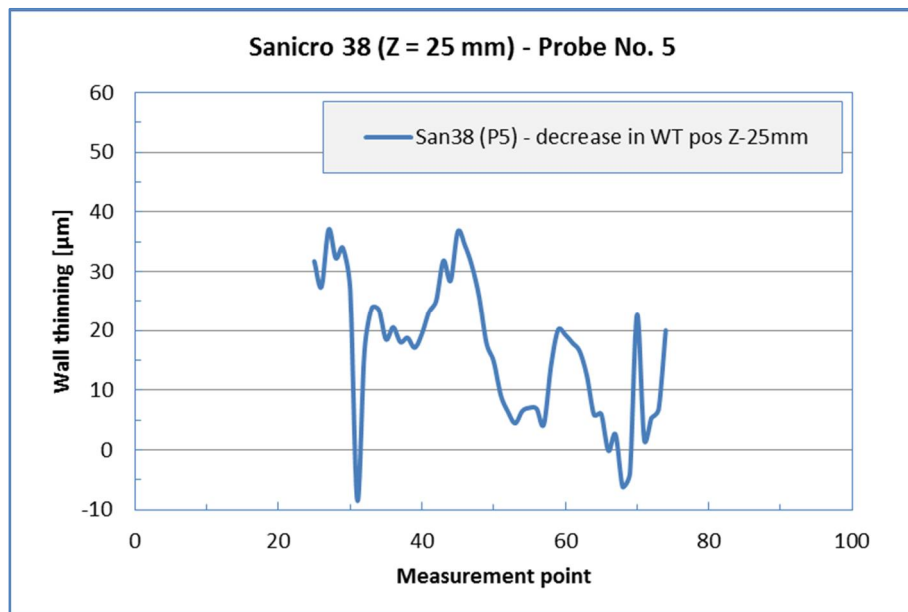
Figure 57. Circumferential wall thinning curves from Sanicro 38 specimen (Probe No. 5): a) axial location  $Z = 25$  mm and b) axial location  $Z = 32$  mm.

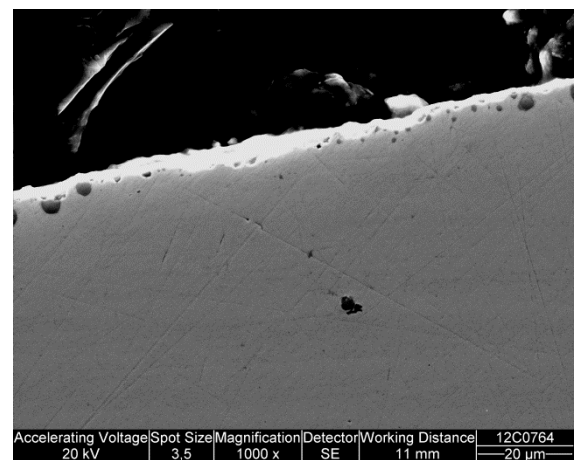
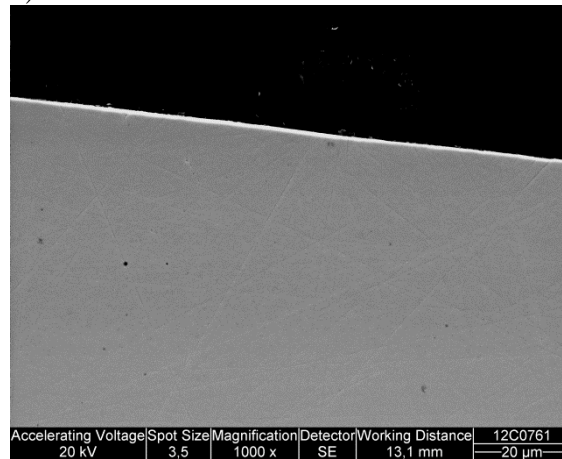
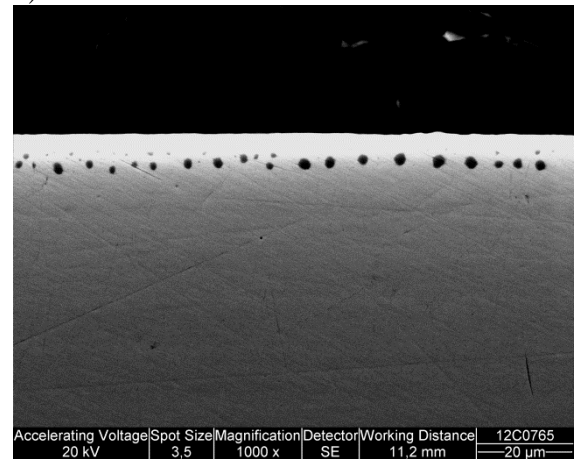
After the tests the samples were examined with optical microscope and/or SEM to determine the type of the corrosion attack. All samples had suffered from general thinning and no marked deposits or oxide/sulphide scales were observed on the surfaces, Figure 49. The layers found on 3R12, Sanicro 28, HR11N and Sanicro 38 were very thin ca. 2  $\mu\text{m}$  in thickness. EDS analysis showed that iron and nickel depletion and chromium enrichment had taken place in some locations in all materials and that in these locations sulphur was also detected (Figure 50).

Figure 59. Cross sections from a) 3R12, b) Sanicro 28, c) HR11N and d) Sanicro 38 after 2157 h exposure in lower furnace at 440 °C (Probe test No. 5).

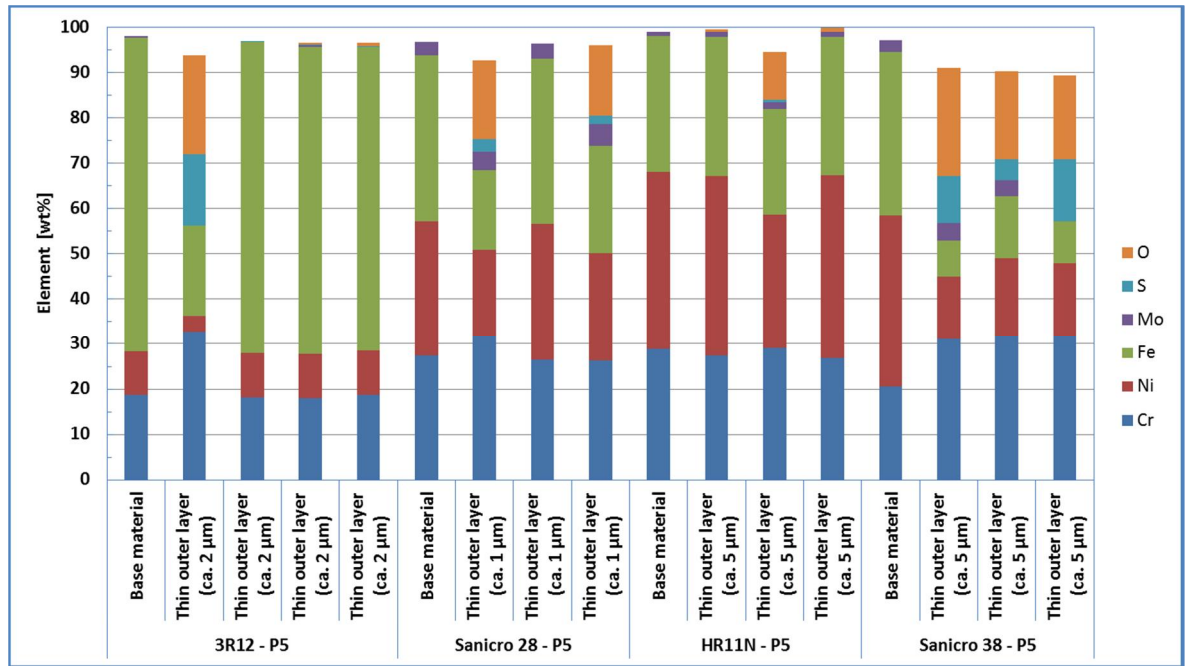
Figure 60. Results from the EDS analysis performed for the 3R12, Sanicro 28, HR11N and Sanicro 38 after 2157 h exposure in lower furnace at 440 °C (Probe test No. 5). Note: Quantitative results from cross sections, carbon excluded. Data from layers are from point analysis, whereas area analysis was used for base materials.
