## **APPENDIX 1**

**Project budget  
5.5.2011**

# SKYREC Budget 5.5.2011

**Åbo Akademi  
Corrosion tests in reducing conditions  
Part II – revised offer  
5.5.2011**

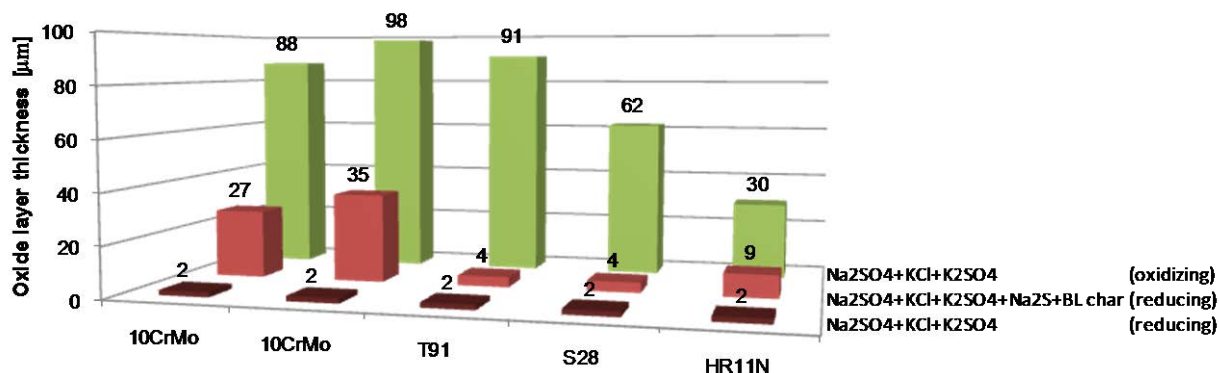
The mean oxide layer thickness from the performed test together with the results from the previously performed tests with Salt 10 ( $\text{Na}_2\text{SO}_4$ -KCl- $\text{K}_2\text{SO}_4$ ) in reducing and oxidizing atmosphere is presented in Figure 2. The 10CrMo material performed significantly worse when comparing to results from tests with Salt 10. The performance of T91 and S28 was comparable and the oxide layer measured in both cases 4 µm. The oxide layer growth on HR11N material was higher than in case of test with Salt 10 but it was not dramatic (~10µm).

Figure 2. The mean oxide layer thickness of the tested materials in reducing and oxidizing atmosphere at 550 °C. The corrosion tests duration 168h. Exposures with Salt 10 and 10r.

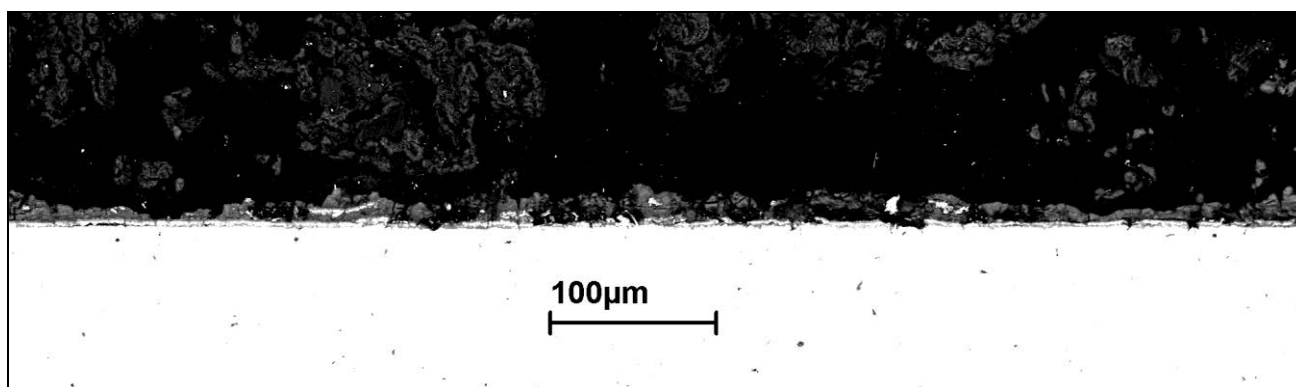
The corrosion products formed on 10CrMo were well adhering to the steel surface and resembled molten phase. The steel surface was rich in Na, S with Cl enrichment in the corrosion products, Figure 2. The surface of HR11N is presented in Figure 3. The thin pieces of the steel from the sample's surface became loose.

Figure 3. The part of panorama picture of HR11N steel after the test.

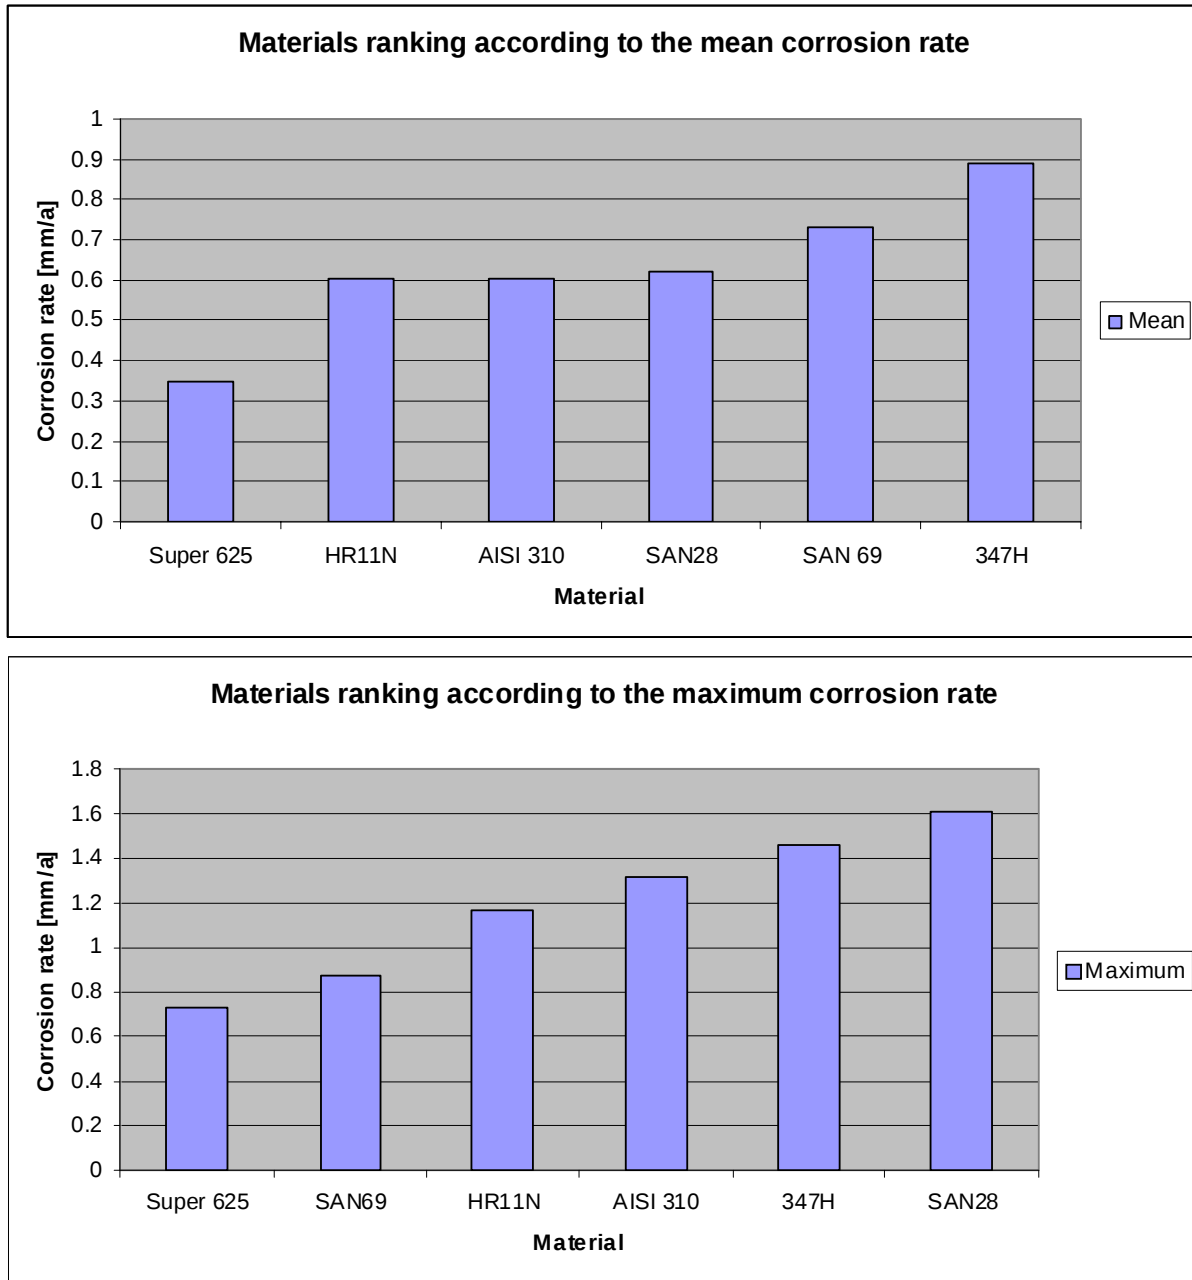
For illustrative purposes the metal loss values given in Table 5 above were converted by linear extrapolation in to annual corrosion rates, see Figure 8 below. Materials rankings according to linear extrapolation of mean or maximum metal loss in Table 5 above are shown in Figure 9.

Figure 9. Materials ranking according to the mean or maximum corrosion rate estimated as explained above. Using the maximum corrosion rate as criterion all materials, except Super 625 and SAN 69, show a corrosion rate > 1 mm/a, i.e., corrode with an unacceptable rate. According to mean corrosion rate all materials corrode at a rate < 1mm/a.

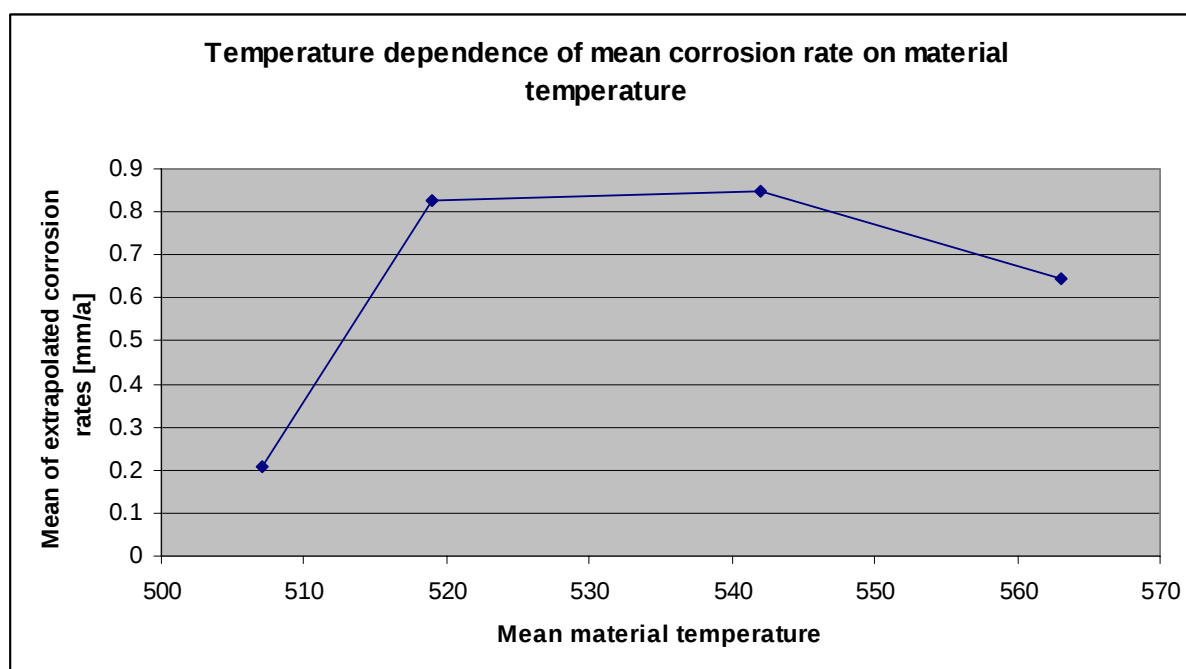
It seems that the corrosion rate is greatly enhanced at material temperatures in the range from 505 °C to 519 °C, Figure 10. Referring to the state-of-the-art theory of high temperature break-away oxidation of chromium alloyed steels and high-nickel alloys, see refs. [5,6,10] for example, one may propose that enhanced corrosion attack of the material samples tested is related here to the enhanced growth of mixed-type iron oxide – chromium oxide scales at locations exposed to high surface temperatures and some aggressive chemical conditions.

Figure 10. Dependence of mean metal loss measured on material temperature including the data for all six test materials exposed in Probe 2. See for reference Table 5.

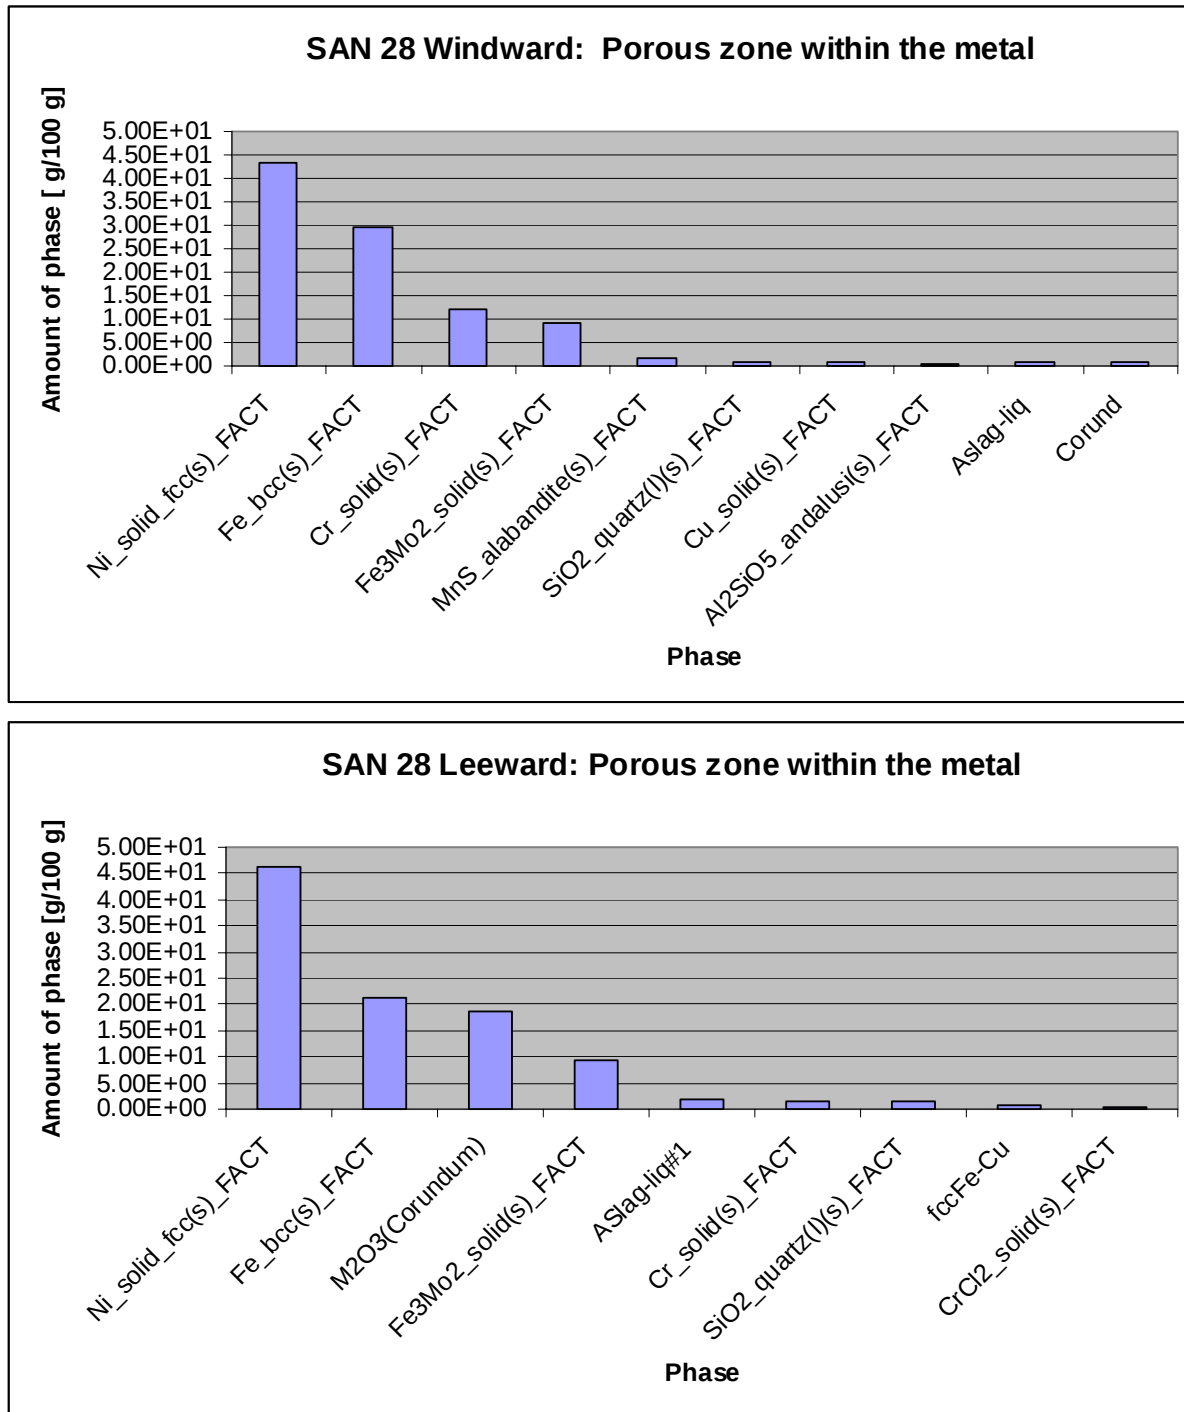
A number of phase equilibrium- or meta-stable phase-equilibriums were calculated based on detailed analyses of local areas within the metal, in the corrosion product layers and in the layers interim of corrosion products and deposited matter. The main interest was to make comparisons amongst little affected and heavily affected sides (or location) for the same material. Calculation results for SAN 28 are illustrated in Figure 13. This material showed, at locations, the most severe and the most minute corrosion attack of all.

Figure 13. Calculated phase composition that corresponds to an areal analysis of porous (de-alloyed) zone on the Windward side (top picture) and Leeward side (bottom picture) of sample of SAN 28. Transport of oxygen and sulphur via molten phases inward is predicted to possibly occur. Chlorine, however, is if present bound as a solid compound  $\text{CrCl}_2$ . (Phase equilibrium calculated for the temperature of 542 °C.)

In the case of SAN 28, mixture phases allowing a rapid transport of metal and oxidant species are predicted to be present in the porous metal. There is, however, no guarantee that the model liquid phase ASlag-liq#1 in Figure 13, or any other liquid, exists in the real physical equilibrium. Chlorine, when present as-analysed, tends to bound as a solid phase compound  $\text{CrCl}_2$  causing that  $\text{Cl}_2$ -activity is very low within the porous zone. Accordingly, chromium must be considered as a beneficial alloying element. In the subsurface layers and multiphase corrosion scales that may show relatively high oxygen activities, low melting mixtures of

metal chlorides and oxy-chlorides may be present. Alkali chlorides NaCl and KCl form with  $\text{CrCl}_2$  various ternary eutectics in the temperature range of about from 604 °C to 548 °C.

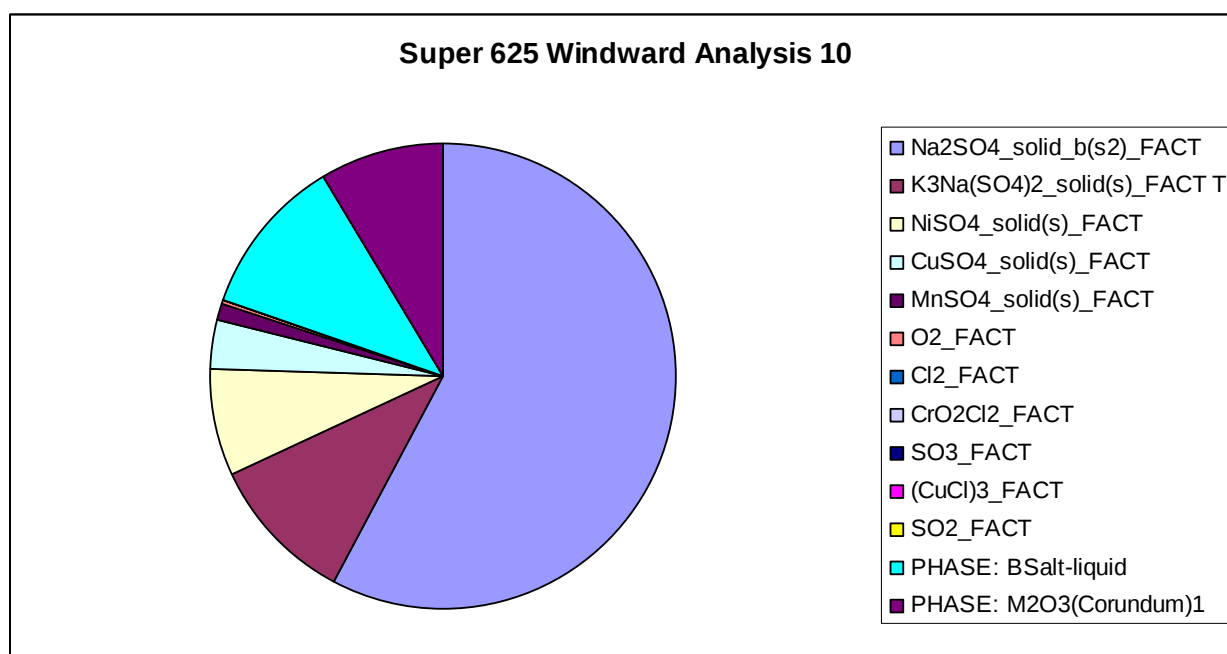
Equilibrium calculations based on areal or point analysis of outer corrosion scales did most often lead to unphysical equilibrium state-predictions showing very high equilibrium partial pressures of sulphur oxides and gaseous chlorine species, see for example the case of deposit analysis representing deposit/scale interaction zone on the Windward side of Super 625, Figure 15 below.

Figure 15. Calculated phase composition that corresponds to an areal analysis of corrosion scale/deposit on Windward side of Super 625 (top picture); the equilibrium state predicted is obviously non-physical due to high partial pressure of gaseous species  $\text{SO}_3$  and  $\text{Cl}_2$ .

This situation may be explained (i) by incomplete local reaction equilibrium amongst oxygen, sulphur and chloride species actually present and (ii) some amount of carbonate (and hydrogen) in the true elemental composition. The short operation cycle of proximate soot blowers makes it plausible that a non-equilibrium state is rather characteristic for the deposit conditions prevailing on the leeward- and up-side of the probe. Catalytic activity of various transition metal and trace metal species may cause that various kinetically restricted reactions advance towards equilibrium immediately on the tube outer surface (on/within the corrosion scale) and eventually in the permanent deposits.

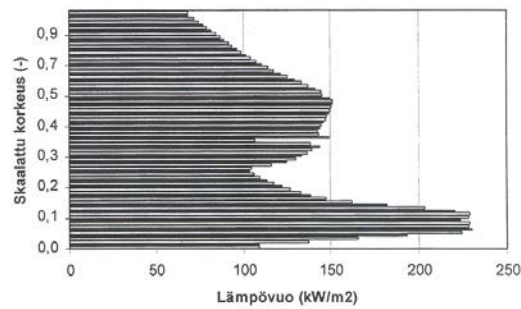
Vetyhyökkäysriski on pahin siellä, missä lämpökuorma on suurin. Kuvassa 7 on lämpövuon jakautuminen etuseinän keskellä primääritason alapuolelta nokan tasolle kattilassa, jossa perinteisesti laskettuna keskimääräinen lämpövuoto 90  $\text{kW/m}^2$ . Kuvan mukaan primaari-ilma-aukkojen alueella lämpövuoto ylittää 230  $\text{kW/m}^2$ .

**Kuva 7.** Lämpövuon jakaantuminen kattilan etuseinällä.

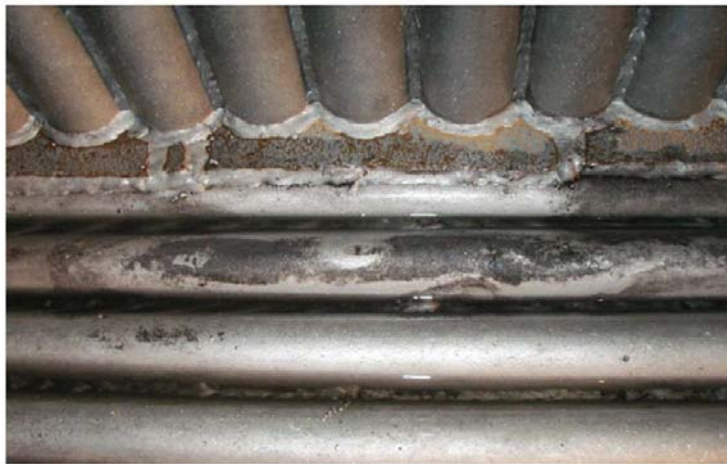
**Kuva L 4.** Korjauskohta pohja-seinä-kamparaudassa

Kuva L4. Pohjan ja seinien väliset kamparaudat on tarkastettava tunkeumanestemenetelmällä, kun pohja tyhjennetty. Jos pohjaa ei ole tyhjennetty,

varmennetaan pohjakaapista, että kamparaudan rikkoutuminen ei ole aiheuttanut sulavuotoa.

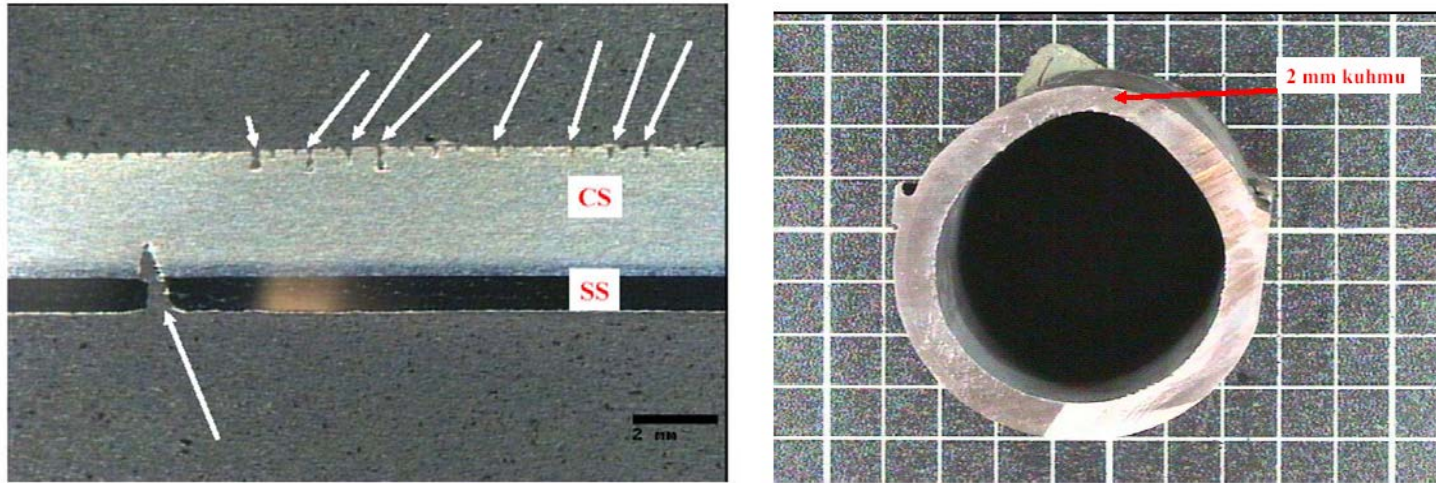
**Kuva L 5.** Kuvassa kiertohäiriön aiheuttama ylikuumeneminen pohjaputkessa, joka on aiheuttanut jopa muodonmuutoksen putkeen

Kuvissa L5 pohjaputken säröytyminen on edennyt compound-pinnoitteen läpi ferriittiseen materiaaliin. Vikaantumista voidaan todeta myös vesipuolella ja putkessa on selvä muodonmuutos. Ylikuumenemisen syynä voi olla kiertohäiriö aiheuttama korkea lämpövuoto, jonka voi aiheuttaa ylileveä seinä-pohja-kamparauta tai pudonneen ”kamin” aiheuttama muodonmuutos tai saostumat vesipuolella.
