Project budget and schedule 14.12.2012

ÅA, Probe Study of Corrosion in the Economizers of a Kraft Recovery Boiler Corrosion – presentation 19.12.2012 PROCESS CHEMISTRY CENTRE

Probe Study of Corrosion in the Economizers of a Kraft Recovery Boiler

Draft Report: Probe Study of Corrosion in the Economizers of a Kraft Recovery Boiler

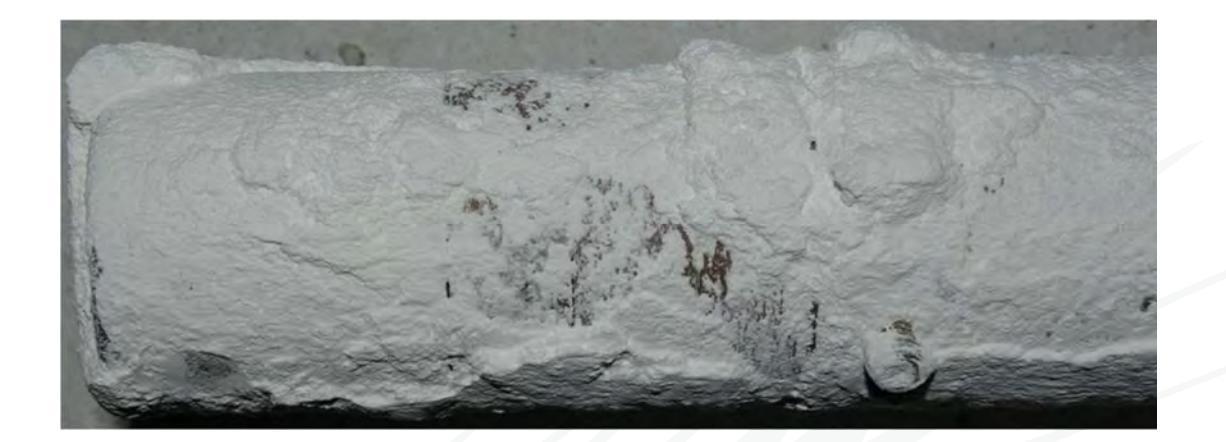
Probe After 811h of Normal Operation

After 811h of normal operation the probe was covered in ash, Figure 5. There was virtually no corrosion on the probe, Figure 6. What little corrosion occured was found on the top of the probe, but not on the bottom-most edge of the probe. The probe was placed in one of the lower turns in the economizers and it is not clear which were the windward and leeward sides of the probe. The corrosion layer was pitting up to approximately 10 μ m, Figure 7. In some spots of the corrosion layer, the chloride was not balanced by alkali indicating iron chloride and chloride induced corrosion. One explanation for the combined observations of corrosion being present on the top but not bottom and the presence of chloride in the corrosion layer is that a small amount of water is dropping on the probe from the sootblowers. This would dissolve NaCl in the salt resulting in a chloride containing solution until the water evaporates. The negligible amount of corrosion seen along with the lack of sulfur in the corrosion layer indicated clearly that there is no acid dew point corrosion.

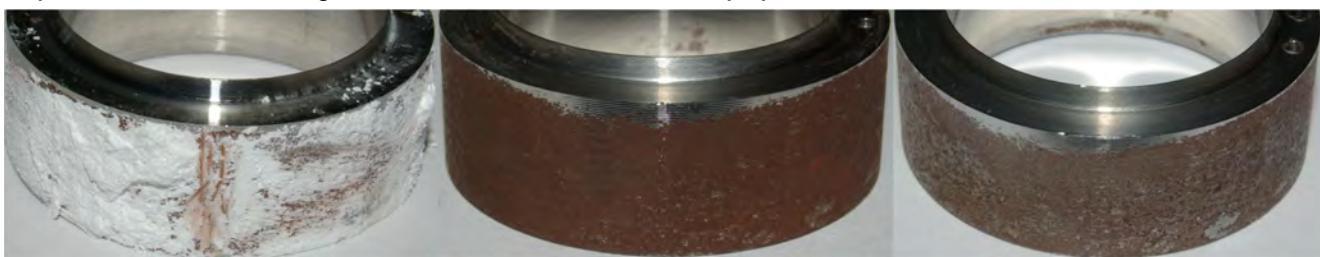
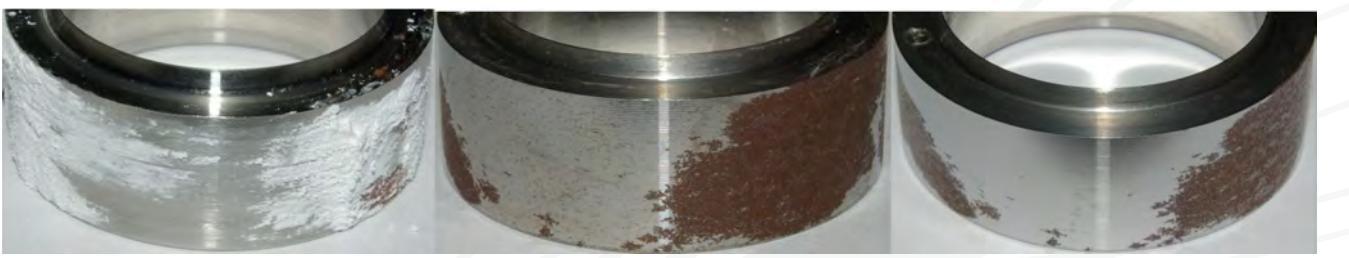
Ring after 811h normal operation

Note: Side pointing downwards (gravimetrically) -> No iron oxide

Figure 6. Ring after 811h normal operation. No iron oxide was found on the bottom edge of the probe.

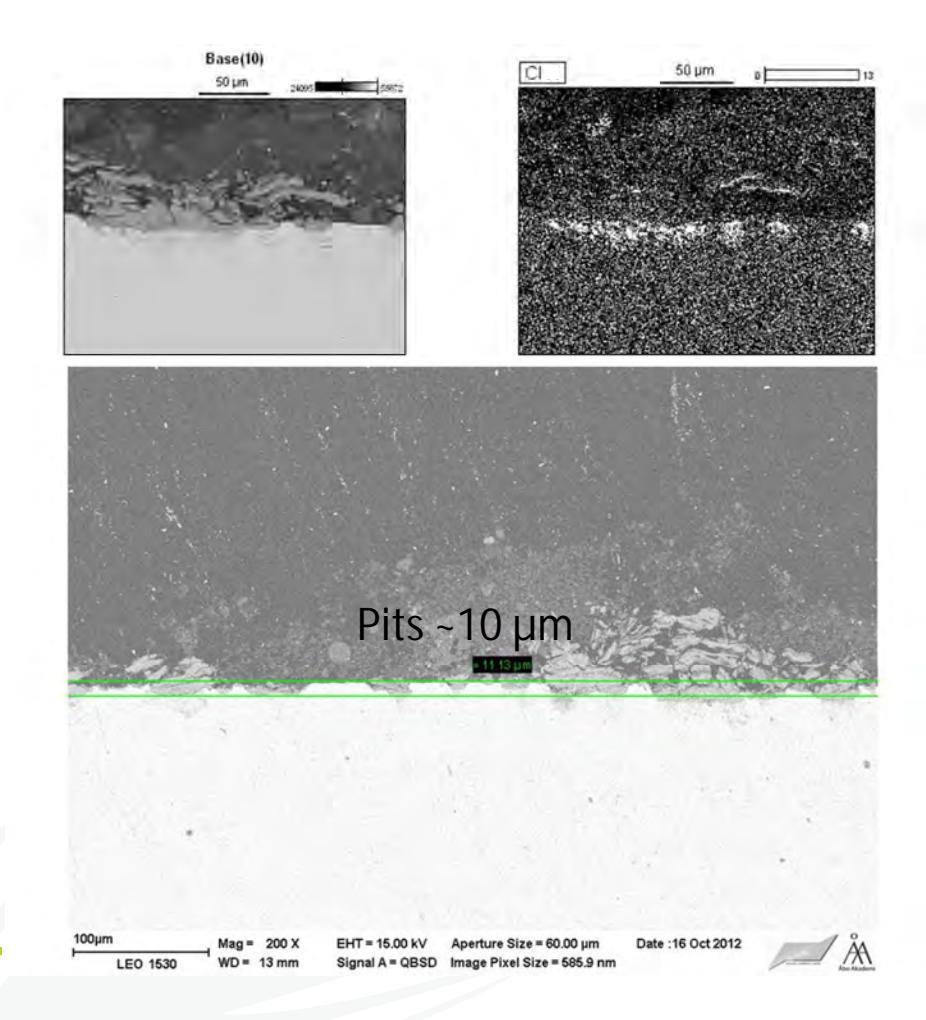
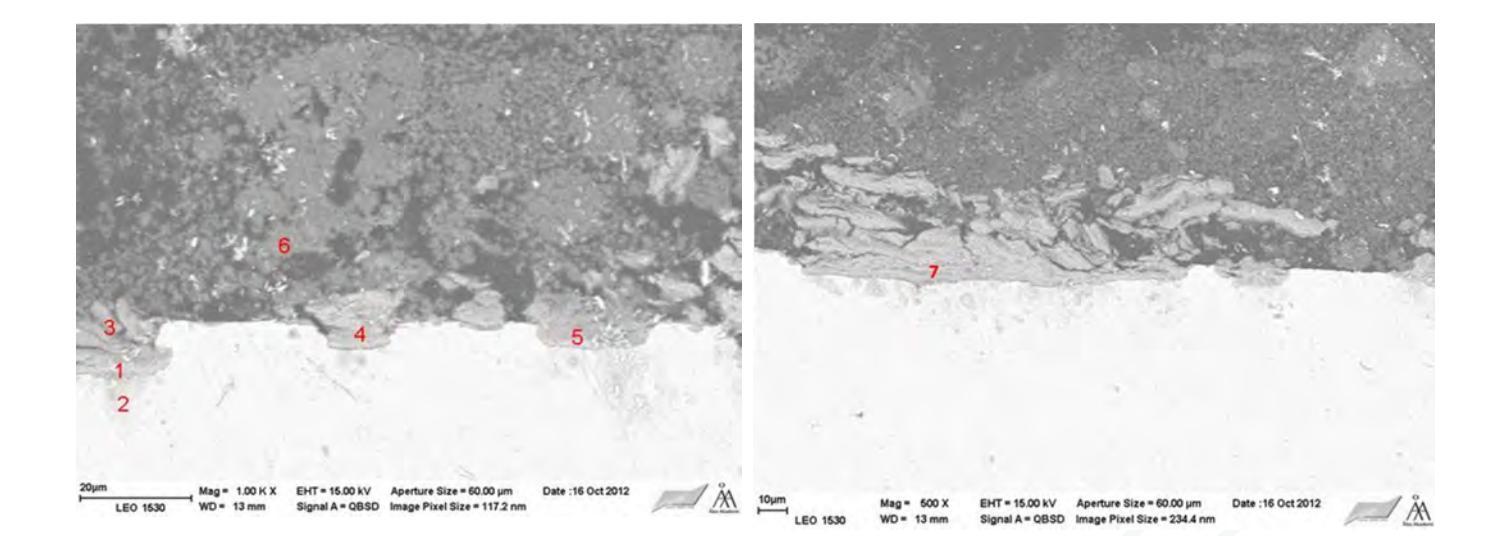
811h exposure "normal" plant operation

atom-%								
	Spot	Na	Al	Si	S	CI	K	Mn	Fe
	1	1.3	0.3	0.2	0.1	0.5	0.1	0.4	38.2
Γ	2	0.0	0.3	0.2	0.0	0.6	0.0		39.3
	3	3.1		0.3	1.4	0.4	1.5		34.9
	4	3.7	0.3	0.2	0.6	0.7	0.3		36.4
	5	1.7	0.5	0.2	0.2	1.2	0.4	0.4	37.2
	6	20.5			13.5	2.3	7.3		1.1
ſ	7	0.4	0.5	0.3	0.1	2.5	0.1	0.3	37.5
<u> </u>

CI not balanced by Na or K

Figure 7. Spot analysis of corrosion layer from probe pulled out after 811 hours of normal operation (before water wash). In spots 2 and 7, the Cl is not balanced by Na or K.

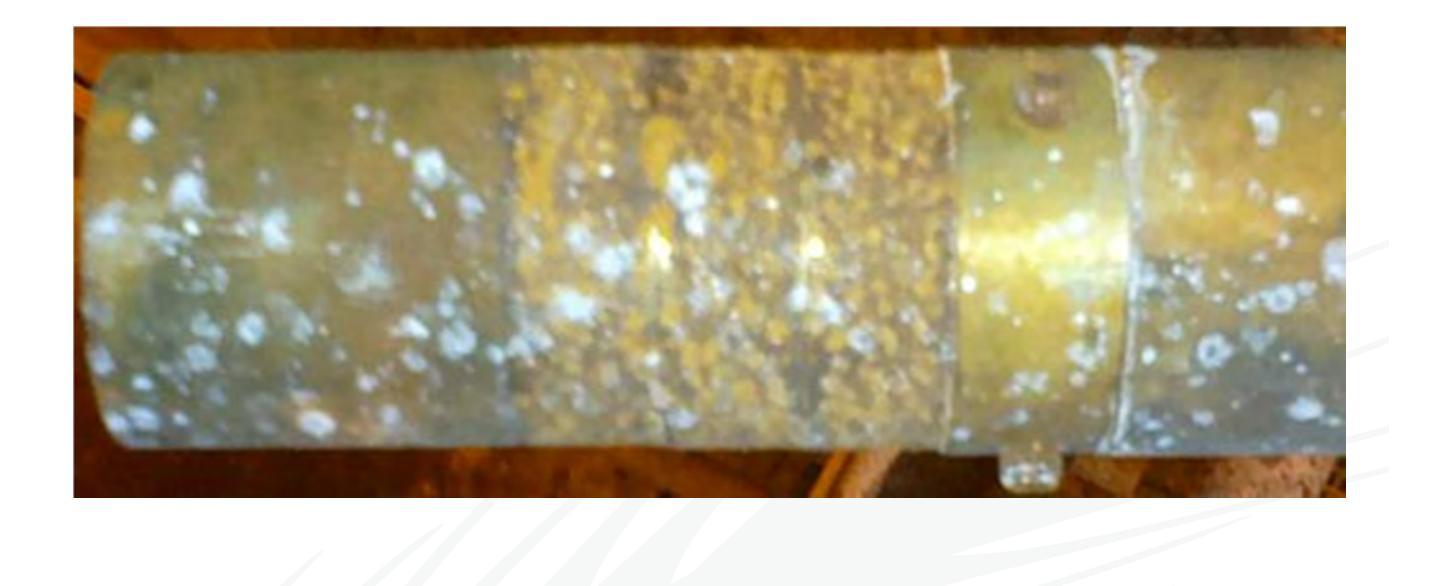
Probe after water wash - 1124h total (811h "normal" operation + water wash)

The probe that was pulled out after the water wash, Figure 8, had more corrosion than the probe pulled out before the water wash, but there was still virtually no corrosion, Figure 9. Again, the bottommost

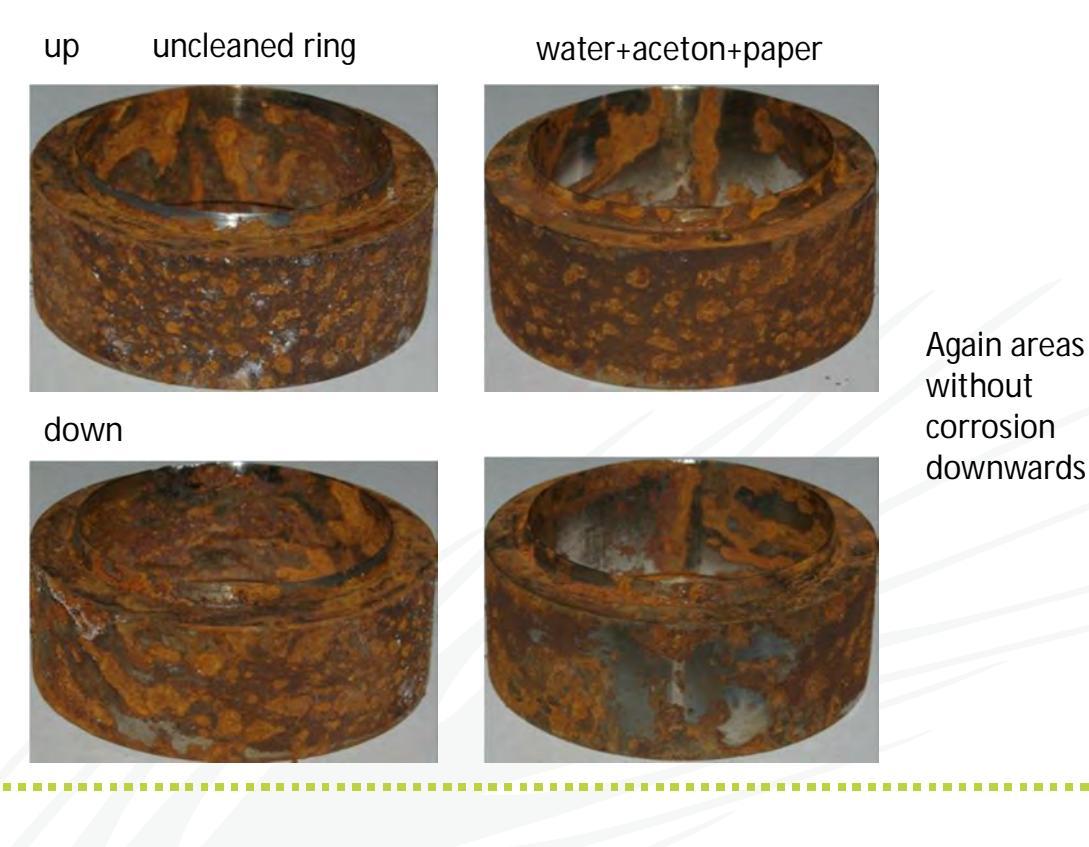
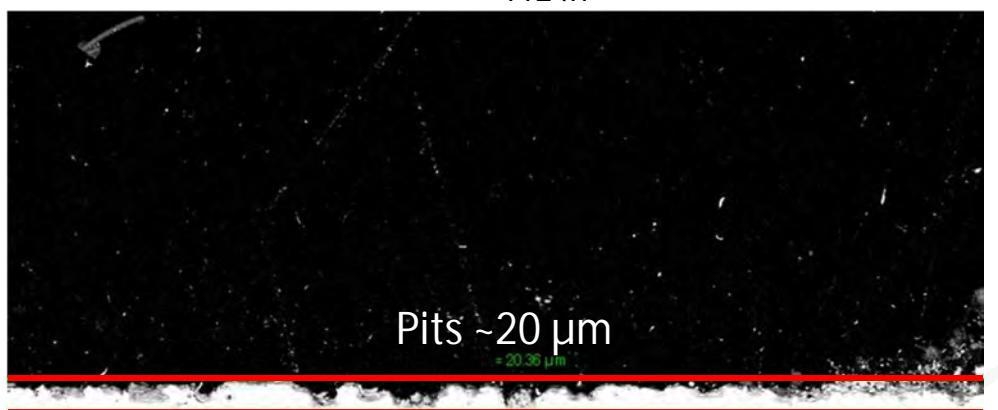
Ring after 1124h

811h exposure "normal" plant operation + boiler shutdown & water wash totally 1124h

• No chlorine or sulfur found in the corrosion layer after the water wash

edge was not corroded. The average corrosion for the two probes estimated on an annual basis was 0.02 and 0.06 mm/year for the probes pulled out before and after the water wash respectively, Table II.

Figure 9. Ring after 1124h. Not that there are some areas without corrosion downwards on the bottom edge of the ring.

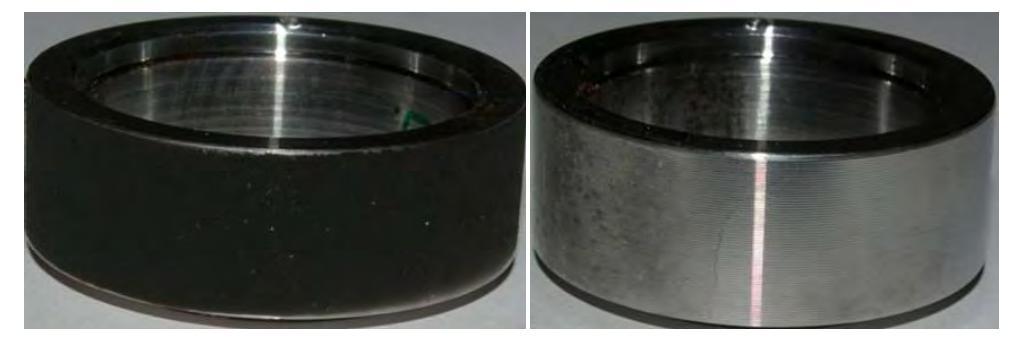
Figure 11. Ring after 2h exposure during oil burning.

A 2h probe (90 °C) study was also made in the economizers. The probe study was carried out at the same time the measured SO_3 level was highest, but no corrosion was seen on the rings, Figure 11. There was clearly no acid dew point, but it is not clear why no acid dew point was seen even when SO_3 neared 3 ppm. Had there been an acid dew point, corrosion would have been expected in the two hour probe study.

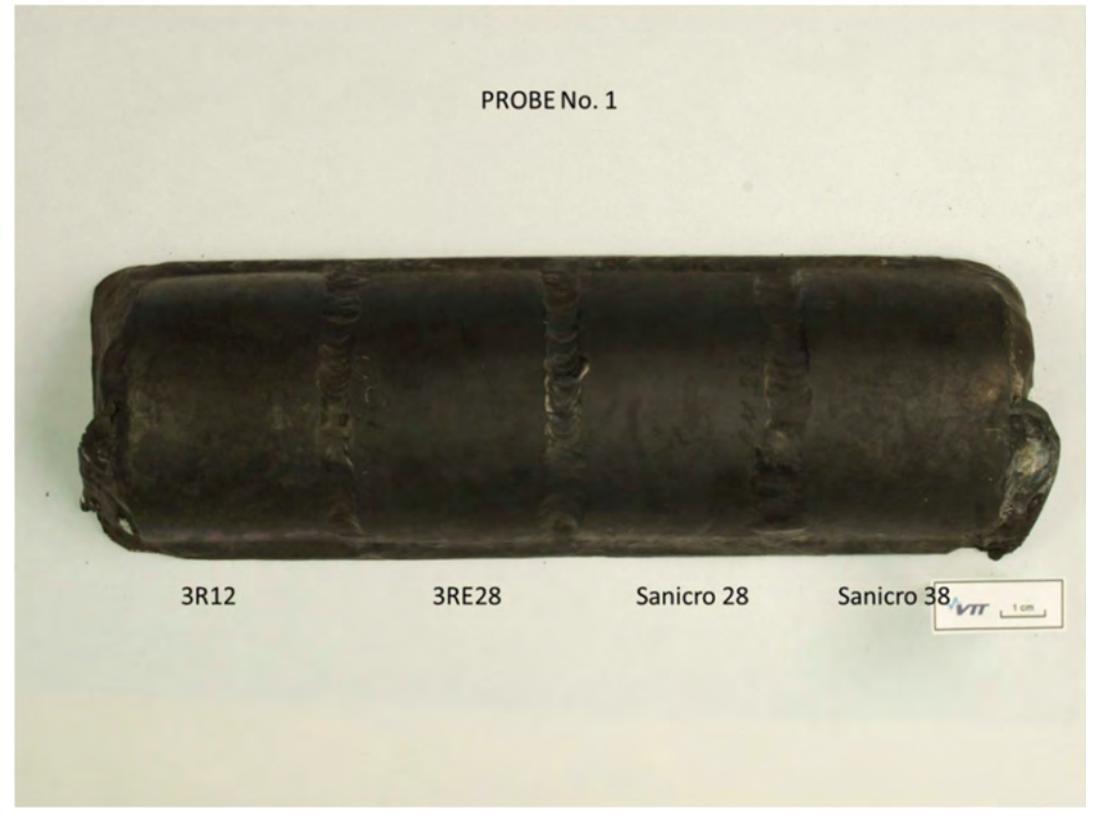
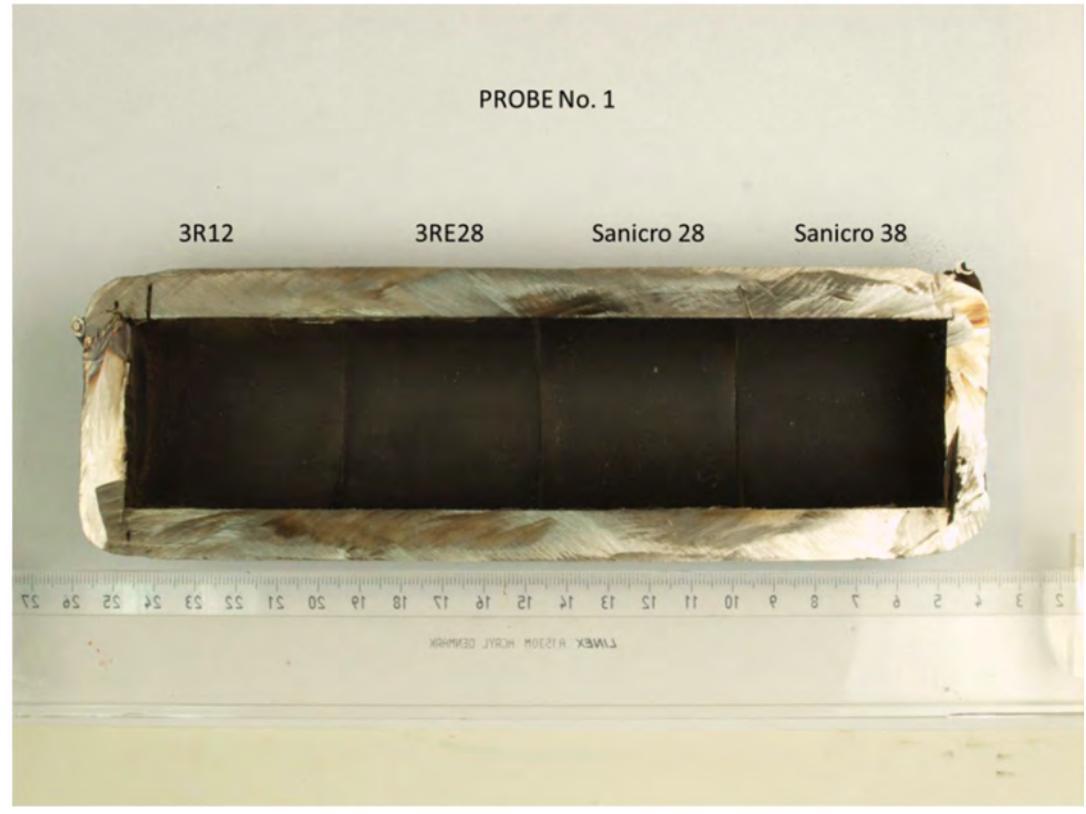
Probe No.1 after the test

Total test duration of the test No. 1 was 1006 hours from which 906 hours at the target temperature of 440 °C. The test materials in this exposure were 3R12, 3RE28, Sanicro 28 and Sanicro 38, Figure 3. According to visual inspection all samples were in good condition after testing i.e. neither marked general or localised corrosion nor deposits or oxide scales were observed either on outer or inner surfaces.

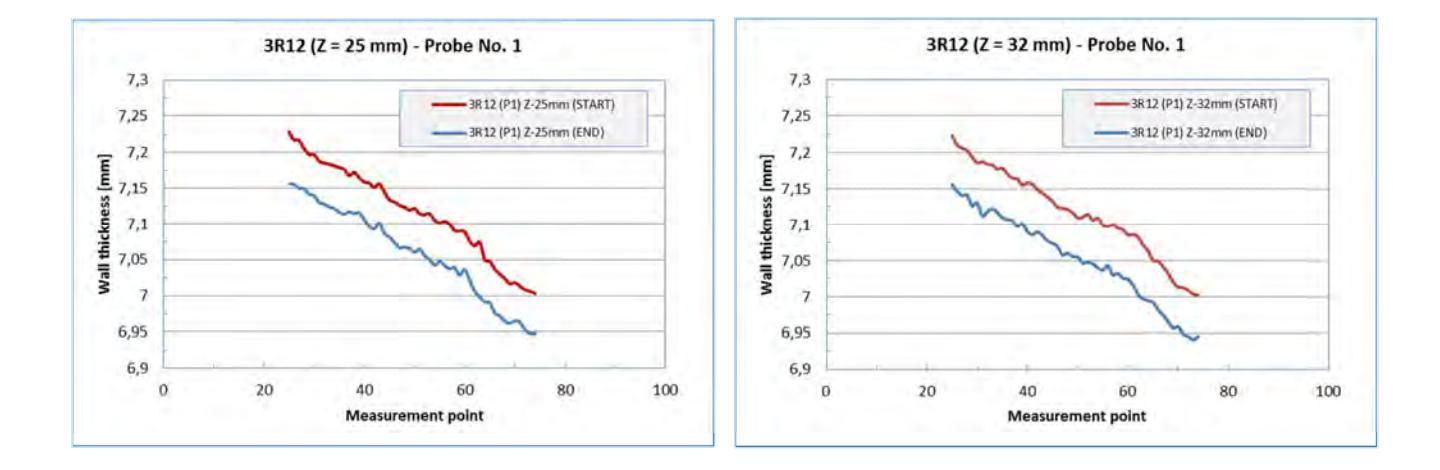
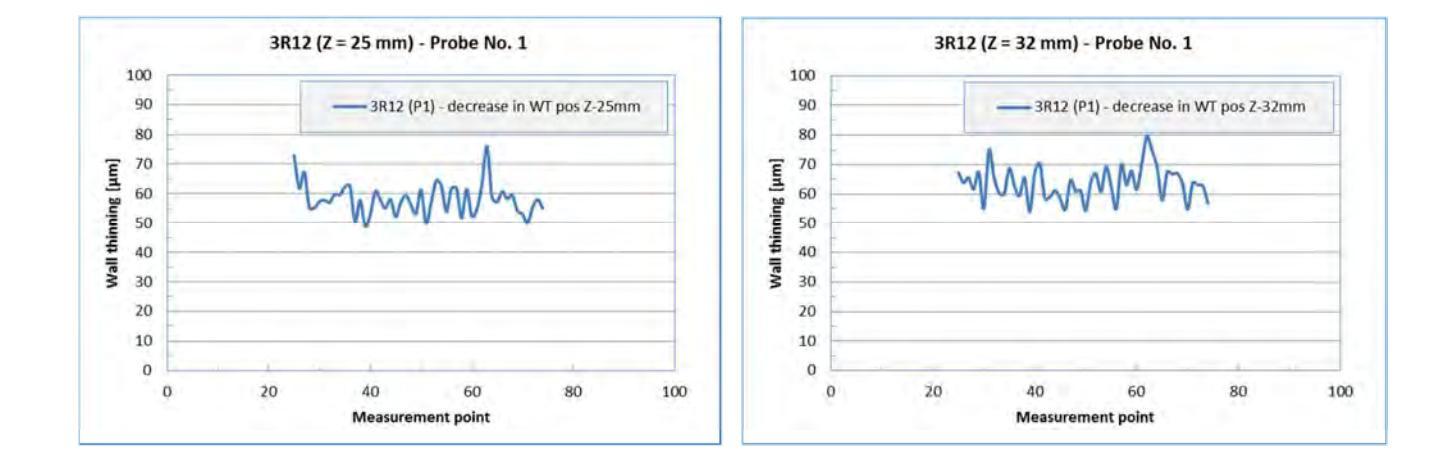
Results – 3R12 (304L)

The results of the wall thickness profile measurements and the wall thinning curves derived from them are presented in Figures 4...11. The results showed that marked wall thinning had taken place on the 3R12 specimen. For the other materials the data was more scattered showing that wall thinning and deposit formation (increase in wall thickness) had taken place locally. Measurements showed also that tube wall thicknesses varied a lot as a function of circumference.

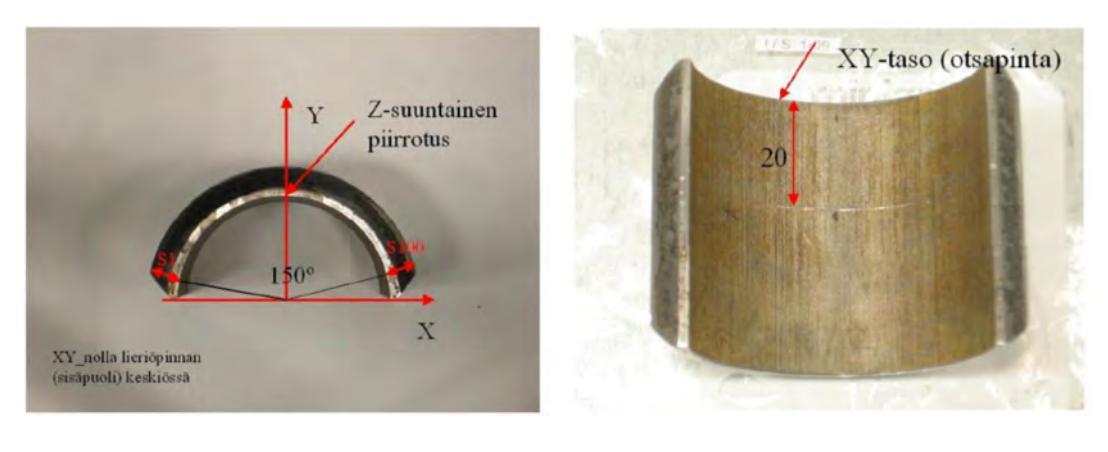
Figure 1. The wall thickness profiles were measured before and after testing with coordinate measurement machine a) as a function of circumference b) from three axial locations (Z = 15, 25 and 32 mm).

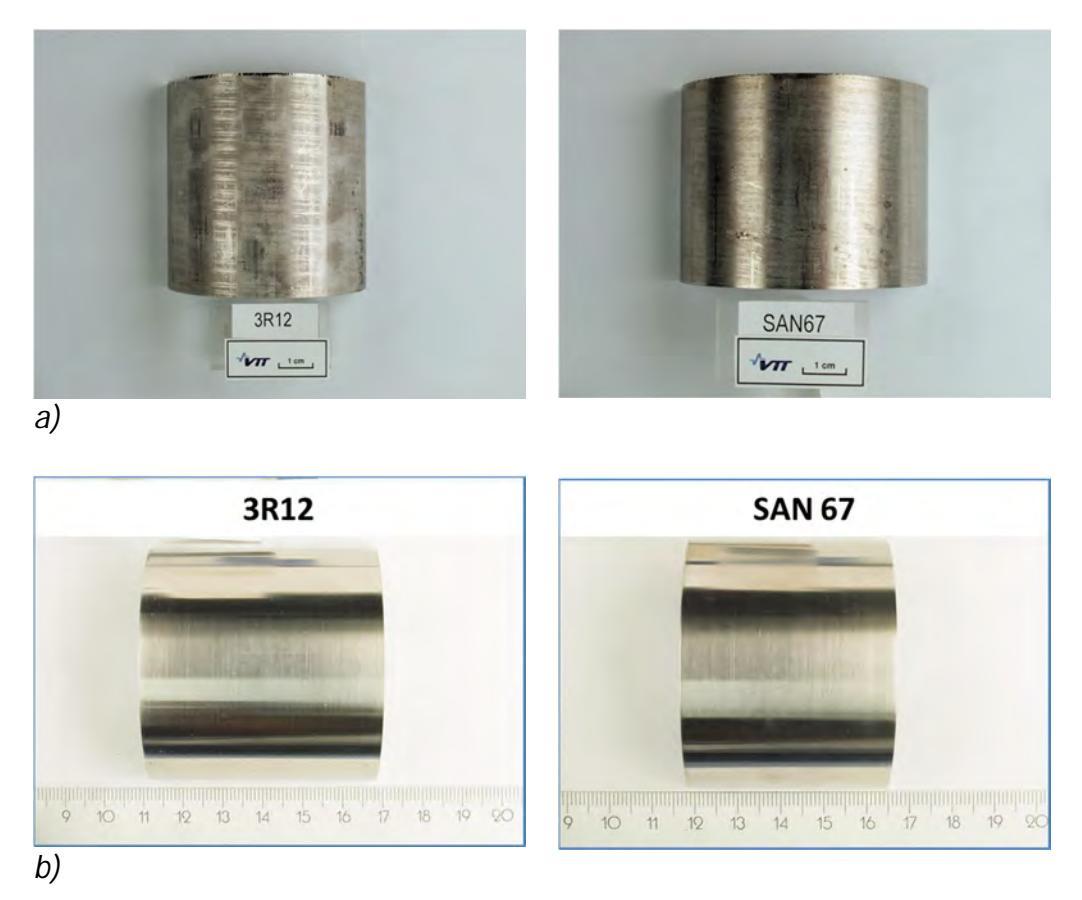
Figure 2. Examples of sample surfaces prior exposure: a) in as received condition for the probe No. 2 and b) after machining and hand grinding for the probe No. 7.

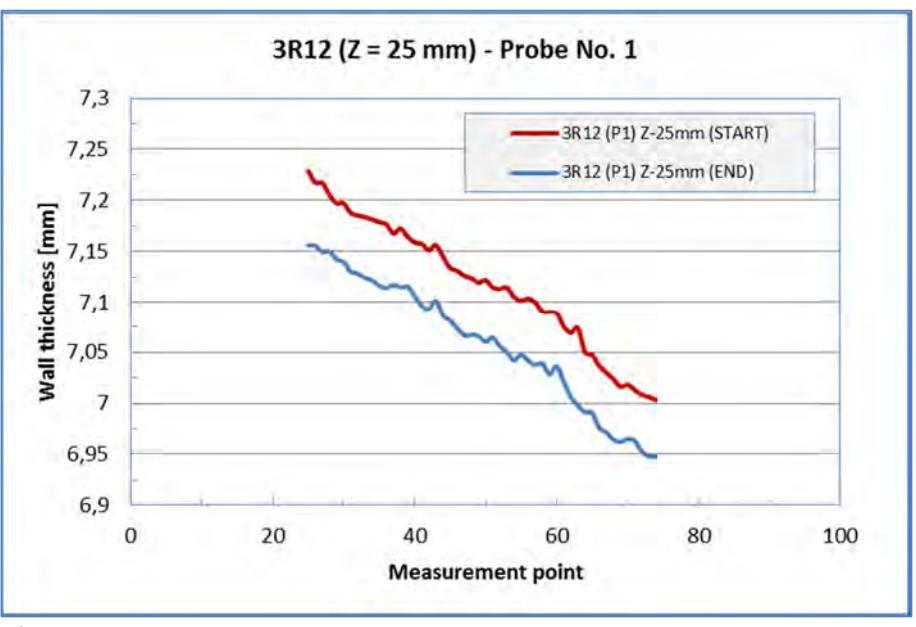
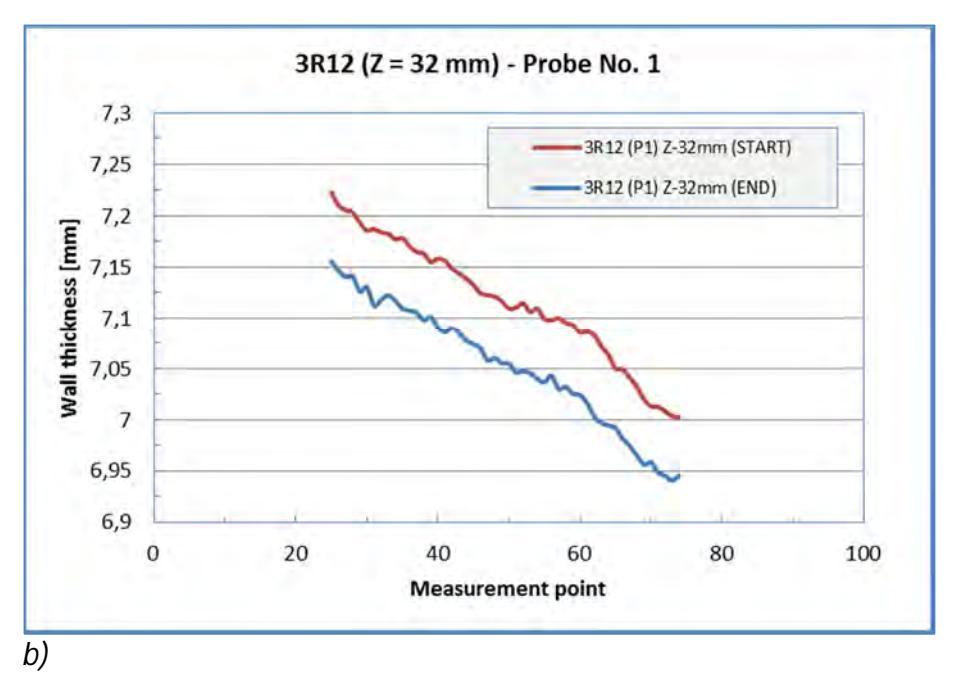
Figure 4. Circumferential wall thickness profiles from 3R12 specimen (Probe No. 1): a) axial location Z = 25 mm and b) axial location Z = 32 mm.

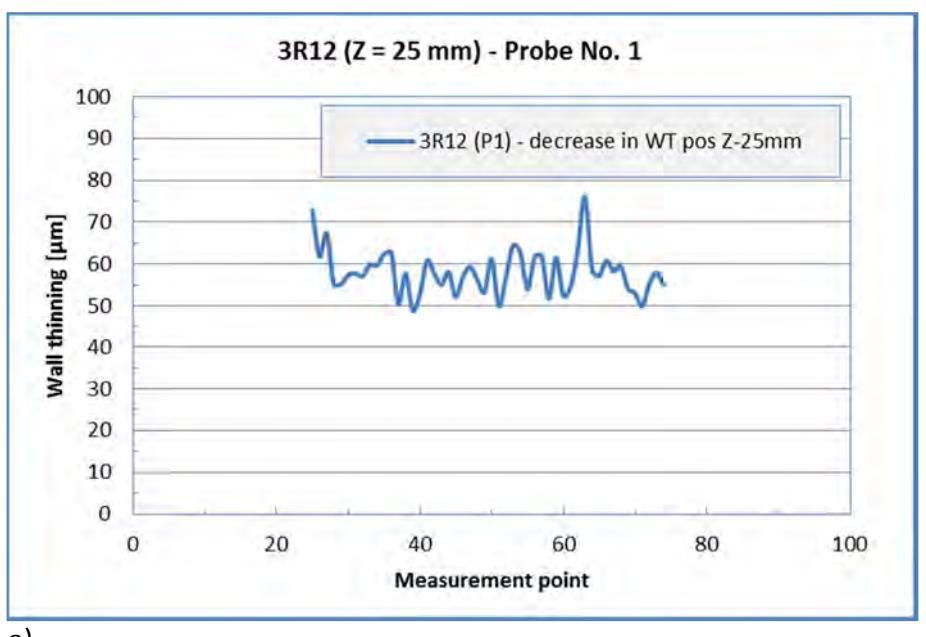
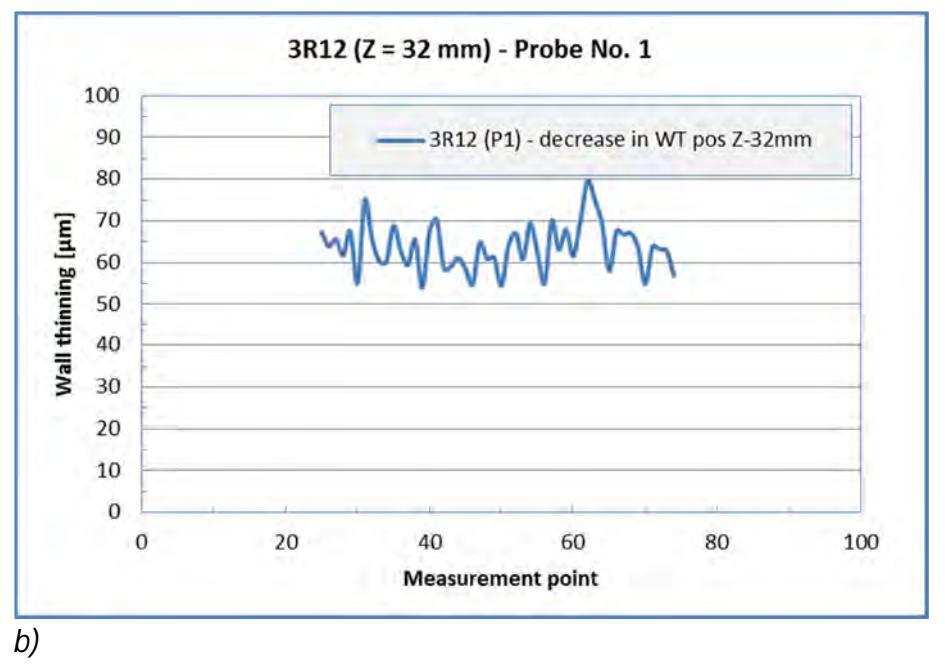
Figure 5. Circumferential wall thinning curves from 3R12 specimen (Probe No. 1): a) axial location Z = 25 mm and b) axial location Z = 32 mm.

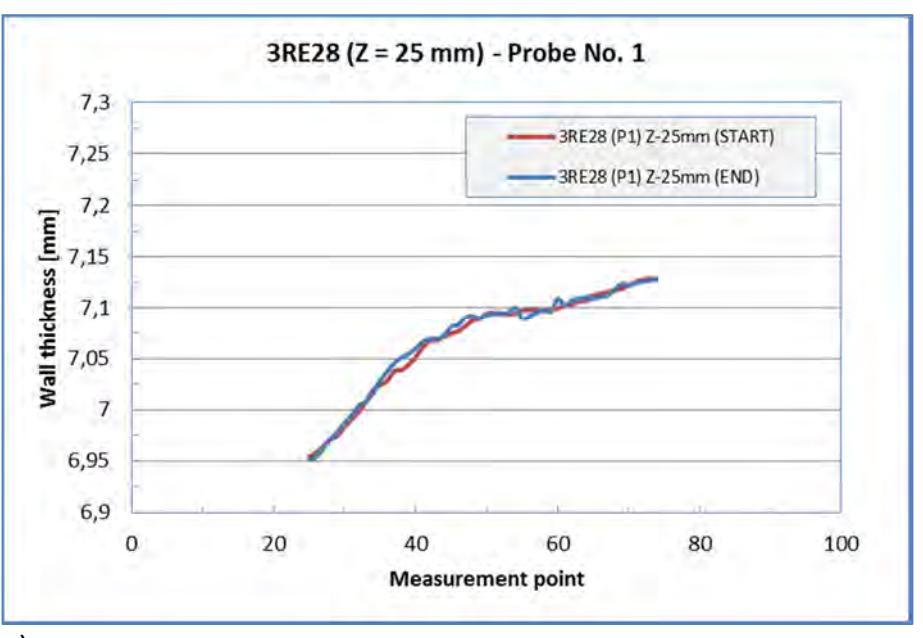
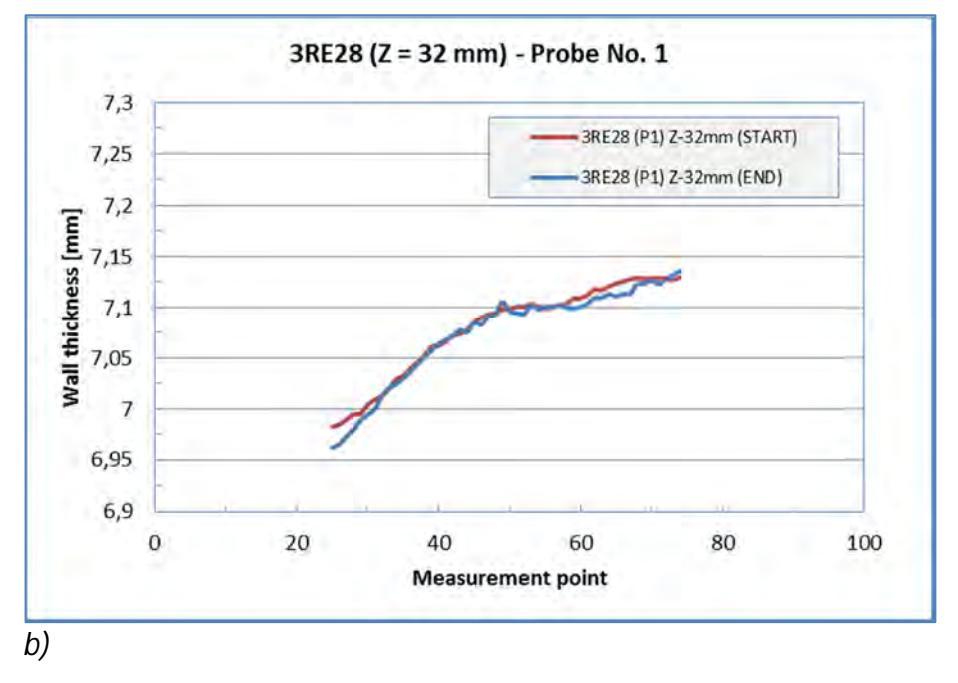
Figure 6. Circumferential wall thickness profiles from 3RE28 specimen (Probe No. 1): a) axial location Z = 25 mm and b) axial location Z = 32 mm.

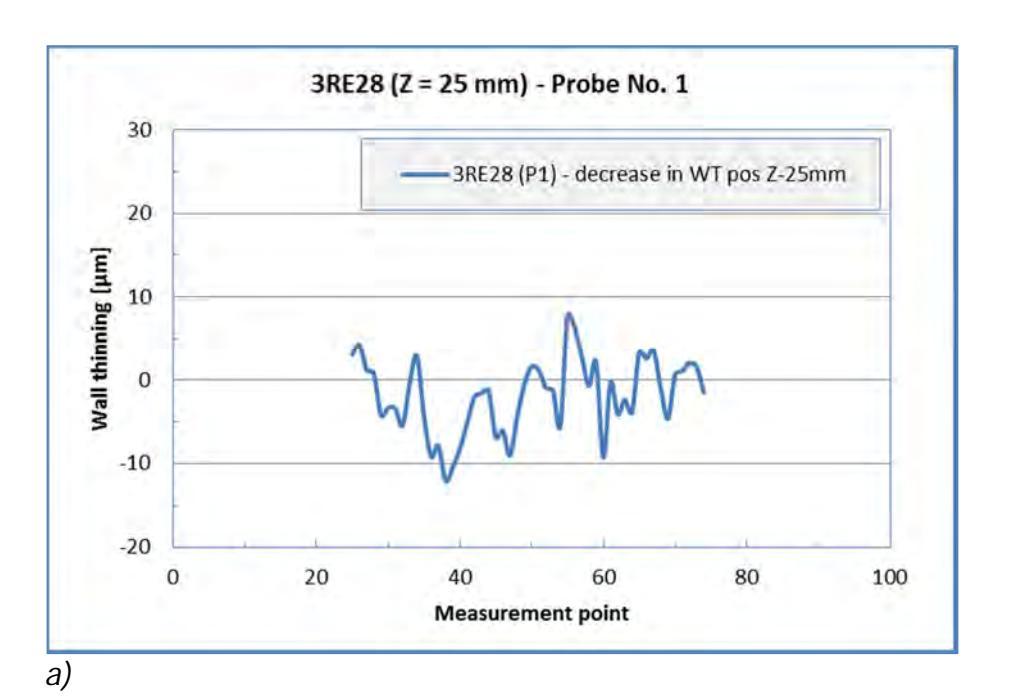
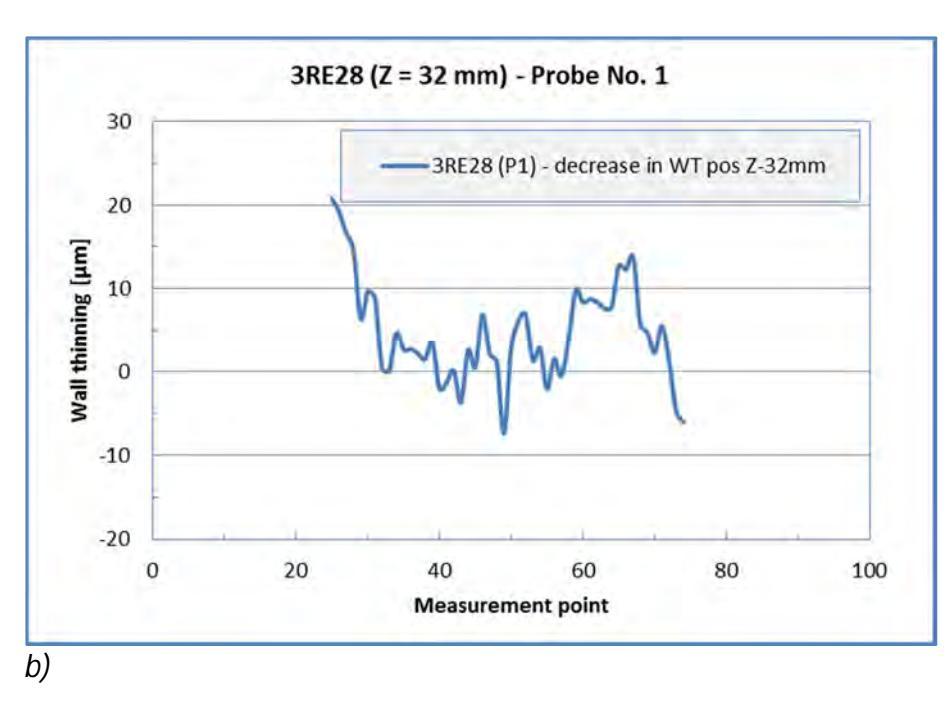
Figure 7. Circumferential wall thinning curves from 3RE28 specimen (Probe No. 1): a) axial location Z = 25 mm and b) axial location Z = 32 mm.

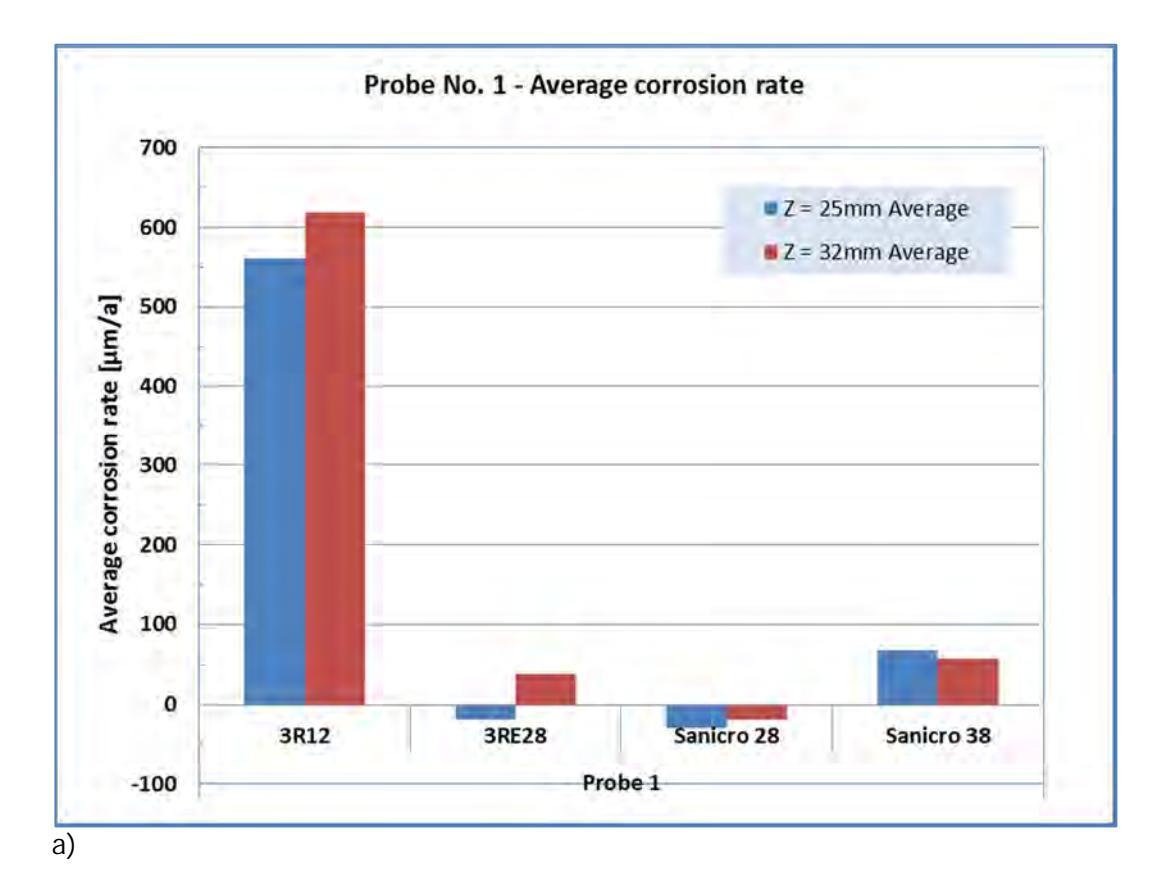
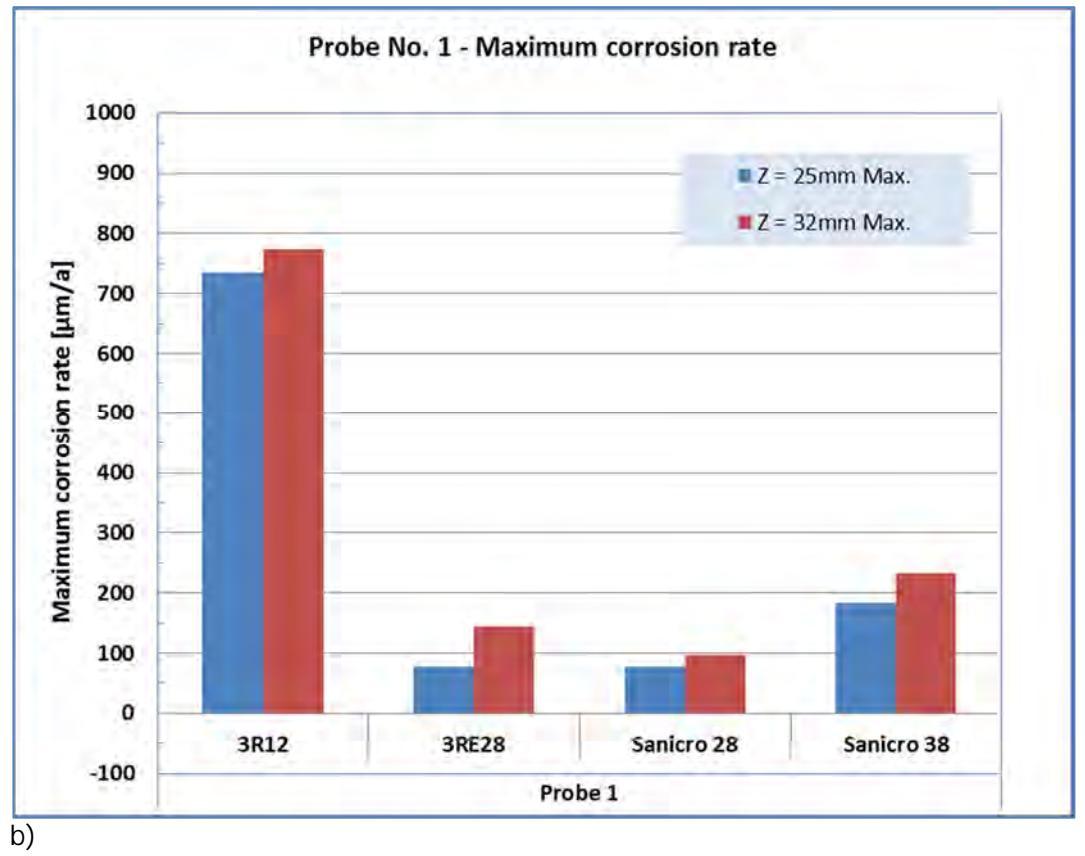
The average and maximum corrosion rates calculated on the basis of the wall thickness measurements are presented in Figure 12. In this test highest corrosion rate, order of 0.7 mm/a, was measured for the 3R12 material. Corrosion rate was next highest in the Sanicro 38, for which a maximum corrosion rate of ca. 0.2 mm/a was determined. The maximum corrosion rates of Sanicro 28 and 3RE28 materials were in the order of 0.1 mm/a and they were best performing materials in this test.

The reason to the negative values in average corrosion rates is that the washing and brushing with nylon brush was not effective enough to remove all deposits from the surfaces prior wall thickness measurements, indicating that average corrosion rates may give too optimistic result. Respectively the maximum corrosion rates may give too conservative results, if there are some problems in specimen alignment during WT measurements; this is a specific concern of samples with scratches or dents.

Figure 12. a) Average and b) maximum corrosion rates of the test materials calculated on the basis of the wall thickness measurements after after 906 h exposure in lower furnace at 440 °C (Probe test No. 1).

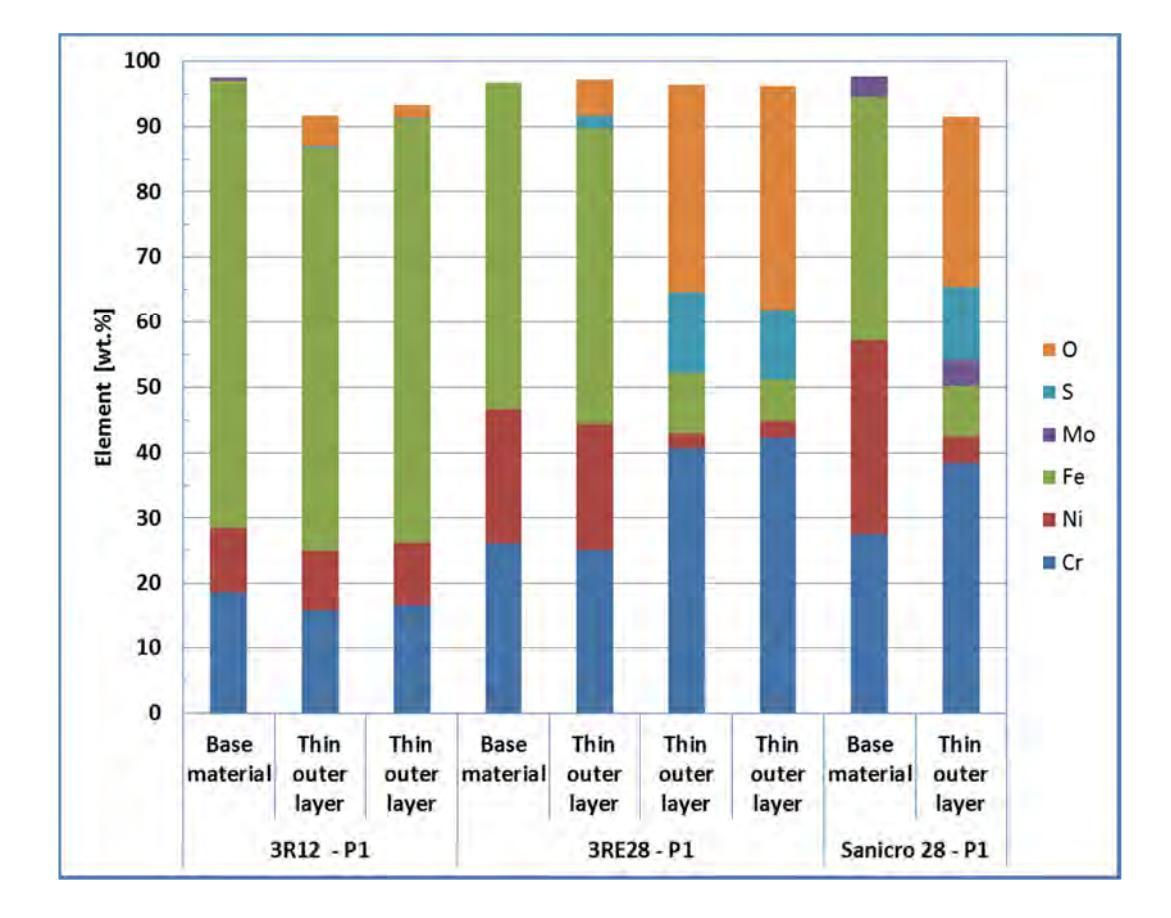
After the tests the samples were examined with optical microscope and/or SEM to determine the type of the corrosion attack. All samples had suffered from general thinning and no marked deposits or oxide/sulphide scales were observed, Figure 13. According to the EDS (Figure 14) analysis the thin layers (thickness ca. 5 μ m) on 3RE28 and Sanicro 28 were depleted in iron and nickel and enriched in chromium and contained also high amounts of sulphur. Whereas the composition of thin layer on 3R12 was similar to the base material and no sulphur was detected.

Figure 13. Cross sections from a) 3R12, b) 3RE28, c) Sanicro 28 and d) Sanicro 38 after 906 h exposure in lower furnace at 440 °C (Probe test No. 1)

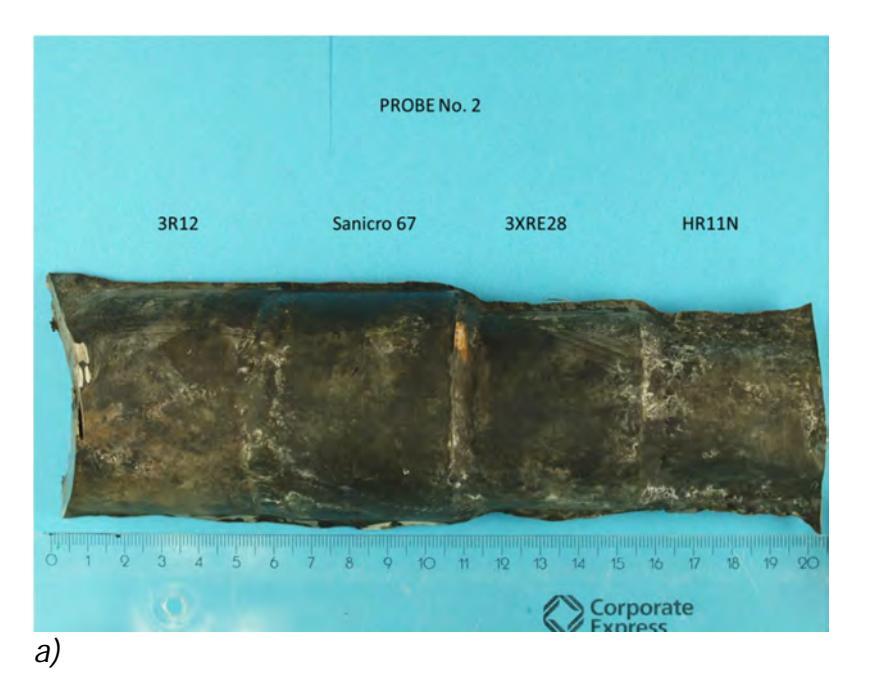
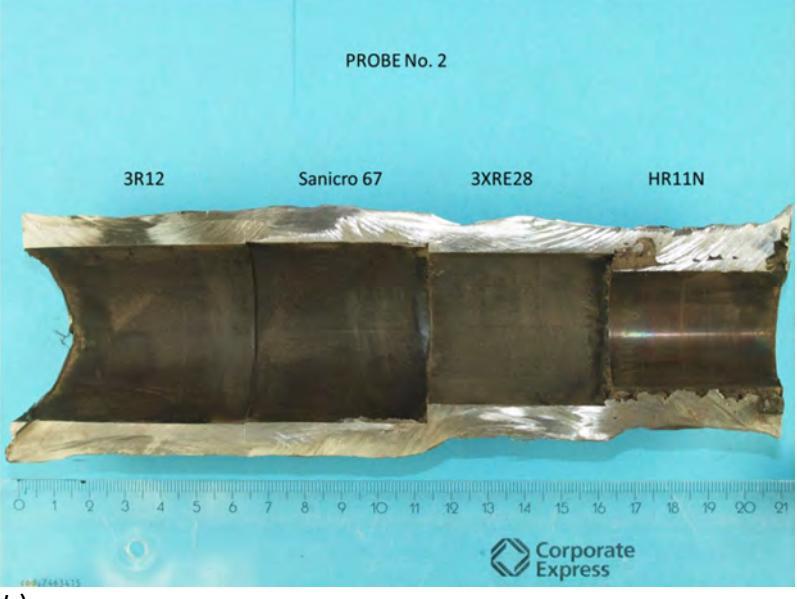
Total test duration of the test No. 2 was 1023 hours from which 744 hours at the target temperature of 440 °C. The test materials in this exposure were 3R12, 3XRE28, HR11N and Sanicro 67, Figure 15. According to visual inspection the inner surfaces of the specimens were in good condition after testing i.e. neither marked general or localised corrosion nor deposits or oxide scales were observed. The outer surfaces of the specimens appeared to be in good condition but the thin dark and white deposits on the surfaces hindered accurate examinations.

Figure 15. Macrographs taken from the probe No. 2 head after exposure: a) outer surface exposed to the furnace side and b) inner surface exposed to the cooling liquid.

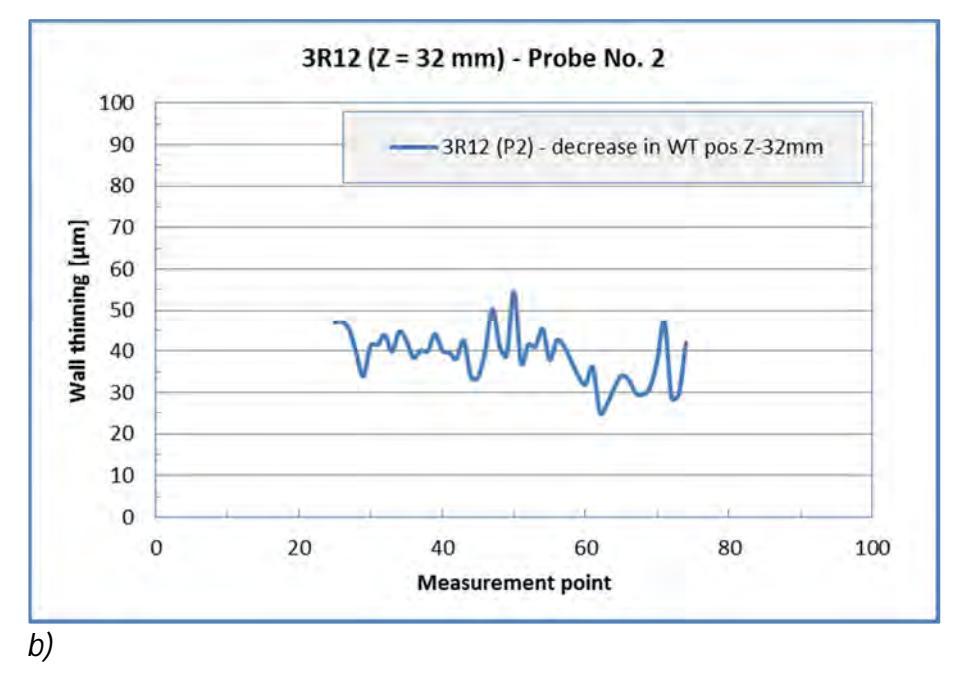
Figure 17. Circumferential wall thinning curves from 3R12 specimen (Probe No. 2): a) axial location Z = 25 mm and b) axial location Z = 32 mm.

The results of the wall thickness profile measurements and the wall thinning curves derived from them are presented in Figures 16...23. The results showed that marked wall thinning had taken place on the 3R12 specimen and lesser degree also on the HR11N specimen. The data of the 3XRE28 and Sanicro 67 materials was more scattered showing that wall thinning and deposit formation (increase in wall thickness) had taken place locally. Measurements showed also that the wall thickness variations were smaller in the machined HR11N specimen than in the other specimens tested in as received condition. The average and maximum corrosion rates calculated on the basis of the wall thickness measurements are presented in Figure 12. In this test highest corrosion rate in the order of 0.6 mm/a was measured for the 3R12 material. The corrosion resistance of the 3XRE28, HR11N and Sanicro 67 was practically at the same level.
