Project budget and schedule 14.12.2012

ÅA, Probe Study of Corrosion in the Economizers of a Kraft Recovery Boiler Corrosion – presentation 19.12.2012 PROCESS CHEMISTRY CENTRE

Probe Study of Corrosion in the Economizers of a Kraft Recovery Boiler

Draft Report: Probe Study of Corrosion in the Economizers of a Kraft Recovery Boiler

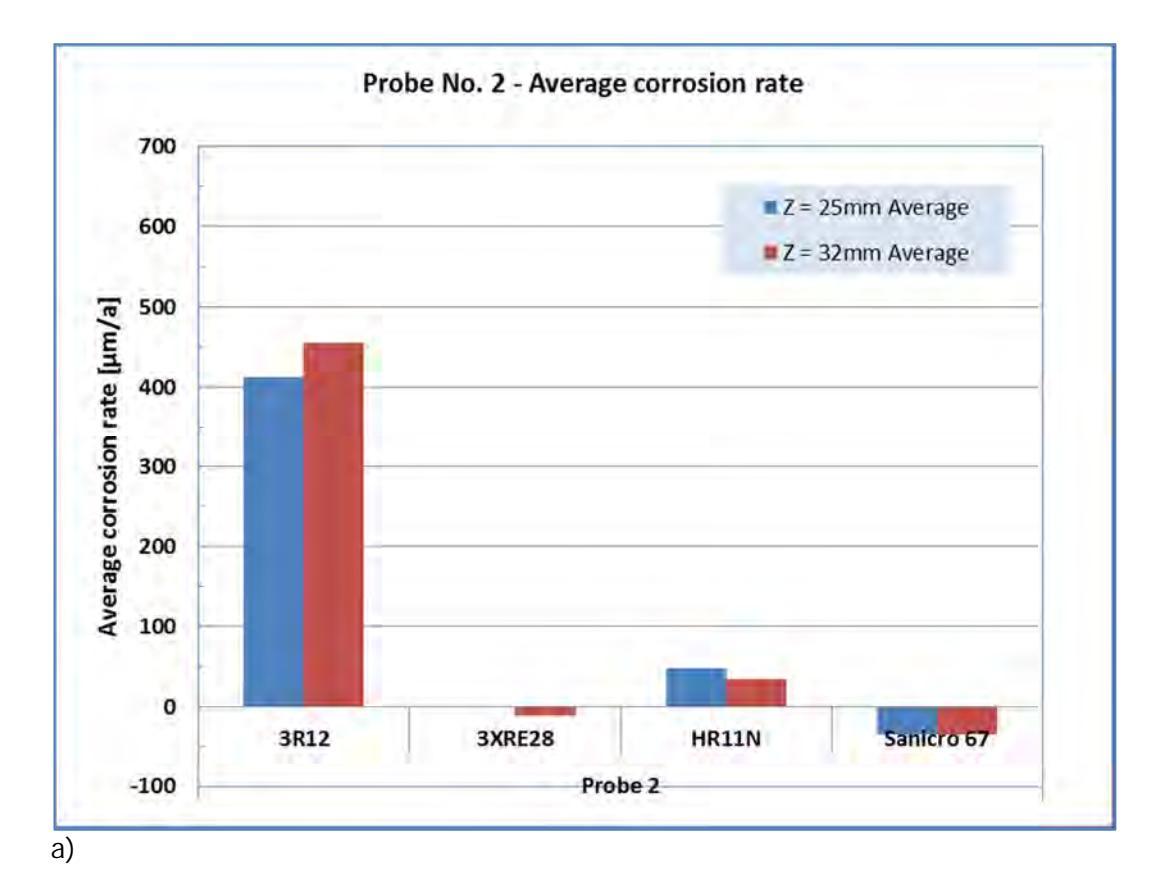
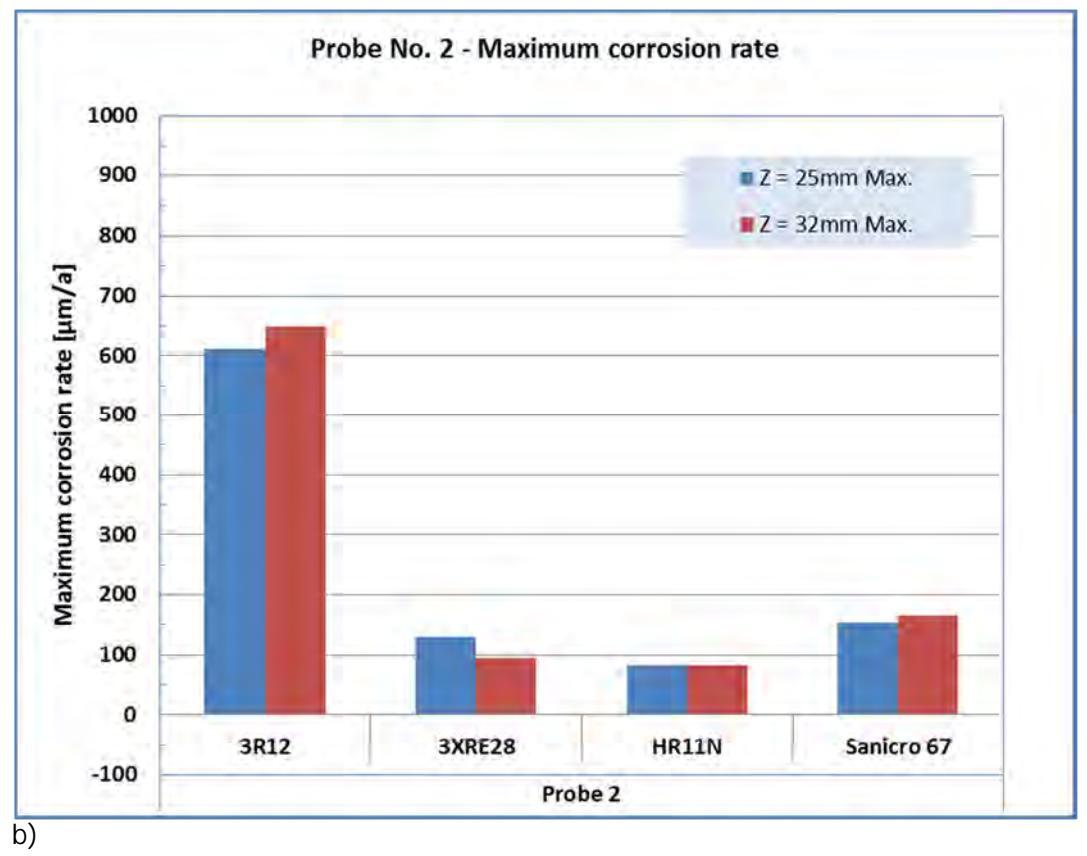
Figure 24. a) Average and b) maximum corrosion rates of the test materials calculated on the basis of the wall thickness measurements after 744 h exposure in lower furnace at 440 °C (Probe test No. 2).

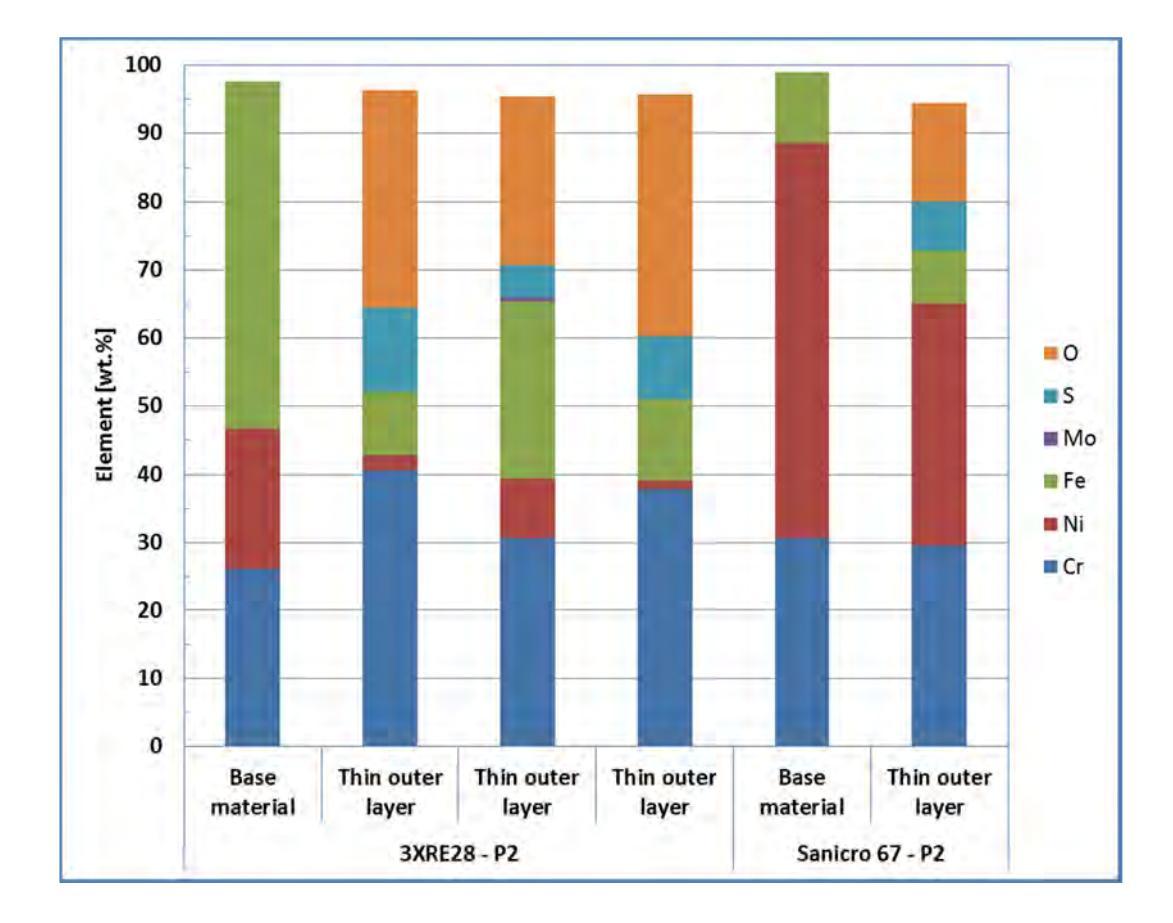
After the tests the samples were examined with optical microscope and/or SEM to determine the type of the corrosion attack. All samples had suffered from general thinning and no marked deposits or oxide/sulphide scales were observed on the surfaces, Figure 25. According to the EDS analysis (Figure 26) the thin, a few μ m thick layer, observed on 3XRE28 was depleted in iron and nickel and enriched in chromium and contained also high amounts of sulphur. The similar thin layer on Sanicro 67 contained high amounts of sulphur and was depleted in nickel and iron whereas chromium content was at the same level than in the base material.

Figure 25. Cross sections from a) 3R12, b) 3XRE28, c) HR11N and d) Sanicro 67 after 744 h exposure in lower furnace at 440 °C (Probe test No. 2)

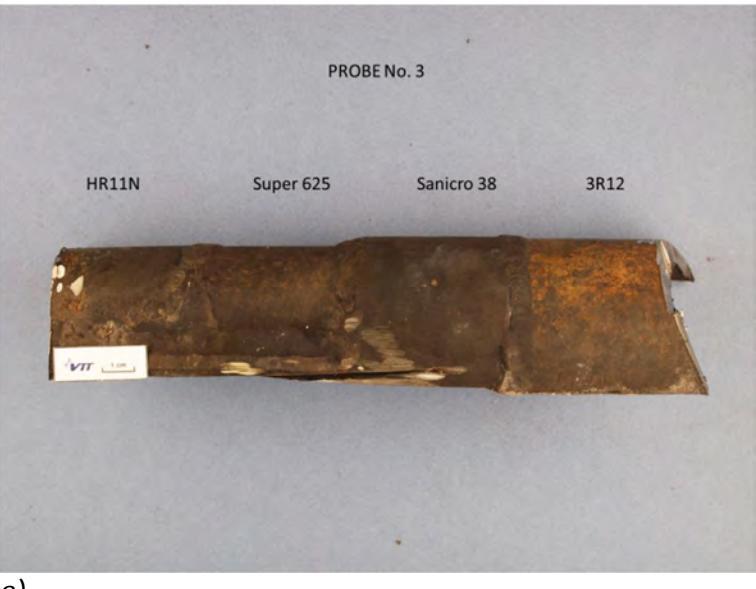
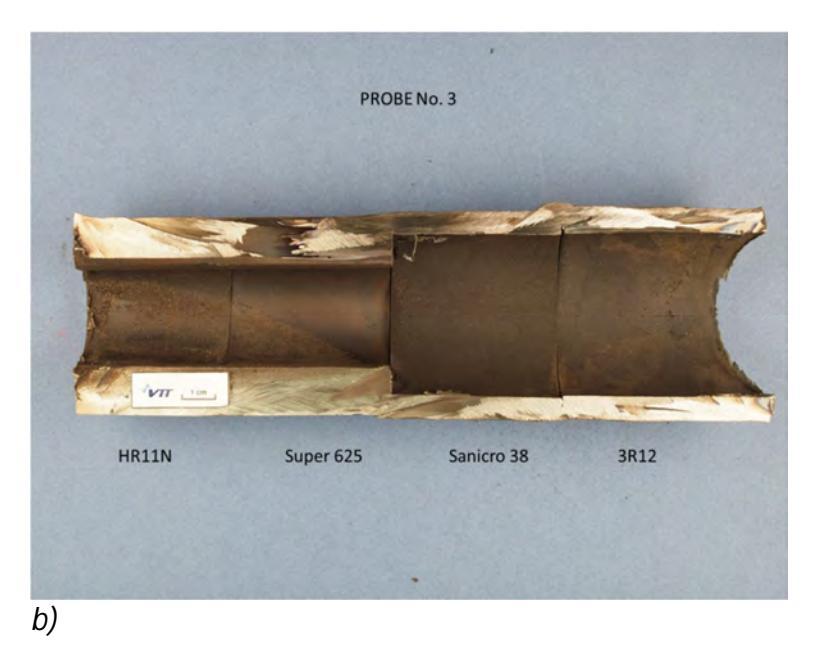
Total test duration of the test No. 3 was 1250 hours from which 750 hours at the target temperature of 430 °C. The test materials in this exposure were 3R12, HR11N, Sanicro 38 and Super 625, Figure 27.

According to visual inspection the inner surfaces of the specimens were in good condition after testing. Some deposits were observed on the inner surfaces but based on their appearance they originate from the probe cutting conducted after the probe has been removed from the boiler. The outer surfaces of the specimens were covered with dark and brown deposits but appeared to be in good condition.

Figure 27. Macrographs taken from the probe No. 3 head after exposure: a) outer surface exposed to the furnace side and b) inner surface exposed to the cooling liquid.

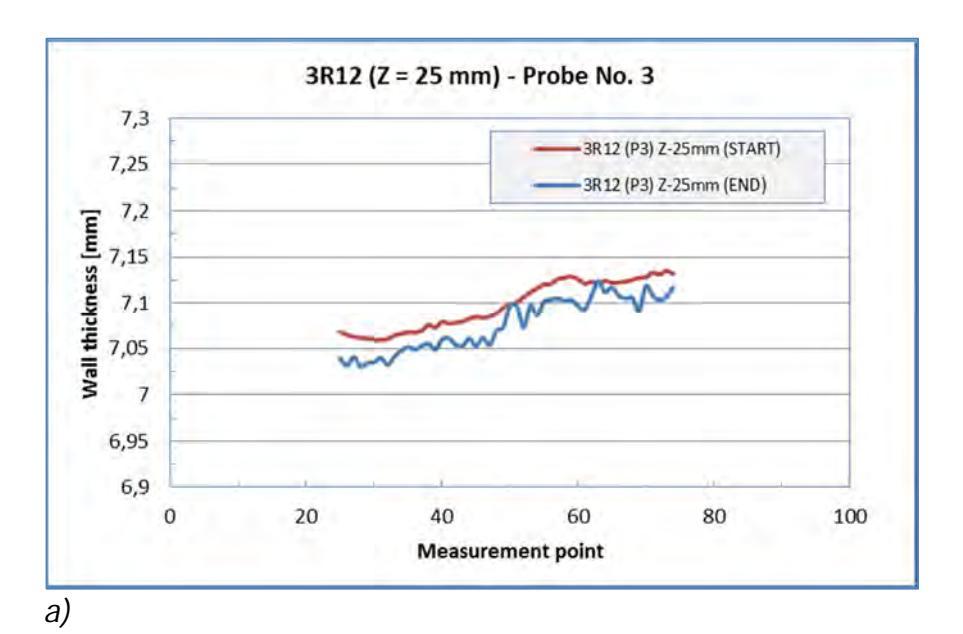
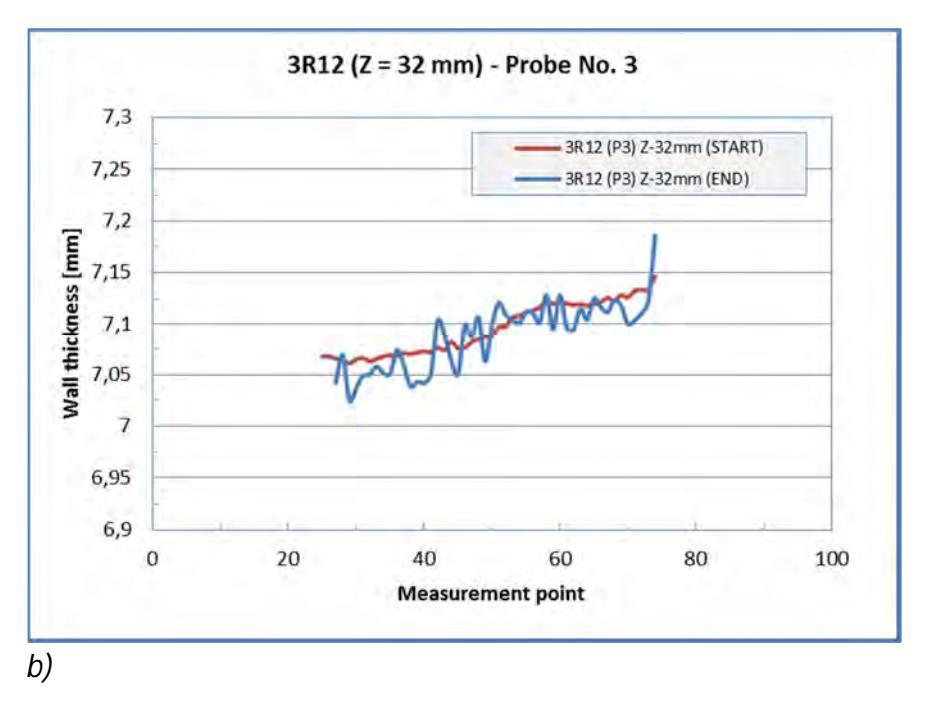
Figure 28. Circumferential wall thickness profiles from 3R12 specimen (Probe No. 3): a) axial location Z = 25 mm and b) axial location Z = 32 mm.

The results of the wall thickness profile measurements and the wall thinning curves derived from them are presented in Figures 28...35. The results showed that marked wall thinning had taken place only on the 3R12 specimen. Some wall thinning was observed also on the Super 625 specimen. The data of the HR11N and Sanicro 38 was more scattered showing that wall thinning and deposit formation (increase in wall thickness) had taken place locally. In addition the data in this test was more scattered than in the previous test indicating that all deposits were not removed from the surfaces in washing performed for the specimens' prior measurements.

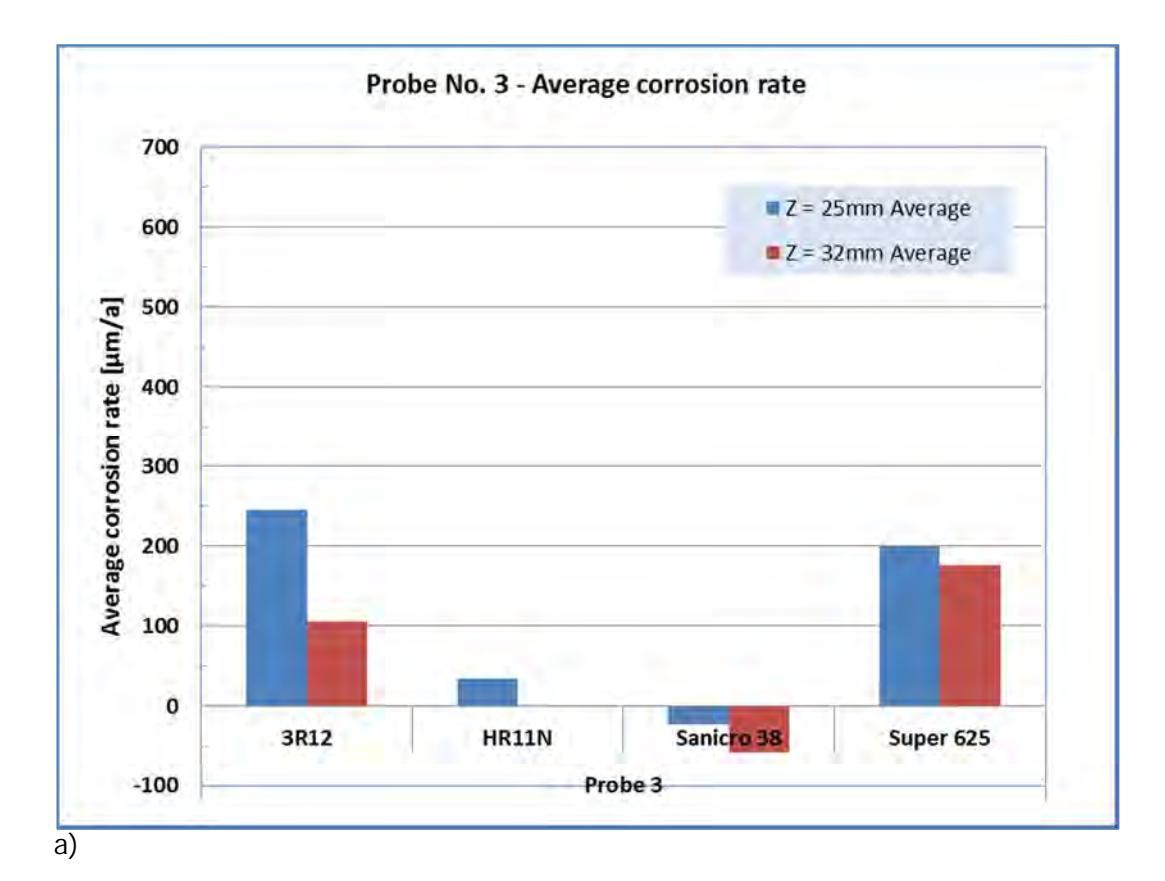
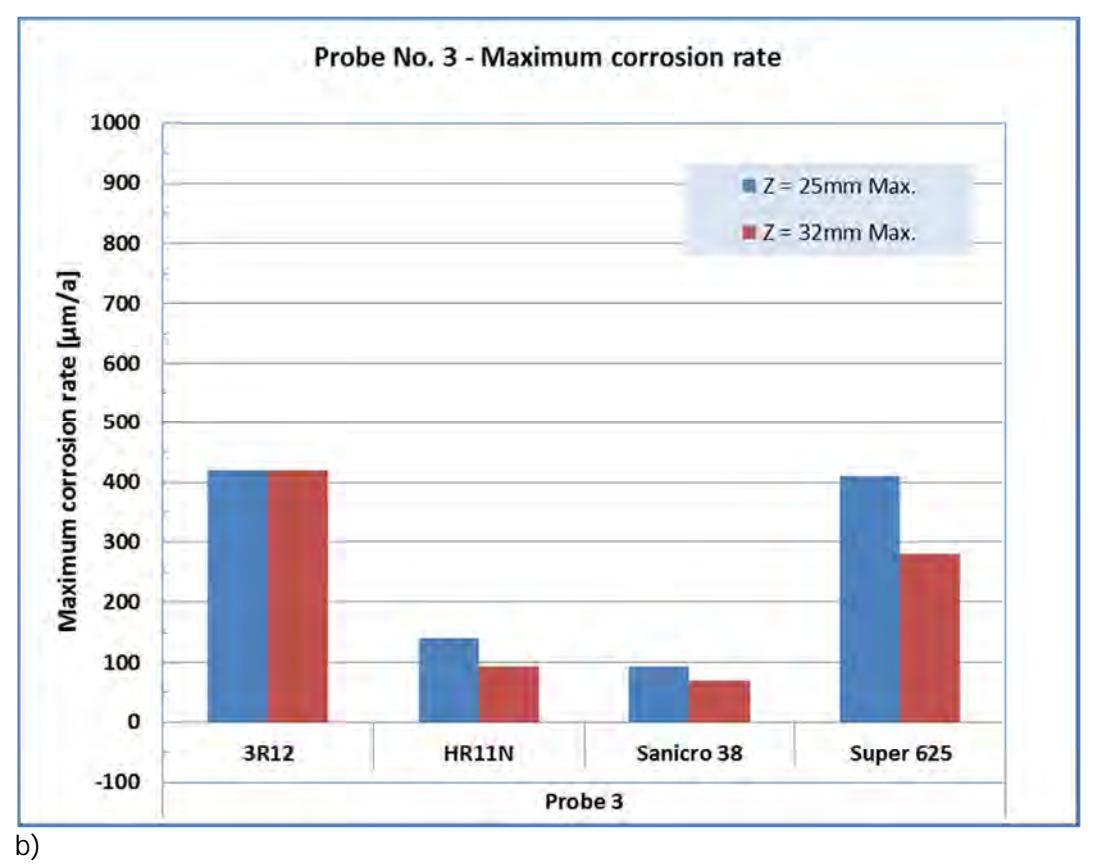
The average and maximum corrosion rates calculated on the basis of the wall thickness measurements are presented in Figure 36. In this test the corrosion rate of 3R12 was in the order 0.4 mm/a, i.e. about 0.2 mm/a lower than in the first two tests, most probably due the lower probe temperature. The corrosion rate of the Super 625 was unexpectedly high ca. 0.3...0.4mm/a. The maximum corrosion rates of HR11N and Sanicro 38 were in the order of 0.1 mm/a, and they were best performing materials in this test.

Figure 36. a) Average and b) maximum corrosion rates of the test materials calculated on the basis of the wall thickness measurements after 750 h exposure in lower furnace at 430 °C (Probe test No. 3)

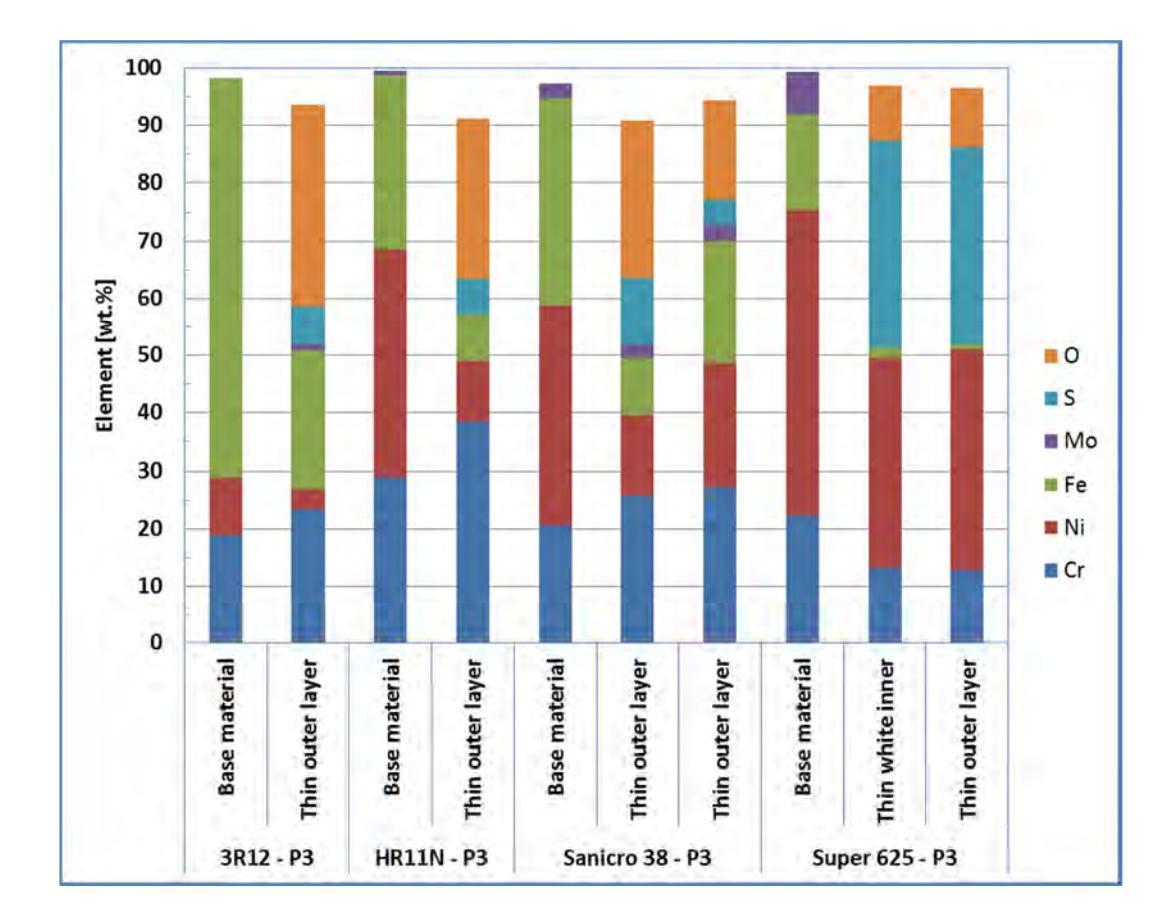
According to the EDS analysis (Figure 38) the layers on 3R12, HR11N and Sanicro 38 were depleted in iron and nickel and enriched in chromium and contained also sulphur. The layers on the Super 625 were depleted in iron, nickel, molybdenum and chromium and contained high amounts of sulphur. Reference analysis made from unexposed reference samples showed that the depleted/enriched layers are formed during exposure and do not originate from the specimen manufacturing process.

Figure 38. Results from the EDS analysis performed for the 3R12, HR11N, Sanicro 38 and Super 625 specimens after 750 h exposure in lower furnace at 430 °C (Probe test No. 3). Note: Quantitative results from cross sections, carbon excluded. Data from layers are from point analysis, whereas area analysis was used for base materials.

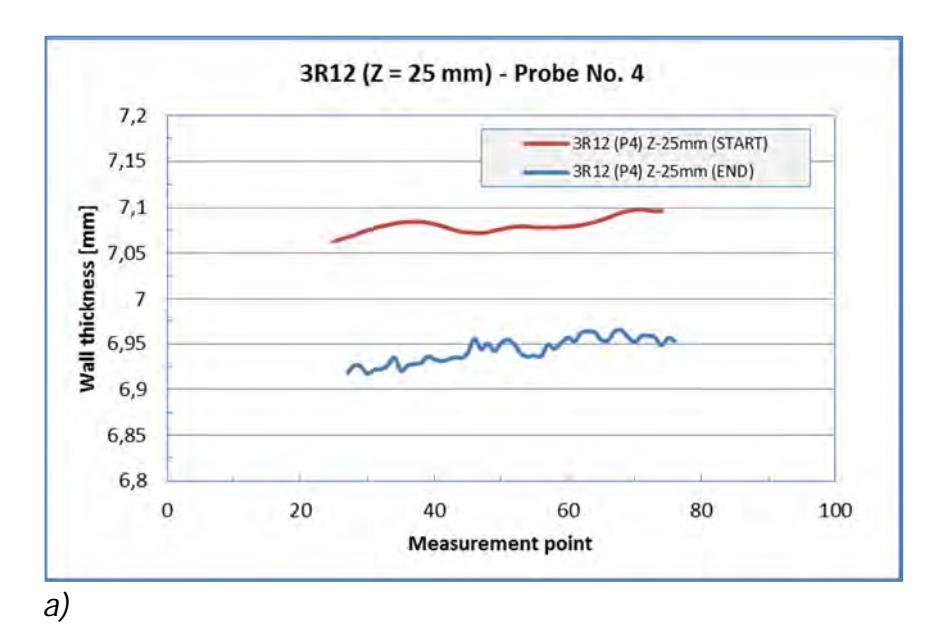
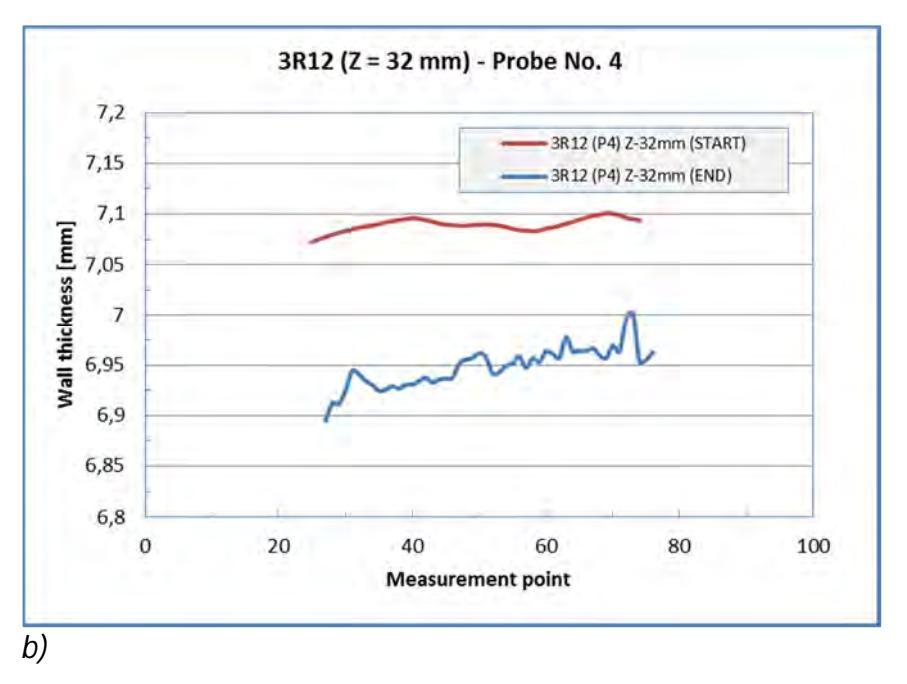
The results of the wall thickness profile measurements and the wall thinning curves derived from them are presented in Figures 40...47. The results showed that intense wall thinning had taken place on carbon steel specimen. Marked wall thinning was also observed on the 3R12 specimen and lesser degree also on the Super 625 specimen. The data of the Sanicro 67 specimen was more scattered showing that wall thinning and deposit formation (increase in wall thickness) had taken place locally. The results showed also that surface polishing prior testing together with longer exposure time reduced data scatter and thus improved accuracy.

Figure 40. Circumferential wall thickness profiles from 3R12 specimen (Probe No. 4): a) axial location Z = 25 mm and b) axial location Z = 32 mm.

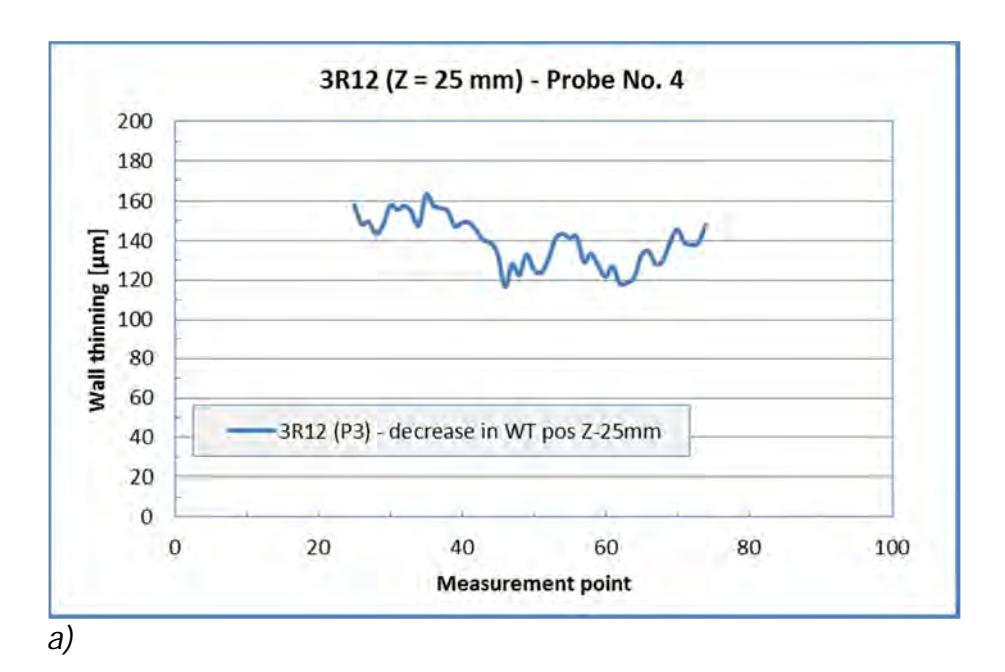
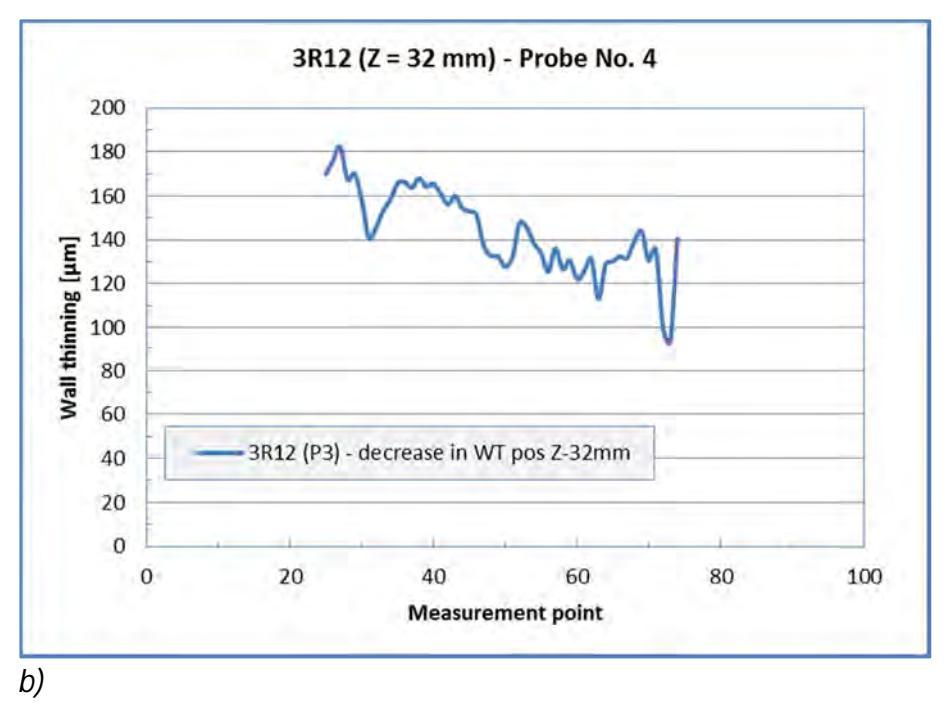
Figure 41. Circumferential wall thinning curves from 3R12 specimen (Probe No. 4): a) axial location Z = 25 mm and b) axial location Z = 32 mm.

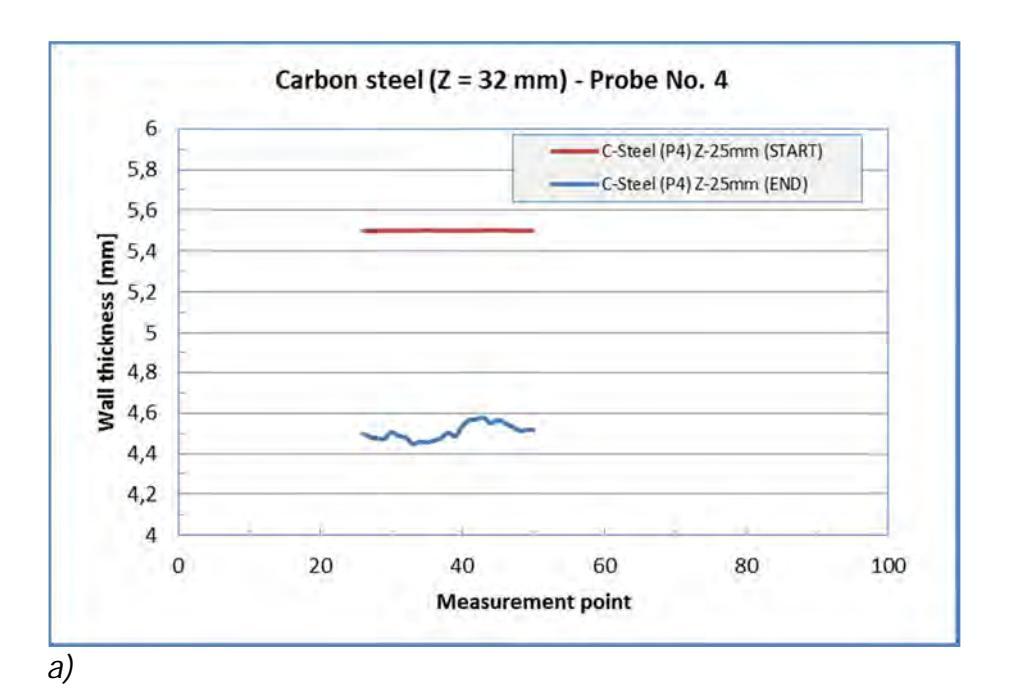
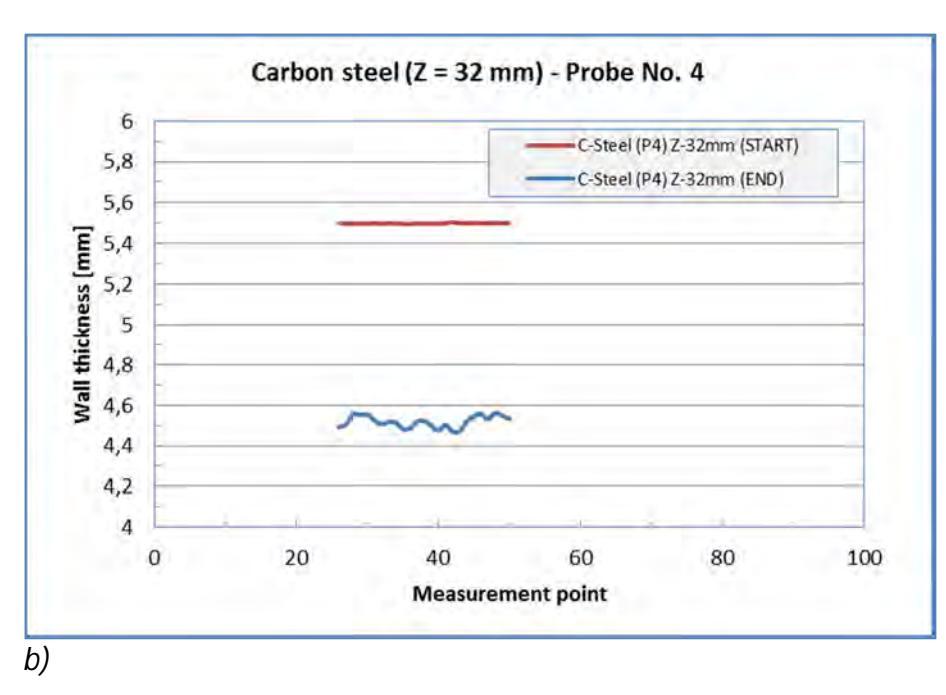
Figure 42. Circumferential wall thickness profiles from carbon steel specimen (Probe No. 4): a) axial location Z = 25 mm and b) axial location Z = 32 mm.

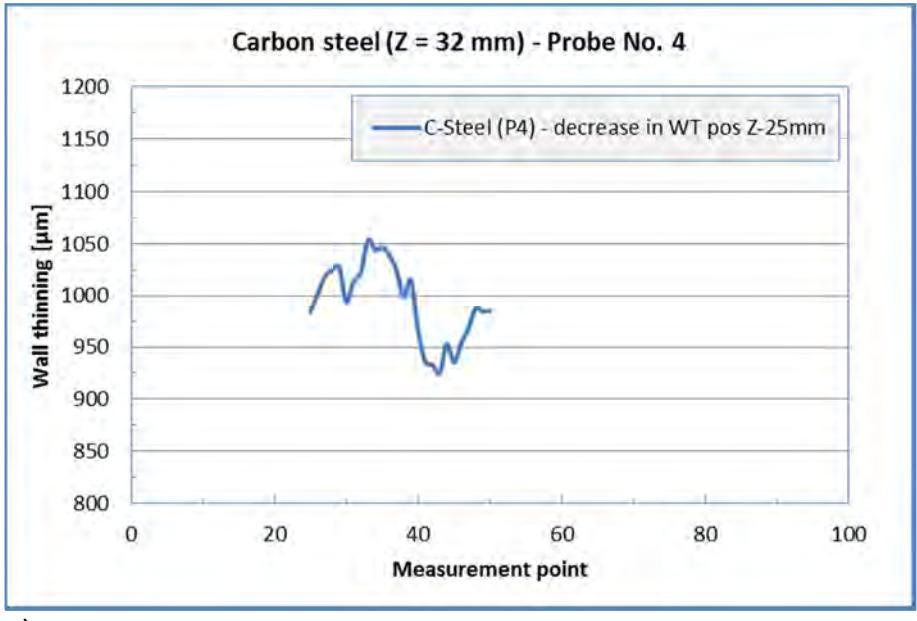
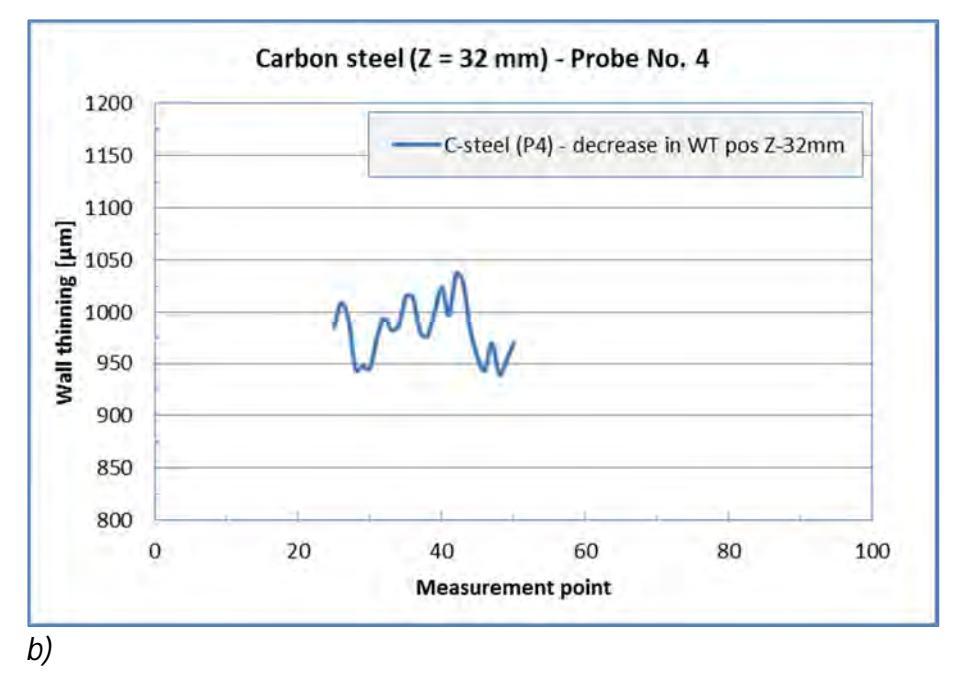
Figure 43. Circumferential wall thinning curves from carbon steel specimen (Probe No. 4): a) axial location Z = 25 mm and b) axial location Z = 32 mm.

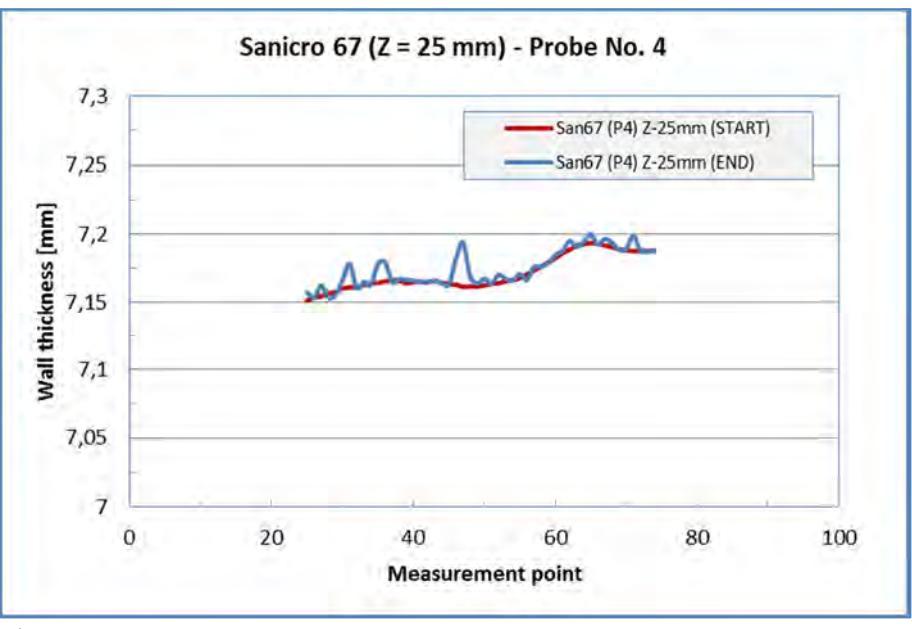
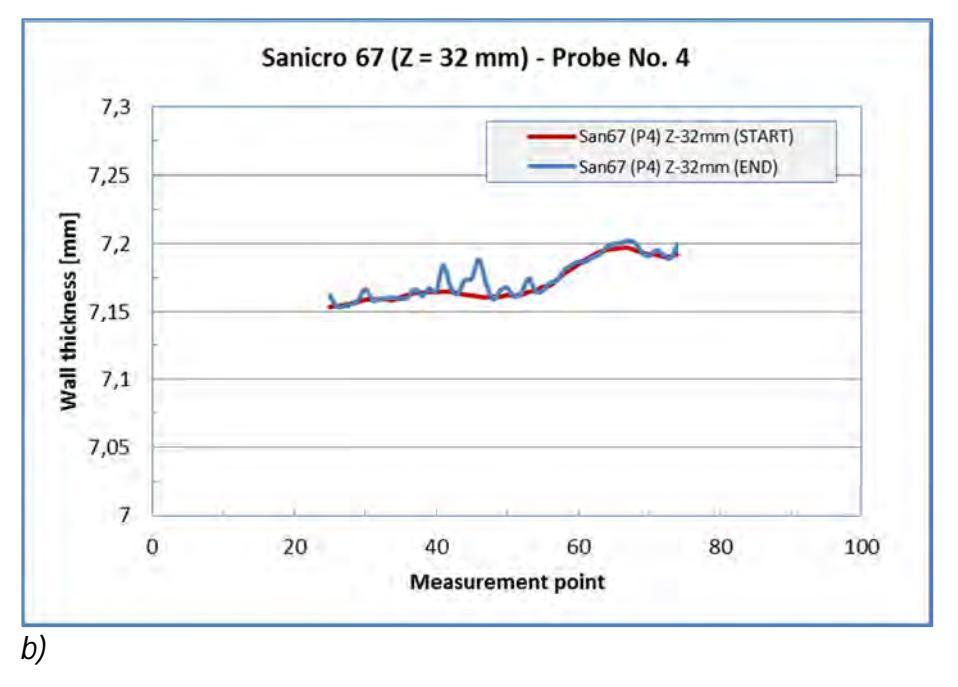
Figure 44. Circumferential wall thickness profiles from Sanicro 67 specimen (Probe No. 4): a) axial location Z = 25 mm and b) axial location Z = 32 mm.

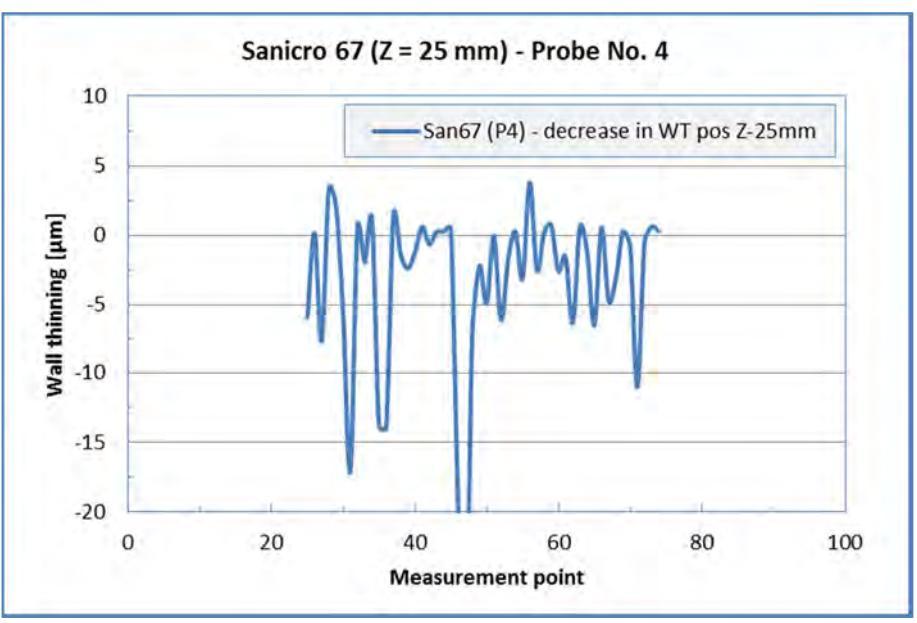
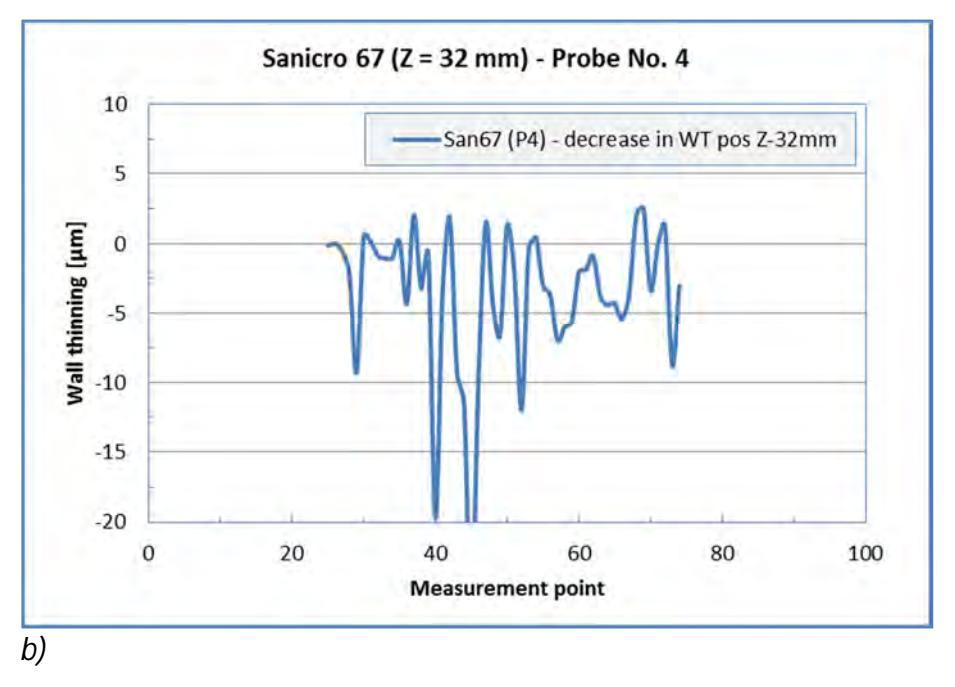
Figure 45. Circumferential wall thinning curves from Sanicro 67 specimen (Probe No. 4): a) axial location Z = 25 mm and b) axial location Z = 32 mm.

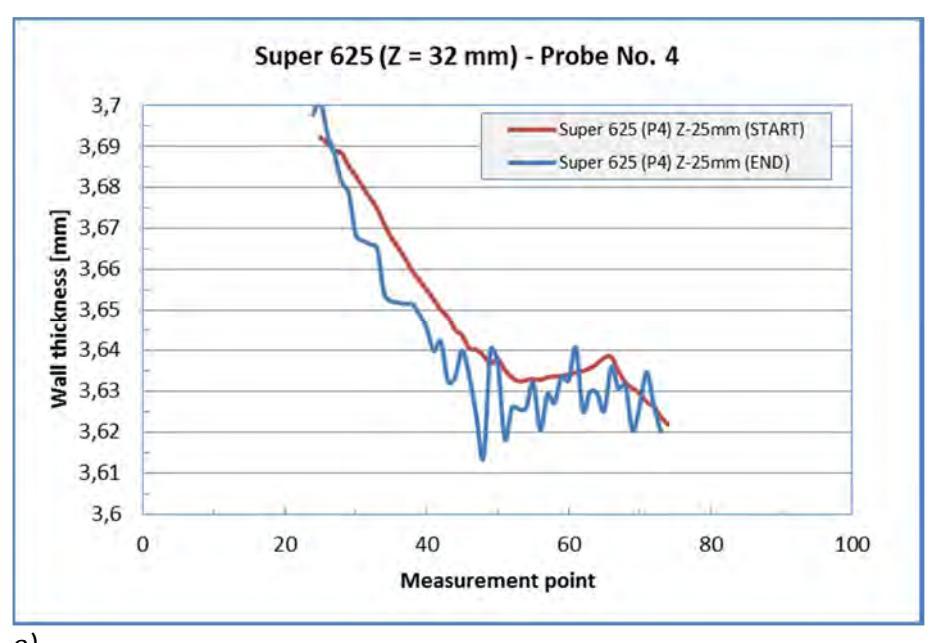
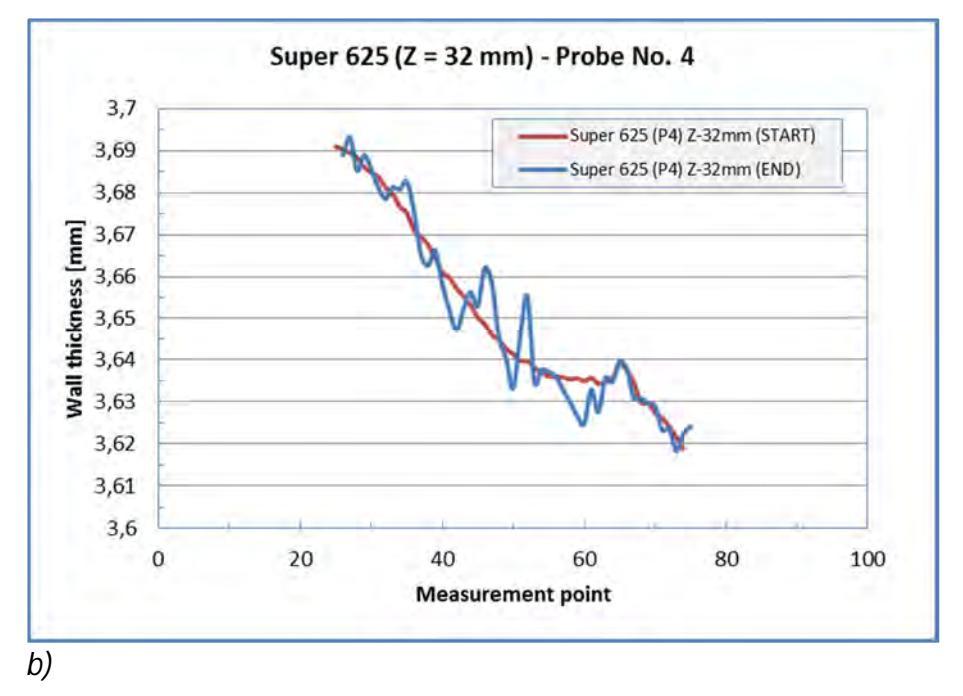
Figure 46. Circumferential wall thickness profiles from Super 625 specimen (Probe No. 4): a) axial location Z = 25 mm and b) axial location Z = 32 mm.

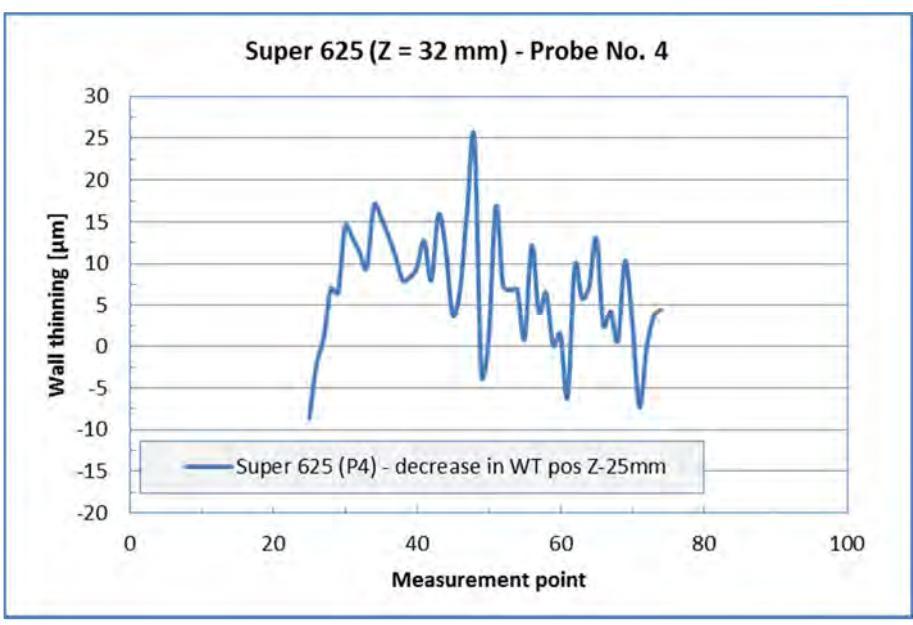
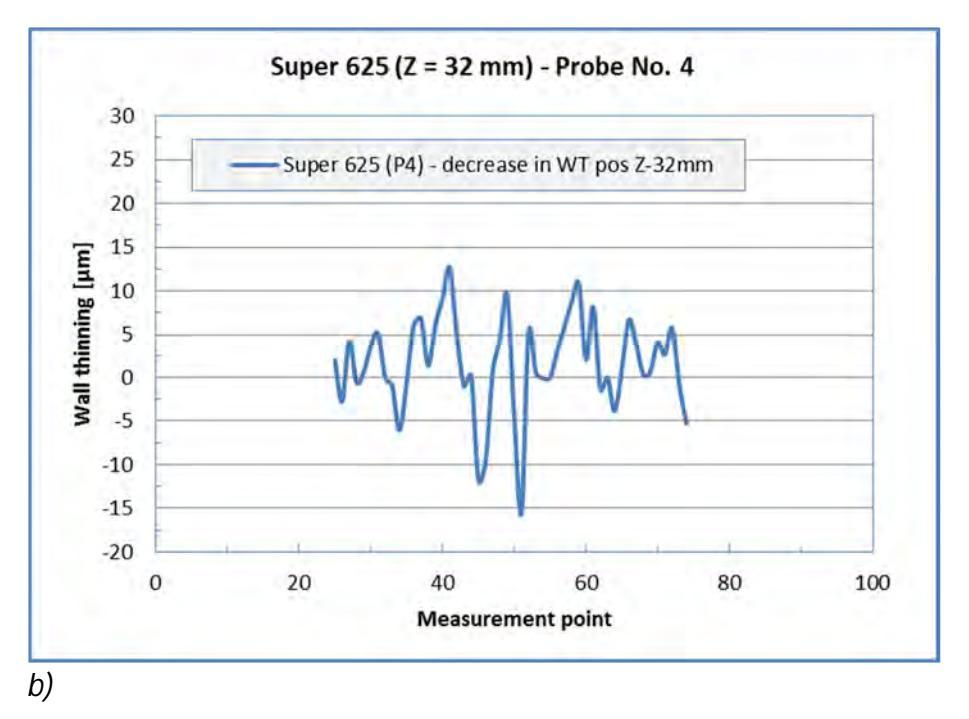
Figure 47. Circumferential wall thinning curves from Super 625 specimen (Probe No. 4): a) axial location Z = 25 mm and b) axial location Z = 32 mm.

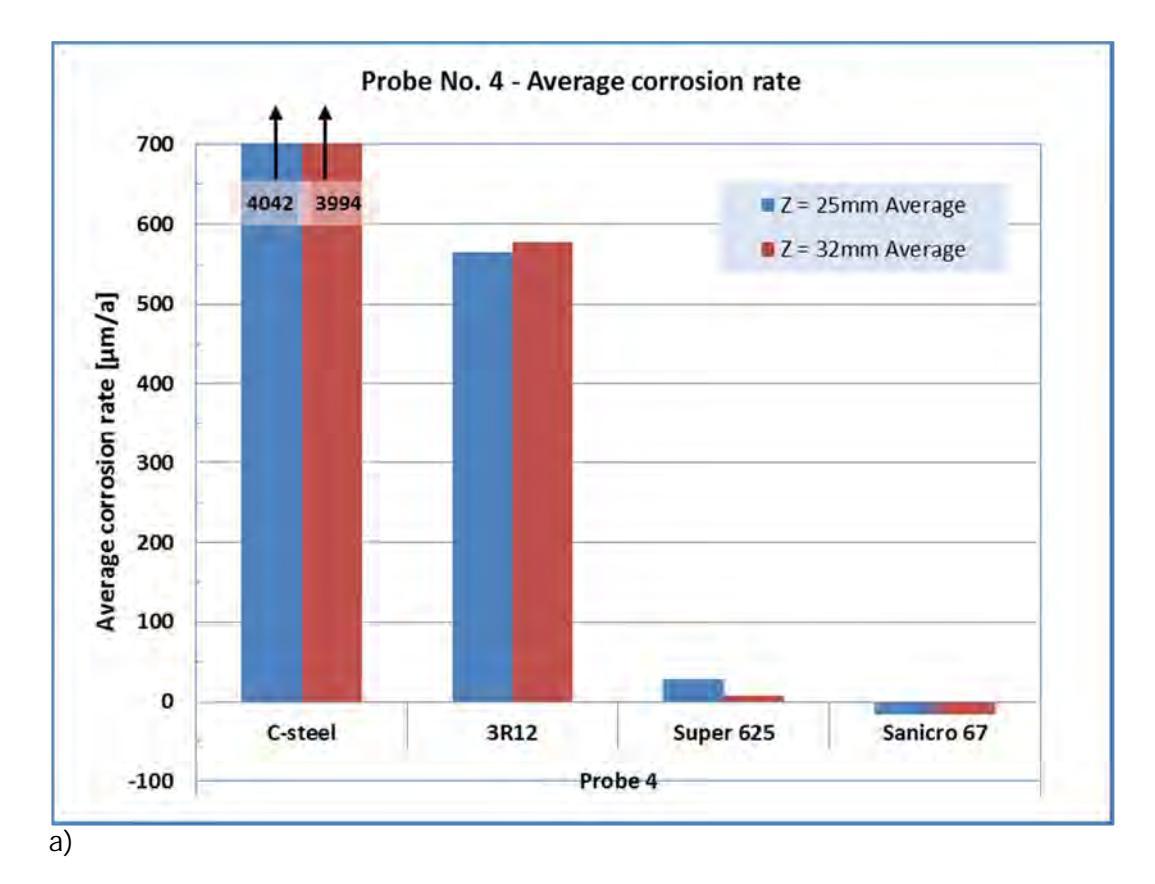
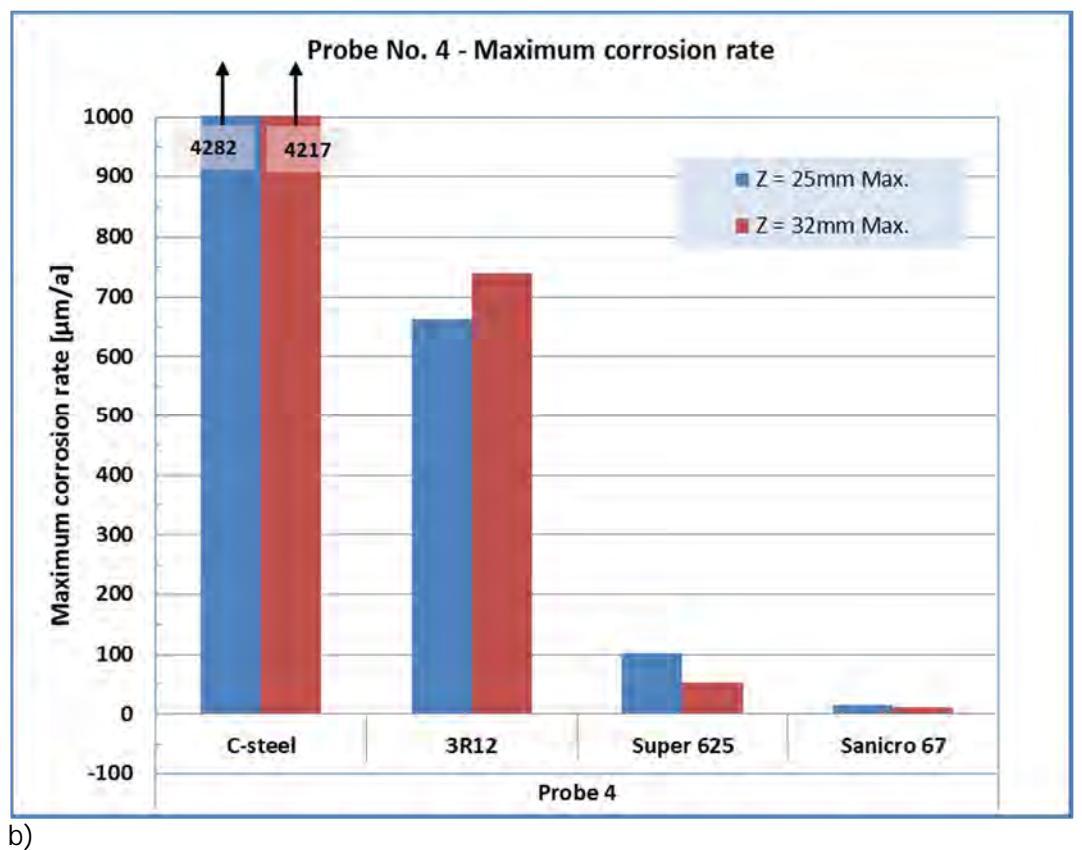
The average and maximum corrosion rates calculated on the basis of the wall thickness measurements are presented in Figure 48. Highest corrosion rates, ca. 4 mm/a, were measured for the carbon steel as expected. The 3R12 had the second highest corrosion rates, order of 0.6 mm/a. Maximum corrosion rate of the Super 625 was in the order 0.1 mm/a in this test, i.e. significantly lower than in the test No.3, where a maximum corrosion rate of 0.2...0.3 mm/a was observed. The best material in this test was Sanicro 67, its maximum corrosion rate was only about 0.02 mm/a.

Figure 48. a) Average and b) maximum corrosion rates of the test materials calculated on the basis of the wall thickness measurements after 2154 h exposure in lower furnace at 440 $^{\circ}C$ (Probe test No. 4).
