Project budget and schedule 14.12.2012

ÅA, Probe Study of Corrosion in the Economizers of a Kraft Recovery Boiler Corrosion – presentation 19.12.2012 PROCESS CHEMISTRY CENTRE

Probe Study of Corrosion in the Economizers of a Kraft Recovery Boiler

Draft Report: Probe Study of Corrosion in the Economizers of a Kraft Recovery Boiler

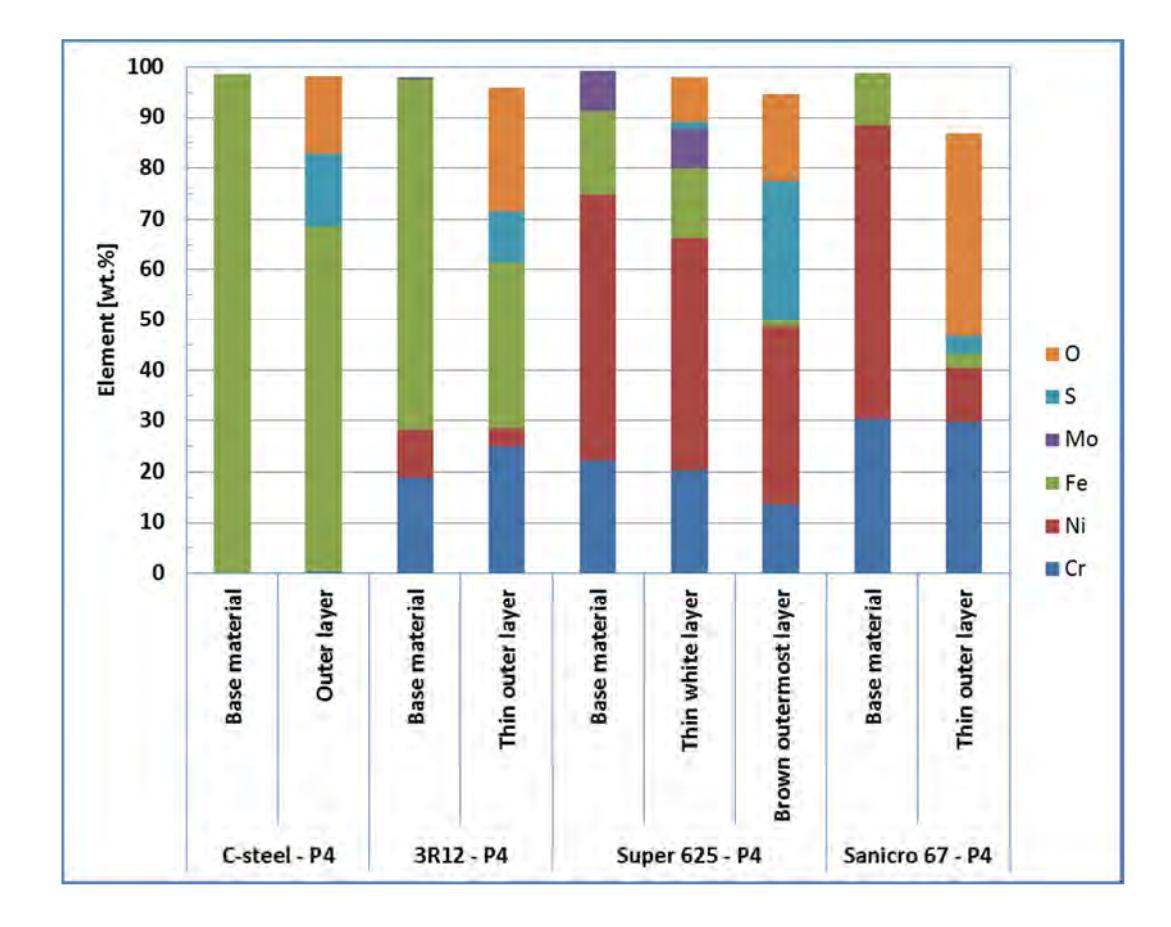
According to the EDS analysis (Figure 50) the layer on 3R12 was depleted in iron and nickel and enriched in chromium and contained also sulphur. The layer on Sanicro 67 contained sulphur and was depleted in iron and nickel, but the chromium content was at the same level than in the base material. The outermost layers on the Super 625 were depleted in iron, nickel, molybdenum and chromium and contained high amounts of sulphur.

Figure 50. Results from the EDS analysis performed for the carbon steel, 3R12, Sanicro 67 and Super 625 after 2154 h exposure in lower furnace at 440 °C (Probe test No. 4). Note: Quantitative results from cross sections, carbon excluded. Data from layers are from point analysis, whereas area analysis was used for base materials.

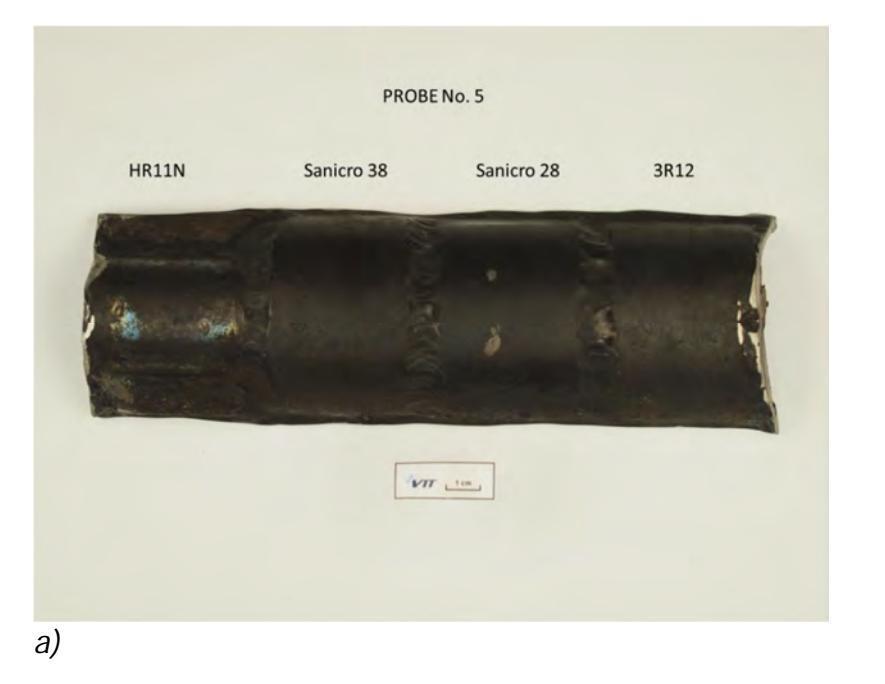
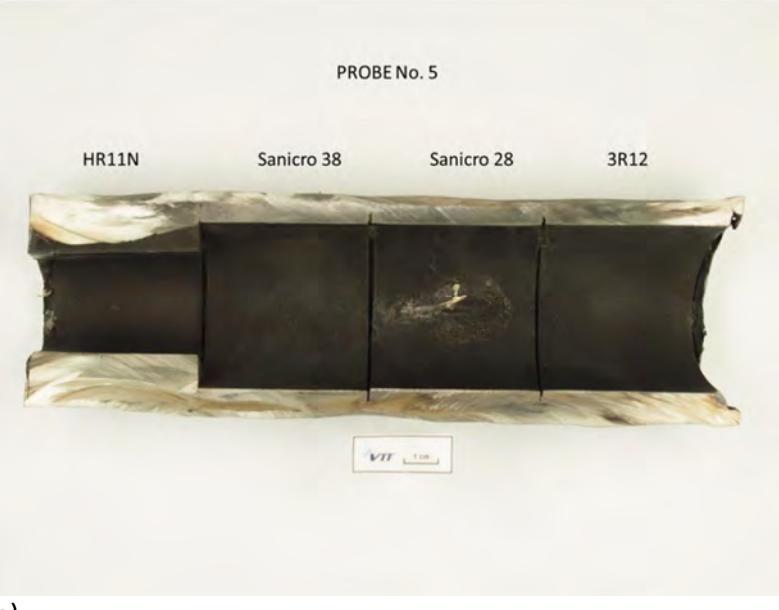
Total test duration of the test No. 5 was 2630 hours from which 2157 hours at the target temperature of 440 °C. The test materials in this exposure were 3R12, Sanicro 28, HR11N and Sanicro 38, Figure 51. According to visual inspection all samples were in good condition after testing i.e. neither marked general or localised corrosion nor deposits or oxide scales were observed either on outer or inner surfaces.

Figure 51. Macrographs taken from the probe No. 5 head after exposure: a) outer surface exposed to the furnace side and b) inner surface exposed to the cooling liquid. A thermocouple soldered on the middle of Sanicro28 specimen, that hindered WT measurements after exposure, is clearly visible on inner surface.

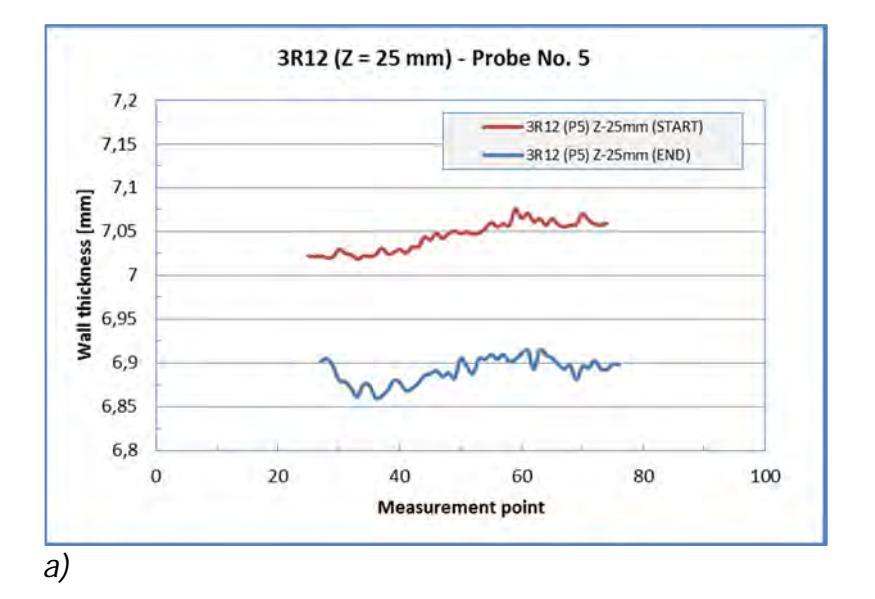
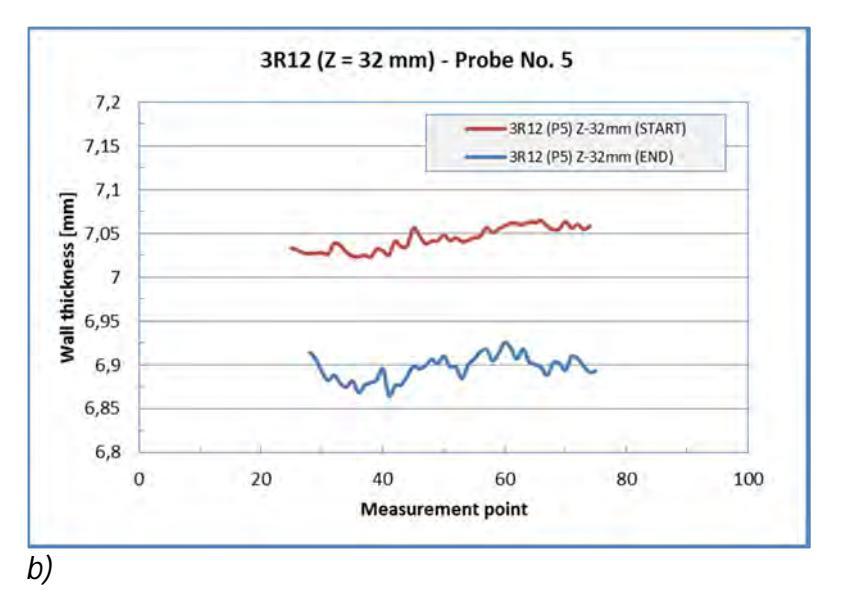
The results of the wall thickness profile measurements and the wall thinning curves derived from them for 3R12, HR11N and Sanicro 38 are presented in Figures 52...57. The results showed that marked wall thinning had taken on the 3R12 specimen. Some wall thinning was observed also on the Sanicro 38 specimen and locally also on the HR11N specimen. The WT profile measurements for the Sanicro 28 sample after the test failed due to the thermocouple that was soldered on the inner surface of the specimen (Figure 51b).

Figure 52. Circumferential wall thickness profiles from 3R12 specimen (Probe No. 5): a) axial location Z = 25 mm and b) axial location Z = 32 mm.

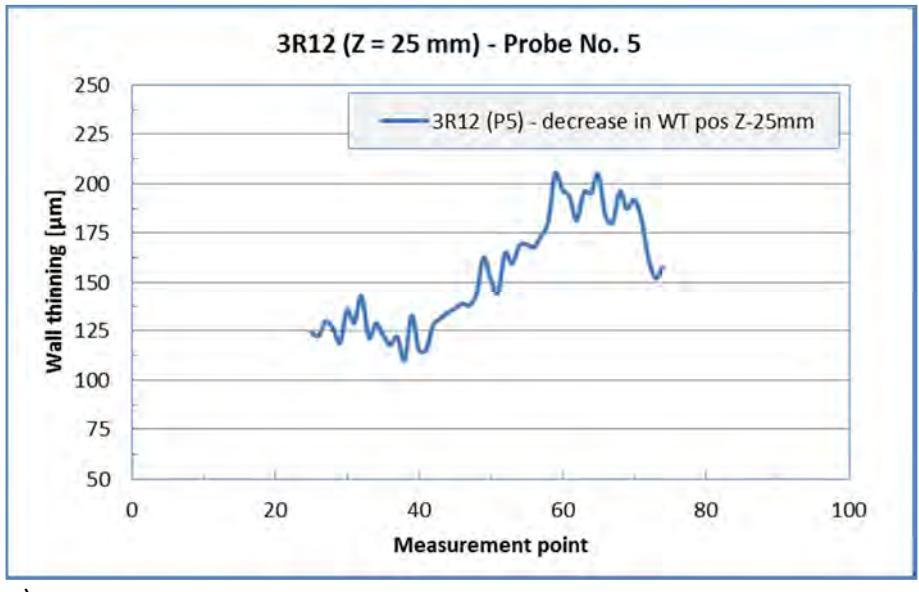
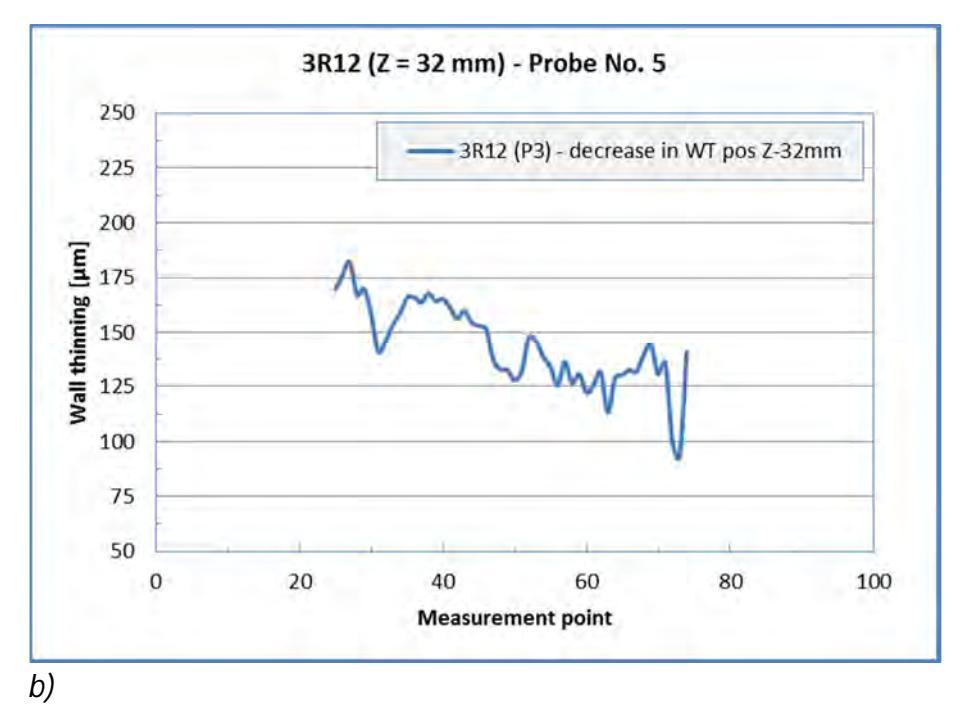
Figure 53. Circumferential wall thinning curves from 3R12 specimen (Probe No. 5): a) axial location Z = 25 mm and b) axial location Z = 32 mm.

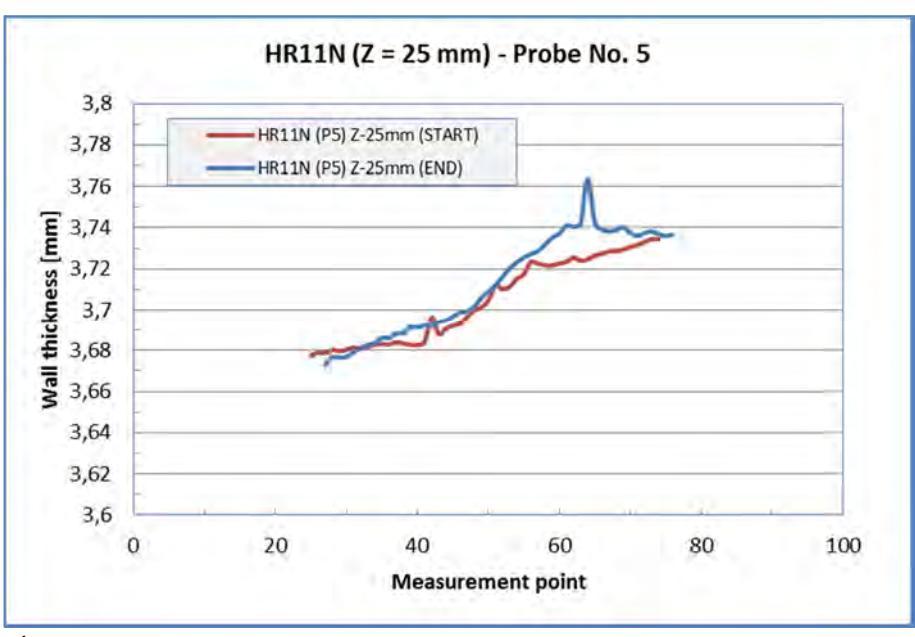
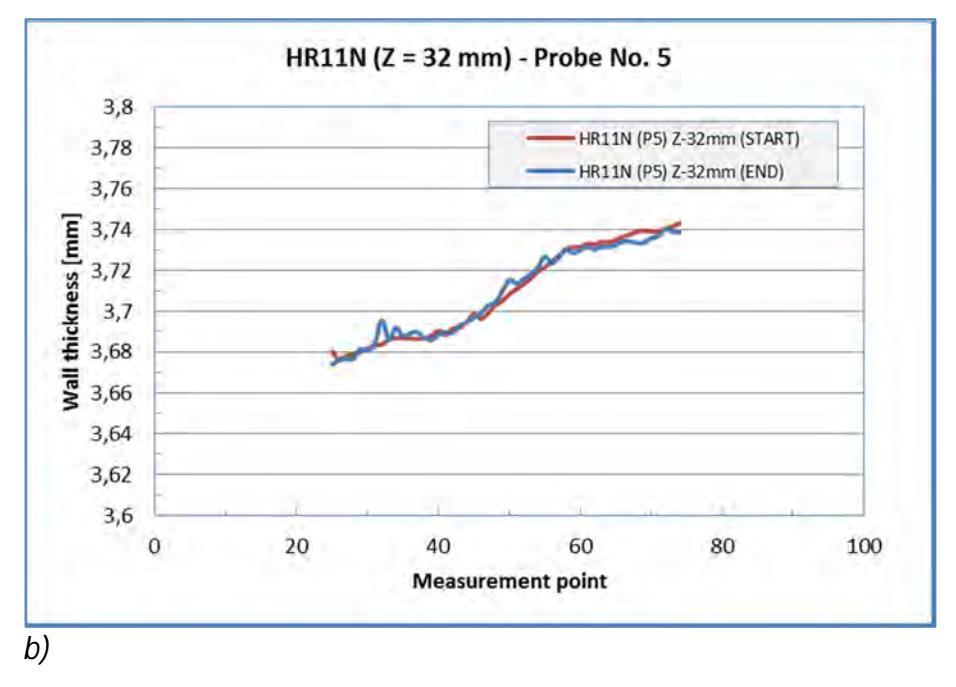
Figure 54. Circumferential wall thickness profiles from HR11N specimen (Probe No. 5): a) axial location Z = 25 mm and b) axial location Z = 32 mm.

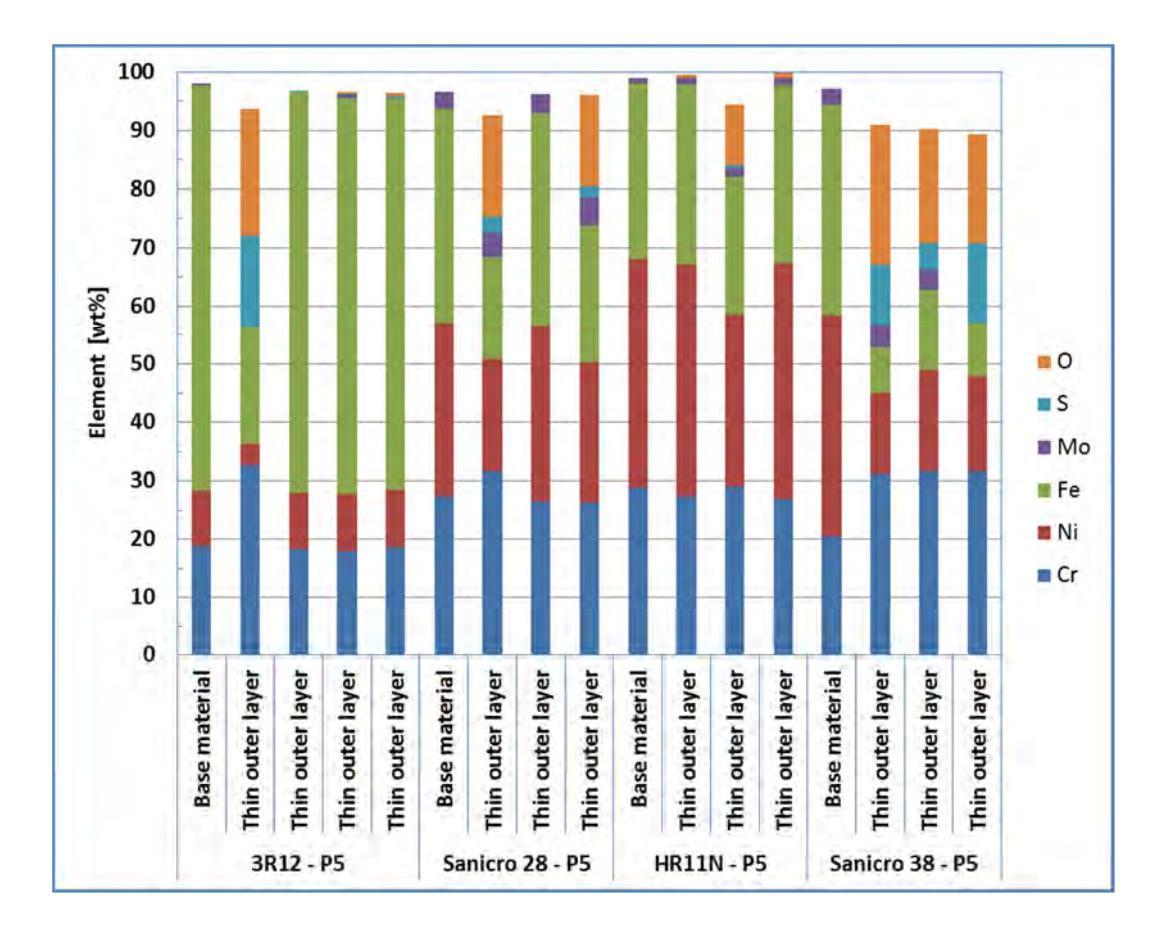
Figure 60. Results from the EDS analysis performed for the 3R12, Sanicro 28, HR11N and Sanicro 38 after 2157 h exposure in lower furnace at 440 °C (Probe test No. 5). Note: Quantitative results from cross sections, carbon excluded. Data from layers are from point analysis, whereas area analysis was used for base materials.

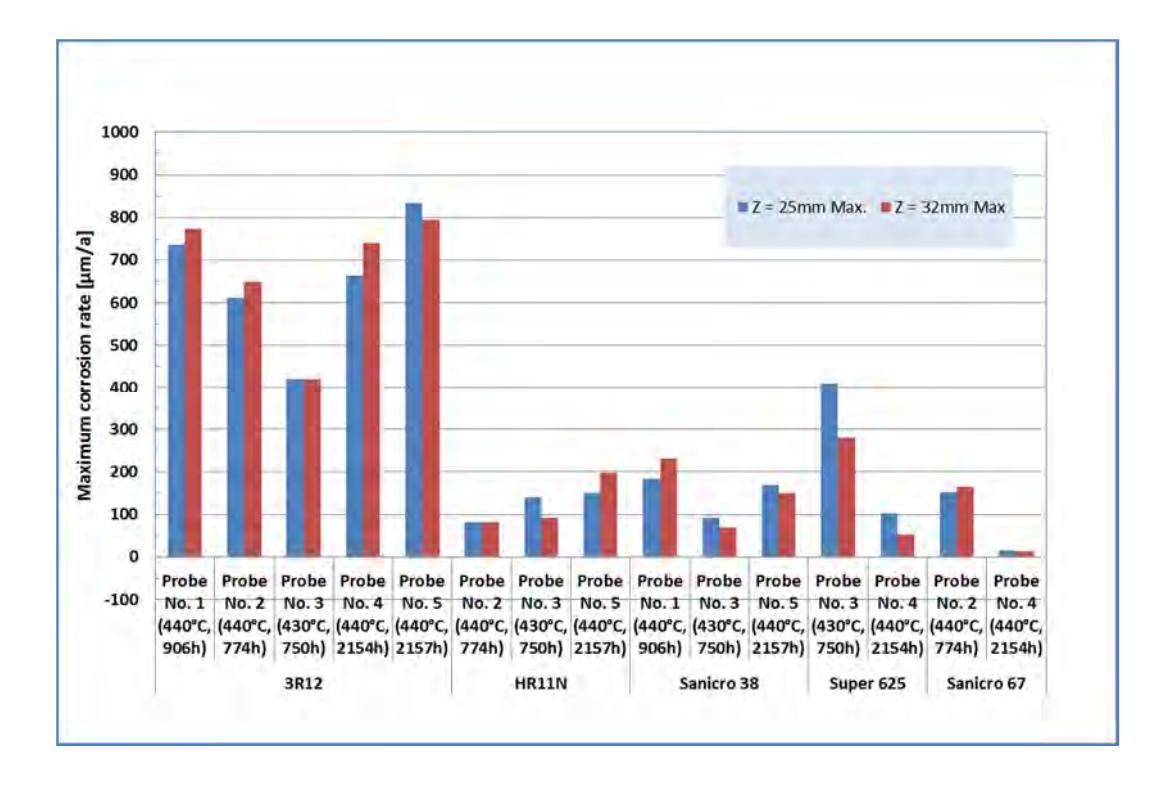
Figure 61. Calculated maximum corrosion rates for the 3R12, HR11N, Sanicro 38, Super 625 and Sanicro 67 materials from the probe test No. 1 - 5.

In current tests highest corrosion rate, ca. 4 mm/a, was measured for the carbon steel as expected. The traditional composite tube material 3R12 had the second highest corrosion rate, order of 0.6...0.8 mm/a at the temperature of 440 °C and ca. 0.4 mm/a at 430 °C (Figure 61). Based on the results of 3R12 the reproducibility of the probe tests was so good that different probe tests can be used to compare different materials to each other.

In current tests no marked differences were observed between Sanicro 38 and HR11N. Their maximum corrosion rates were in the order of 0.15...0.2 mm/a in the long term (>2000 h) test, i.e. about four times lower than that of the 3R12 (Figure 61).

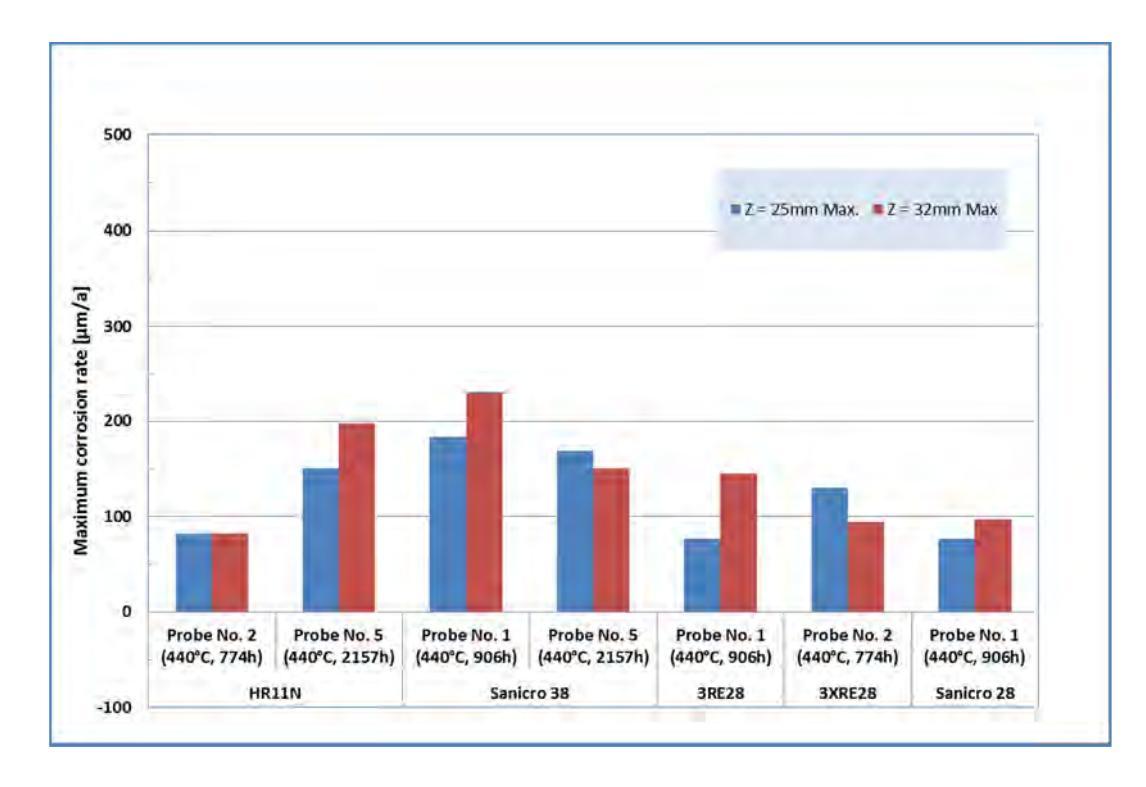
Figure 62. Calculated maximum corrosion rates for the 3RE28, 3XRE28, HR11N and Sanicro 38 from the probe test No. 1-3 and 5.

In short term (<1000 h) tests the corrosion resistance of the 3RE28, 3XRE28 and Sanicro 28 were as good as or even slightly better than that of the Sanicro 38 or HR11N (Figure 62). Because the 3RE28 and 3XRE28 were not included in the long term tests and no results were obtained for the Sanicro 28 from the long term test No. 5, due to the misplaced thermocouple, it is recommended to verify their promising performance with long term tests in the future.

The results for the Super 625 were inconsistent. In short term 750 h test at 430 °C it's corrosion resistance was only slightly better than that of the 3R12, but in the long term 2154 h test at 440 °C it's resistance was even better that of the Sanicro 38 and HR11N (Figure 62). Similar kind of behaviour was observed in Sanicro 67. In short term 744 h test at 440 °C it's corrosion resistance was only slightly better than that of the Sanicro 38 and HR11N, but in the long term 2154 h test at 440 °C it's corrosion resistance was only slightly better than that of the Sanicro 38 and HR11N, but in the long term 2154 h test at 440 °C it's corrosion rate was only 1/10 of that of the Sanicro 38 and HR11N and 1/5 of the Super 625.

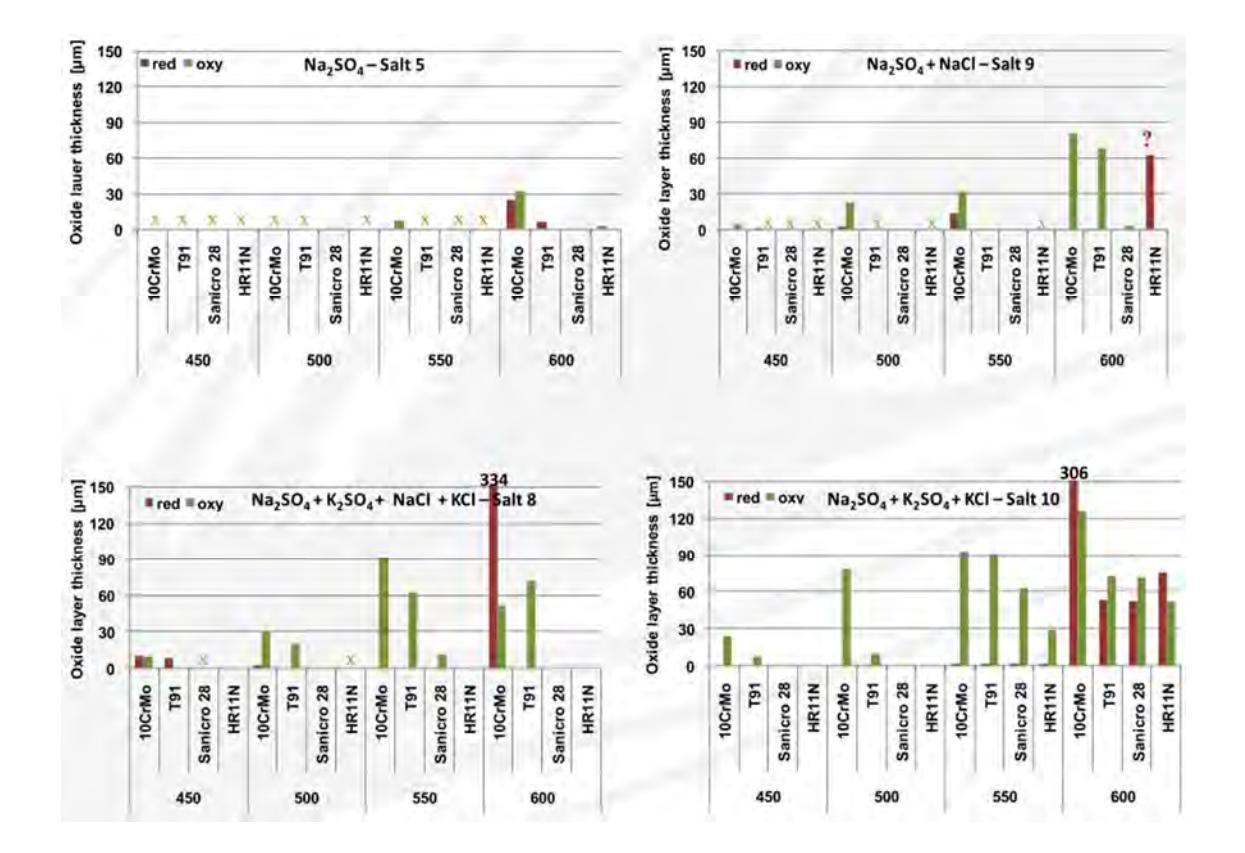
FIGURE 5-10. The mean oxide layer/corrosion product thickness of the tested materials in ambient (green bars - oxy) and reducing atmosphere (red bars- red). The corrosion tests duration 168h.

Reducing conditions induced mainly internal attack of the steel and in ambient conditions growth of the oxide layer was promoted. Ambient atmosphere appeared to be more harmful than reducing. Thermodynamic calculations in combination with the results and the literature give indications that no significant reduction of sulfate to sulfide occurred below 600°C and even at 600°C this reaction was limited. In combination with the corrosion results this also further suggests that the corrosion in reducing conditions is strongly dependent on Na_2S formation in combination with a melt being present.

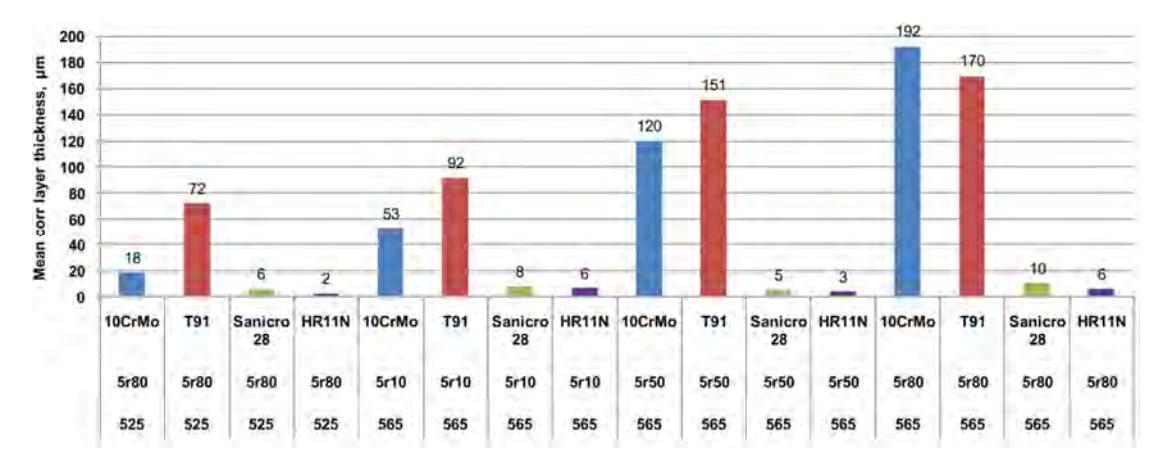
FIGURE 5-11. The mean corrosion layer thickness of the tested materials with Salts 5r10, 5r50 and 5r80 in reducing atmosphere at 525°C and 565°C. The corrosion tests duration 168 h.

The exposures to Salt 5r10, Salt 5r50 and Salt 5r80 resulted in high corrosion of the low alloy materials, 10CrMo9-10 and T91, FIGURE 5-11. The corrosion products were very brittle, voluminous and had a form of curled flakes. The flakes composed of Fe, O and high amounts of C. The high alloy materials, Sanicro 28 and HR11N,

performed well under the tested conditions. The corrosion measured on those materials did not exceed $10 \,\mu$ m.
