**Tulistinmateriaalien laboratoriokokeet OSA 2  
alustavien kokeiden tulokset ja tarjous  
5.5.2011**

## **Corrosion tests in reducing conditions – PART II**

Laboratory of Inorganic Chemistry  
Åbo Akademi University

**May 2011**

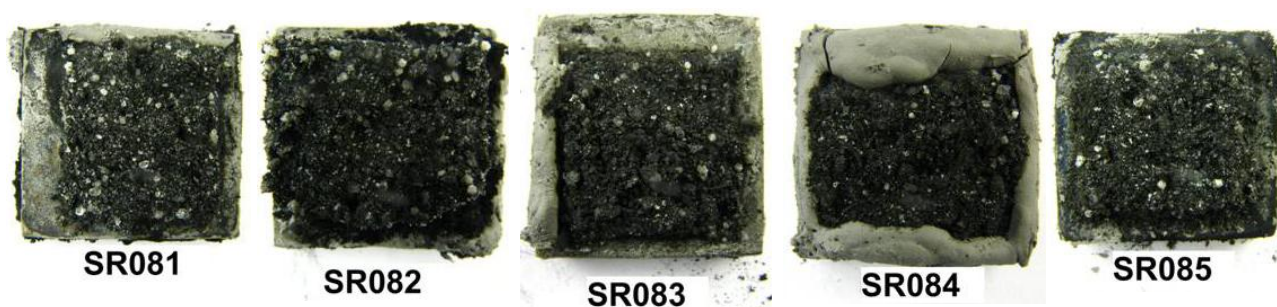
The 168 h test was performed in 5CO-95N<sub>2</sub> (vol%) atmosphere at 550 °C. The appearance of the samples after the heat treatment is shown in Figure 1. The sample holder was full of “soot” after the test.

Figure 1. The appearance of the samples after 168 h exposure at 550 °C with the  $\text{Na}_2\text{SO}_4$ - $\text{Na}_2\text{S}$ -KCl- $\text{K}_2\text{SO}_4$ -BL char synthetic ash in 5CO-95N<sub>2</sub> atmosphere.

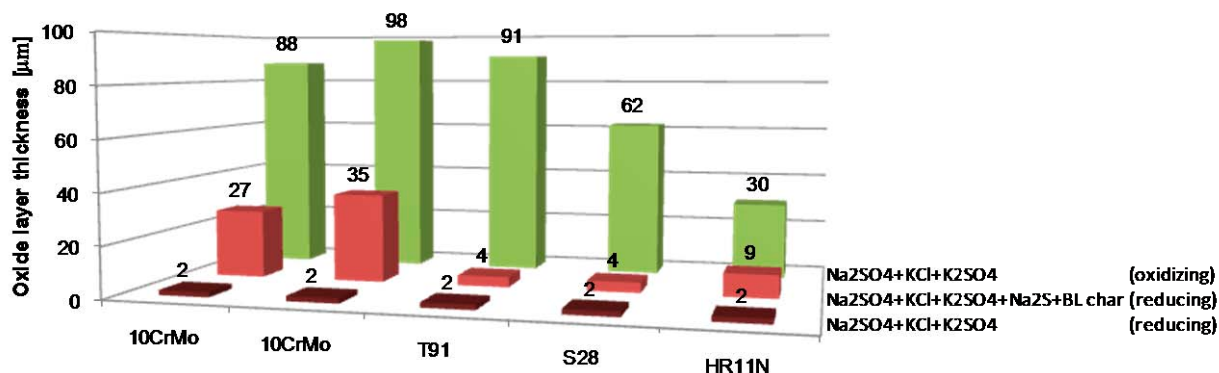
The mean oxide layer thickness from the performed test together with the results from the previously performed tests with Salt 10 ( $\text{Na}_2\text{SO}_4$ -KCl- $\text{K}_2\text{SO}_4$ ) in reducing and oxidizing atmosphere is presented in Figure 2. The 10CrMo material performed significantly worse when comparing to results from tests with Salt 10. The performance of T91 and S28 was comparable and the oxide layer measured in both cases 4 µm. The oxide layer growth on HR11N material was higher than in case of test with Salt 10 but it was not dramatic (~10µm).

Figure 2. The mean oxide layer thickness of the tested materials in reducing and oxidizing atmosphere at 550 °C. The corrosion tests duration 168h. Exposures with Salt 10 and 10r.

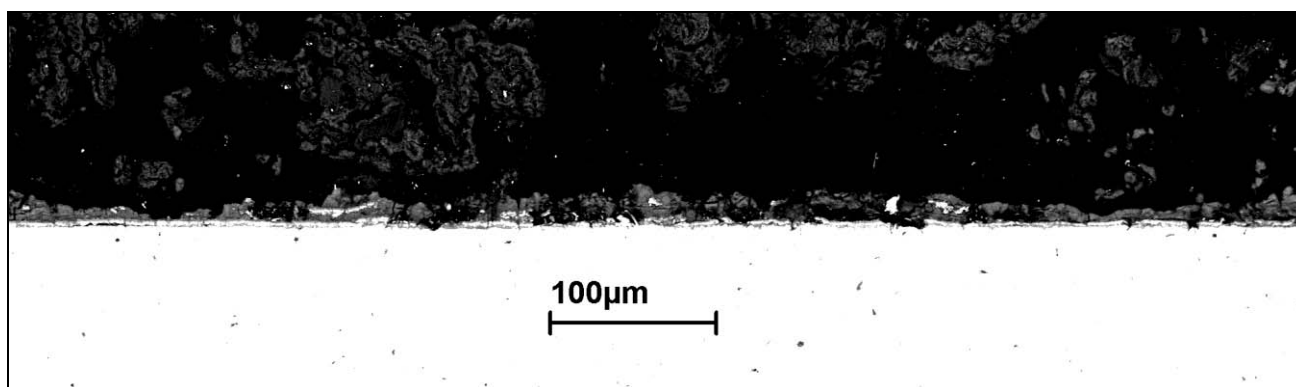
The corrosion products formed on 10CrMo were well adhering to the steel surface and resembled molten phase. The steel surface was rich in Na, S with Cl enrichment in the corrosion products, Figure 2. The surface of HR11N is presented in Figure 3. The thin pieces of the steel from the sample's surface became loose.

Figure 3. The part of panorama picture of HR11N steel after the test.

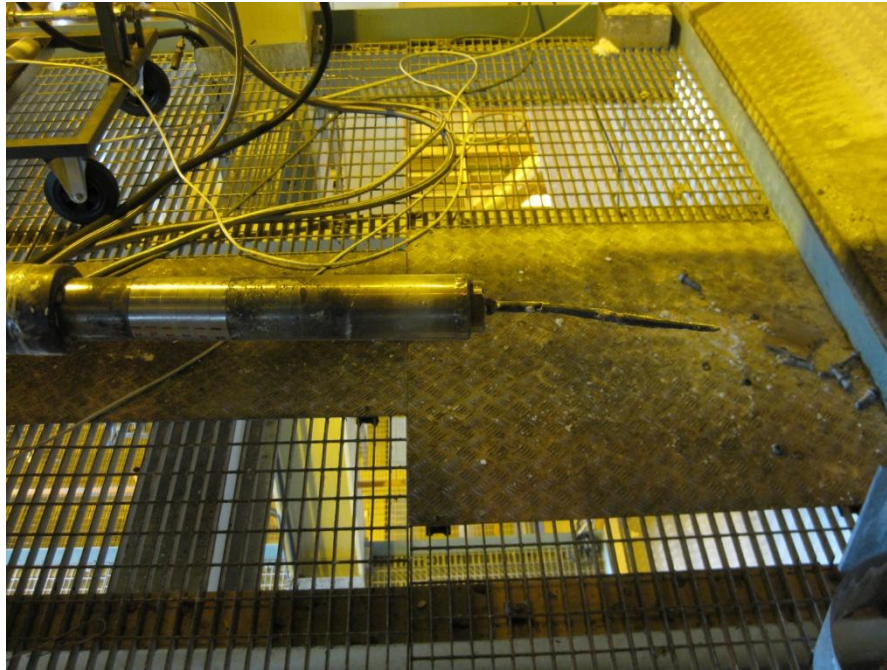
Figure 2. The flue-gas end of the Probe 1. Test material rings, in all six, appear as metallic on the left in the picture. The flue gas temperature sensing element is attached to the tip of the probe on the right in the picture and it was damaged during the measurements.

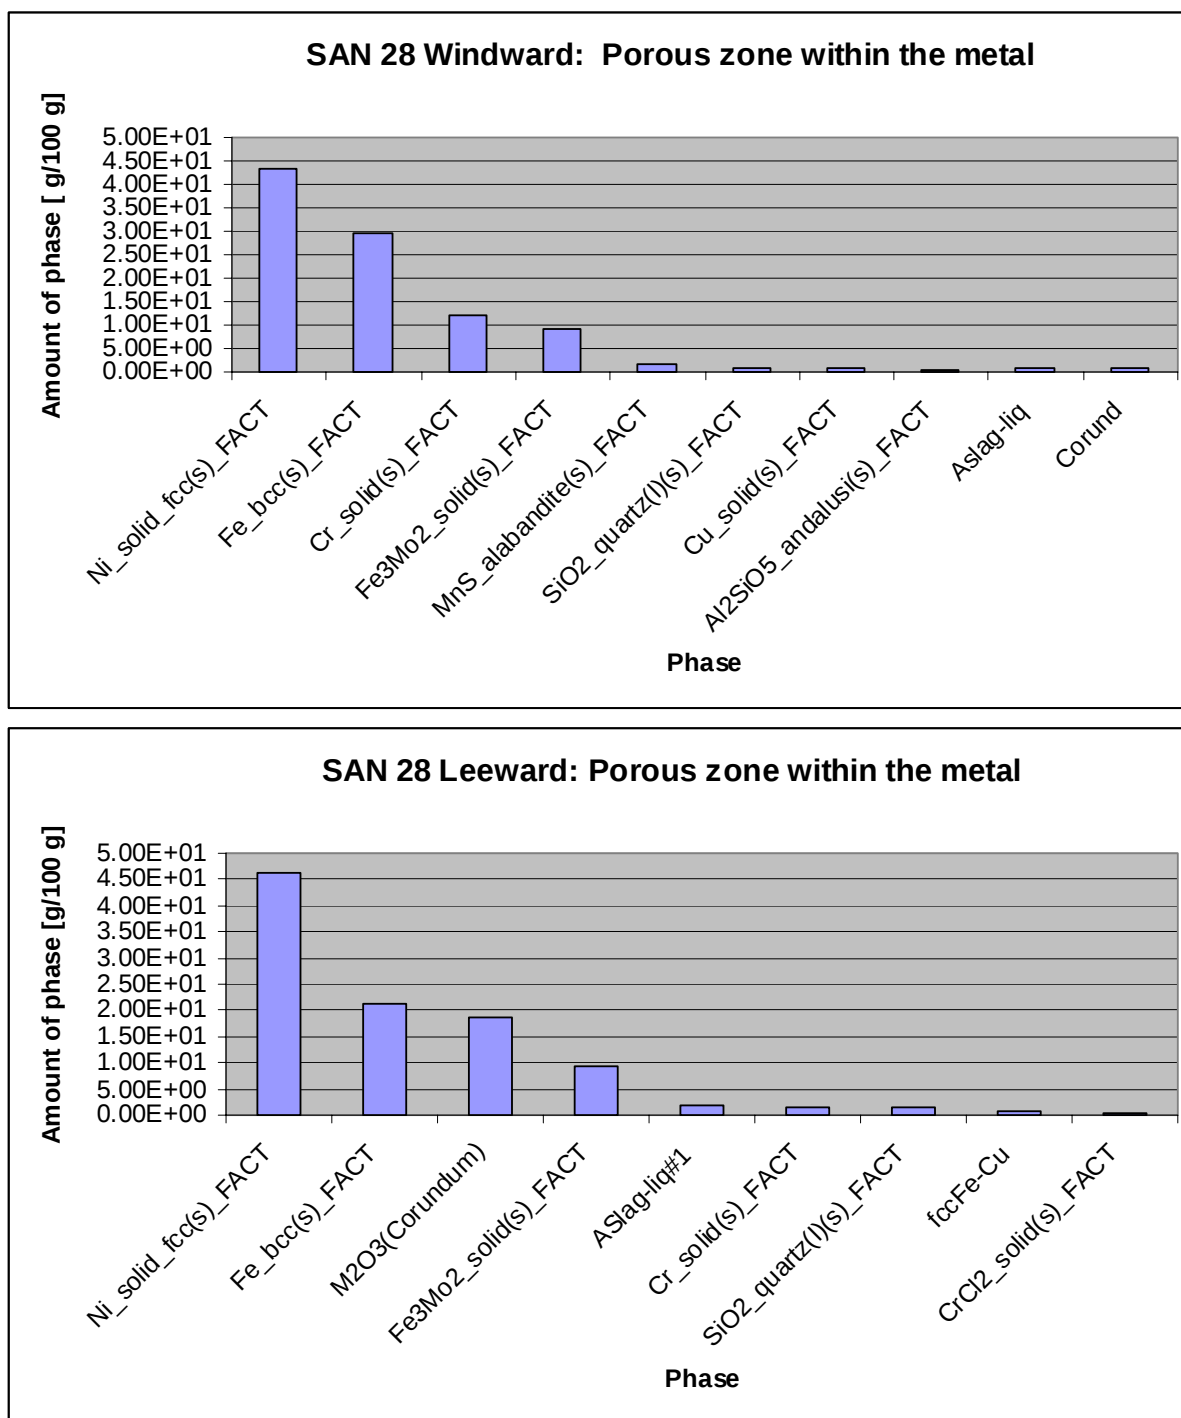
Figure 13. Calculated phase composition that corresponds to an areal analysis of porous (de-alloyed) zone on the Windward side (top picture) and Leeward side (bottom picture) of sample of SAN 28. Transport of oxygen and sulphur via molten phases inward is predicted to possibly occur. Chlorine, however, is if present bound as a solid compound  $\text{CrCl}_2$ . (Phase equilibrium calculated for the temperature of  $542^\circ\text{C}$ .)

In the case of SAN 28, mixture phases allowing a rapid transport of metal and oxidant species are predicted to be present in the porous metal. There is, however, no guarantee that the model liquid phase ASlag-liq#1 in Figure 13, or any other liquid, exists in the real physical equilibrium. Chlorine, when present as-analysed, tends to bound as a solid phase compound  $\text{CrCl}_2$  causing that  $\text{Cl}_2$ -activity is very low within the porous zone. Accordingly, chromium must be considered as a beneficial alloying element. In the subsurface layers and multiphase corrosion scales that may show relatively high oxygen activities, low melting mixtures of

metal chlorides and oxy-chlorides may be present. Alkali chlorides NaCl and KCl form with  $\text{CrCl}_2$  various ternary eutectics in the temperature range of about from 604 °C to 548 °C.

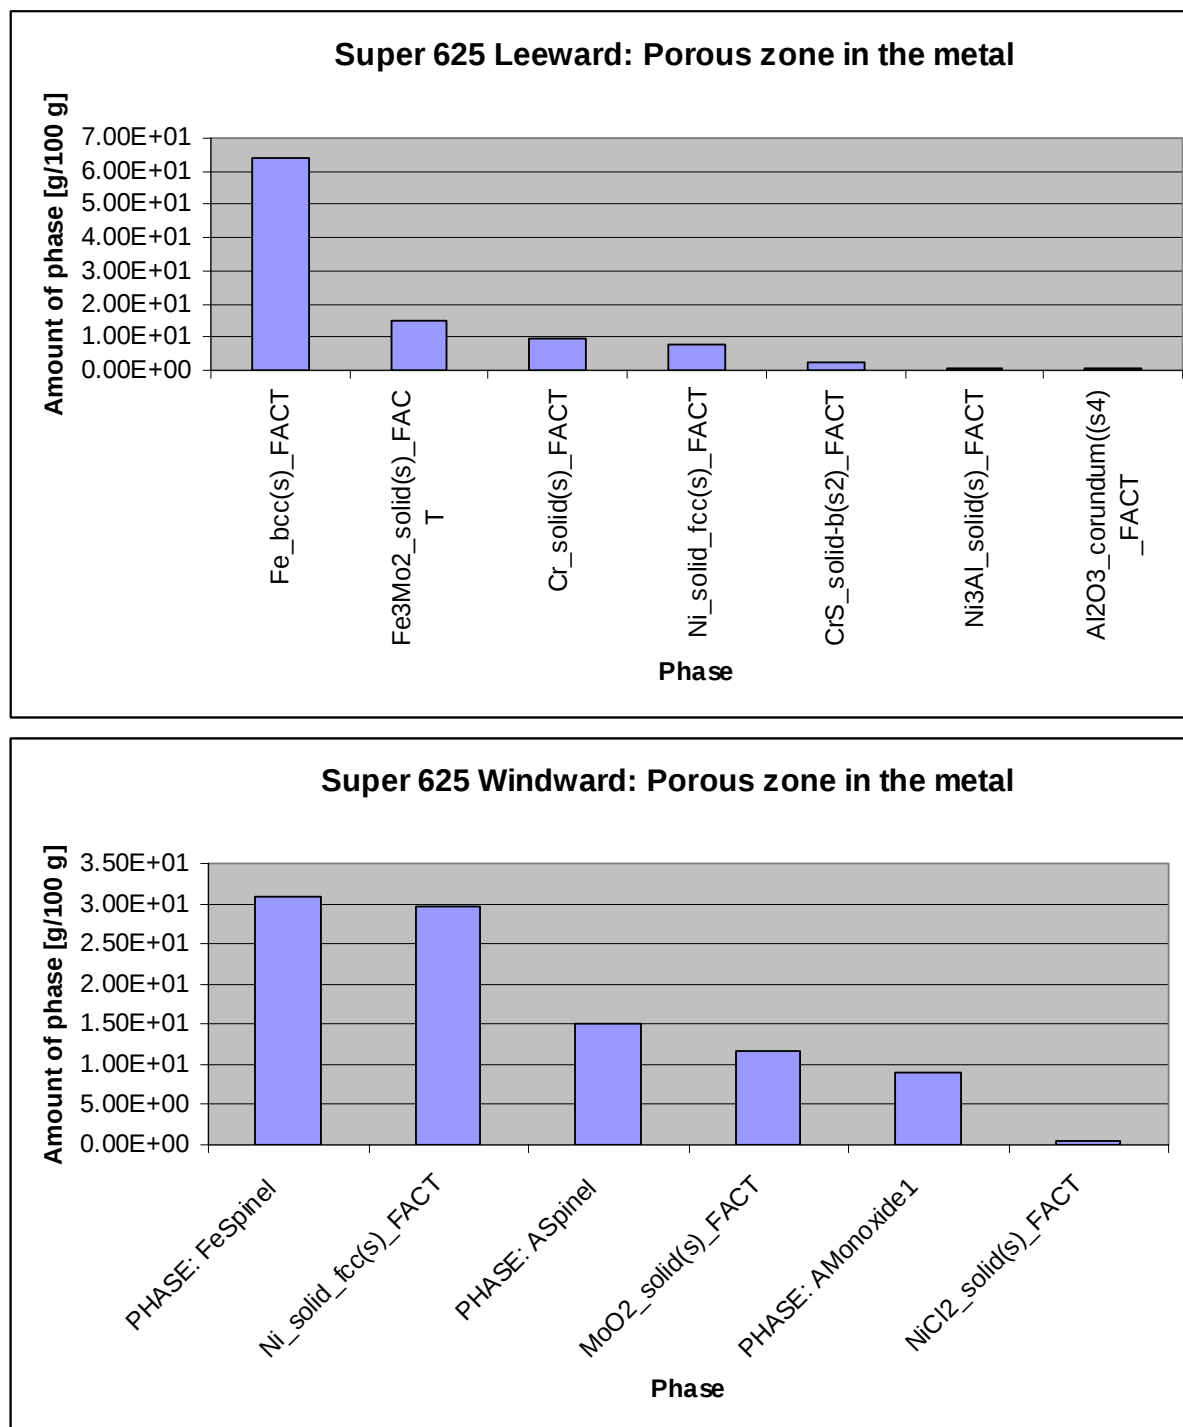
Figure 14. Calculated phase composition that corresponds to an areal analysis of porous (de-alloyed) zone on the Windward side (top picture) and Leeward side (bottom picture) of sample Super 625. Transport of oxygen and sulphur via molten phases inward may not readily occur (according to the prediction). Chlorine, if present, is bound as a solid compound  $\text{NiCl}_2$ . (Phase equilibrium calculated for the temperature of 542 °C.)

In the case of Super 625 (Fig 14) no molten phases were predicted to be present in the porous zone within the metal at an equilibrium temperature of 542 °C applied. On the windward side some chlorine together with a relatively high amount of oxygen was analysed. Chlorine was,

however, bound as a solid compound  $\text{NiCl}_2$  with moderate vapour pressure at high material temperatures of recovery boiler superheater tubes.  $\text{NiCl}_2$  form low-melting eutectics with  $\text{NaCl}$  and  $\text{KCl}$  at temperatures about of 563 °C and 494 °C, for  $\text{NaCl}$  and  $\text{KCl}$ , respectively. In the system  $\text{KCl-NiCl}_2$  there exists also a peritectic melting temperature about of 502 °C.

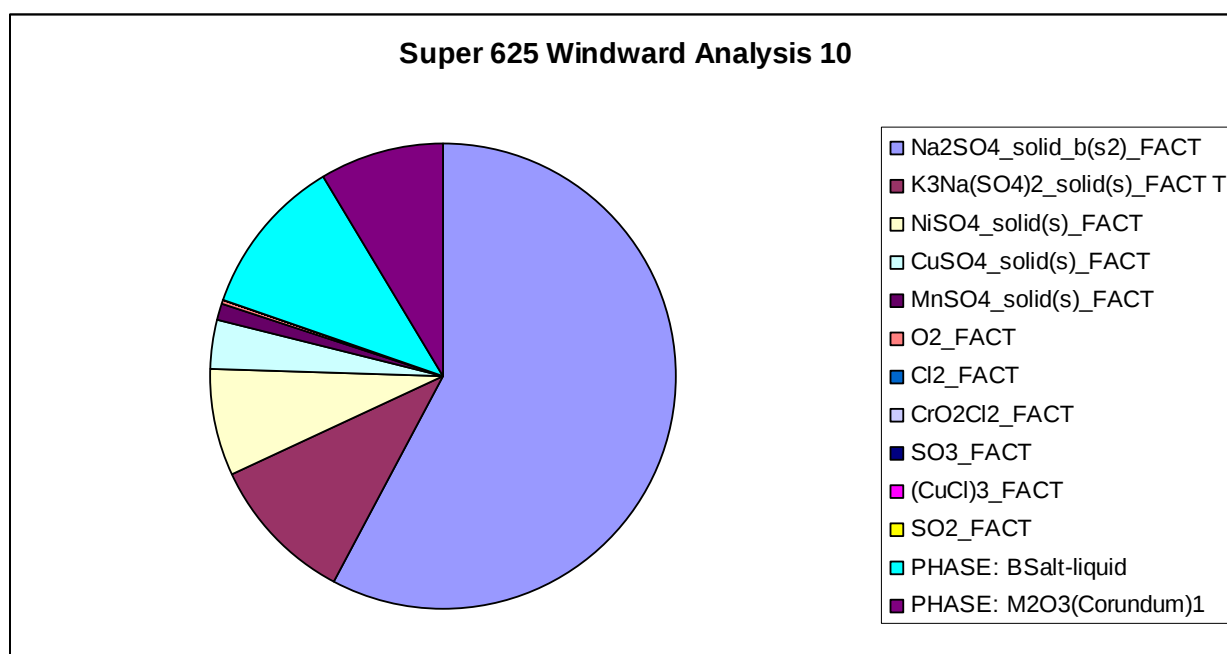
Figure 15. Calculated phase composition that corresponds to an areal analysis of corrosion scale/deposit on Windward side of Super 625 (top picture); the equilibrium state predicted is obviously non-physical due to high partial pressure of gaseous species  $\text{SO}_3$  and  $\text{Cl}_2$ .

This situation may be explained (i) by incomplete local reaction equilibrium amongst oxygen, sulphur and chloride species actually present and (ii) some amount of carbonate (and hydrogen) in the true elemental composition. The short operation cycle of proximate soot blowers makes it plausible that a non-equilibrium state is rather characteristic for the deposit conditions prevailing on the leeward- and up-side of the probe. Catalytic activity of various transition metal and trace metal species may cause that various kinetically restricted reactions advance towards equilibrium immediately on the tube outer surface (on/within the corrosion scale) and eventually in the permanent deposits.

From the corrosion point of view the actual ranges of partial pressure of chlorine and oxygen are of special importance. Phase equilibrium for Super 625 windward side analysis (analysis No 10), Figure 15, was recalculated assuming that some carbonate is actually present. Calculations were for qualitative purposes only; calculation results are thus not given here in more detail. Equilibrium amounts of various metallic chloride and oxy-chloride species were recorded in the phase equilibrium partial volume corresponding to the partial pressure range of gaseous chlorine ( $p\text{Cl}_2$ ) from  $10^{-17}$  atm to  $10^{-5}$  atm were noted. Transition metal chloride species of interest in the corrosion mechanism, that of active oxidation in particular, were found to be  $(\text{CuCl})_3(\text{g})$ ,  $\text{NiCl}_2(\text{g})$  and  $\text{NaFeCl}_4(\text{g})$ . Partial pressure of chromium oxy-chloride species  $\text{CrClO}_2(\text{g})$  did become important but above the  $p\text{Cl}_2$  range of  $10^{-5}$  atm. The molten

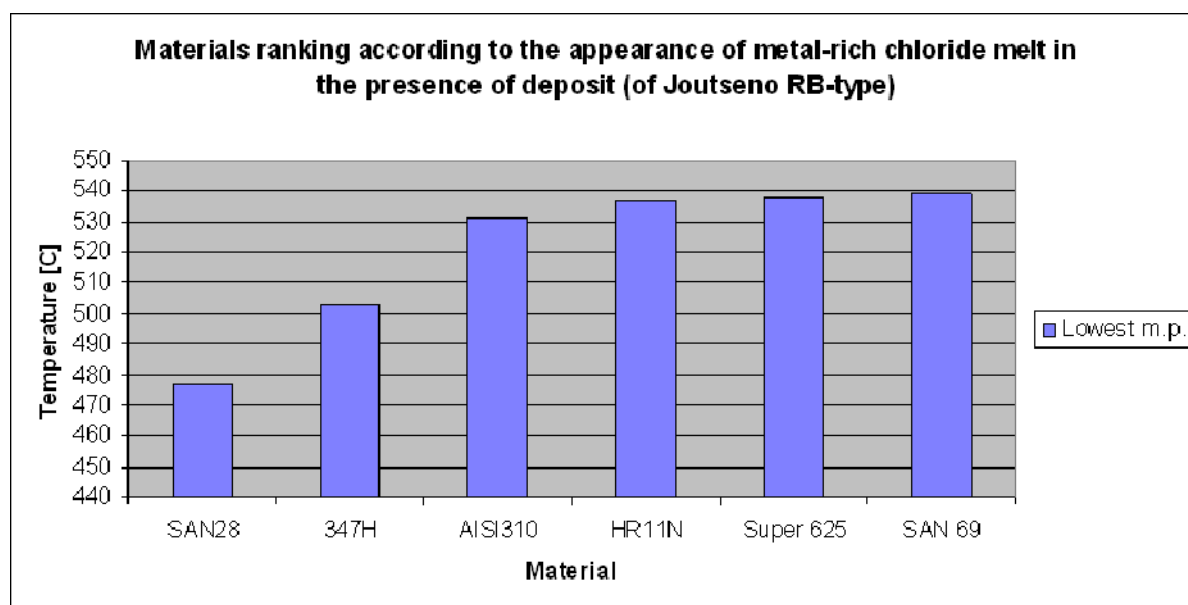
In order to be able to study corrosion behaviour in a more generalised manner superheater deposit analyses relevant to Joutseno Recovery Boiler were referred to, [16, 17]. In the model calculations each of the six materials tested was exposed to the same model deposit with the content of chloride, potassium and carbonate in the range of 0.5 wt-% Cl, 5 wt-% K and 1.5 wt-% C, respectively. Equilibrium temperature was used as a variable. Oxide scale growth rate was considered to increase steeply at a limiting temperature above which a model melt with some content of transition metals elements of the alloy may co-exist with an oxide scale. In most cases studied such model melts did contain transition metal chlorides. It is interesting to note that sodium chromate ( $\text{NaCr}_2\text{O}_4$ ) was a rather stable species. If one assumes that the ranking order of the materials in the deposit conditions in question is the same as the order of the limiting temperatures obtained by calculation, one gets a ranking order like the one shown in Figure 16 below. The model ranking is similar to the ranking according to maximal corrosion attack observed, Figure 17.

Figure 16. Calculated lowest temperature where a transition metal chloride-rich melt may exist within oxide scale in the presence of deposit of Joutseno recovery boiler type containing some carbonate. Transport of metal, sulphur, oxygen and chlorine ions is predicted to occur readily above the alloy-specific temperature indicated on the left axis.

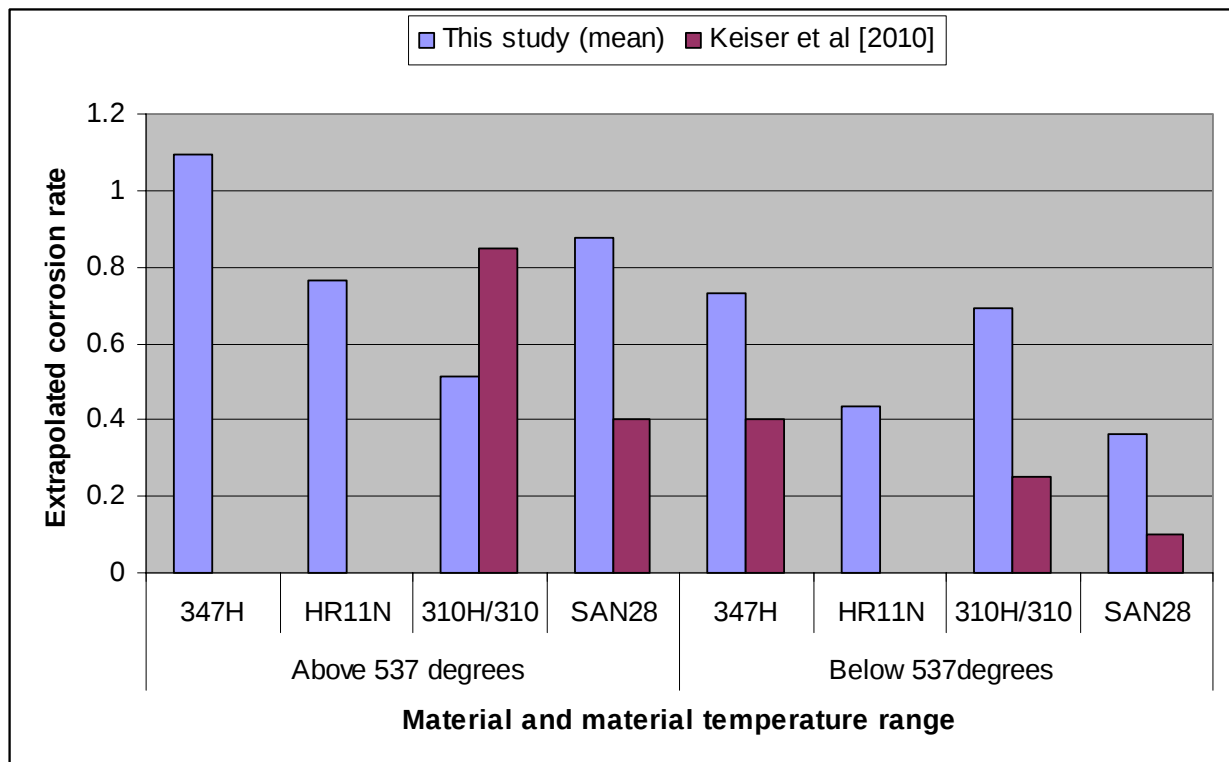
Figure 17. Schematic presentation of extrapolated corrosion data applied from two different sources. Experimental exposure time in RB superheater area in each case is as follows. This study: 600 h; Keiser et al [2010]: 1000 h.

Extrapolated corrosion rate for the same type high chromium alloys materials is found to be lower after the exposure time of 1000 h [9] compared to that of 600 h (this study). Related deposit chemistries are presented in Figure 18 and the lowest melting temperature of deposits respectively in Figure 19.

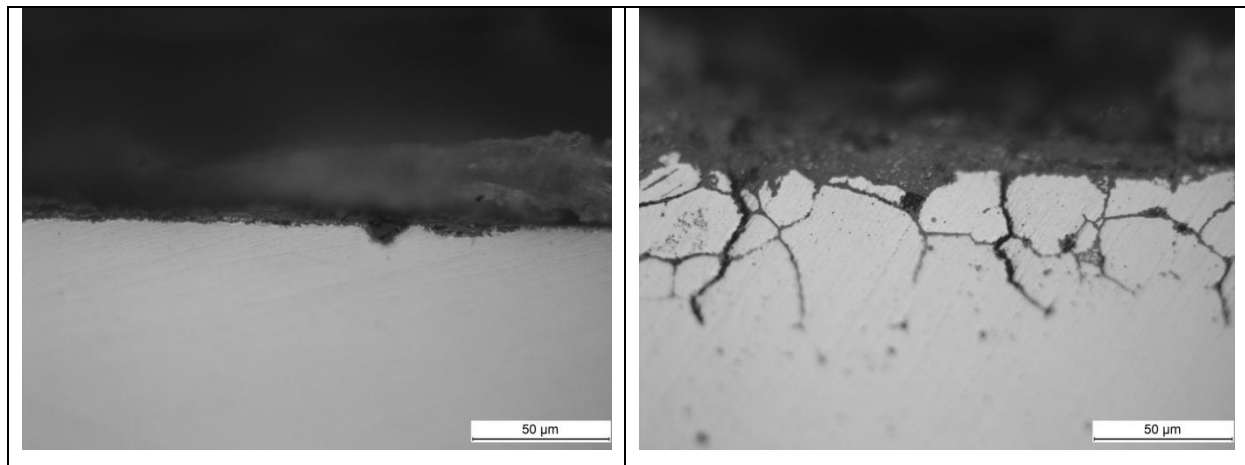
Figure 8. Cross sectional views of the material 347H exposed in the Probe 1: Windward position ( $T: 526^{\circ}\text{C}$ ), left picture; Leeward position ( $T: 487^{\circ}\text{C}$ ), right picture. Un-etched specimen. Temperature values are tentative, in average values.

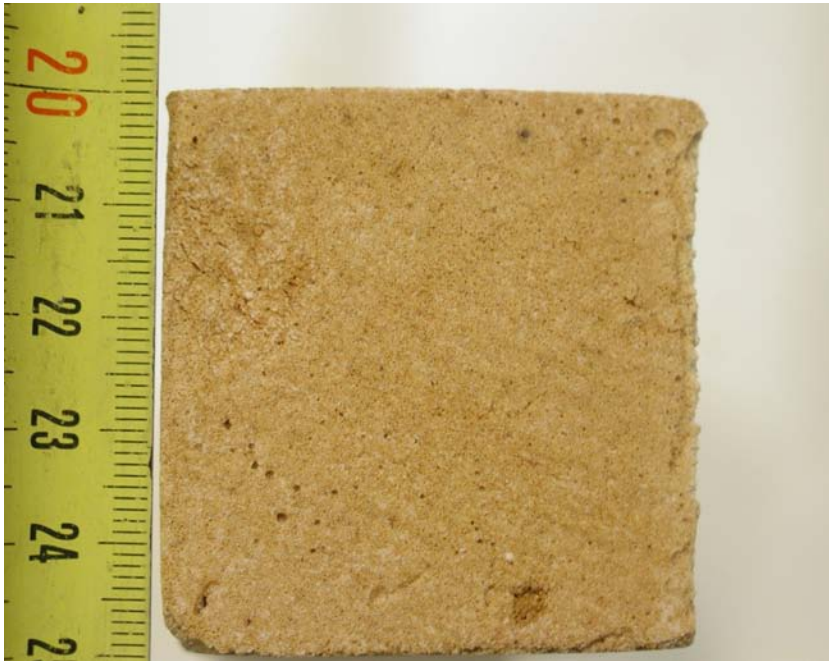
Kuva1. Oma massa kokeessa1. Syntetisoitu forsteriitti. Tehty kiinalaisesta magnesiasta ja nilsiän kvartsista. Sidokseen käytettiin kolloidista silikaa sekä puhdasta erittäin hienorakeista magnesiumoksidia. Synteesi tehty 1500°C 2h. Mittoja 50x50x150mm. Poltossa hieman käyrästynyt ja halkeillut.

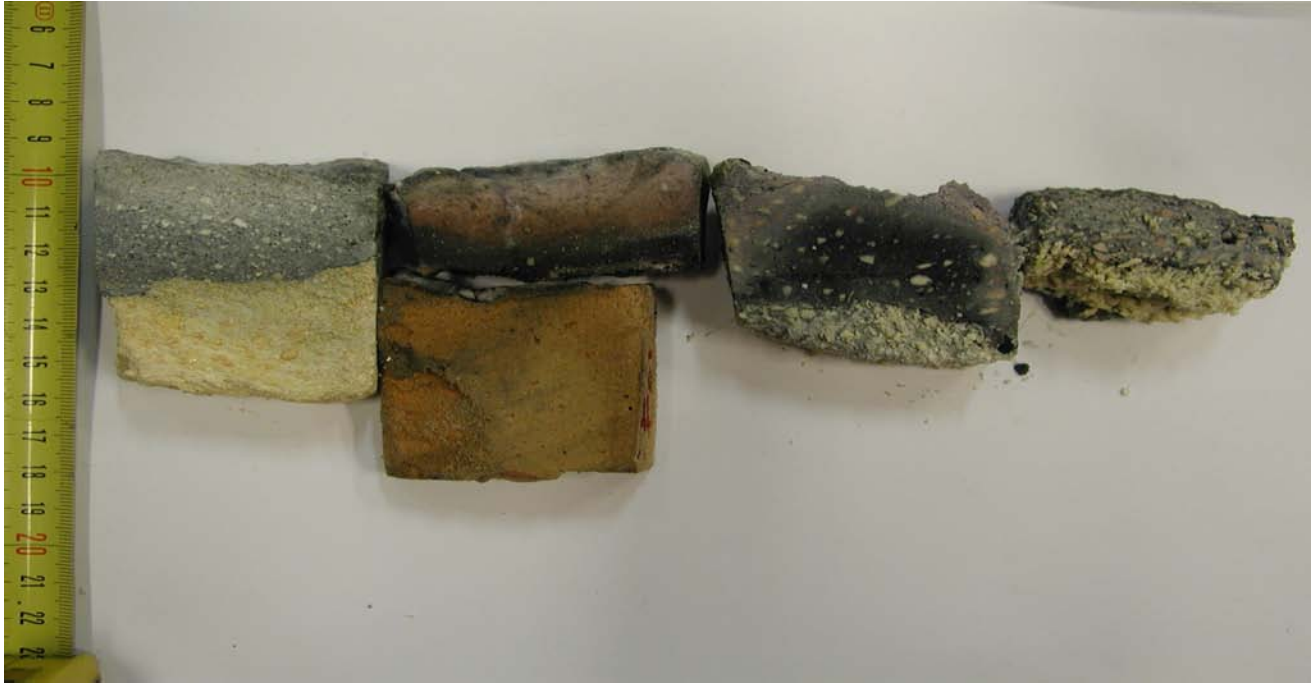
Kuva 9. Testissä 1 huonoiten menestyneet. Ei paljoa raportoitavaa.

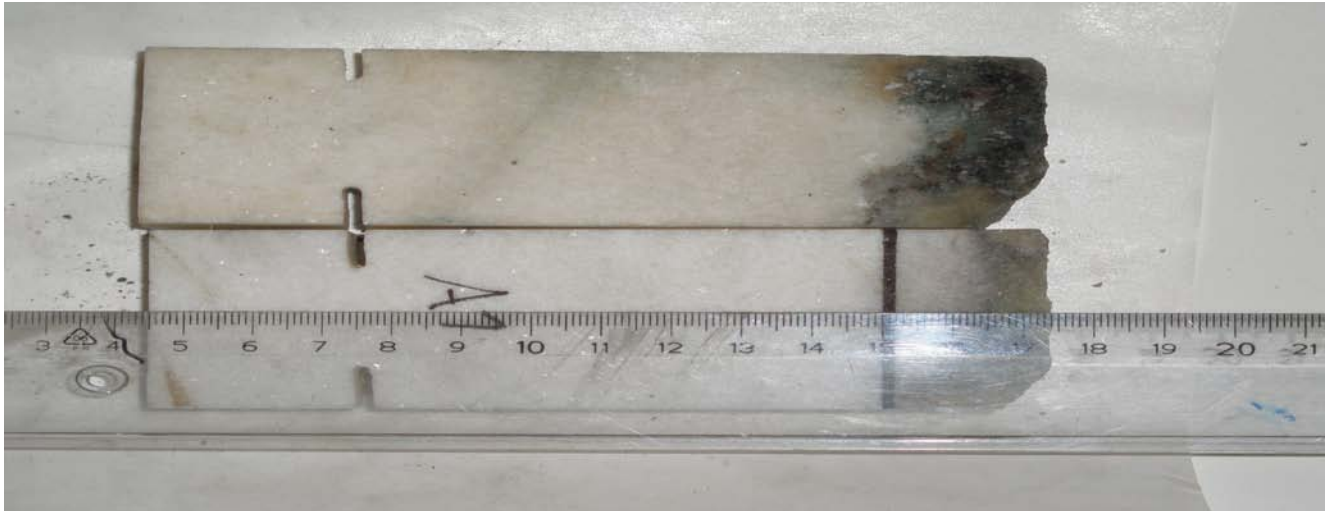
Kuva 6. Sulavalettussa aloksitiilessä ei näytä olevan kovin paljoa tunkeutumista, toisin kuin samassa kappaleessa eri puolella soodakattilaa, mutta osa tiilestä on ilmeisesti lohjennut pois testin aikana.

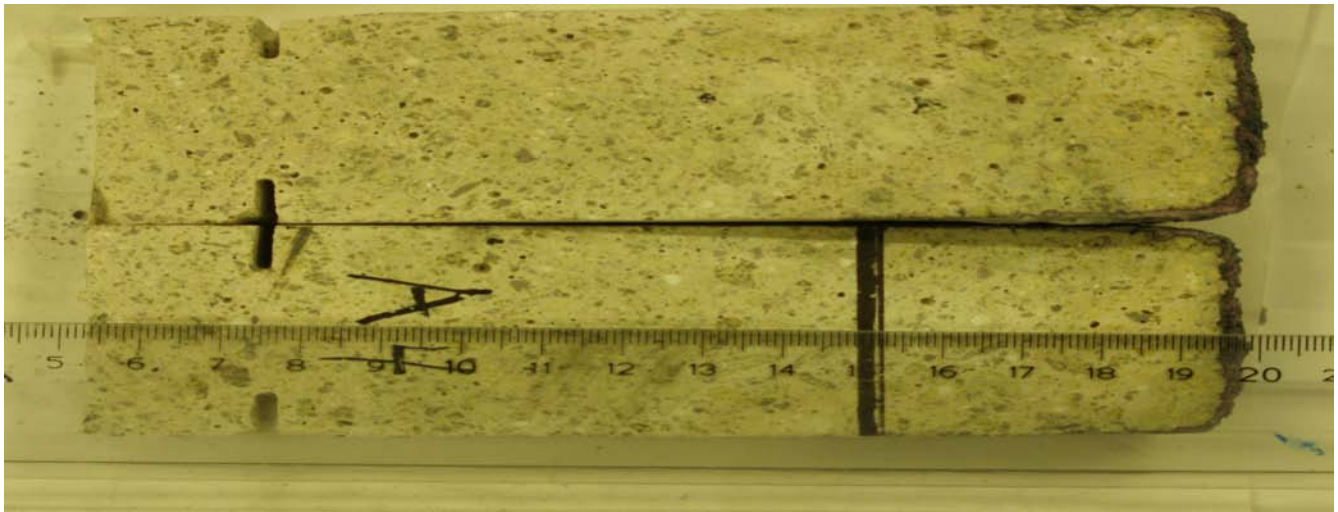
Kuva 8. Hassle D39A ei sula juurikaan tunkeudu. Kulumisprofiili on tasainen.

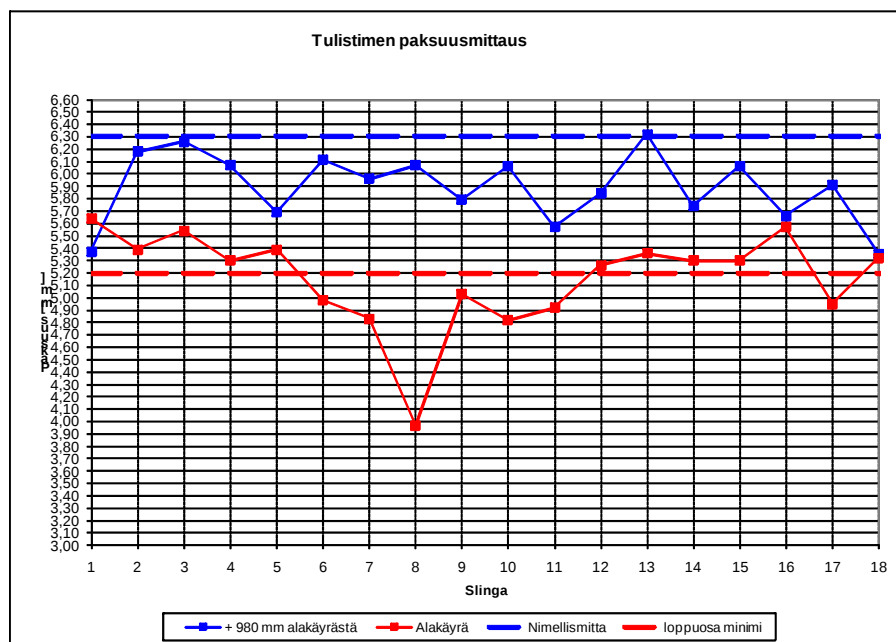
Kuva 2. Tulistimen paksuusmittaustulokset kaaviona.

Kuvassa punainen suoraviiva kuvaa kohteen laskennallista minimiä. Ennen paksuusmittauksien suorittamista on kyseisen kohteen kriittiset rajat selvitettävä tarkastuksien vetäjille ja ennen kaikkea mittauksia suorittaville henkilöille, jotta alimittaisuudesta saadaan välittömästi tieto kattilanomistajalle.

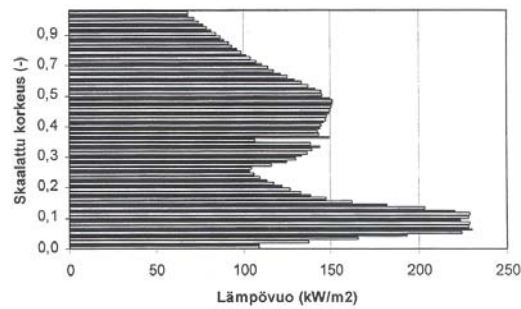
Vetyhyökkäysriski on pahin siellä, missä lämpökuorma on suurin. Kuvassa 7 on lämpövuon jakautuminen etuseinän keskellä primääritason alapuolelta nokan tasolle kattilassa, jossa perinteisesti laskettuna keskimääräinen lämpövuoto 90  $\text{kW/m}^2$ . Kuvan mukaan primaari-ilma-aukkojen alueella lämpövuoto ylittää 230  $\text{kW/m}^2$ .

**Kuva 7.** Lämpövuon jakaantuminen kattilan etuseinällä.
