## **LIITE 2**

### **Tuntiseuranta ja kassavirta**

**SKYREC/KTR: Characterisation of probe test samples exposed to BLRB  
lower furnace environments, VTT – draft report 26.11.2012**

# Characterisation of probe test samples exposed to BLRB lower furnace environments

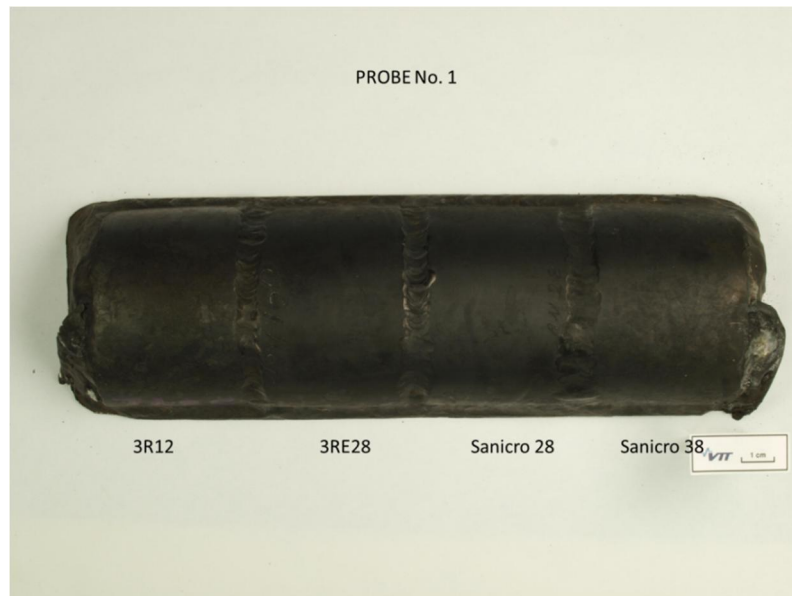
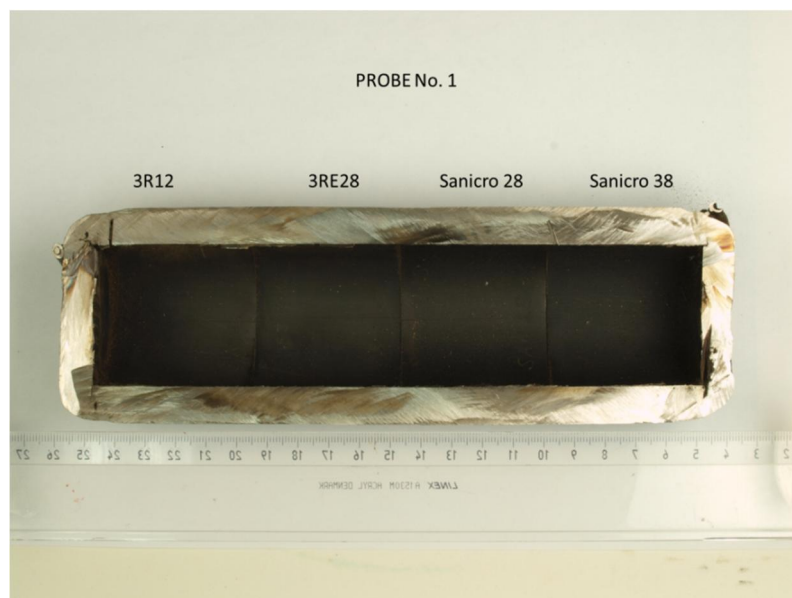
Figure 3. Macrographs taken from the probe No. 1 head after exposure: a) outer surface exposed to the furnace side and b) inner surface exposed to the cooling liquid.

Total test duration of the test No. 1 was 1006 hours from which 906 hours at the target temperature of 440 °C. The test materials in this exposure were 3R12, 3RE28, Sanicro 28 and Sanicro 38, Figure 3. According to visual inspection all samples were in good condition after testing i.e. neither marked general or localised corrosion nor deposits or oxide scales were observed either on outer or inner surfaces.

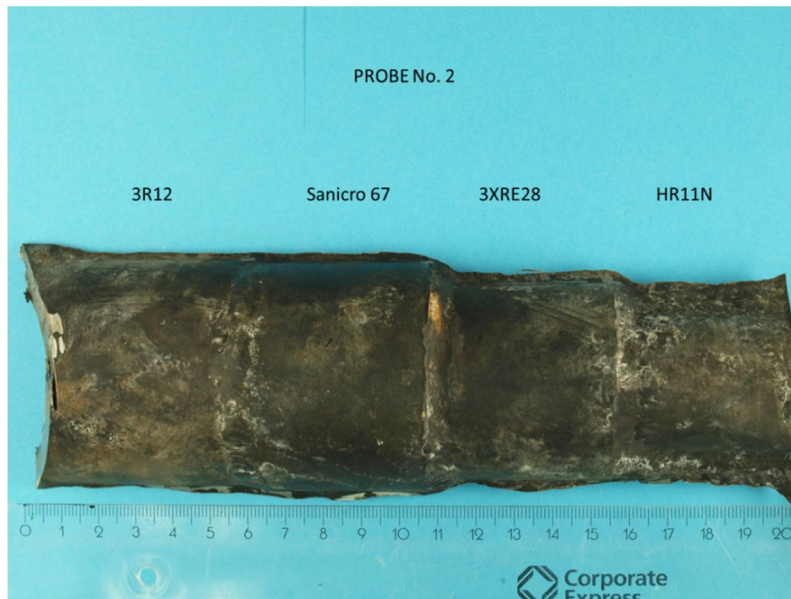
Figure 15. Macrographs taken from the probe No. 2 head after exposure: a) outer surface exposed to the furnace side and b) inner surface exposed to the cooling liquid.

Total test duration of the test No. 2 was 1023 hours from which 744 hours at the target temperature of 440 °C. The test materials in this exposure were 3R12, 3XRE28, HR11N and Sanicro 67, Figure 15. According to visual inspection the inner surfaces of the specimens were in good condition after testing i.e. neither marked general or localised corrosion nor deposits or oxide scales were observed. The outer surfaces of the specimens appeared to be in good condition but the thin dark and white deposits on the surfaces hindered accurate examinations.

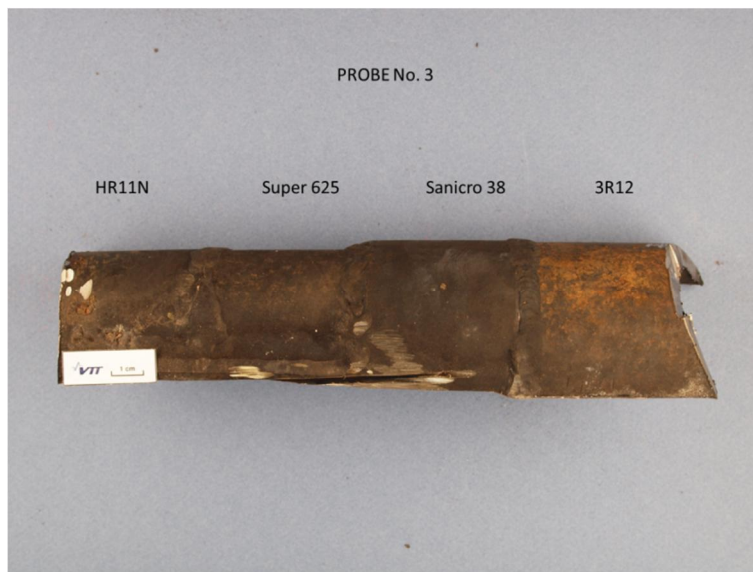
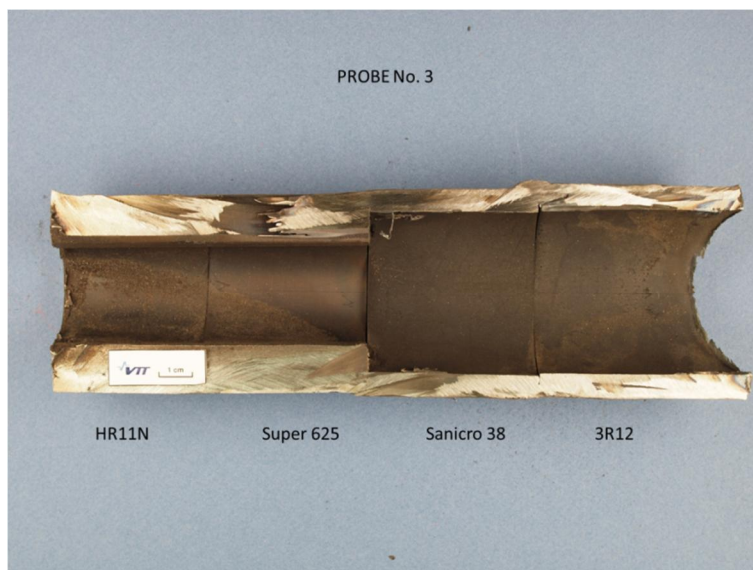
Figure 27. Macrographs taken from the probe No. 3 head after exposure: a) outer surface exposed to the furnace side and b) inner surface exposed to the cooling liquid.

Total test duration of the test No. 3 was 1250 hours from which 750 hours at the target temperature of 430 °C. The test materials in this exposure were 3R12, HR11N, Sanicro 38 and Super 625, Figure 27.

According to visual inspection the inner surfaces of the specimens were in good condition after testing. Some deposits were observed on the inner surfaces but based on their appearance they originate from the probe cutting conducted after the probe has been removed from the boiler. The outer surfaces of the specimens were covered with dark and brown deposits but appeared to be in good condition.

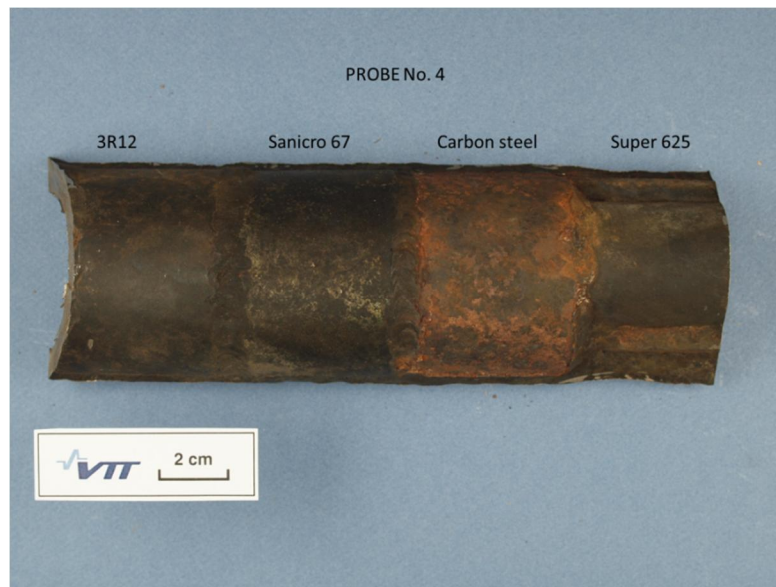
*Figure 39. Macrographs taken from the probe No. 4 head after exposure: a) outer surface exposed to the furnace side and b) inner surface exposed to the cooling liquid. A thermocouple soldered on the side surface of carbon steel specimen is clearly visible on inner surface.*

Total test duration of the test No. 4 was 2700 hours from which 2154 hours at the target temperature of 440 °C. The test materials in this exposure 3R12, carbon steel, Sanicro 67 and Super 625, Figure 39.

According to visual inspection the inner surfaces of the specimens were in good condition after testing. The outer surfaces of the 3R12, Sanicro 67 and Super 625 specimens were covered with thin dark deposits but appeared to be in good condition. The carbon steel specimen was heavily corroded.

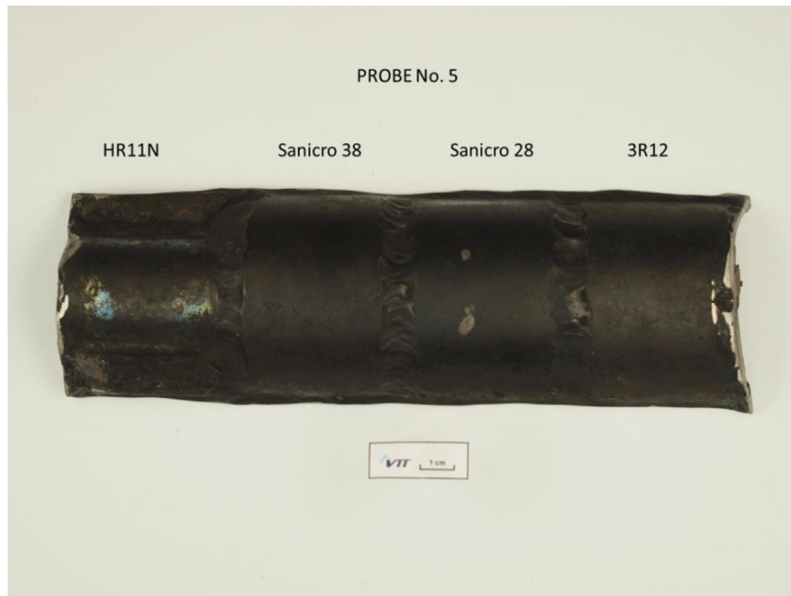
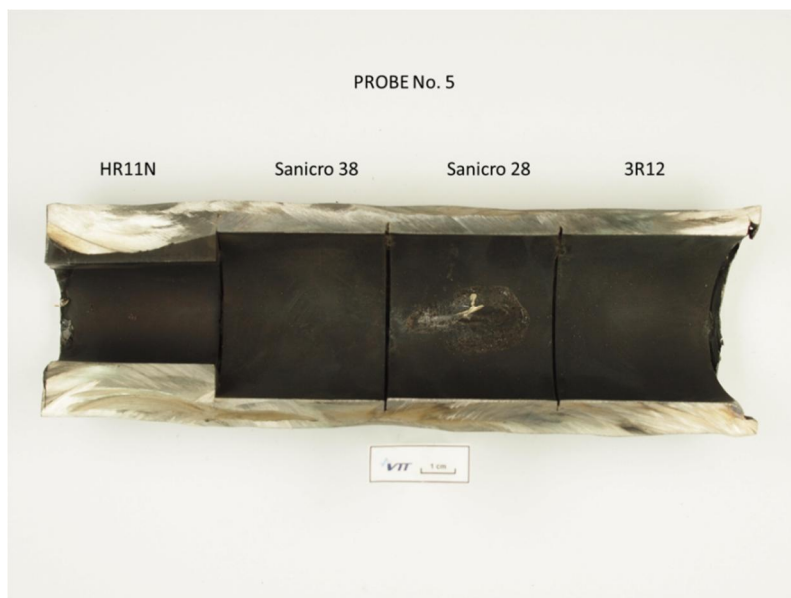
*Figure 51. Macrographs taken from the probe No. 5 head after exposure: a) outer surface exposed to the furnace side and b) inner surface exposed to the cooling liquid. A thermocouple soldered on the middle of Sanicro28 specimen, that hindered WT measurements after exposure, is clearly visible on inner surface.*

Total test duration of the test No. 5 was 2630 hours from which 2157 hours at the target temperature of 440 °C. The test materials in this exposure were 3R12, Sanicro 28, HR11N and Sanicro 38, Figure 51. According to visual inspection all samples were in good condition after testing i.e. neither marked general or localised corrosion nor deposits or oxide scales were observed either on outer or inner surfaces.

The results of the wall thickness profile measurements and the wall thinning curves derived from them for 3R12, HR11N and Sanicro 38 are presented in Figures 52...57. The results showed that marked wall thinning had taken on the 3R12 specimen. Some wall thinning was observed also on the Sanicro 38 specimen and locally also on the HR11N specimen. The WT profile measurements for the Sanicro 28 sample after the test failed due to the thermocouple that was soldered on the inner surface of the specimen (Figure 51b).

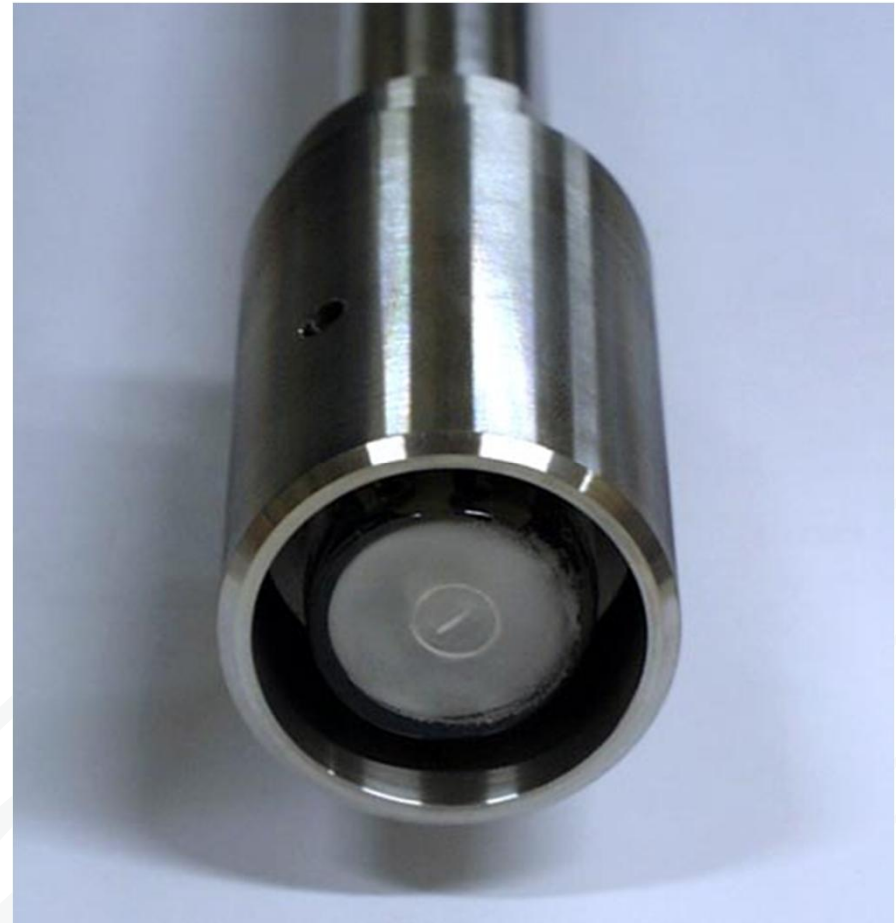
### 3. Dew point measurement

- Dew point probe (Land)
- Two electrodes in the probe tip
- Probe tip cooled with pressurized air
- When dew point reached, water or acid, a current is detected

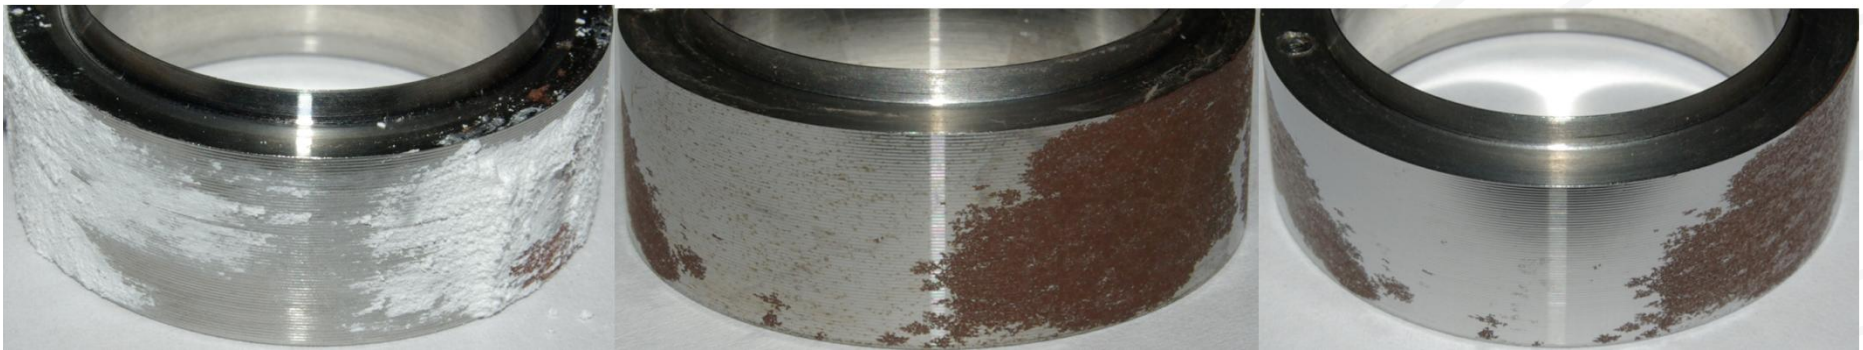
# Ring after 811h normal operation

30s acid wash

Note: Side pointing downwards (gravimetrically) -> No iron oxide

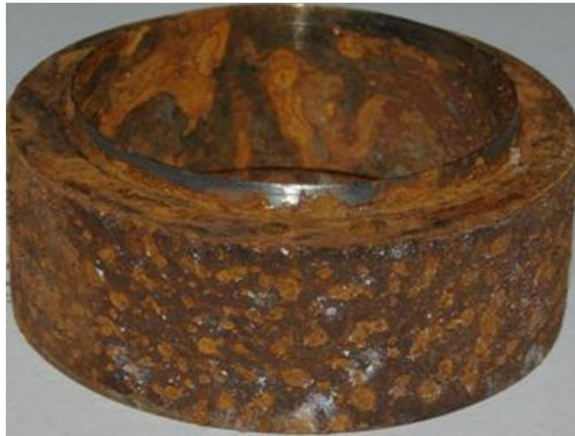
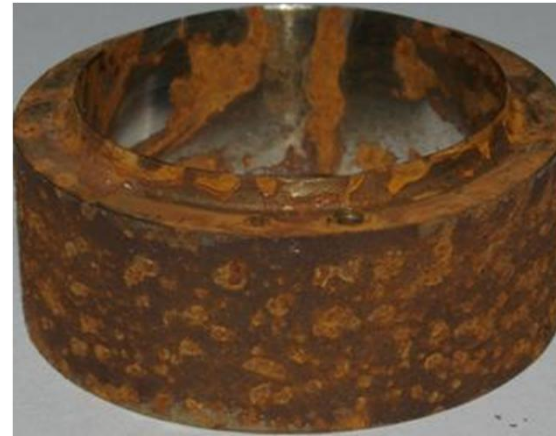
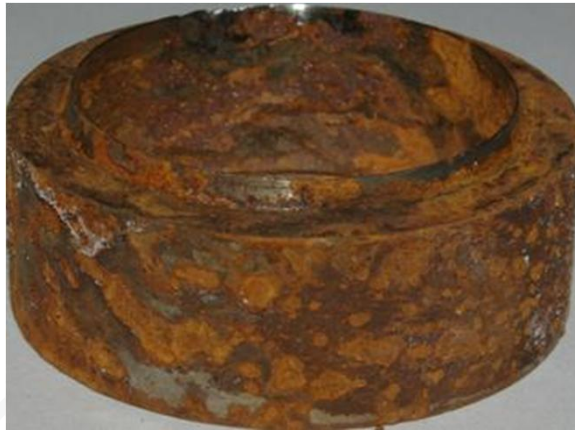
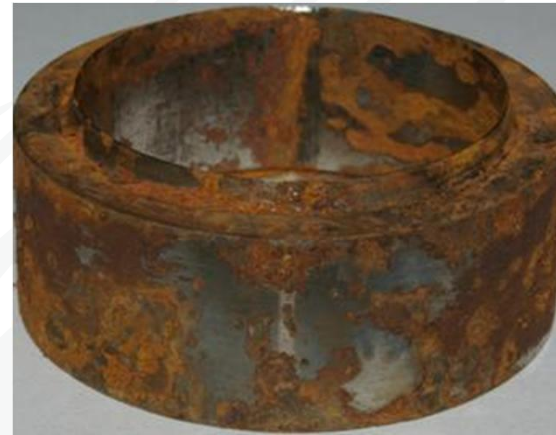
# Ring after 1124h

Again areas  
without  
corrosion  
downwards

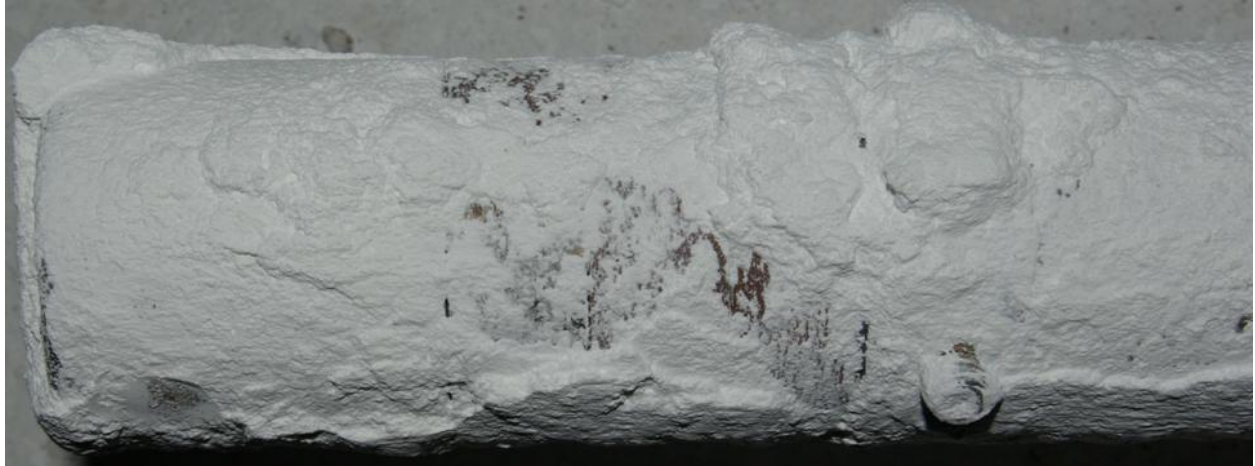
Figure 5. Probe after 811h of Normal Operation

After 811h of normal operation the probe was covered in ash, Figure 5. There was virtually no corrosion on the probe, Figure 6. What little corrosion occurred was found on the top of the probe, but not on the bottom-most edge of the probe. The probe was placed in one of the lower turns in the economizers and it is not clear which were the windward and leeward sides of the probe. The corrosion layer was pitting up to approximately 10  $\mu\text{m}$ , Figure 7. In some spots of the corrosion layer, the chloride was not balanced by alkali indicating iron chloride and chloride induced corrosion. One explanation for the combined observations of corrosion being present on the top but not bottom and the presence of chloride in the corrosion layer is that a small amount of water is dropping on the probe from the sootblowers. This would dissolve NaCl in the salt resulting in a chloride containing solution until the water evaporates. The negligible amount of corrosion seen along with the lack of sulfur in the corrosion layer indicated clearly that there is no acid dew point corrosion.

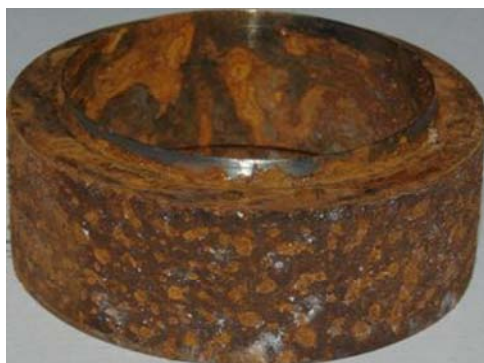
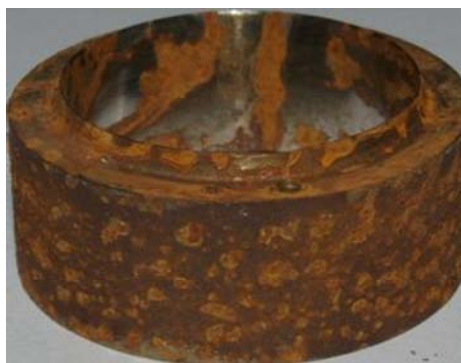
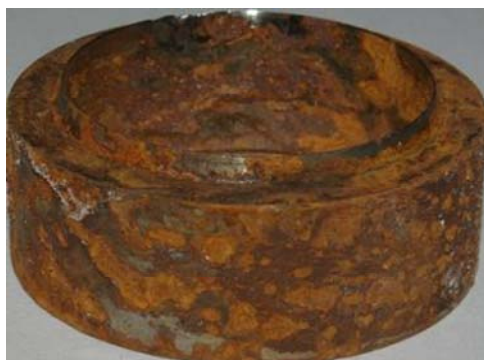
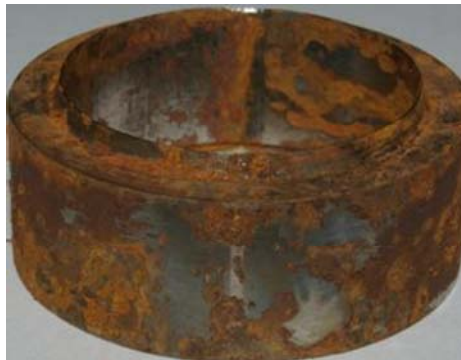
**up**      uncleaned ring

water+aceton+paper

**down**

Figure 9. Ring after 1124h. Not that there are some areas without corrosion downwards on the bottom edge of the ring.

The probe that was pulled out after the water wash, Figure 8, had more corrosion than the probe pulled out before the water wash, but there was still virtually no corrosion, Figure 9. Again, the bottommost

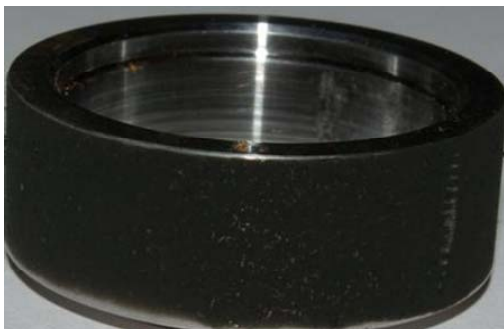
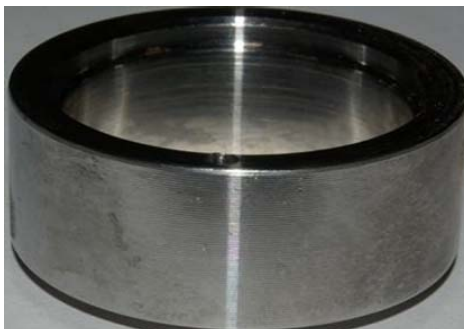
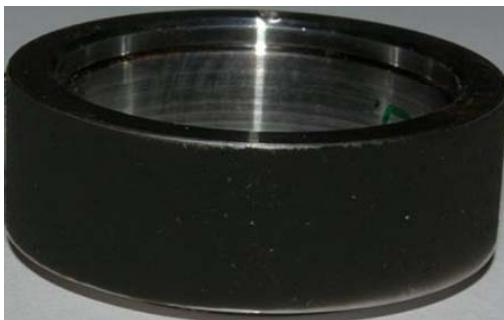
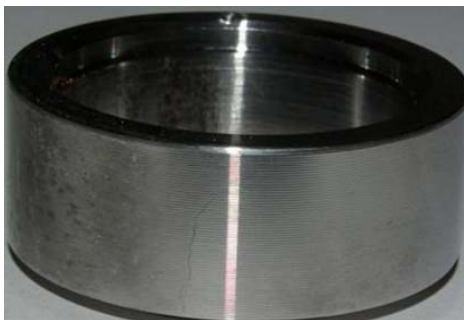
Figure 11. Ring after 2h exposure during oil burning.

uncleaned ring

water+aceton+paper

**down**

A 2h probe (90 °C) study was also made in the economizers. The probe study was carried out at the same time the measured SO<sub>3</sub> level was highest, but no corrosion was seen on the rings, Figure 11. There was clearly no acid dew point, but it is not clear why no acid dew point was seen even when SO<sub>3</sub> neared 3 ppm. Had there been an acid dew point, corrosion would have been expected in the two hour probe study.
