Suomen Soodakattilayhdistys ry

## KESTOISUUSTYÖRYHMÄN KOKOUS 1/2013

**VTT, Characterisation of probe test samples exposed to BLRB lower  
furnace environments – draft report 26.11.2012**

# Characterisation of probe test samples exposed to BLRB lower furnace environments

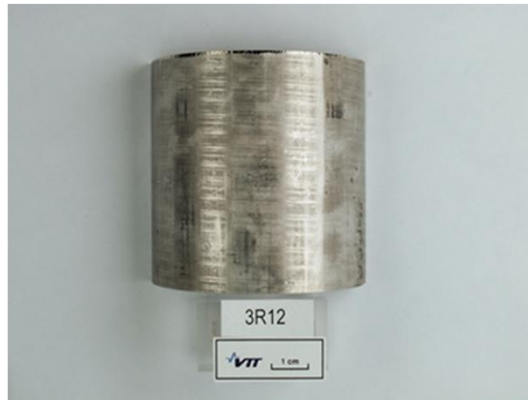
*Probe No. 2 – Specimens tested in as received condition*

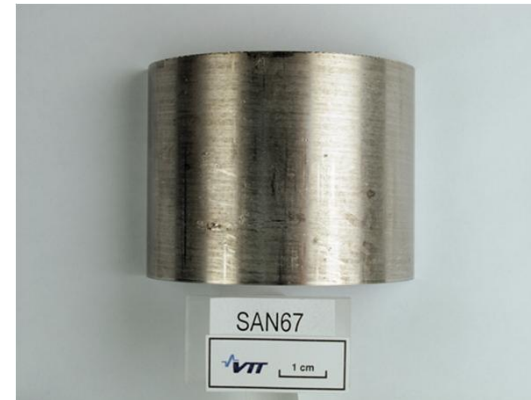
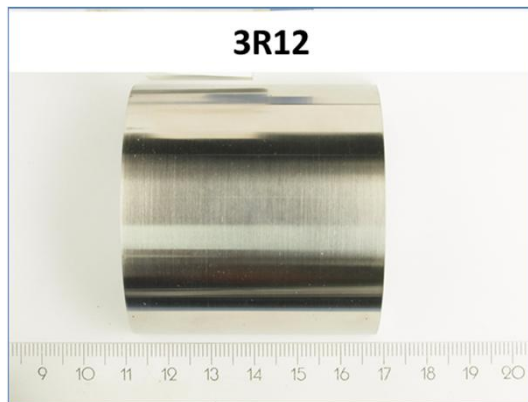
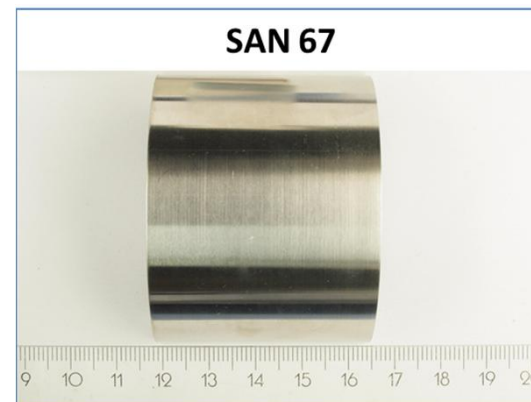
*Probe No. 4 - Surfaces machined and hand grinded/polished*

- SEM/EDS from metallographic cross sections after/before the profile measurements
  - Few analysis also from unexposed reference samples
- ✓ Tests No.1...3 - Materials tested in as received condition
- ✓ Tests No.4 and 5 - The outer and inner surfaces machined and hand grinded/polished
