# BLACK LIQUOR RECOVERY BOILER

## MINUTES OF MEETING Crowne Plaza Hotel/Atlanta Airport Atlanta, Georgia April 12, 13 & 14, 2010

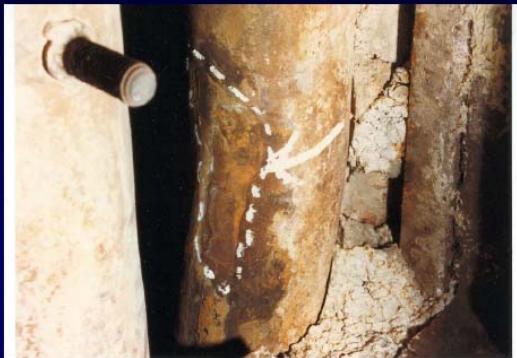
## Balding

- “Balding” (hydroxide corrosion)
- Air port and wall tube thermal cracking
- Floor tube cracking (SCC)
- Finger-Nail Corrosion (Carbon Steel)
- **Butt Weld Cracking**

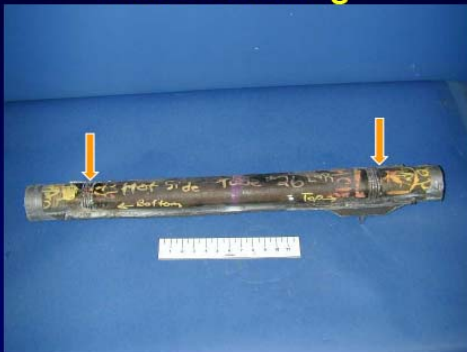
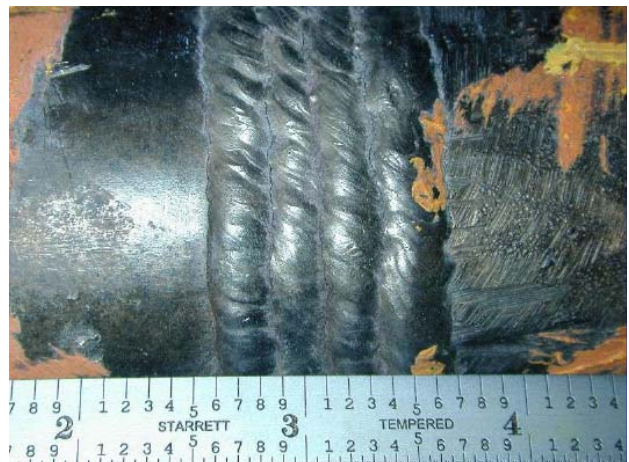
## Weld Cracking

## Case History Composite-to-Composite

## Thermal fatigue is the likely damage mechanism

- Cracking in Primary Air Port region
- Weld caps (ER309L)
  - Cracking is usually interbead
  - Can progress into carbon steel
  - High coefficient of thermal expansion SS
  - Low thermal conductivity SS
  - Susceptible welds have excessive reinforcement, > 4 mm
