BLACK LIQUOR RECOVERY BOILER

ADVISORY COMMITTEE

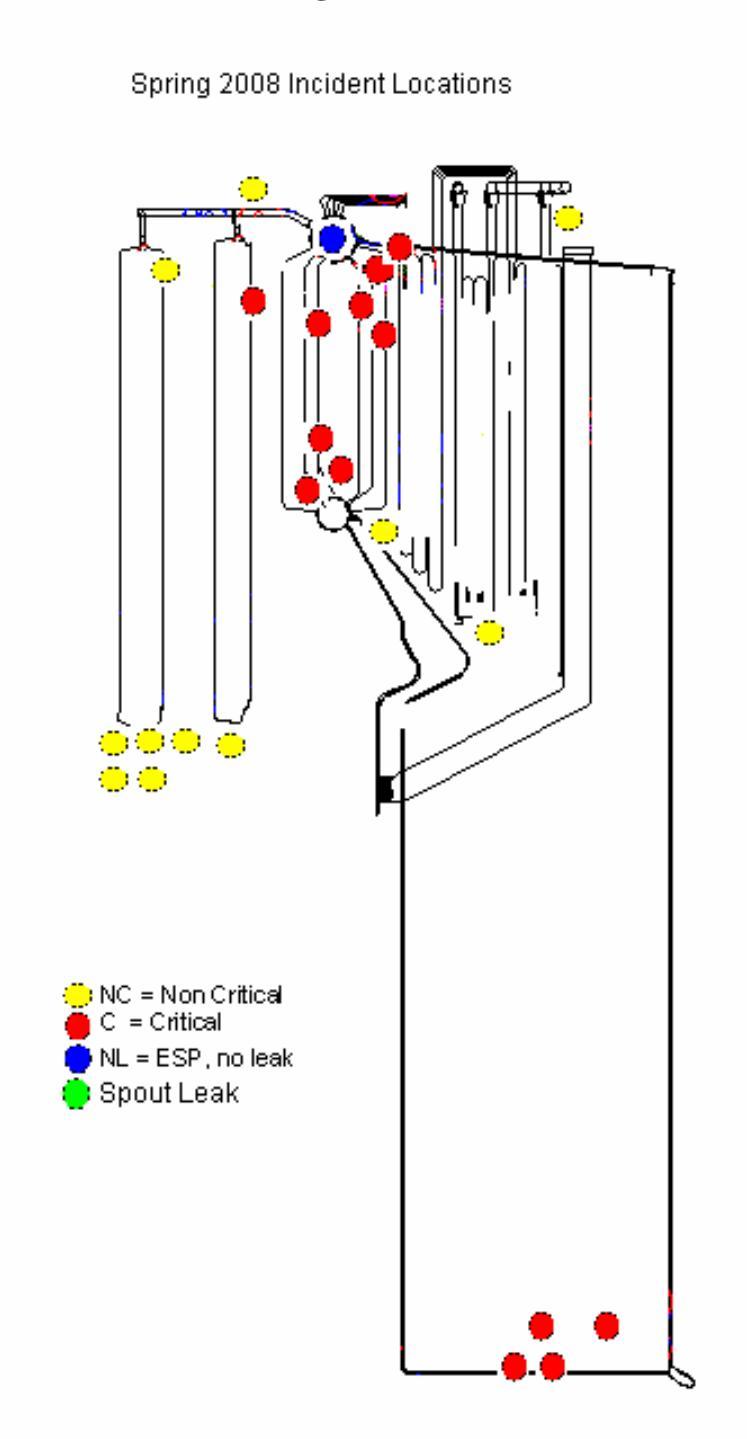
Figure 1

The general locations of the leaks for boilers in North America are shown in Figure 1, which displays a typical boiler, not representing any particular style or model. The yellow marks are the non-critical incidents, the red were listed as critical incidents and the blue mark indicates an ESP with no leak. The leaks locations are summarized as follows:

- 9 Economizer
- 2 Superheater
- 7 Boiler Bank
- 0 Furnace Screen
- 3 Wall Tubes
- 2 Floor Tubes
- 1 Smelt water reaction during a waterwash
- 1 ESP w/ no leak

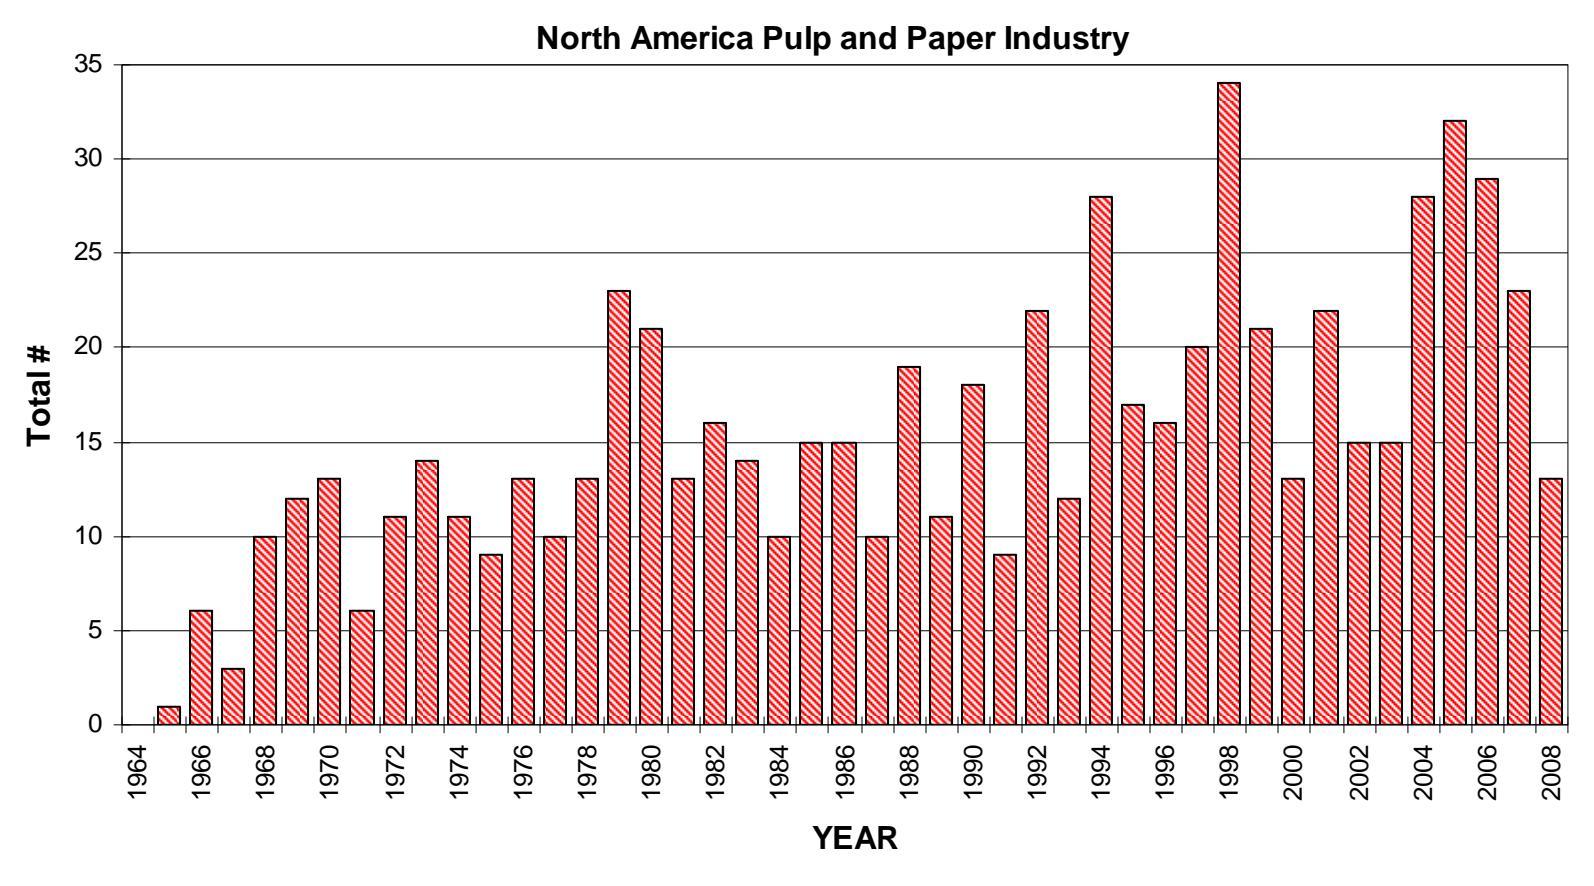
Figure 2

KRAFT RECOVERY BOILER CRITICAL INCIDENTS

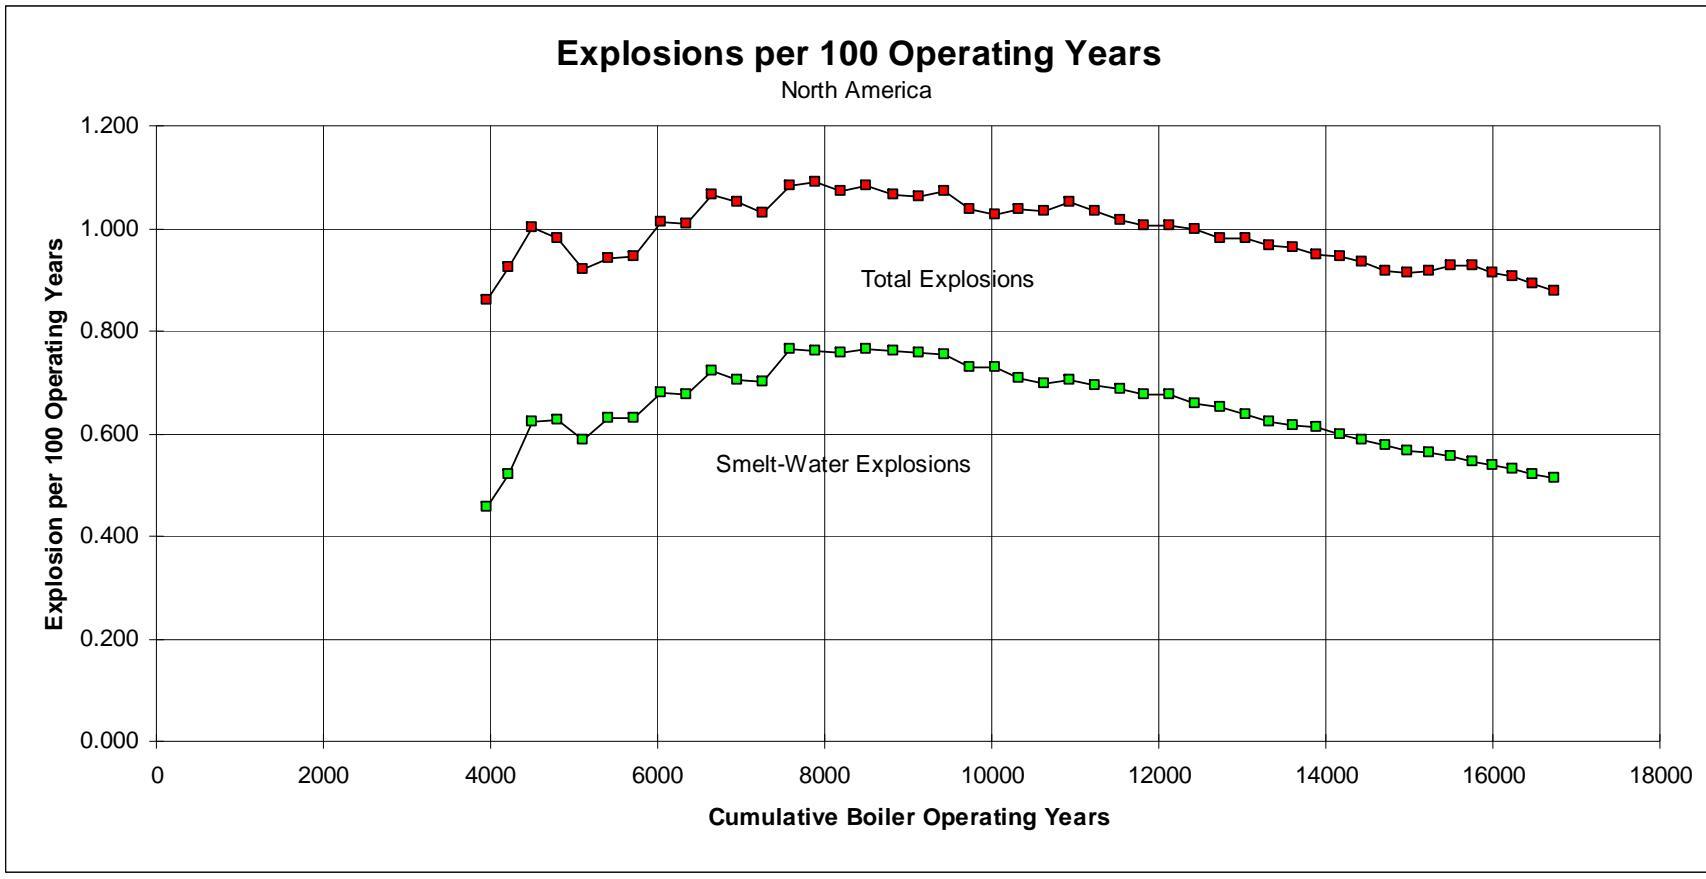
Figure 5 is a plot of explosion history per 100-boiler operating years. This is a statistical summary of the experience across the industry. The smelt water explosion experience is continuing to trend down over time and is just above 0.5 explosions per 100 boiler operating years. The total explosions, which includes dissolving tank explosions, is also starting to drop slightly at just under 0.9 explosions per 100 boiler years. The Total Explosions includes all causes combined, and is being driven by the recent dissolving tank explosions. The factor is calculated by a summation of all reported explosions since 1948 divided by a summation of the number of boilers reported in service each year during the same period. We all need to continue making the effort to keep these graphs trending down. Effort should be focused in developing better procedures to handle heavy smelt runs and plugged spouts.

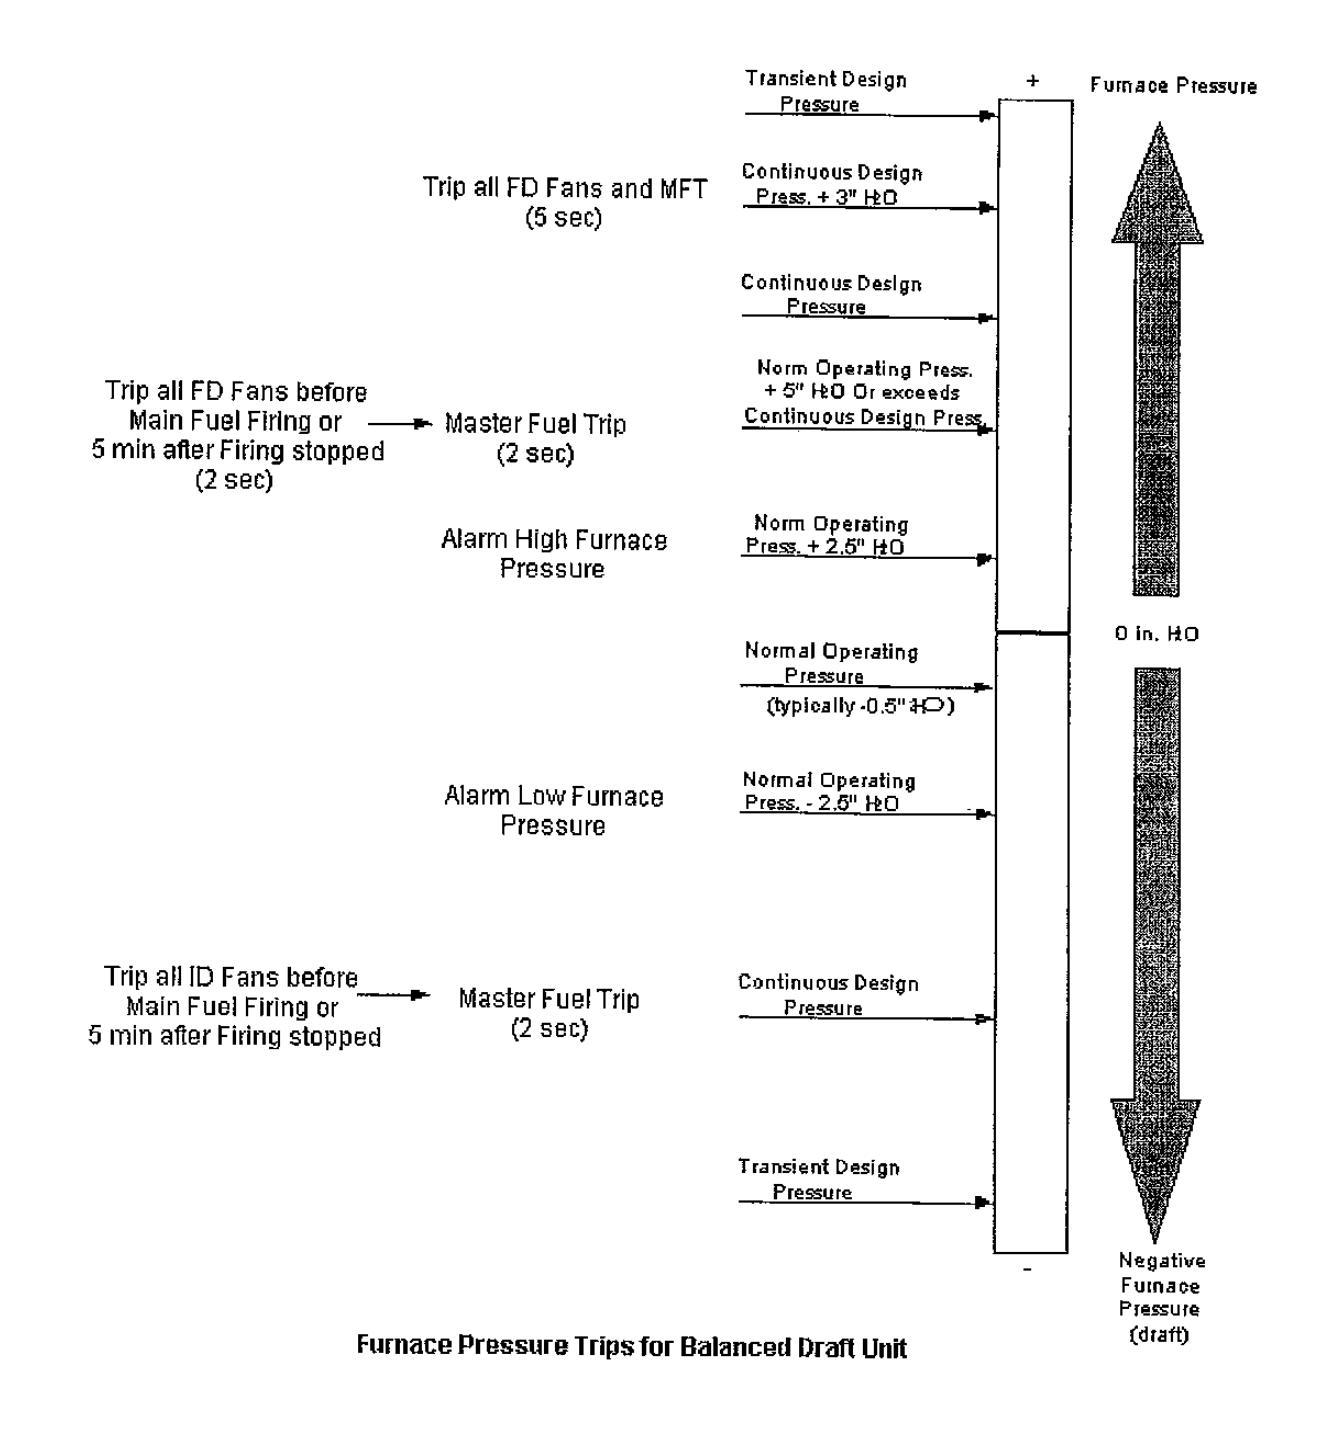
B&W's Furnace Pressure Tripping Philosophy (Cont'd.)

Another question asked via e-mail was related to the logic regarding furnace pressure (high and low) trip logic. The concern was that recommendations from manufacturers and NFPA 85 were in conflict with the Auxiliary Fuel document. Included in the e-mail was a detailed write-up from Babcock & Wilcox on furnace pressure tripping philosophy. The write-up included pressure set points for alarms and trips for both high and low furnace pressure and when master fuel trips should occur and any time delays recommended for shutting down I.D. and/or F.D fans. A pdf file of the Babcock & Wilcox write-up is included in the minutes. (See *Appendix B* -- **B&W's Furnace Pressure Tripping Philosophy**)
