SUOMEN SOODAKATTILAYHDISTYS FINNISH RECOVERY BOILER COMMITTEE

Understanding Low Temperature Corrosion in Black Liquor Combustion

Niklas Vähä-Savo, Emil Vainio, Nikolai DeMartini, Patrik Yrjas & Mikko Hupa Åbo Akademi, 14.4.2015

Raportti 5/2015

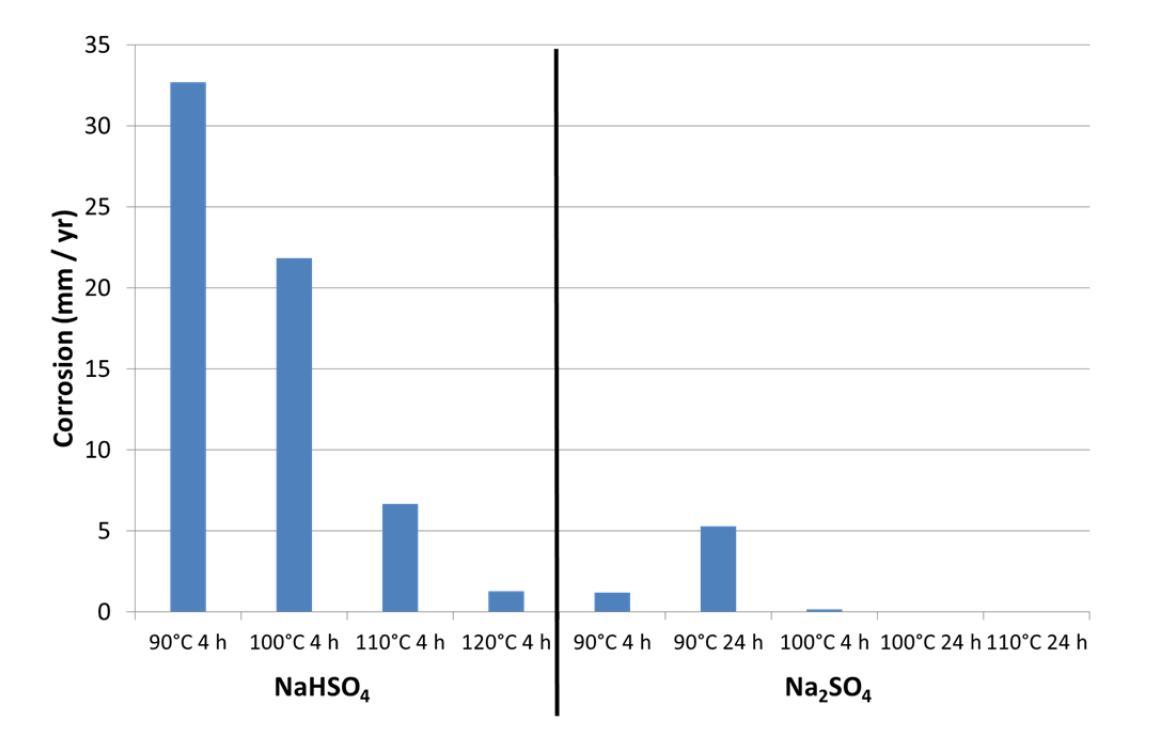
Figure 1. Calculated annual corrosion layer thickness based on mass loss after washing off corrosion layer in 4h and 24h tests.

A laboratory set-up to study low temperature corrosion was built and tested. The set-up worked as planned and stable water vapor concentrations were maintained. Corrosion of carbon steel coupons, measured as weight change, with either Na₂SO₄ or NaHSO₄ salt placed on top of the coupon was studied at the temperatures 90, 100, 110 and 120°C, Figure 1. The water vapor concentration was 60 vol% in the experiments, simulating the localized high humidity that can be seen near soot blowers. For the NaHSO₄ covered samples, pitting was found as well as an iron sulfate corrosion product, which is consistent with acid bisulfate solution corrosion. Corrosion increased with decreasing temperatures, with deeper pits at the lowest temperatures. For the Na₂SO₄ experiments, iron oxide formation was observed at 90°C and to a lesser extent at 100°C. No corrosion was observed at 110°C and 120°C under Na₂SO₄.

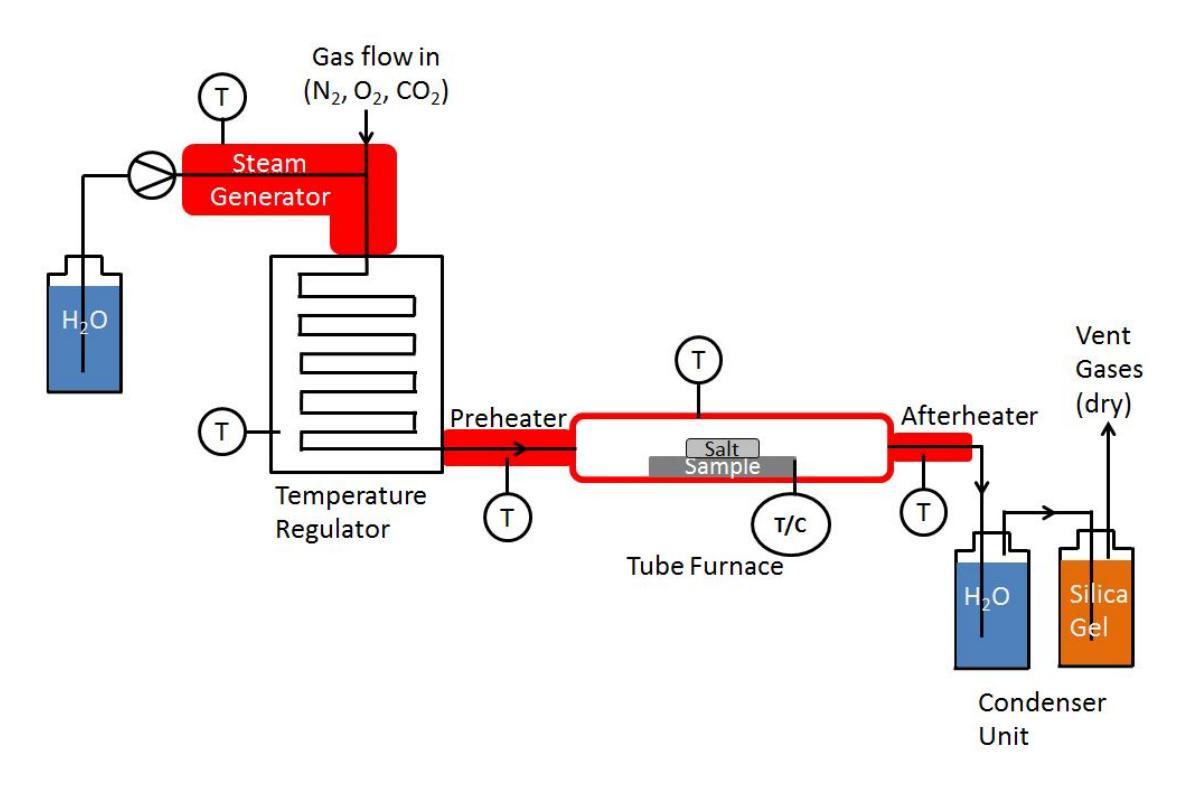
A schematic picture of the final experimental setup is shown in Figure 1. To create a constant feed of water vapor, the water is pumped with a Masterflex L/S pump at a constant flow to the steam generator. The steam generator consists of a thin pipe with heating. The temperature in the steam generator was set to 165° C in order to insure that water was vaporized at a constant rate. The hot steam was mixed with N₂, O₂ and CO₂, and the temperature of the wet gas

mixture flowed to a temperature regulator in which the temperature of the wet gas mixtures was cooled to the desired temperature. After the temperature regulator unit the wet gases flowed through a preheater before entering the quartz reactor, where the corrosion samples were placed, located in a tube furnace. The back end of the quartz reactor was heated to minimize water condensation and water from flowing back into the reactor. The wet gases exited the tube furnace to a water condenser unit where water was condensed and finally dry gases were vented out. With this setup the gas composition, gas flow, water vapor content and temperature can be easily adjusted.

Figure 1. Schematic picture of the experimental setup.

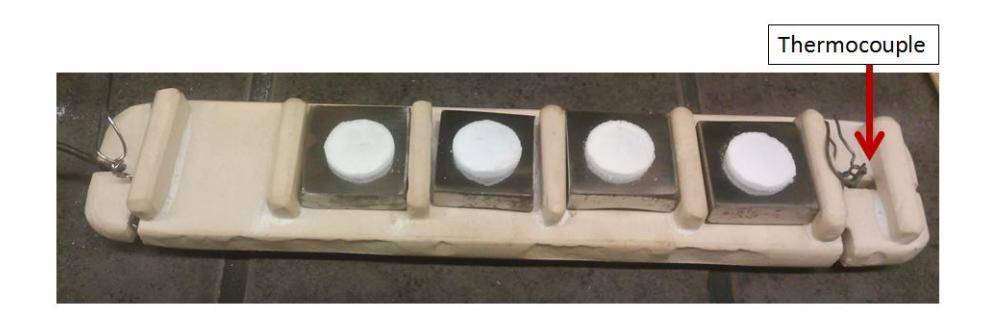
The corrosion samples were 2x2 cm coupons of carbon steel and between 3-4 coupons were used during one experiment. The coupons were weighed before salt addition and roughly 0.1 g of the studied salt was added on top of the coupon. The carbon steel coupons with salts on top placed on the sample tray are shown in Figure 2. A thermocouple is located at the tip of the sample tray to record the temperature close to the samples during the experiments.

Figure 2. Carbon steel coupons with salt in top placed on the sample tray.

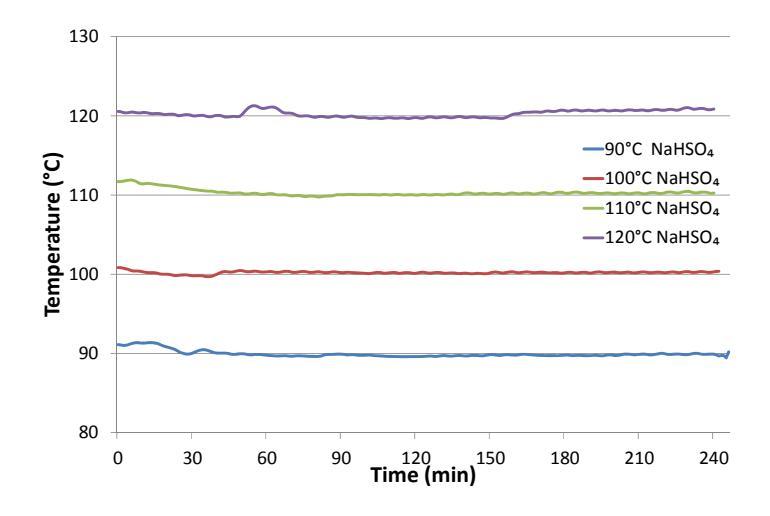
Figure 3. Temperature during 4 hour NaHSO₄ experiments.

The recorded temperatures at the sample tray for the 4 hour NaHSO₄ experiments are shown in Figure 3, 4 hour Na₂SO₄ experiments in Figure 4, and the 24 hour Na₂SO₄ experiments in Figure 5. When the experiments started it took roughly 30 minutes for the temperature inside the tube furnace to stabilize. This is because the steam exits the generator at 165 C and the other temperature controllers have to adjust to get the system temperature down to the target temperature. However, the key is that the temperature is only very slightly above the target temperature for those approximately 30 minutes and won't affect the corrosion results. The temperature was stable during the experiments and the tube furnace was suitable for running experiments in low temperatures. For some reason during the 24 hour 90°C Na₂SO₄ experiment every 4 hours a small decrease in temperature was detected. The reason behind this regular decrease remained unknown.

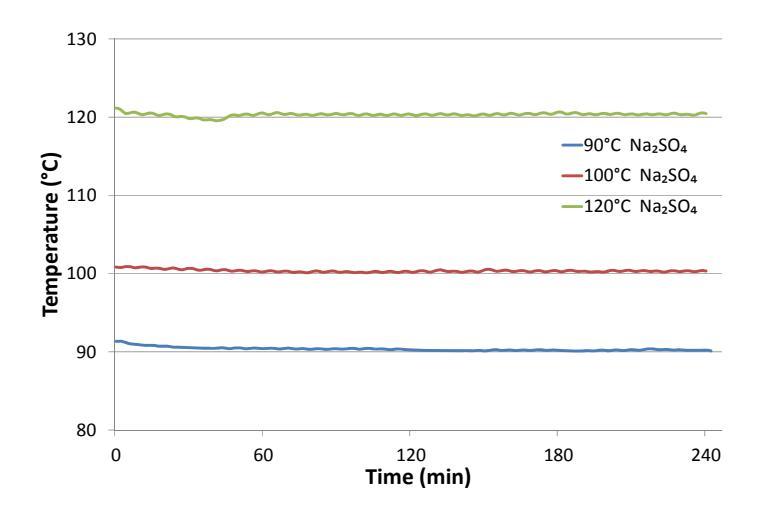
Figure 4. Temperature during 4 hour Na₂SO₄ experiments.

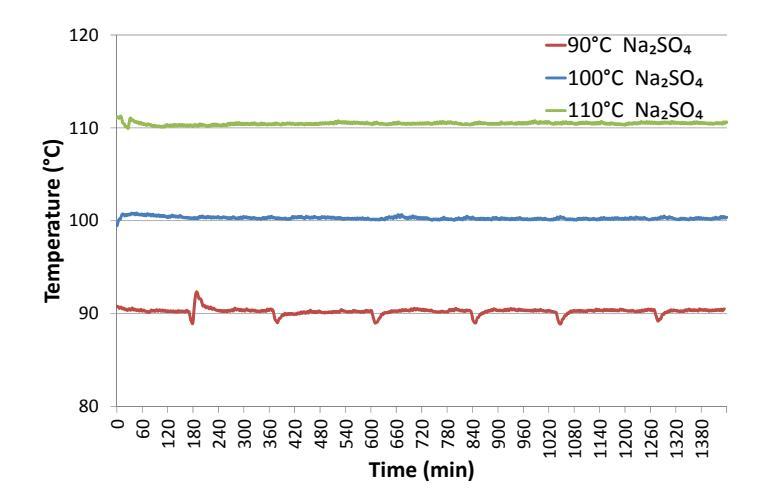
Figure 5. Temperature during 24 hour Na₂SO₄ experiments.

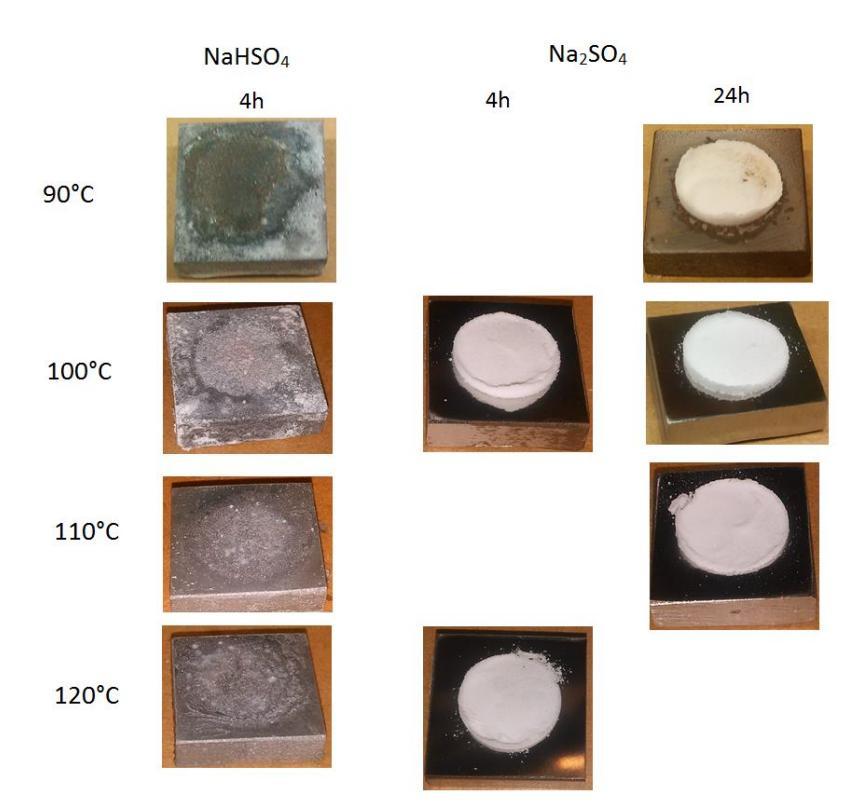
A photograph of the carbon steel coupons after the experiments before washing is shown in Figure 6. Sodium bisulfate was extremely hygroscopic, and absorbed moisture from the wet gas flow in all conditions. This can be seen as there was little to no salt remaining on the coupon after the experiments. This was not expected. Based on literature data for the humidity of deliquescence, it was expected that the temperature at which water would no longer be absorbed was _____ °C. Sodium sulfate is much less hygroscopic, and the salt was only slightly moist at the lower temperatures. It can be seen that the salt cake for the Na₂SO₄ experiments are more intact.

Figure 6. Corrosion samples after the experiments.

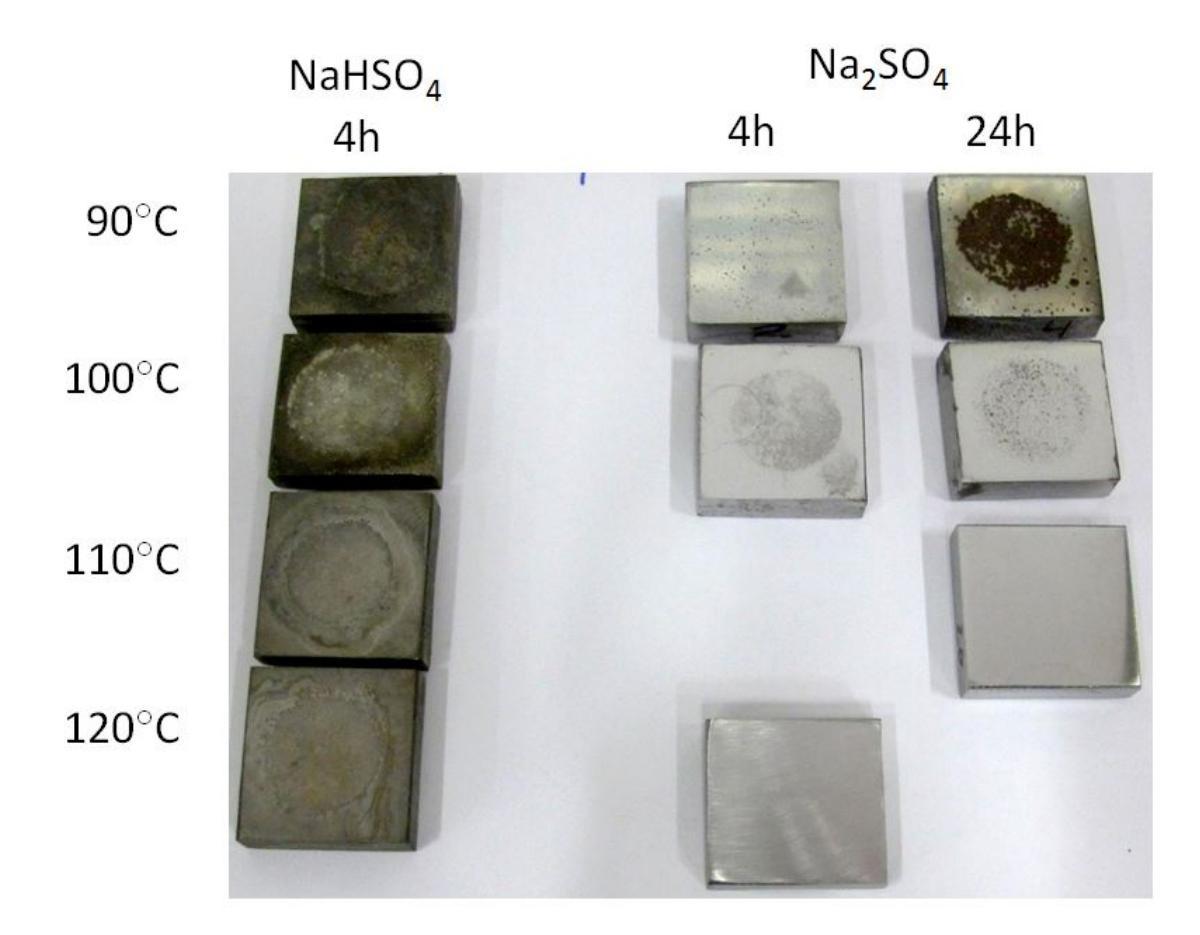
Figure 7 shows the carbon steel coupons after the salt residue was washed off. After the visual inspection it was clear that NaHSO₄ caused corrosion of the carbon steel at all temperatures with the corrosion being more severe the lower the temperature. This is due to the formation of an acidic bisulfate solution on the coupon. In the experiments with Na₂SO₄, no corrosion was visible after the 110°C and 120°C. After the 4 h experiments at 90°C and 100°C small spots of corrosion could be observed. To these results, 24h runs were made. These runs showed the same, that corrosion occurs at 90°C and 100°C, with more corrosion at 90°C than 100 °C. The corrosion experiment with Na2SO4 at 110 °C was run for 24 hours since if corrosion were to occur at 4 hours it would have been very slight. The coupon from the 24 hour run at 110 °C, however, showed no corrosion.

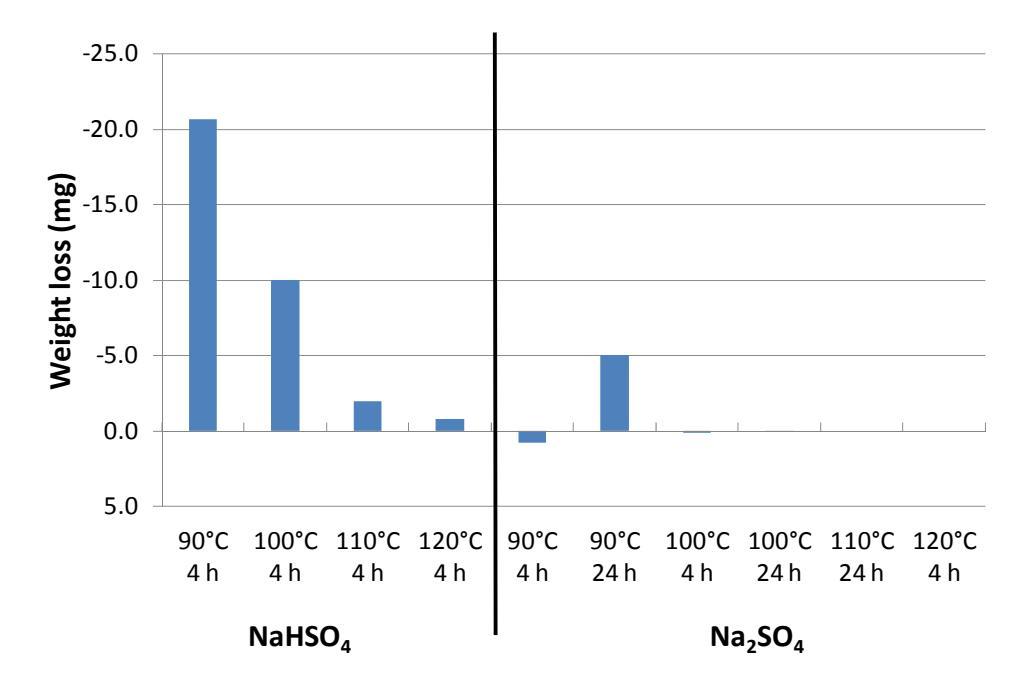
After the experiment the carbon steel coupons were washed to remove the salt residue and then weighed in order to determine the weight change due to corrosion. Generally, the corrosion layer is removed during the washing process and the weight loss is due to the removal of the corrosion product. This weight was compared to the initial coupon weight, Figure 8. The results clearly show that the corrosion was more severe for the NaHSO₄ covered carbon steel samples at lower temperature than at higher temperatures. The 4 h 90°C Na₂SO₄ experiment showed a slight increase in weight after the experiments because the iron oxide was not removed by the washing process. The coupon from the 24 h 90°C Na₂SO₄ experiment, in which the corrosion was more severe, showed a decrease in weight. The formation of iron oxide during the 100°C Na₂SO₄ experiments was so low that no weight change was recorded. At higher temperatures no corrosion product was formed with Na₂SO₄.

Figure 8. Material loss of the carbon steel samples due to corrosion.

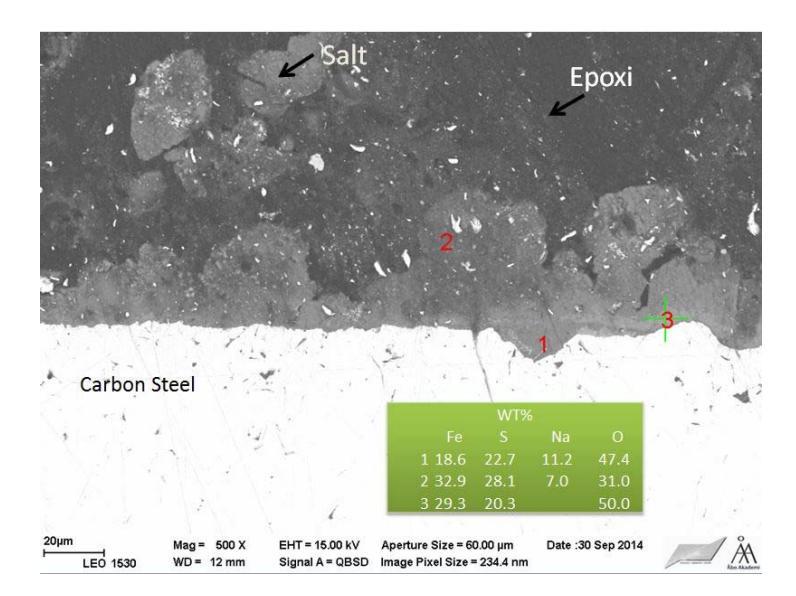
Figure shows the cross section SEM image of the carbon steel covered with NaHSO₄ after the 4h exposure at 90°C. The white flakes are pieces of metal originating from the cutting and polishing of the cross section sample. The dark grey areas are the epoxy mold and the light grey is either salt or salt mixed with the corrosion product. From the SEM image clear pitting corrosion can be observed. This is consistent with acidic corrosion due to the acid bisulfate solution produced when NaHSO₄ absorbed water from the gas. The corrosion products consisted of a mixture of iron, sodium, sulfur and oxygen (analysis spots 1 and 2 on the figure). The spot analysis (spot 3) showed clearly that FeSO₄ is formed as a corrosion product.

Figure 9. Cross section SEM image of the NaHSO₄ covered carbon steel after 4 h and 90°C experiment.

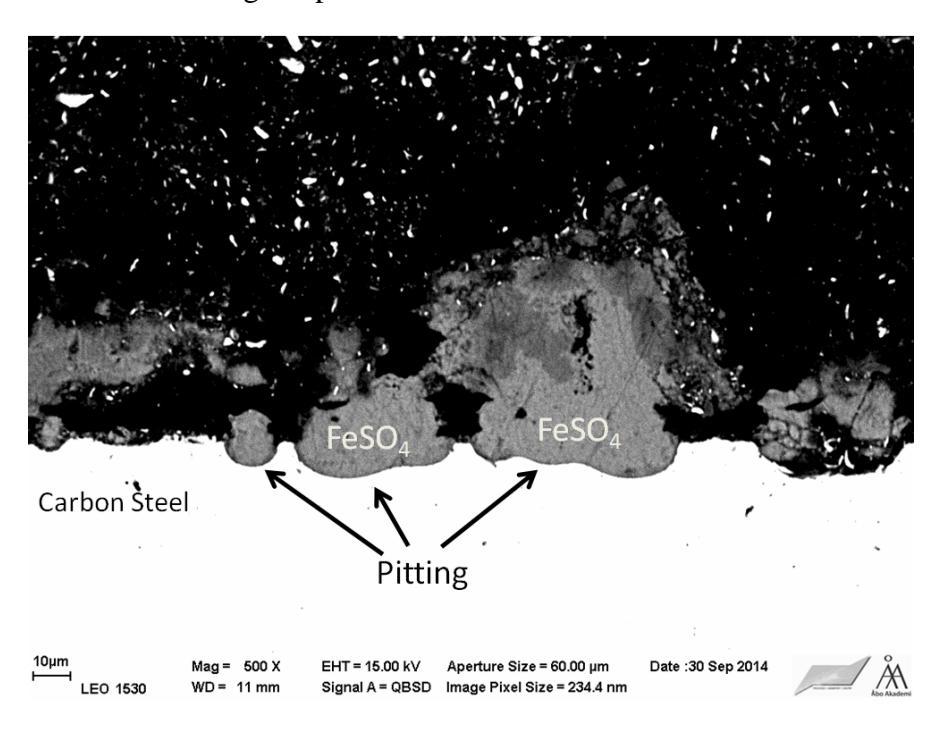
Figure clearly shows the pits formed from the acid corrosion after exposure with NaHSO₄ for 4h and 100°C. The pits are about 10 μ m deep and are filled with FeSO₄. Increasingly deep pits were observed with decreasing temperature.

Figure 10. Cross section SEM image of the NaHSO₄ covered carbon steel after 4 h and 100°C experiment.

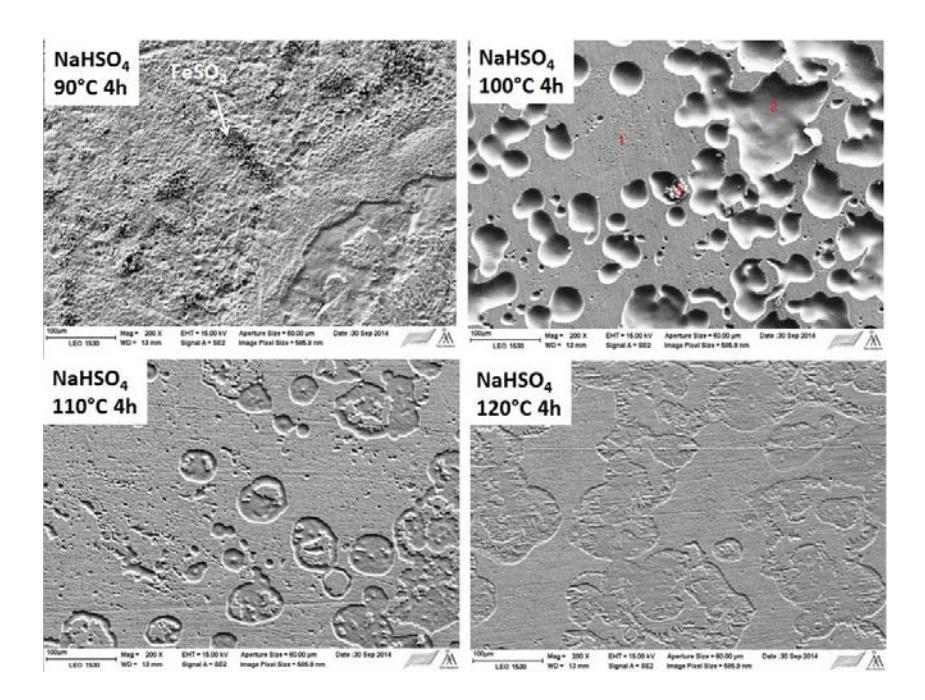
Figure 9 shows the top surface of the washed carbon steel coupons after the experiments with NaHSO₄ at different temperatures. After washing, some corrosion product (FeSO₄) remained on the surface of the carbon steel sample used in the 90°C experiment. The corrosion was more severe at lower temperatures than at higher. At the lowest temperature the whole sample was corroded, while at higher temperatures pit corrosion was only detected on the surface of the carbon steel sample. The cross section SEM images of the NaHSO₄ covered carbon steel samples showed increasingly deep pits at decreasing temperature; for the 90°C case the pits were around 19 μ m deep, for 100°C 10 μ m deep, and for 110°C the pits were approximately 4 μ m deep. The pit depth for the 120°C NaHSO₄ corrosion sample was not measured.

Figure 9. SEM surface image using 200x magnification with secondary electron detector of the washed NaHSO₄ corrosion coupons.

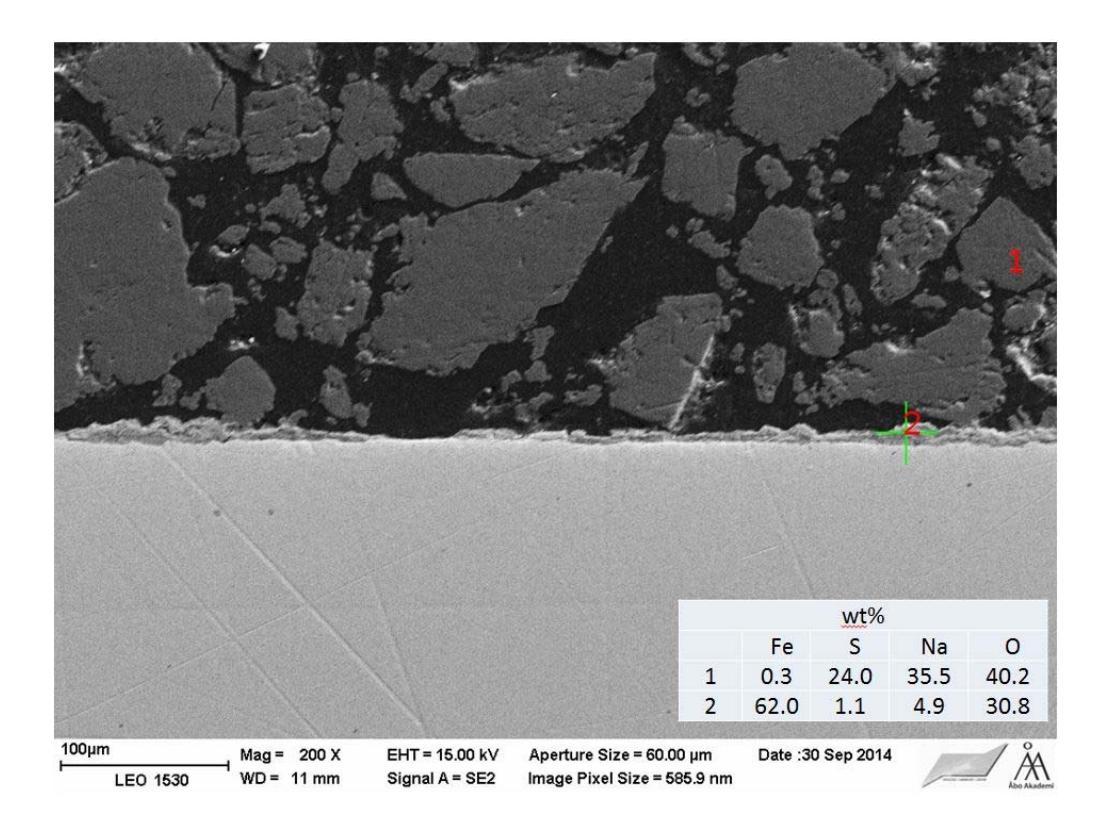
Figure 10 shows the SEM cross section image of the carbon steel sample covered with Na_2SO_4 after 24h exposure at 90°C. The black in the Figure is the epoxy, lightest grey is the steel and the darkest grey is the salt crystals. There was a clear corrosion layer on top of the carbon steel which consisted of iron oxide (spot 2 in Figure 10) and had an average thickness of roughly 10 µm. Unlike with the NaHSO₄ samples, there is not pitting. This is characteristic of water dew point corrosion.

Figure 10. Cross section SEM image of the Na₂SO4 covered carbon steel after 24 h 90°C experiment.

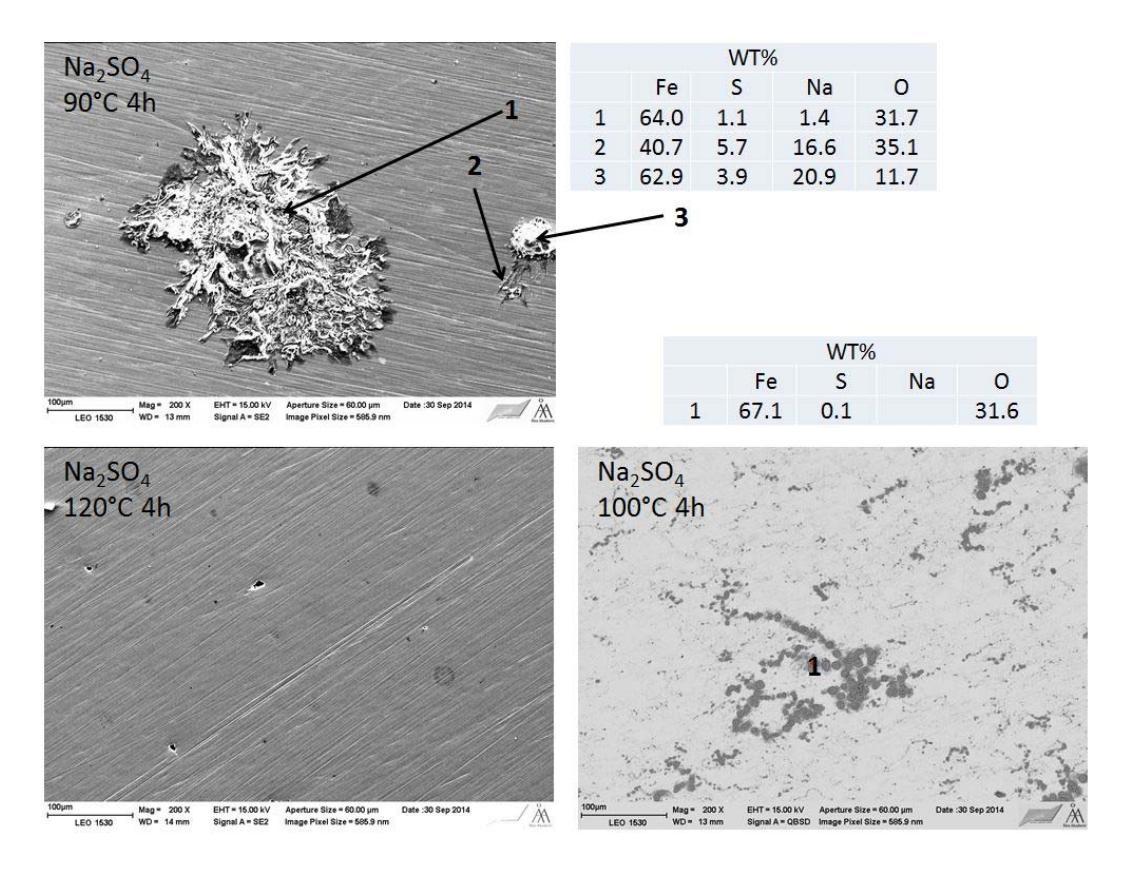
Figure 11 shows the surface SEM images of the washed carbon steel samples after the 4 hour experiments at different temperatures. At 90 °C, there are clear areas of iron oxide on the surface. At 100 °C, there has been significantly less corrosion of the surface, but iron oxide is still detected. No visible corrosion was seen in the corrosion coupon after the 4 hour experiment at 120° C.

Figure 11. SEM surface image using 200x magnification of the washed Na₂SO₄ corrosion coupons after 4 hour exposure.

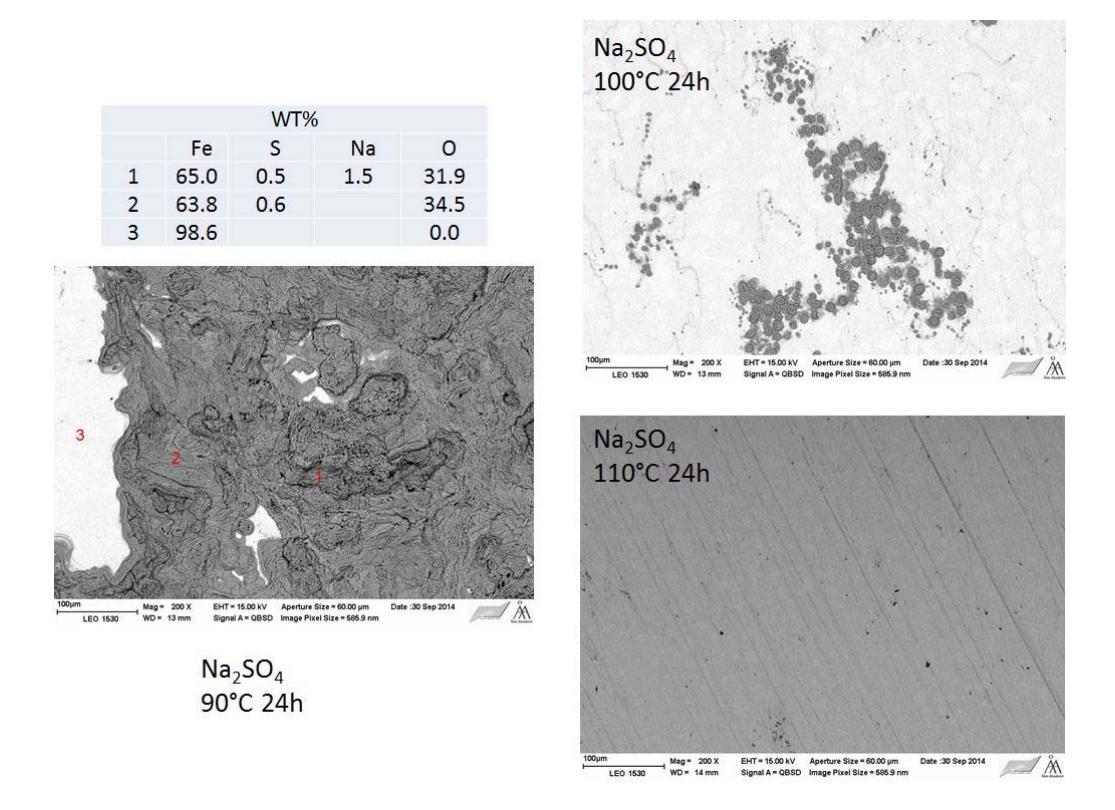
Figure 12 shows the SEM images of the surfaces of the washed carbon steel samples after the 24 hour experiments at different temperatures. The same trend with the carbon steel samples was noted after the 4 h experiments as after the 24h experiments. The severest corrosion was seen at 90 °C, some corrosion at 100 °C and no corrosion at 110 °C.

Figure 12. SEM surface image using 200x magnification of the washed Na₂SO₄ corrosion coupons after 24 hour exposure.

The fact that corrosion is seen at 100 °C, indicates that more work needs to be done to measure the humidity of deliquesce for sodium sulfate at conditions relevant to the recovery boiler.
